WANL-TME-1479
August, 1966

EVALUATION OF EXTRUDED-TO-SIZE ELEMENTS
(Title Unclassified)

INTRODUCTION

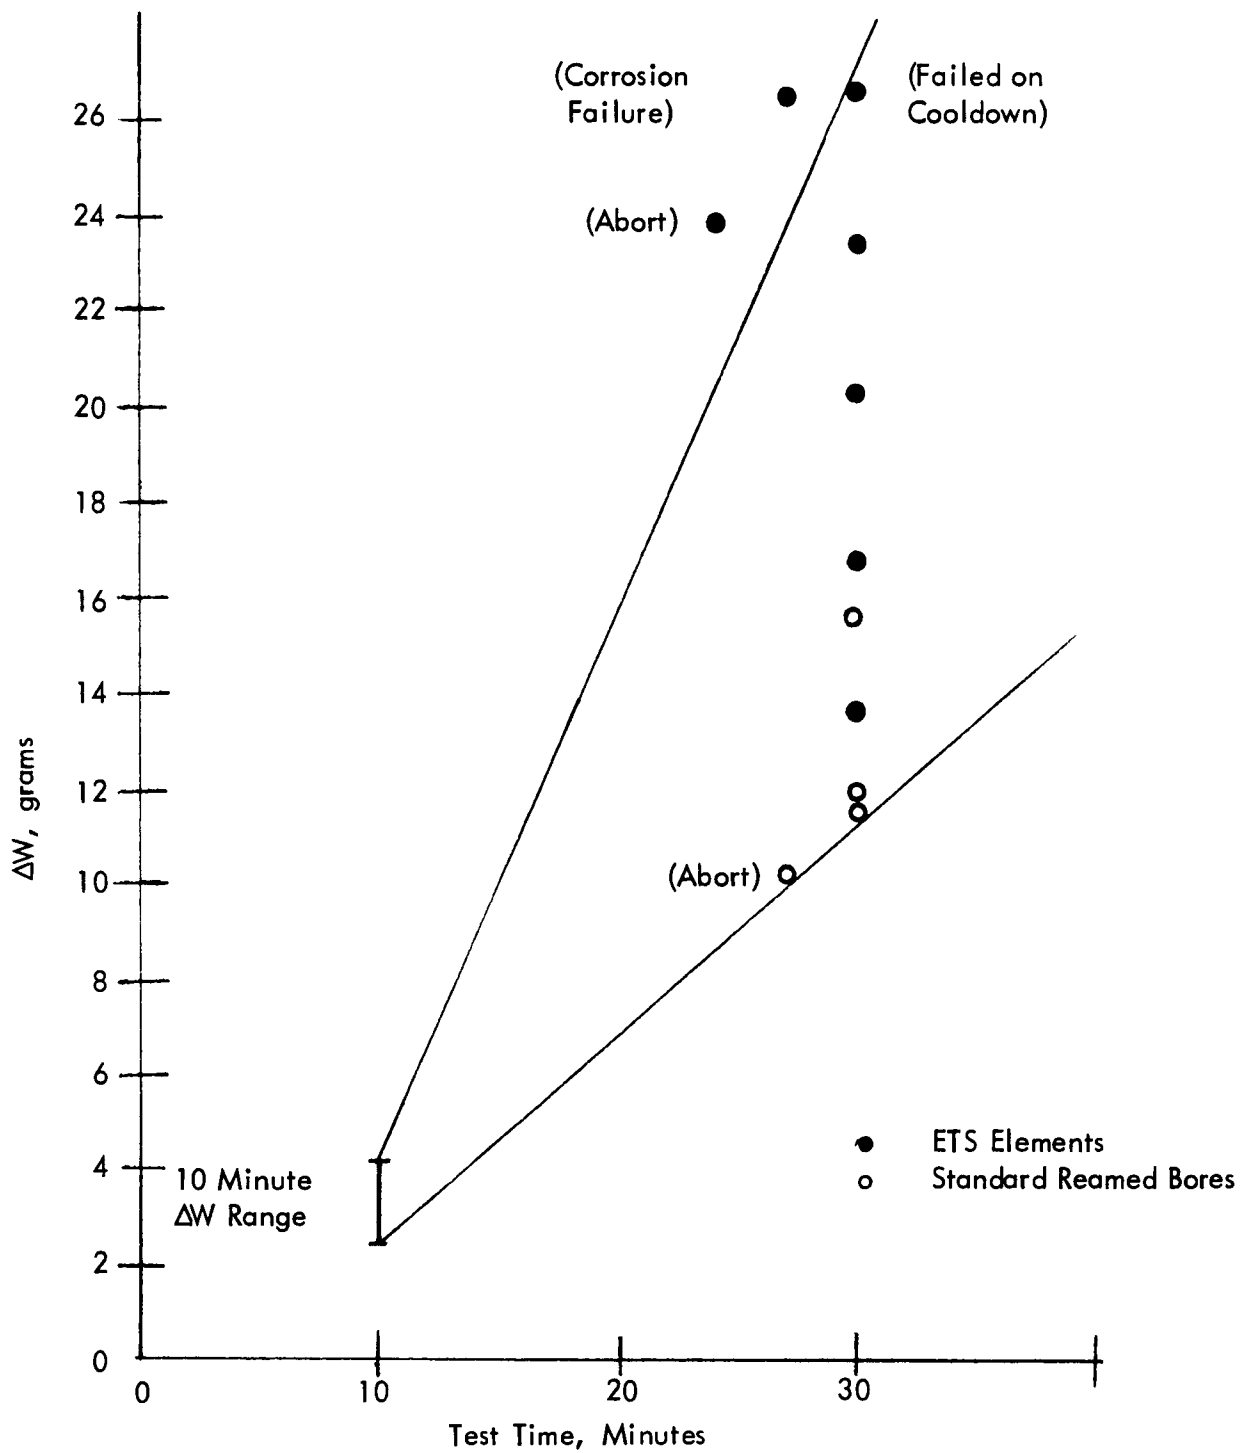
FIGURE 1 - Comparison of IB Corrosion Behavior of ETS and Standard Reamed Elements

Although the hydrogen test results show little difference in 10-minute weight losses, there is a tendency for the ETS elements to have larger 30-minute weight losses as shown in Figure 1. This additional weight loss in the ETS elements appears to be due to increased corrosion in the mid-band region as reflected in the electrical resistance curves. The resistance curves show a much wider mid-band peak for the ETS elements than is seen in elements with standard reamed bores. It should also be noted that two ETS elements failed in the mid-band region, one after 27 minutes of testing and one after 30 minutes. There were no failures in the elements with reamed bores.

The limited number of corrosion tests performed on ETS leached and non-leached elements show that these elements have poorer corrosion behavior than do standard reamed elements. The standard elements had an average ΔW of 12.3 grams while the ETS elements had an average ΔW of 20.0 grams for 30 minutes of testing at 1B temperatures. The additional weight loss observed in the ETS elements is believed to occur in the mid-band region. In addition, two ETS elements failed due to mid-band corrosion while the elements with reamed bores had no failures.

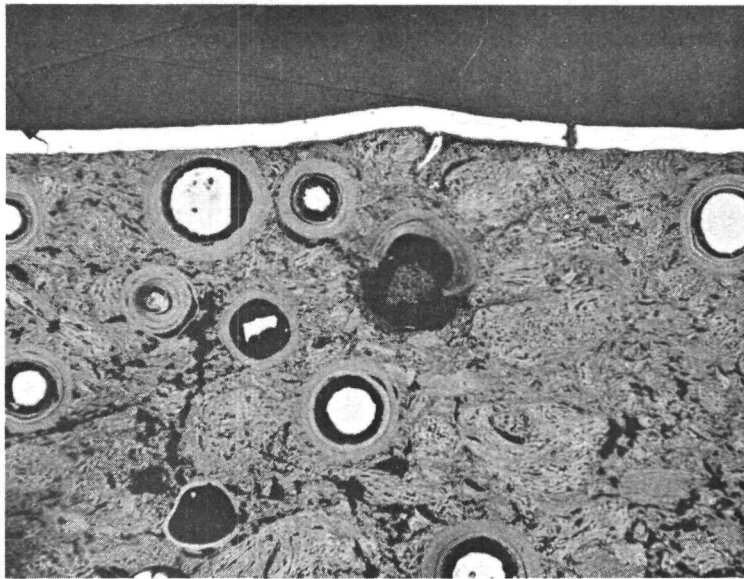
FIGURE 2

One of the most noticeable effects of extruding bores to size is the formation of large porous areas near the coating-graphite interface that protrude into the channels. It appears that some of these areas form when damaged fuel beads expand (due to interaction

of exposed UC_2 with binder), forcing relatively large volumes of matrix material toward the channel. Two typical porous areas are shown in Figure 2. It should also be noted that this type of defect was observed in earlier ETS elements.

(a) Damaged Bead Causing Buckling of Matrix

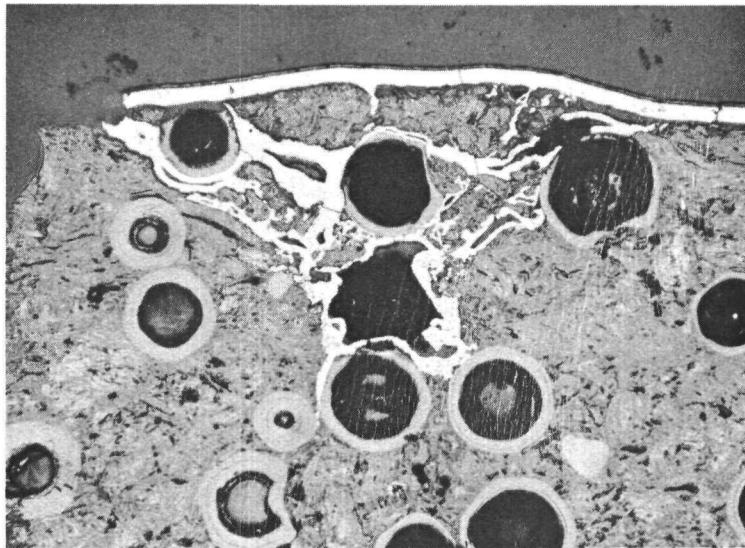
The major effect resulting from extruding elements to size that can be seen in the microstructure of these elements is the presence of large porous areas which extend into the channels. There are indications that some of these areas may break away during hydrogen testing allowing large areas of graphite exposed during subsequent tests.

(b) Porous Area
