**Ultrasonic Examination of
Double-Shell Tank 241-AN-101
Examination Completed November 2005**

AF Pardini
GJ Posakony

November 2005

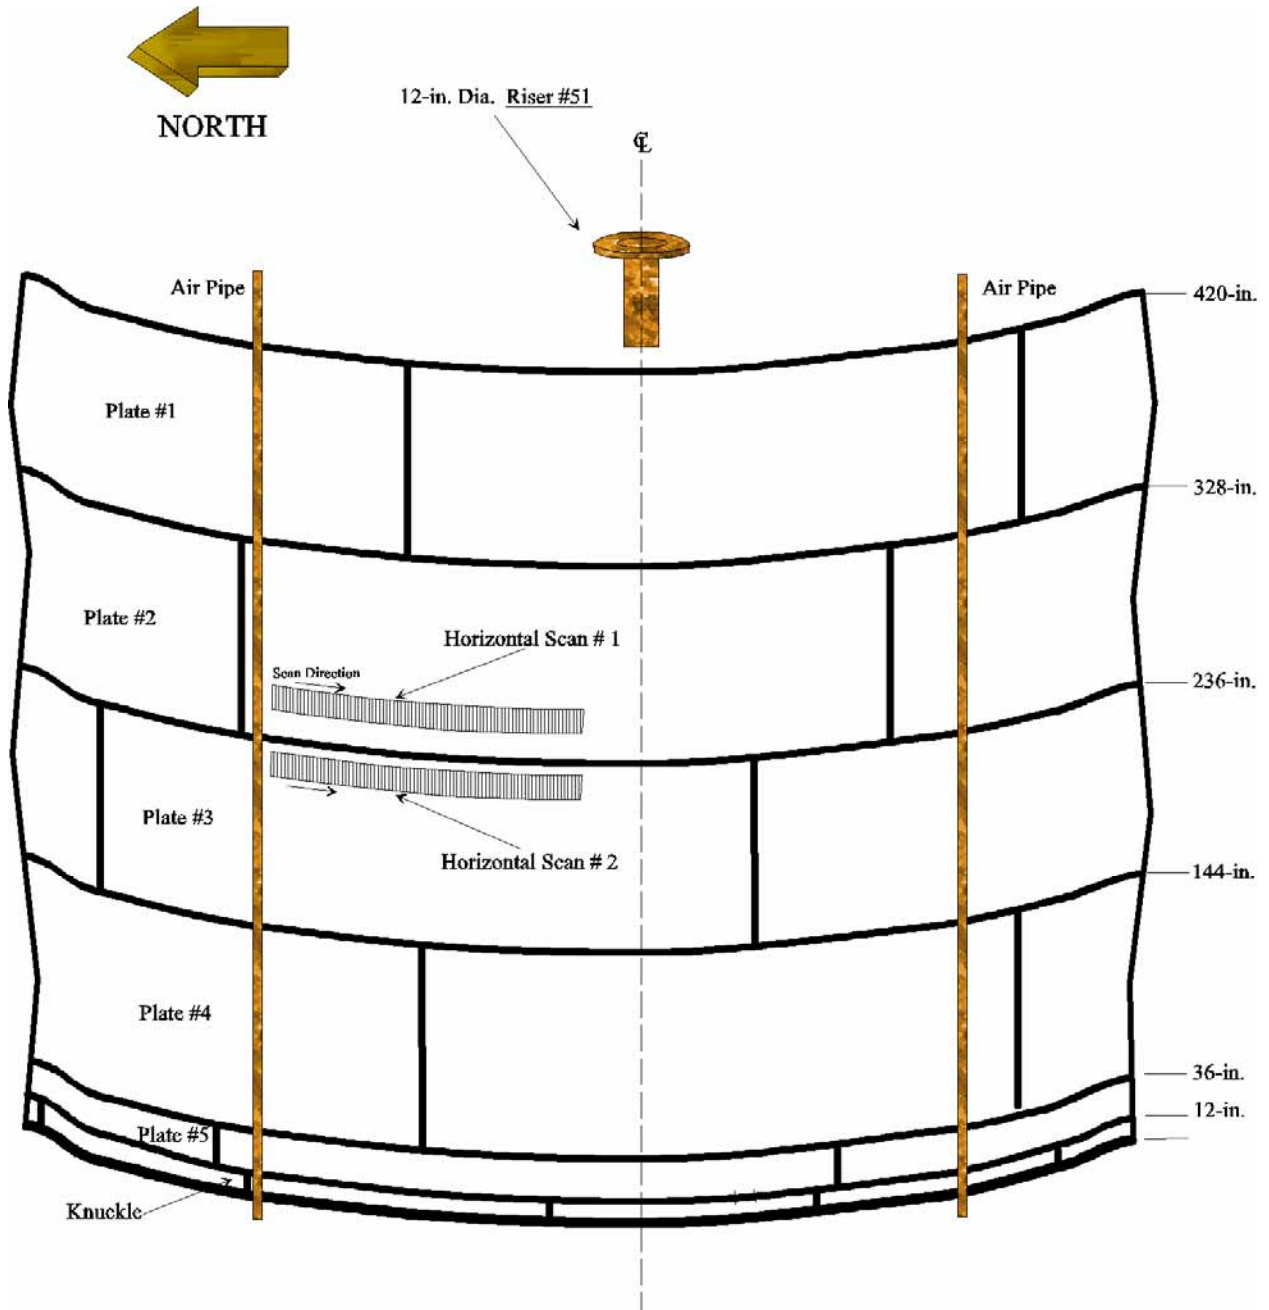
Figure 4.2. Sketch of Scan Paths on Tank 241-AN-101

Figure 4.2 describes the areas on the primary wall of Tank 241-AN-101 that were ultrasonically examined. One 11-in.-wide horizontal scan path was performed on Plate #2, and one 11-in.-wide horizontal scan path was performed on Plate #3. Both scans began at the air line north of the 12-in. entrance riser #51.

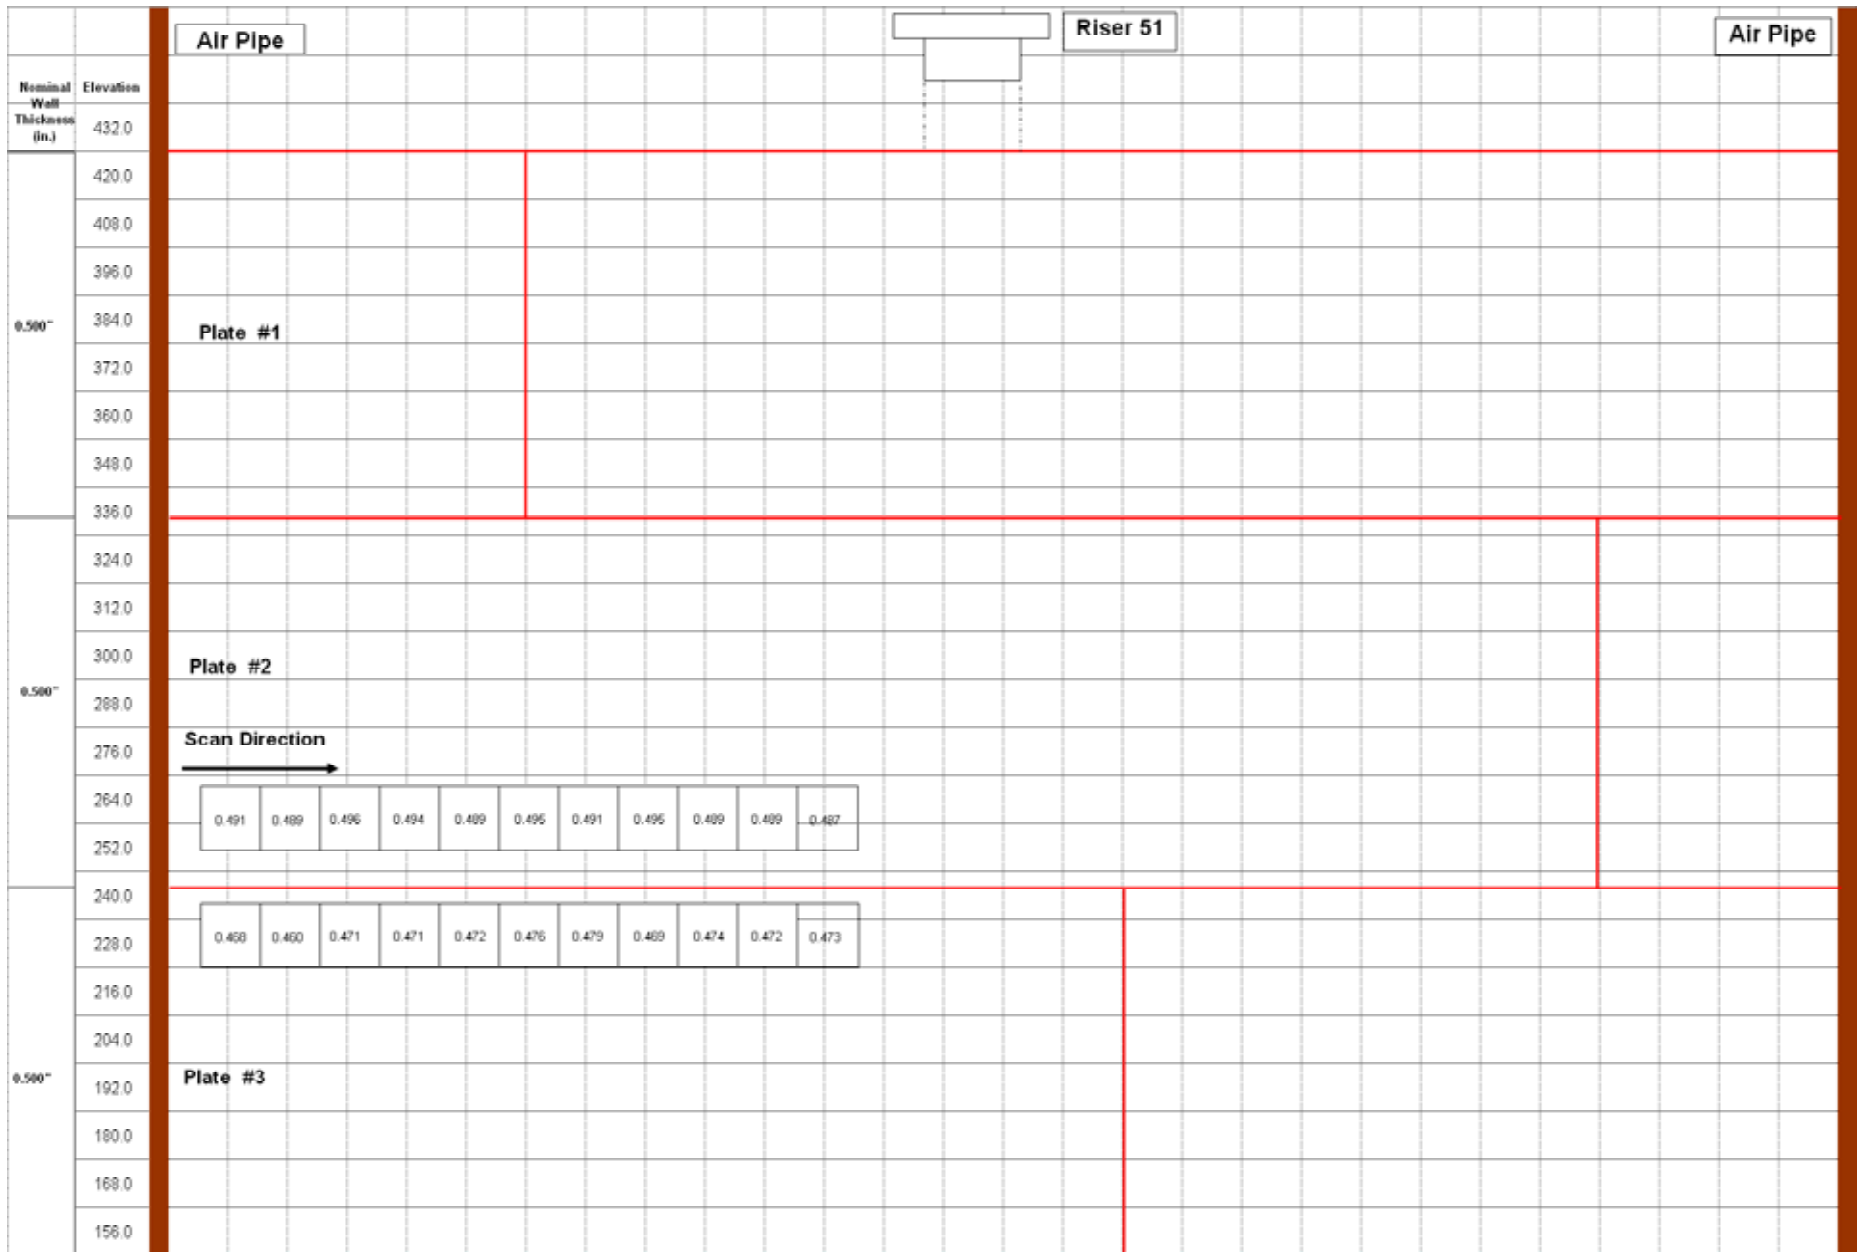
Figure 5.1. UT Data from Tank 241-AN-101

Figure 5.1 shows the wall thickness examination results for the primary tank wall. The examination consisted of one 11-in. wide scan path approximately 11-ft. long on Plate #2 and one 11-in. wide scan path approximately 11-ft. long on Plate #3. Figure 5.1 displays the minimum readings taken in each 11-in. wide by 12-in. long area of the scan.

One 11-in.-wide horizontal scan path approximately 11-ft. long was performed on Plate #2. The plate was examined for wall thinning and pitting on the primary tank wall. The results indicated that the minimum thickness in the areas scanned on Plate #2 with nominal thickness of 0.500-in. was 0.487-in. There were no areas of wall thinning that exceeded the reportable level of 10% of the nominal thickness. No pitting indications were detected in Plate #2.

One 11-in.-wide horizontal scan path approximately 11-ft. long was performed on Plate #3. The plate was examined for wall thinning and pitting on the primary tank wall. The results indicated that the minimum thickness in the areas scanned on Plate #3 with nominal thickness of 0.500-in. was 0.460-in. There were no areas of wall thinning that exceeded the reportable level of 10% of the nominal thickness. No pitting indications were detected in Plate #3.
