**Pacific Northwest
National Laboratory**

**Ultrasonic Examination of Double-Shell
Tank 241-AN-103
Examination Completed October 2005**

AF Pardini
GJ Posakony

January 2006

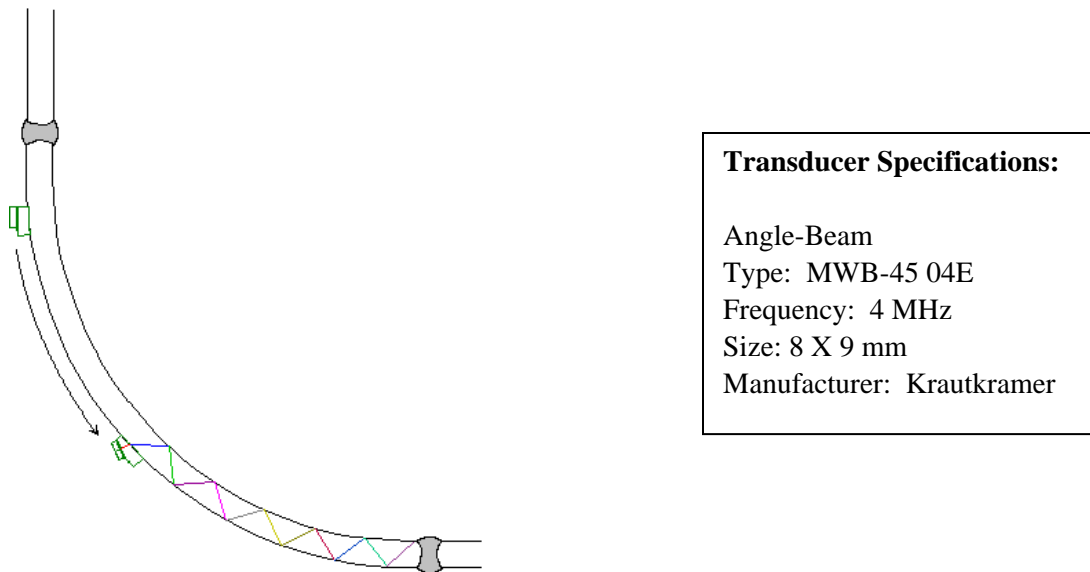
Figure 3.1 Lower Section of the Knuckle Examined

Examination of the knuckle utilizes a modified scanning bridge known as the Y-arm scanner. The Y-arm provides scanning of the transducers directly on the knuckle region. The Y-arm is a special fixture that attaches to the AWS-5D magnetic wheel crawler. Its purpose is to extend the reach of the transducer assembly. This extension allows the transducer assembly to follow the curve of the upper portion of the knuckle below the transition Plate #5 to upper knuckle weld. It is designed to hold the dual 0-degree or two 45-degree transducers in the same configuration as used for the examination of the tank wall. The transducer configuration used for crack detection in this examination was a single 45-degree angle-beam transducer oriented in the axial direction. This configuration is designed to detect cracks that are in a circumferential direction with respect to the axis of the tank. Figure 3.1 is a sketch showing the section of the knuckle examined using the Y-arm fixture. With the transducer positioned 2-in. below the transition Plate #5 to upper knuckle weld, the scanning bridge was set to scan the transducer downward an additional distance of approximately 8-in. in 0.035-in steps (or as set by the UT inspector). The remaining distance between the transducer and the lower knuckle weld joining the bottom plate is interrogated utilizing a multiple V path technique qualified for the extended Y-arm scanner. (Pardini 2005)

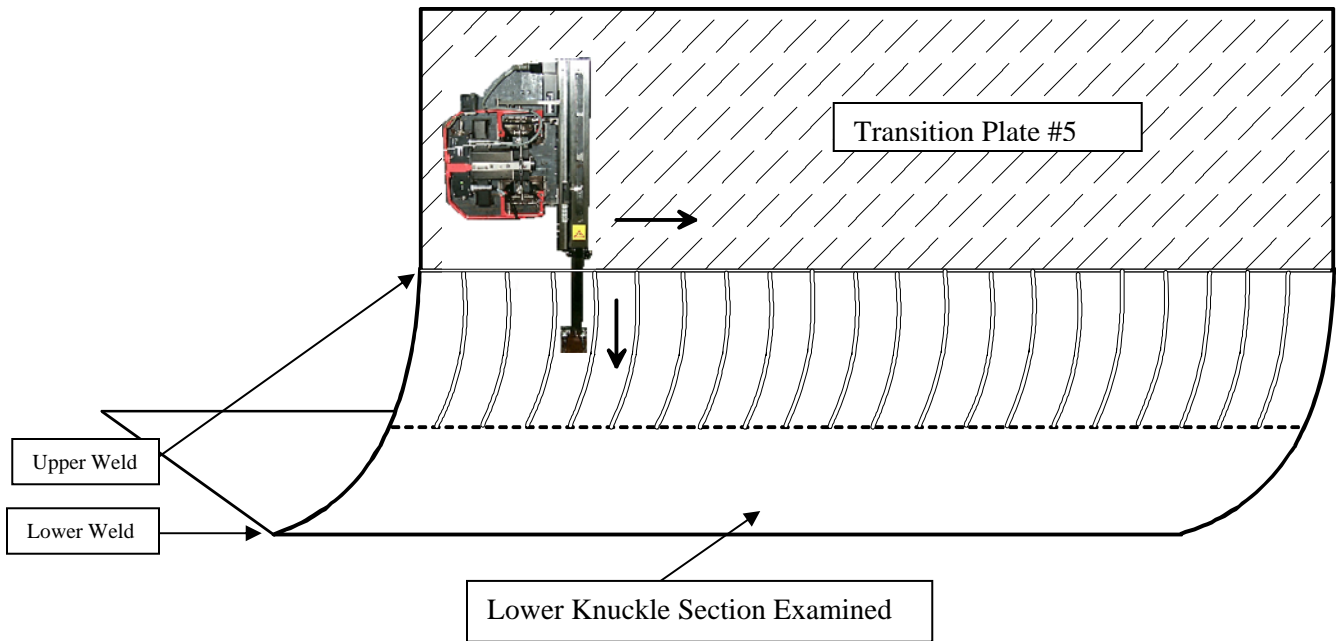
Figure 3.2. Sketch of the Lower Section of the Knuckle Examined with the Y-Arm Scanner

Upon completion of the single line scan, the bridge was indexed circumferentially 0.035-in. (or as set by the UT inspector) and the scan downward is repeated to obtain a pixel size 0.035-in. x 0.035-in. This scan pattern continued for approximately 20-ft. circumferentially as shown in Figure 3.2.

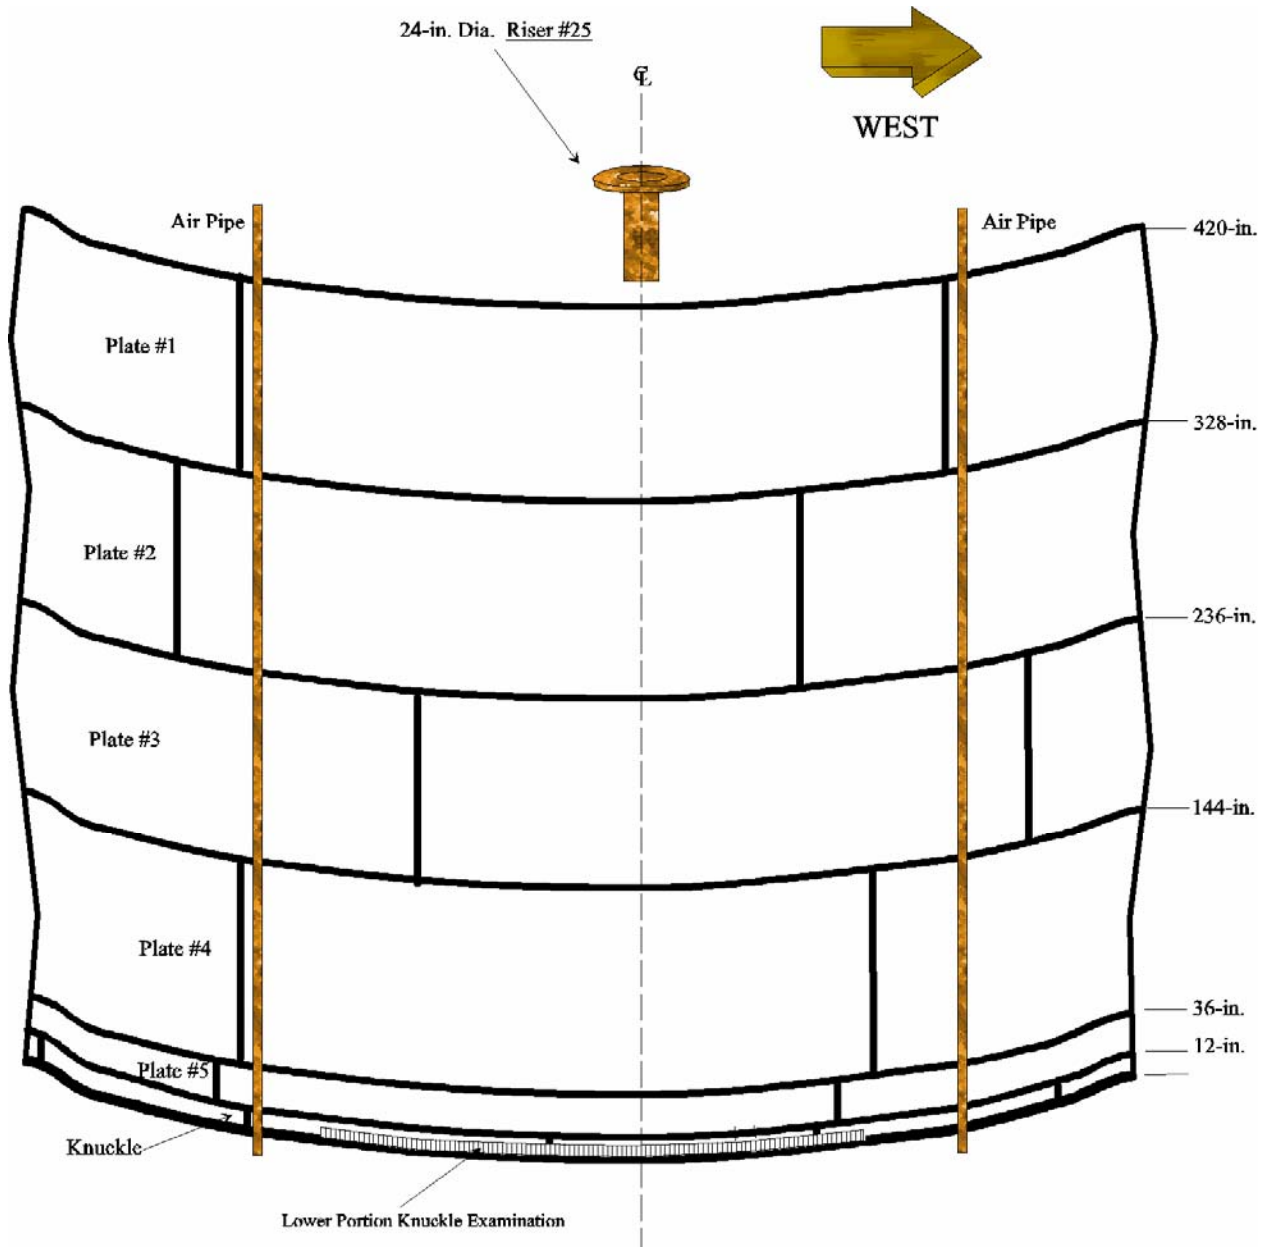
Figure 4.2. Sketch of Scan Paths on Tank 241-AN-103

Figure 4.2 describes the areas on the primary wall of Tank 241-AN-103 that were ultrasonically examined. The ultrasonic examination consisted of one approximately 20-ft long scan around the circumference of the primary tank lower knuckle region. The examination was performed to detect any circumferential cracking that may be present in the lower portion of the primary tank knuckle region.

COGEMA has provided detailed reports, including P-Scan hard copies of all areas that were ultrasonically examined, to PNNL for third-party review. The data was acquired and analyzed by COGEMA Level III Mr. Wes Nelson. The results of the examination of Tank 241-AN-103 showed no indication of cracking present in the approximately 20-ft. of lower knuckle area examined.
