2006 Annual Operations Report for INTEC Operable Unit 3-13, Group 1, Tank Farm Interim Action

February 2007

DOE/ID-11310
Revision 0
Project Nos. 20978 and 23614

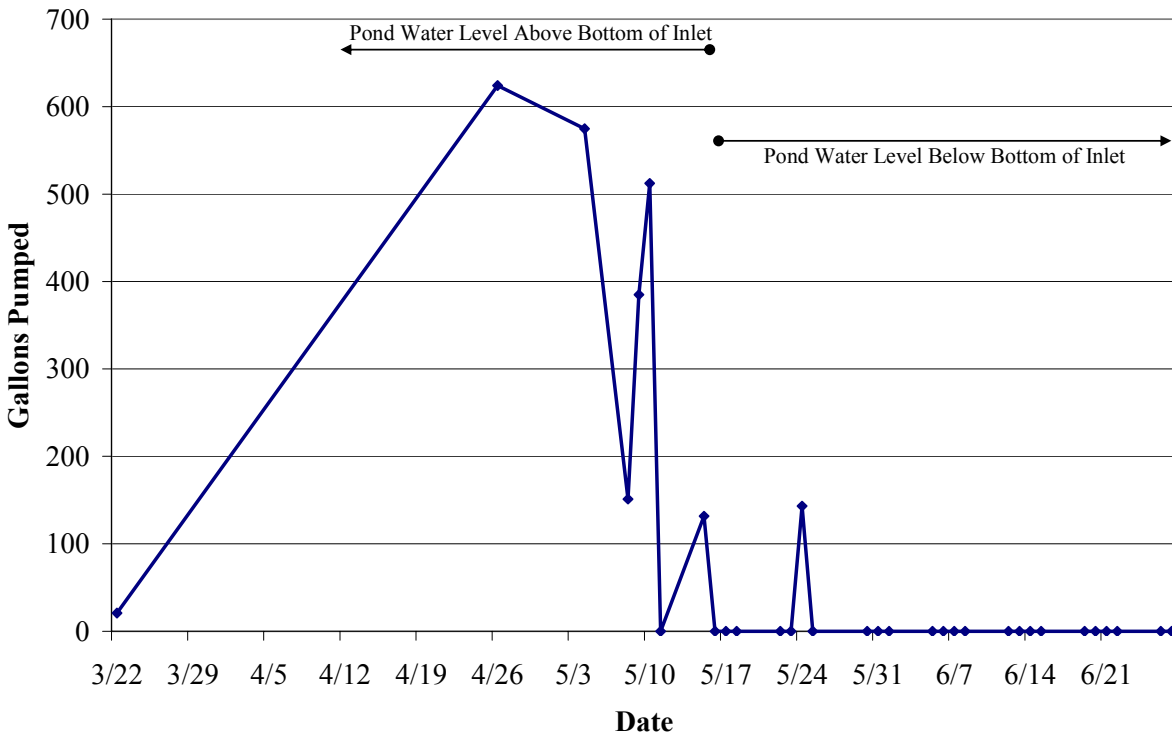
Figure 4-1. Daily gallons of water pumped from the evaporation pond sump from March 22 through June 27, 2006.

During an Agency inspection visit on April 26, 2006, it was observed that the leak detection system's totalizer reading was significantly higher than what was recorded the previous month during the quarterly inspection. On March 22, 2006, during a scheduled quarterly inspection, the totalizer reading was noted to be 6,166.5 gal and on April 26, 2006, the totalizer reading was noted to be 28,005.1 gal for a difference of 21,838.6 gal. Upon receipt of notification of this off-normal totalizer reading, project management formulated a technical response team to discuss and implement appropriate action to evaluate the excessive pumpage of water from the secondary liner in the evaporation pond. Actions implemented were

With the information obtained from the visual inspections and the evaluation of the monitoring data, the project concluded that the rubber seal was the cause of the high leak rate. The HDPE liner manufacturer was contacted and provided the recommendation to apply a neoprene flashing cement to the contact between the boot liner and CMP as it was compatible for use on HDPE material. The old seal has since been removed and replaced with neoprene cement and the work was completed during the first week of December 2006. Success by this repair in reducing the leak rate will be determined when the water level again rises to the CMP inlet level (spring 2007). The boot area is the only place where this rubber sealing material was used during initial construction. This issue is restricted to the boot area and is not a more widespread problem within the pond.

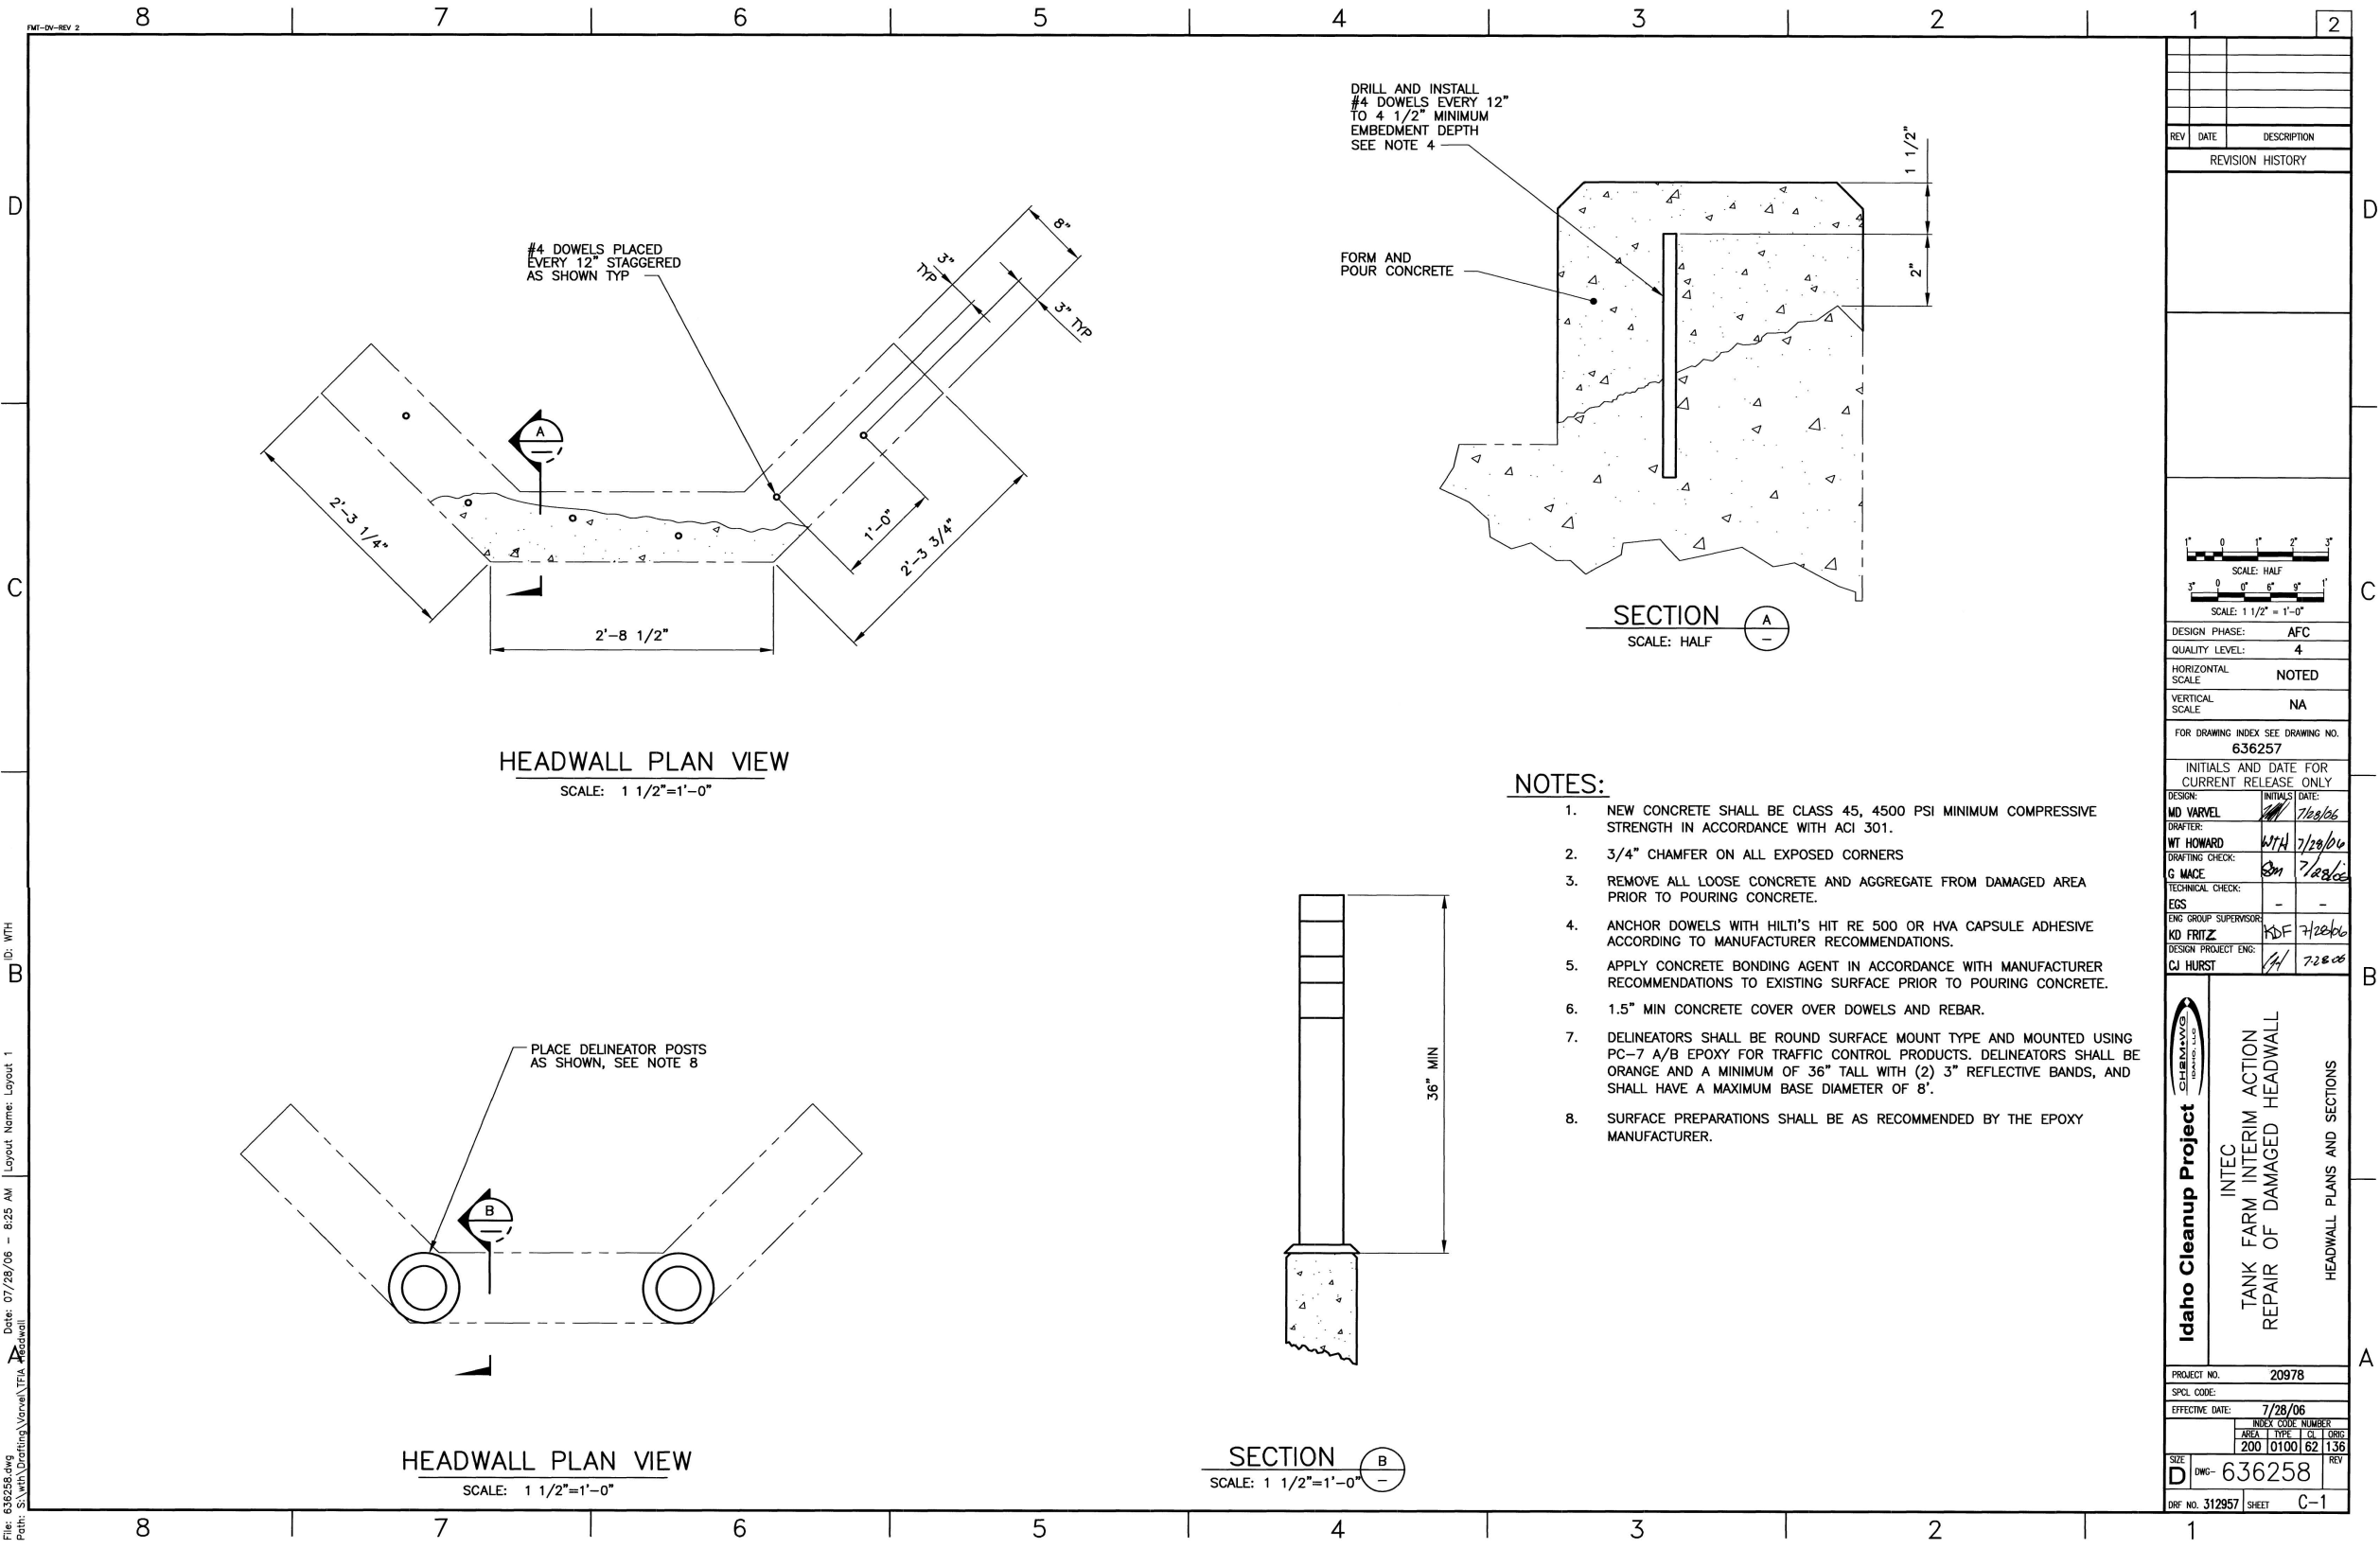
Design Drawing for the Repair of Damaged Headwall

Reported Date	Item	Comments and Action Taken
3/22/06	Several ditches contain sand/gravel and debris and many culvert inlets are filled with debris.	Reoccurring preventative maintenance work order established to clean sand/gravel and debris from the ditches and culverts implemented. Maintenance work completed.
3/22/06	The surface of approximately 68 ft of concrete-lined ditch (BS1) along Beech Street (northwest of the tank farm) has spalled. Surface of the concrete is deteriorating.	Subcontract prepared and awarded to have five sections, totaling approximately 68 ft of concrete-lined ditch removed and replaced. Original design followed. Replacement work completed.
3/22/06	Headwall to culvert C10 (see Figure 2-2) damaged during the winter months by vehicle contact. Approximately one-half of the top has been broken off.	Subcontract prepared and awarded to have the headwall repaired. Reflective orange delineator posts attached to the repaired headwall to deter future damage by vehicles (see Appendix A for headwall repair design drawing). Repair work completed.

DRILL AND INSTALL #4 DOWELS EVERY 12" TO 4 1/2" MINIMUM EMBEDMENT DEPTH SEE NOTE 4

FORM AND POUR CONCRETE
