U.S. Department of Energy
Idaho Operations Office

2005 Annual Operations Report for INTEC Operable Unit 3-13, Group 1, Tank Farm Interim Action

July 2006

DOE/ID-11275
Revision 1
Project Nos. 20978 and 23614

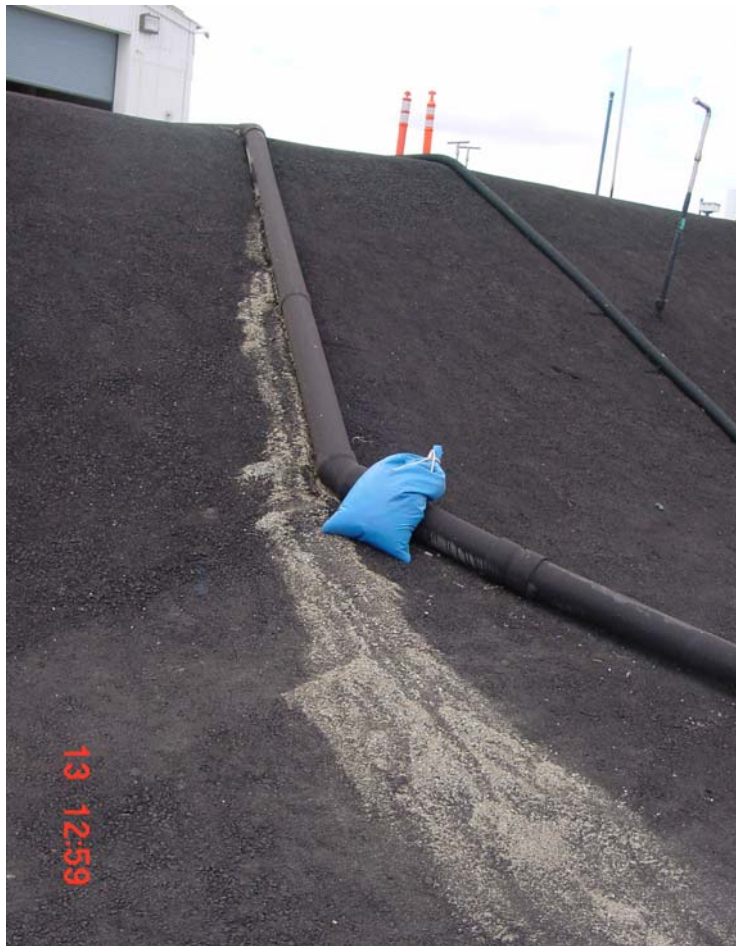
Reported Date	Item	Comments and Action Taken
9/13/05	Polyvinyl chloride (PVC) drainpipe from the top of the Site CPP-79 berm has separated from the asphalt and is allowing surface runoff to get under the surface-sealed area.	Lower part of drainpipe was removed and depression filled in with concrete. Areas around inlet/outlet of remaining drainpipe were sealed. Heat blankets were used to prevent freezing of concrete during curing process. Area seal-coated after concrete was cured. Repair method and materials approved by TFIA design engineer. Agencies were informed of repair plans during a WAG 3 conference call dated October 13, 2005, and Agencies approved of the use of concrete. Repairs were made within the 30-day time period between discovery and repair as required in the O&M plan (see Figures B-2, B-3, and B-4 in Appendix B).
10/18/05	Materials stored on top of the HDPE drainpipe near Site CPP-79.	All materials were removed from the area on October 19, 2005. The materials caused no damage to the HDPE pipe.

Figure B-2. Drain line over Site CPP-79 separated from asphalt and allowed water to get under asphalt layer.

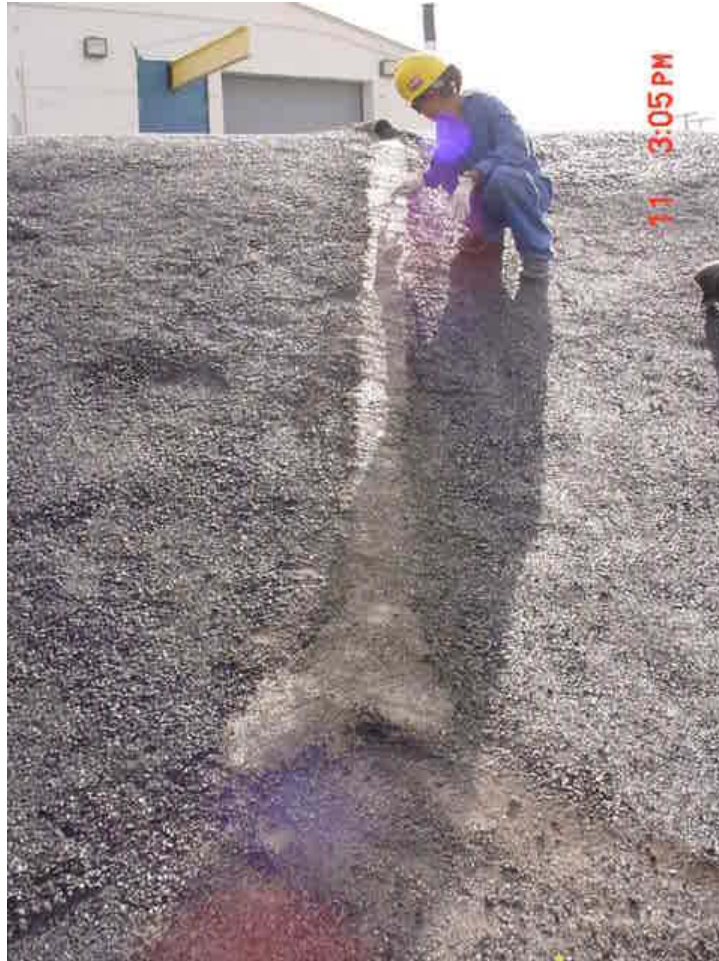
Figure B-3. Lower part of drain line over Site CPP-79 removed and depression filled in with concrete.

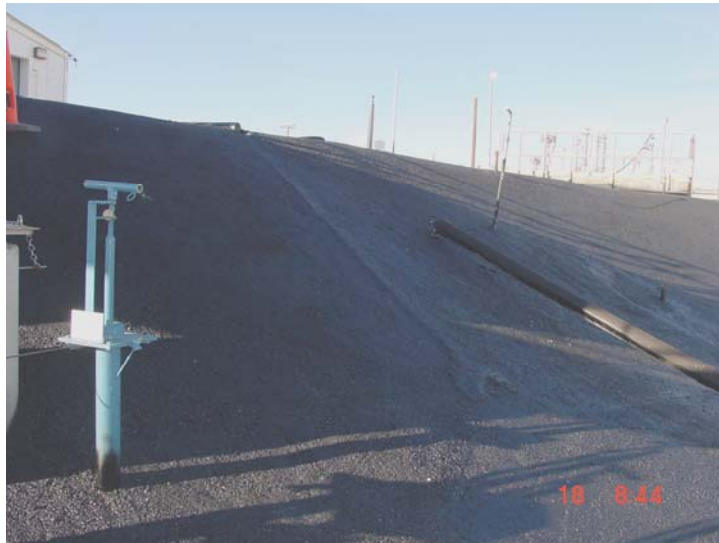
Figure B-4. Showing drain line over Site CPP-79 removed, depression filled in with concrete, and area sealed with seal coat.

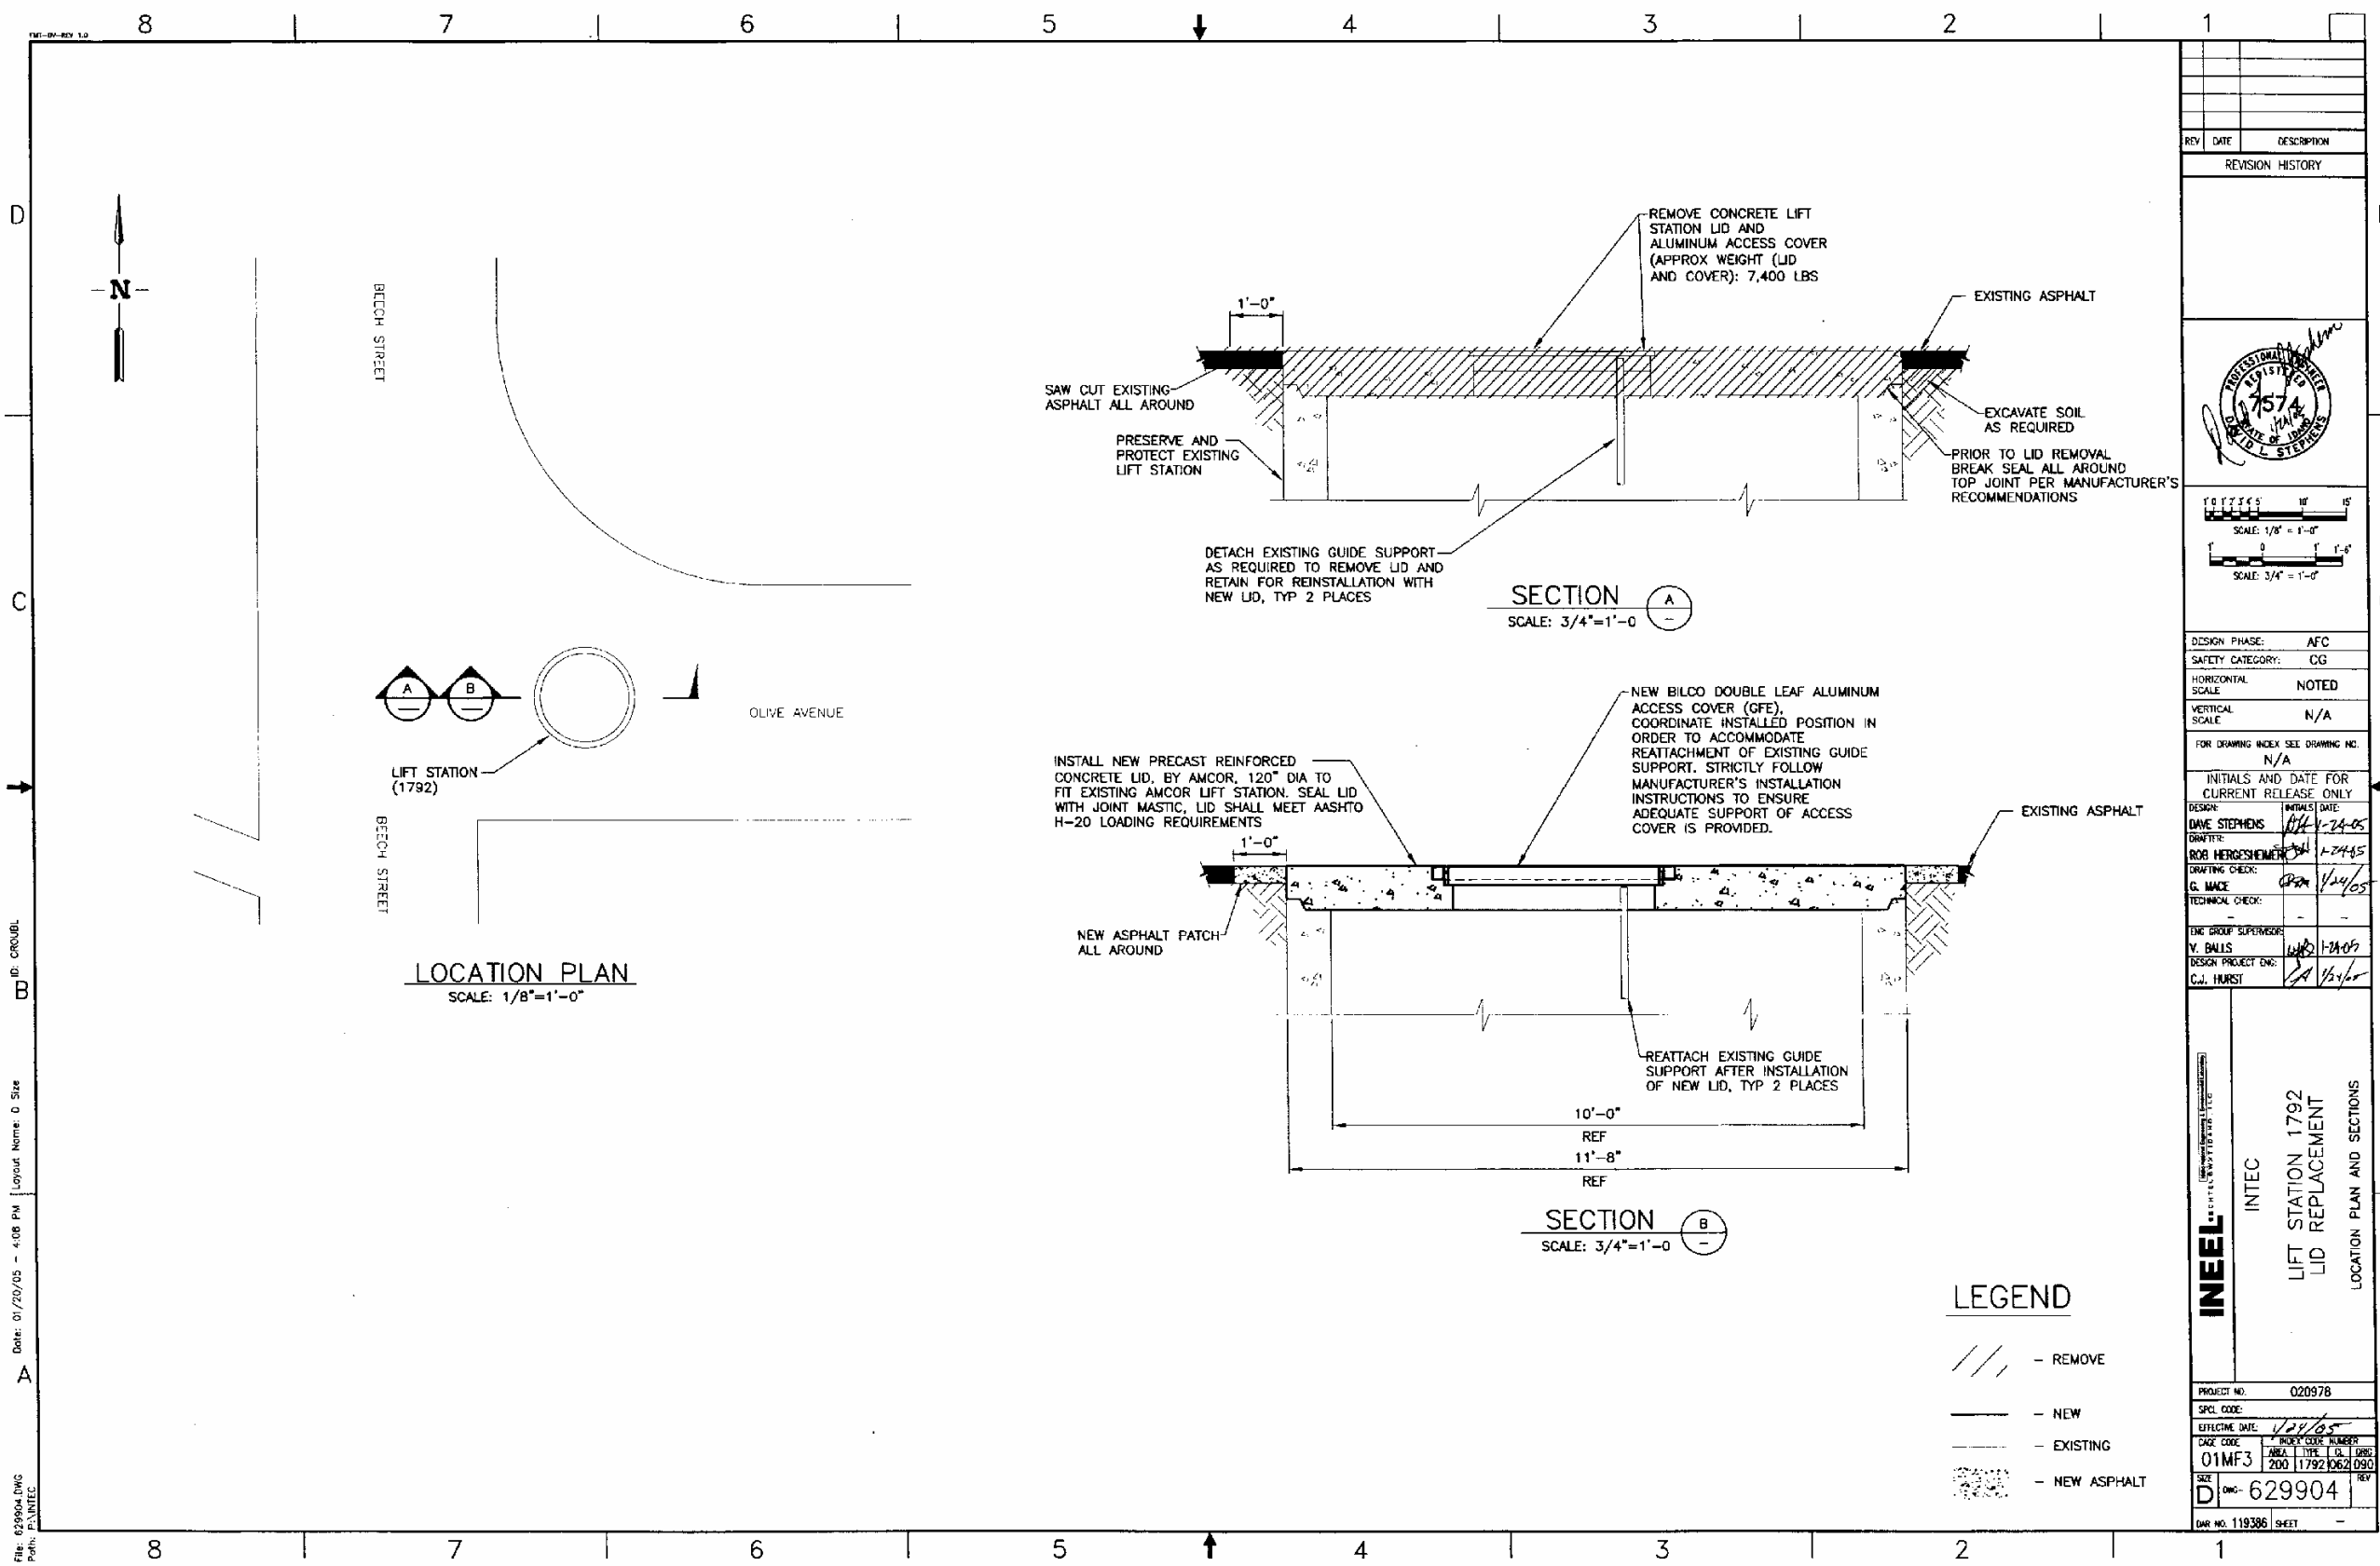
INTEC
 LIFT STATION 1792
 LID REPLACEMENT
 LOCATION PLAN AND SECTIONS

The lift station is located in the intersection of Olive Avenue and Beech Street and is identified on Figure 2-2 as CPP-1792. The station is a 10-ft-diameter by 15.8-ft-deep concrete sump covered with a pair of metal hatch doors. Major components include two 5-hp submersible sewage pumps, a forced main from the sump to the ditch discharge point, and the system controls. The system was inspected routinely as part of completing a Utilities Outside Equipment Checks (Form INTEC-6998) and quarterly as part of the TFIA routine inspections. Quarterly inspections were performed on the dates listed in Table 4-1. Inspections entailed checking for high-water-level alarms, observing water level in the sump, and visually inspecting system components. During the year only one maintenance item was reported. On January 28, 2004, it was noted on the inspection form that the lift station hatch doors had been damaged (broken weld and bent surface corners) due to excessive loads on the doors. The hatch doors were barricaded off, using traffic stanchions and rope, to prevent further damage by vehicle traffic.

As stated in the FY-04 annual report, the initial plan was to add metal bracing beneath the hatch door frame and bolt it to the concrete vault section. But, upon further inspection by the project's structural engineer and original design engineer, the decision was made to replace the lift station hatch doors and concrete lid. A precast reinforced concrete lid was fabricated that incorporated a new double-leaf aluminum access cover and was designed to meet American Association of State Highway and Transportation Officials H-20 loading requirements to prevent a recurrence. In August 2005, the old hatch cover was replaced by the new precast cover (see drawing in Appendix C for replacement details). The replacement activities required the removal of the asphalt from around the old lid, and this asphalt was not replaced due to delays in the INTEC facility annual asphalt maintenance program. This area was filled in with soil and compacted. The compacted soil is scheduled to be replaced with asphalt during the 2006 INTEC asphalt maintenance activity. This did not impact the operability of the system, which functioned normally during 2005.
