# Magnet Reliability in the Fermilab Main Injector and Implications for the ILC

M. A. Tartaglia, J. Blowers, D. Capista, D. J. Harding, O. Kiemschies, S. Rahimzadeh-Kalaleh, J. C. Tompkins

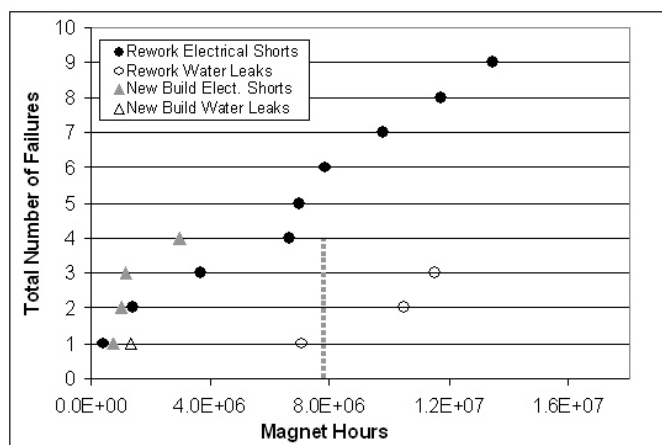
Fig. 1. History of quadrupole magnet failures in the Fermilab Main Injector. Dashed line shows newly built FMI quadrupole service time, and full scale shows the total number of magnet hours for rebuilt Main Ring quadrupoles.

The actual history of failures in these categories, from start of operations to present, is plotted in Fig. 1 separately for all newly constructed FMI quadrupoles and refurbished Main Ring quadrupoles. In this figure, the full time scale represents the total service history for the reworked Main Ring quadrupoles, while the newly designed and built FMI quadrupoles have experienced about half that, as shown by the

vertical dashed line. Not shown in Fig. 1 is the single Main Ring dipole electrical failure, which occurred after  $7.12E+06$  integrated magnet hours of reworked dipole operation in the FMI.
