# Production and test results of SC 3.9-GHz accelerating Cavity at Fermilab

Timergali Khabiboulline, Charlie Cooper, Helen Edwards, Mike Foley, Ivan Gonin, Donald Mitchell, D.Olis, Allan Rowe, Tariq Salman, Nikolay Solyak. FNAL, Batavia, IL 60510, U.S.A.

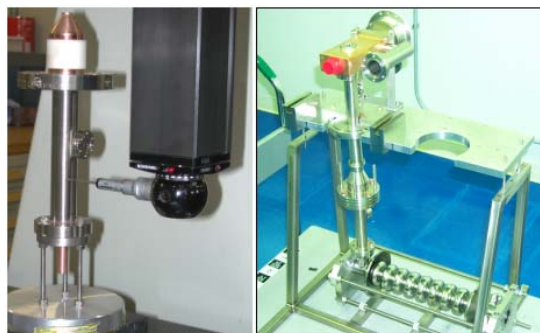
Fig. 1. Cold End Assembly on CMM and coupling test of the input coupler.

and overall workmanship. A CMM is used to check that couplers meet mechanical tolerances specified on the prints (Fig.1).

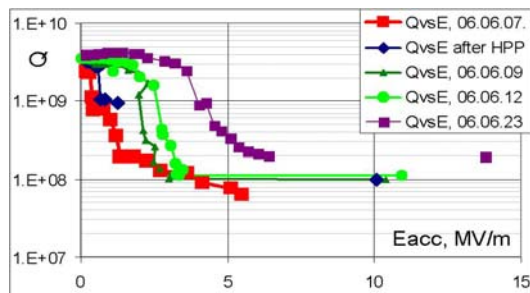
Fig. 2. History of the Q vs. E measurements.

residual resistance  $\sim 3000$  n $\Omega$ , but after high power processing, the residual resistance dropped off  $\sim 40$  n $\Omega$ . The history of Q vs E measurements is shown in Fig. 2.

In the cavity tests we observed strong multipactoring (MP), which causes Q-slope even at low field. After high fields “processing” Q improved for small fields and the MP level shifted from  $\sim 0.5$  MV/m accelerating gradient to  $\sim 4$  MV/m in CW regime. In pulsed regime accelerating gradient was higher

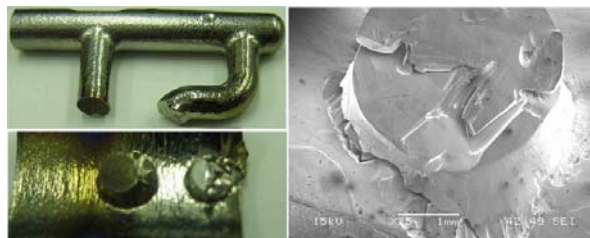
After few high power tests, the visual inspection of the HOM couplers showed a gap between the curved leg of the formteil and the HOM can near the weld joint. More detailed analysis revealed that 1<sup>st</sup> leg of the formteil was completely separated from the can (Fig. 3). To understand which step of cavity production and preparation resulted in this damage we started different tests, such as BCP, cold shock, and HPR. So

Fig. 3. Curved leg of the HOM formteil fractured from HOM can. far none of these investigations can give us a clear picture of the reason for the damage. The failure mechanism is most likely thermal stresses, discussed below in more details.

Following its fourth cold test, cavity #2 was opened for visual inspection in an attempt to find indications of MP. It was discovered that one leg (dog leg) of the F-piece antenna had been fractured completely through. Inspection of the other leg revealed a fracture though not as severe.

Physical analysis of the failure is being carried out both under Fermilab auspices and at DESY. One of the broken formteils and a sample piece has been sent to DESY and we are also awaiting testing results from a nearby analysis laboratory. SEM analysis has already been done at Fermilab, which also shows cracking at the base of the weldment (Fig.3).

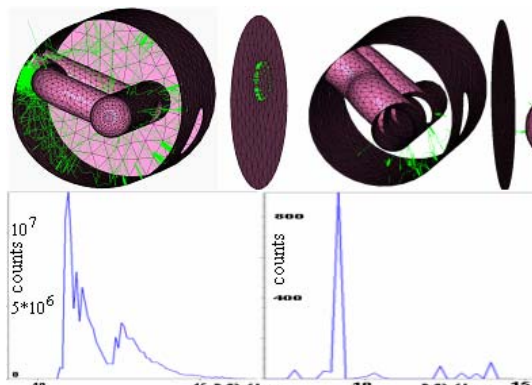
Experimental data clearly shows strong MP activity in the HOM coupler. To simulate MP a recently developed extension to the 3D computer code ANALYST was used. The results of calculation show a possible problem in the HOM coupler in the range of  $\sim 10$  mT surface fields in formteil: one-point MP on the HOM coupler body and two-point MP between the

Fig. 4. Resonant particle trajectories in old (left) and new (right) designs of HOM coupler.

formteil and the cylindrical part of the coupler occurs at  $E_{acc} \sim 11-13$  MV/m (Fig. 4 left). Two-point MP occurs also in the tuning gap at low accelerating fields:  $E_{acc} \sim 0.55-0.8$  MV/m.

resonant trajectories were found in a new design, but the impact energy is not enough for MP. In the tuning gap no resonant trajectories were found. On the HOM coupler body, we do not observe the two-point MP but still have the one-point MP, which is a few order of amplitude weaker than in existing design.

To avoid MP in the described areas a new profile of formteil has been designed (described below). Only a few

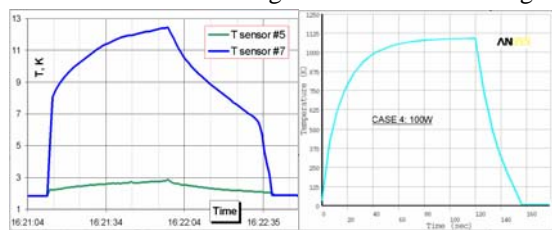
Initial heating starts as a result of MP. When the formteil surface reaches normal-conducting temperature, the surface resistance increases dramatically and it results in additional power loss in the formteil. The outside surface of the HOM can stay cold, cooled by the surrounding superfluid helium. Significant temperature difference and associated thermal extension could result in enough stress to cause damage [6].

Fig. 5. Measured (left) and calculated (right) temperature profiles.

Dynamic calculations for warming up and cooling down show results very similar to data the temperature measurement from the cold test (Fig.5) Thermal and stress analyses show a possibility to reach stresses close to the yield point.
