LAWRENCE LIVERMORE NATIONAL LABORATORY

SEISMIC SAFETY STUDY

MAY 2006

UCRL-TR-221420

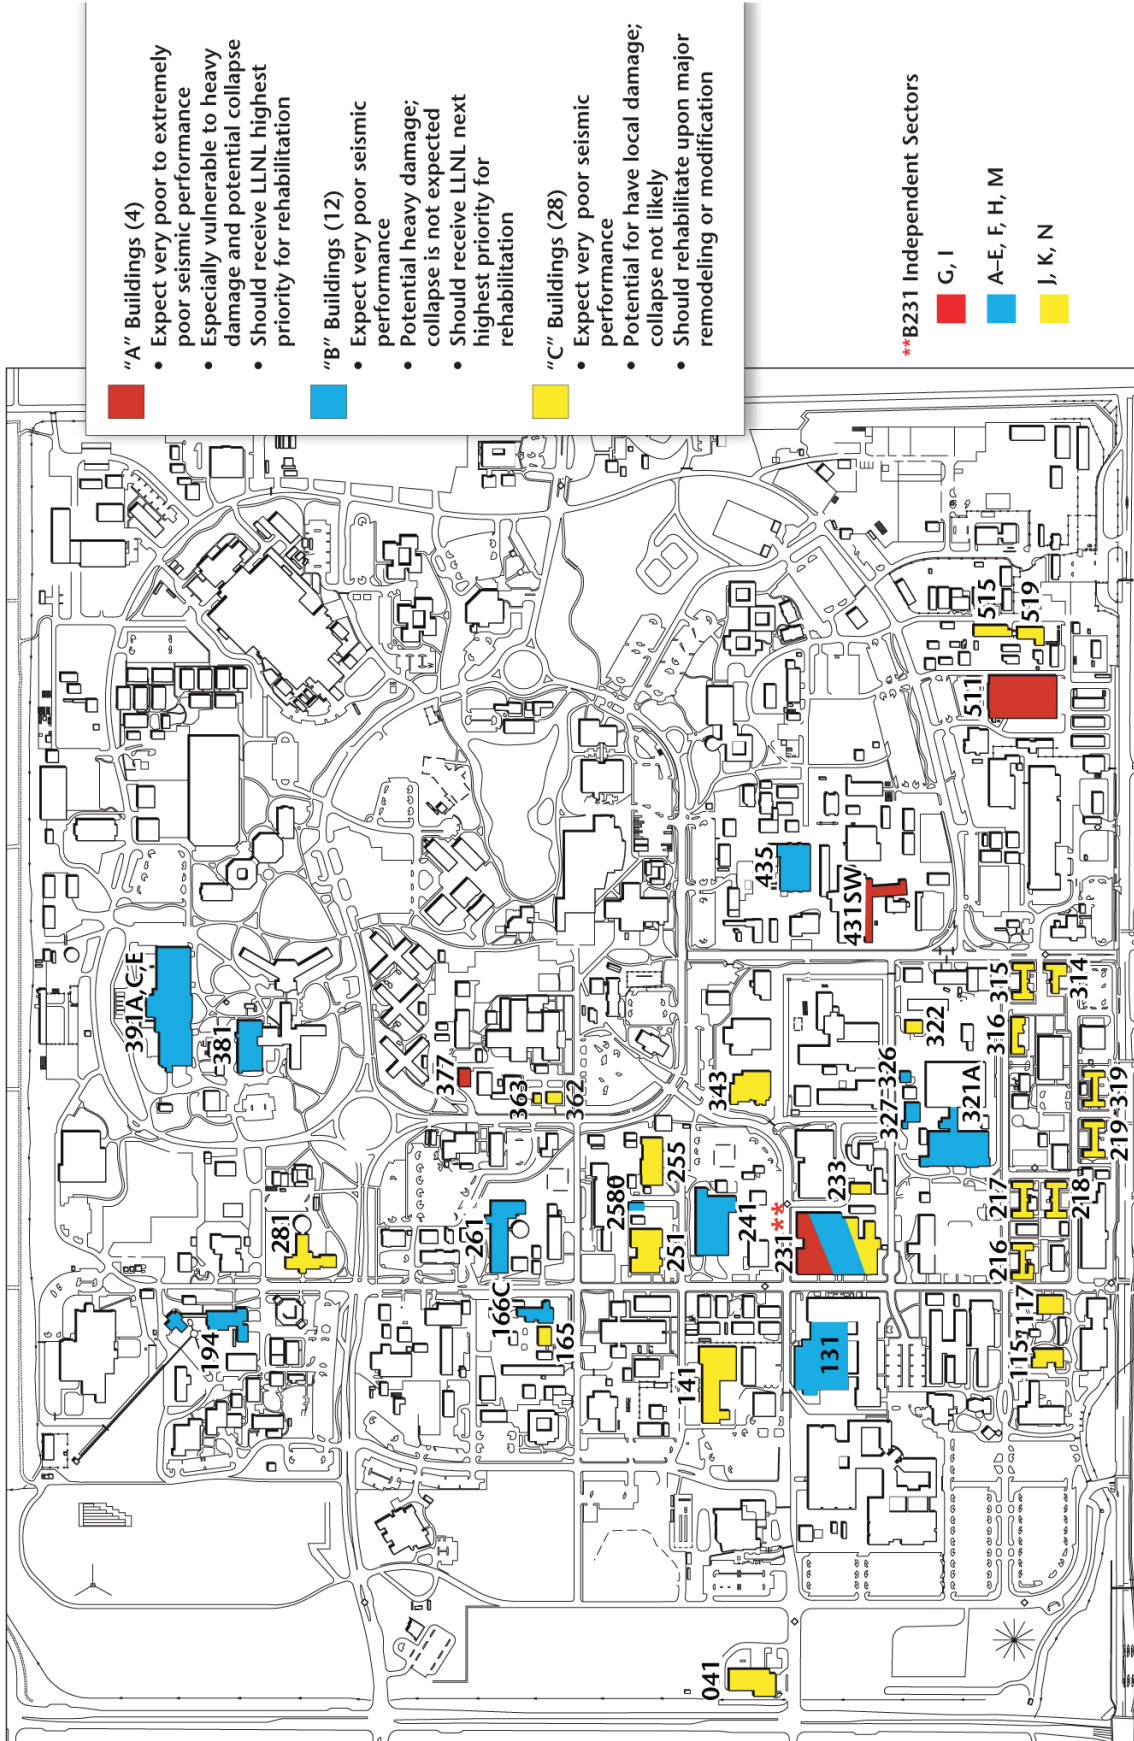
The 58 buildings were ranked according to three risk-based priority classifications (A, B, and C) as shown in Figure 1-1 (all 58 buildings have structural deficiencies). Table 1-1 provides a brief description of their expected performance and damage state following a major earthquake, rating the seismic vulnerability (1–10) where the number 10 represents the highest and worst. Buildings in classifications A and B were judged to require the Laboratory's highest attention towards rehabilitation, classification C buildings could defer rehabilitation until a major remodel is undertaken. Strengthening schemes were developed by Degenkolb Engineers for the most seriously deficient A and B classifications (15 total), which the Laboratory's Plant Engineering Department used as its basis for rehabilitation construction cost estimates.^{6,7} A detailed evaluation of Building 2580, a strengthening scheme, and a construction cost estimate are pending.

Figure 1-1. Livermore buildings not meeting seismic safety standards (Site 300 has 14 "C" buildings but no "A" and "B" buildings).
