## Pacific Northwest National Laboratory

# Ultrasonic Examination of Double-Shell Tank 241-AY-101 Examination Completed March 2007

AF Pardini  
DR Weier

June 2007

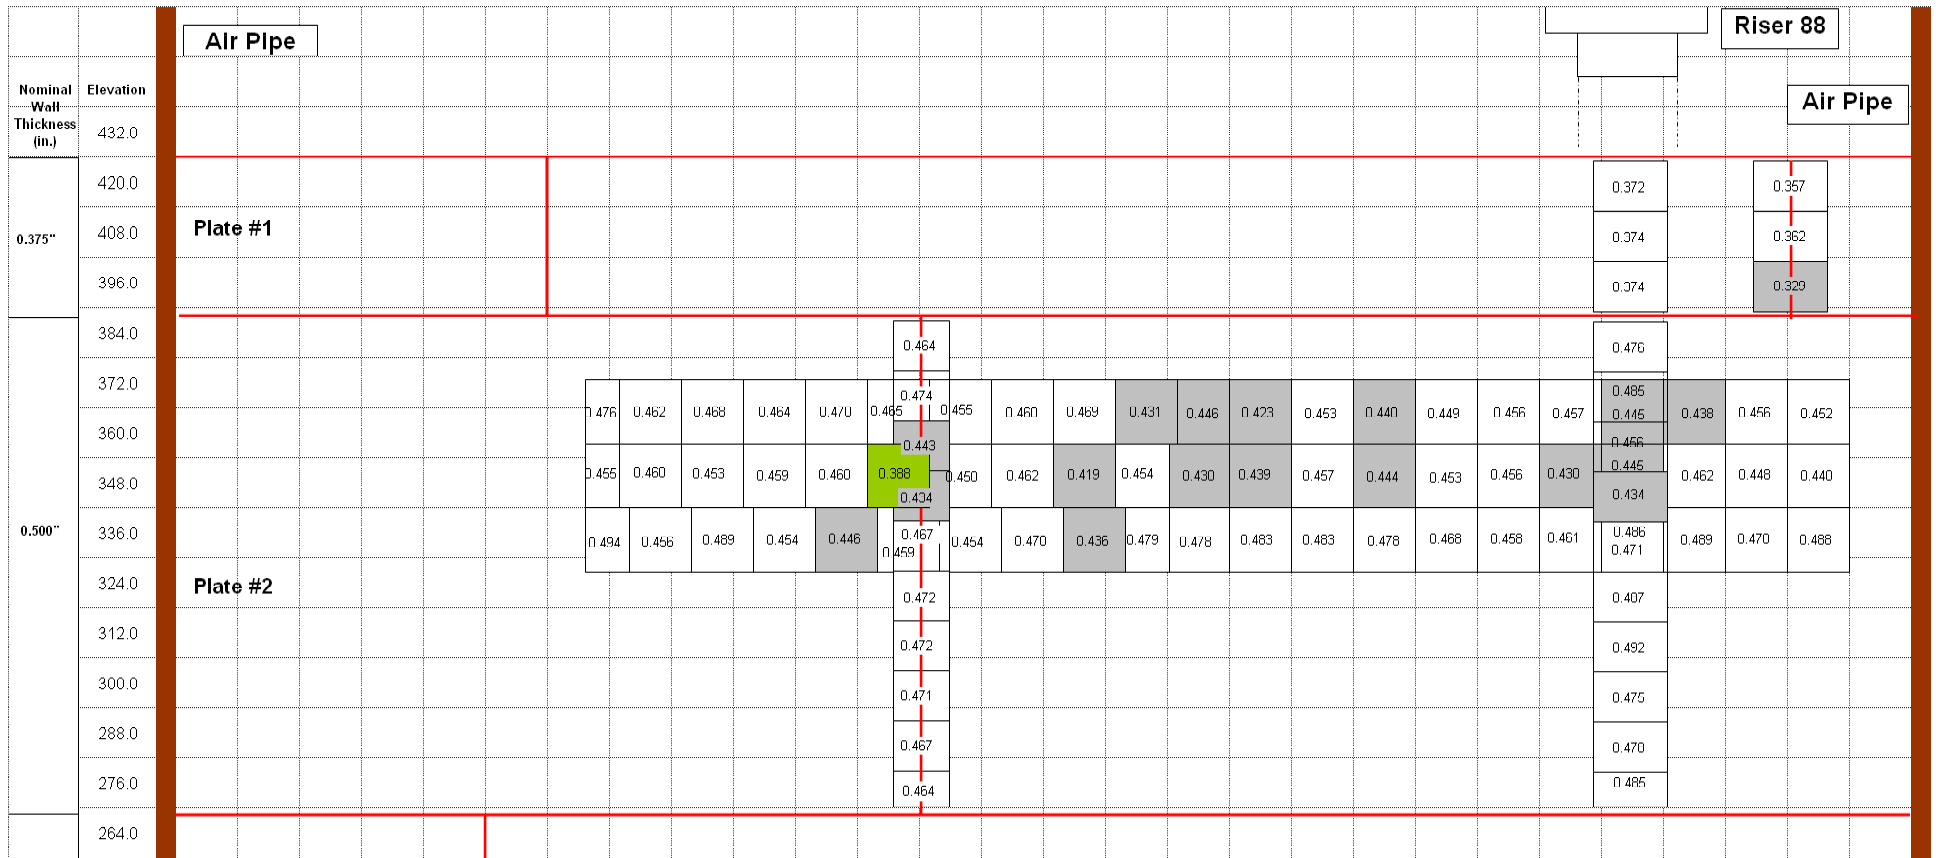
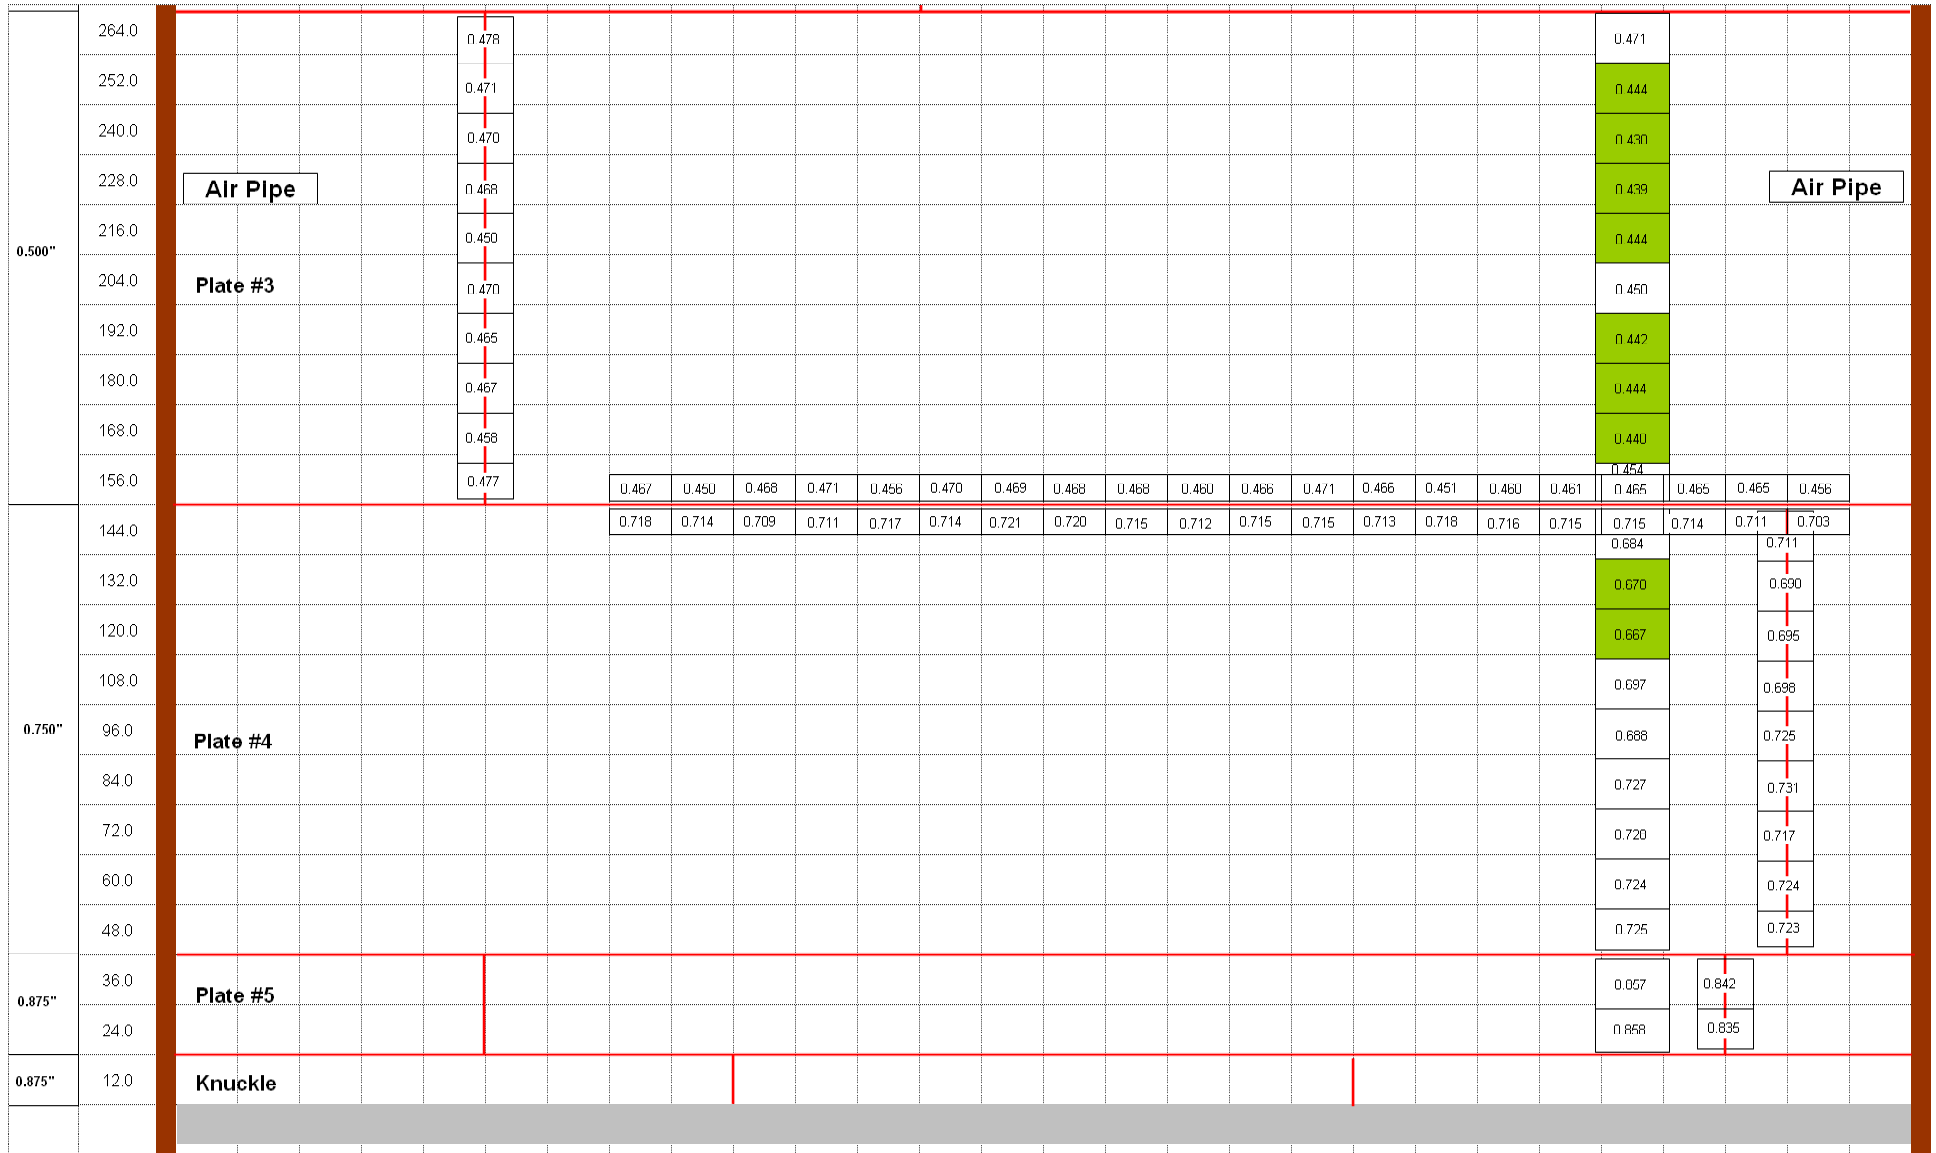
Figures 5.1 and 5.2 show the wall thickness examination results for the primary tank wall and the HAZs of both vertical and horizontal welds from Riser 88. The examination consisted of one 15-in.-wide vertical path beneath the centerline of the 24-in. diameter riser on Plates #1, #2, #3, #4, and #5. Vertical scan was conducted in the downward direction. Three horizontal scans were performed in the LAI region on Plate #2. Figures 5.1 and 5.2 display the minimum readings taken in each 15-in.-wide by 12-in.-long area of the scan. The HAZs of vertical welds in Plates #1, #2, #3, #4, and #5 were examined and the HAZ in the horizontal weld between Plate #3 and Plate #4 was also examined. Weld area exams include approximately 5-in. on each side of the weld. Areas in the figures that show two measurements in the same box are the result of the vertical scan paths overlapping the horizontal scan paths. In the overlapping areas, both minimum readings from each vertical and horizontal scan paths are given. The gray highlighted areas indicate that the minimum wall thickness exceeded the reportable level of 10% of the nominal wall thickness. The green highlighted areas indicate that the minimum wall thickness exceeded the 10% level, but the UT Level III has characterized these as pit-like indications. None of these pit-like indications exceed the pitting criteria of 25% of nominal thickness and are therefore not reportable.

Figure 5.1. UT Data from Tank 241-AY-101 Primary Tank Riser 88

Figure 5.2. UT Data from Tank 241-AY-101 Primary Tank Riser 88 cont.

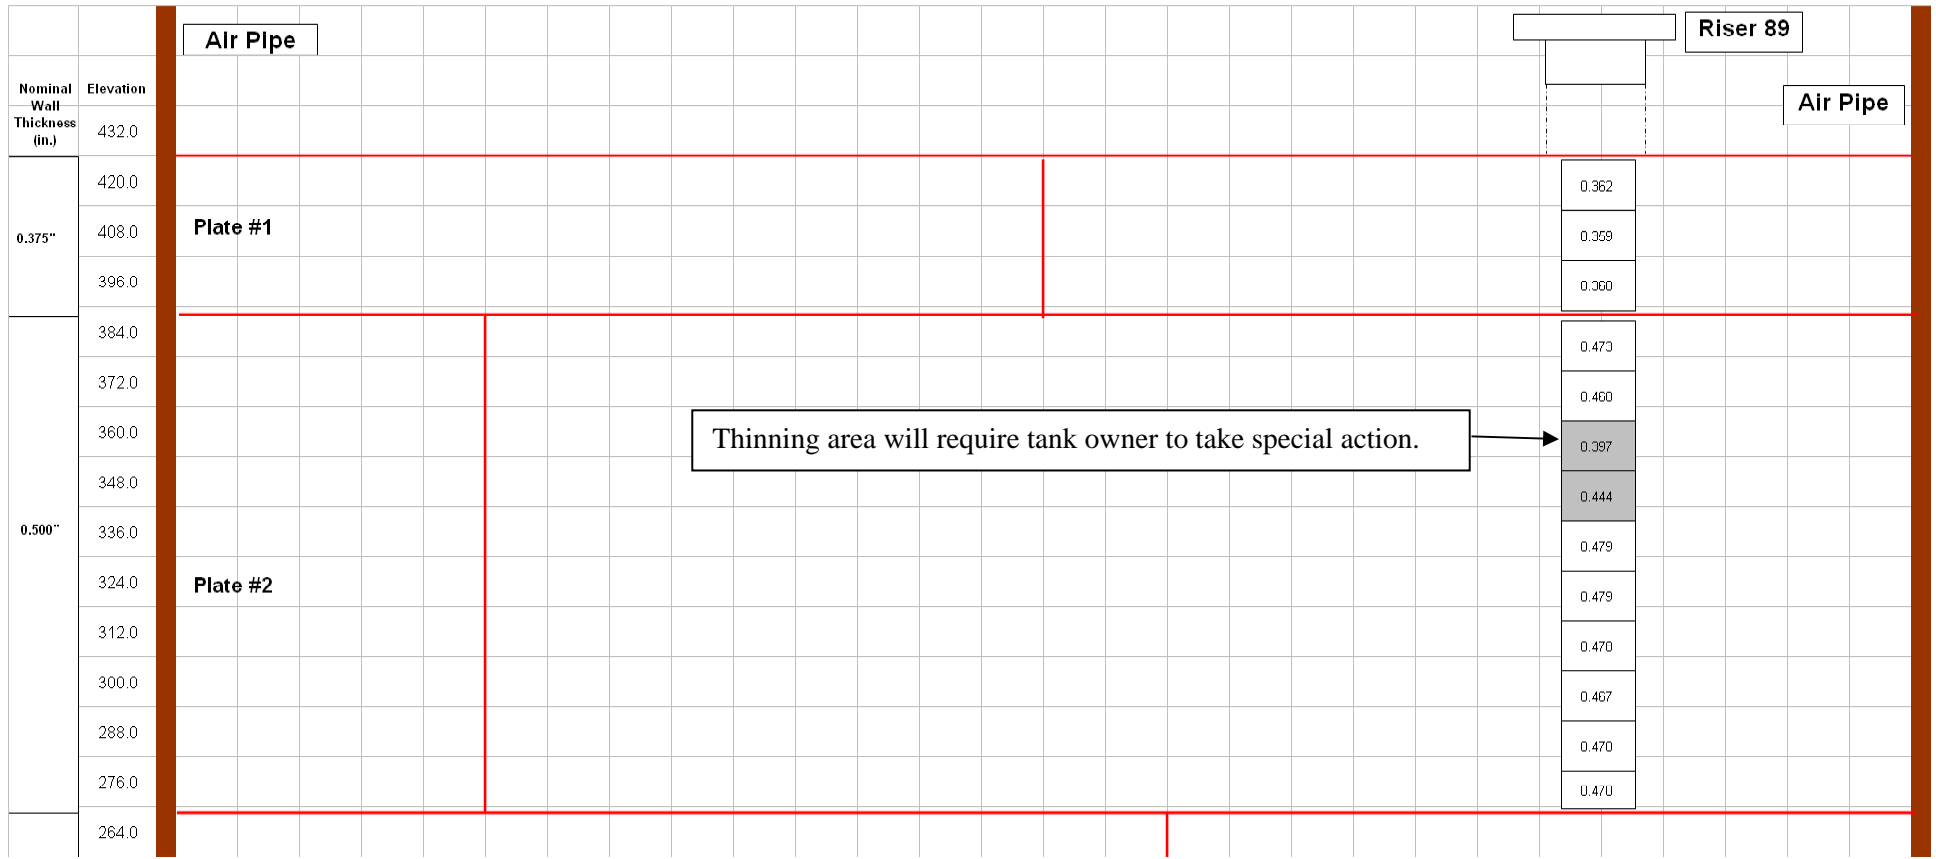
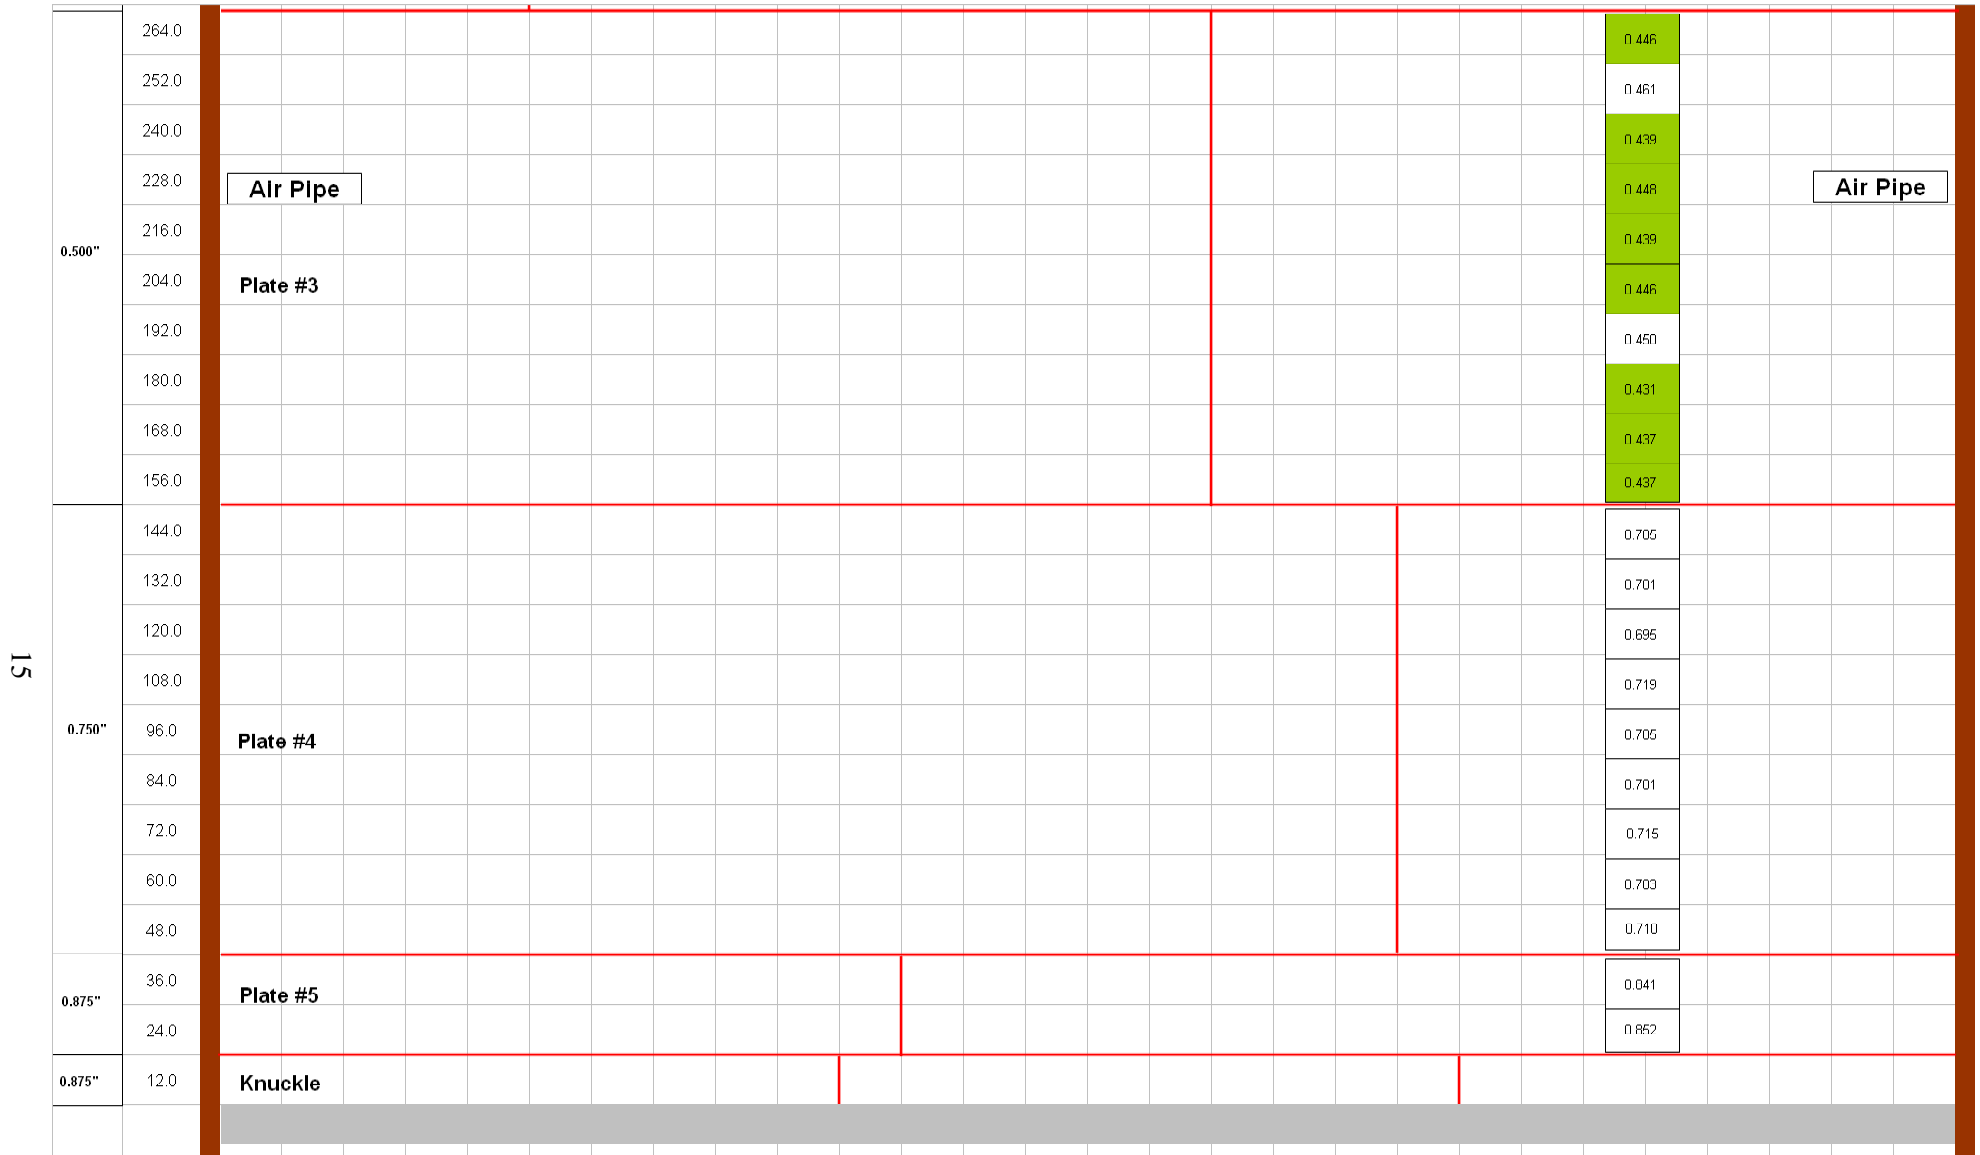
Figures 5.3 and 5.4 show the wall thickness examination results for the primary tank wall from Riser 89. The examination consisted of one vertical path beneath the centerline of the 24-in. diameter riser on Plates #1, #2, #3, #4, and #5. Vertical scan was conducted in the downward direction. Figures 5.3 and 5.4 display the minimum readings taken in each 15-in.-wide by 12-in.-long area of the scan. The gray highlighted areas indicate that the minimum wall thickness exceeded the reportable level of 10% of the nominal wall thickness. The 0.397-in. shown as a gray highlighted area exceeded the acceptance criteria of 20% and will require the tank owner to take special action. The green highlighted areas indicate that the minimum wall thickness exceeded the 10% level, but the UT Level III has characterized these as pit-like indications. None of these pit-like indications exceed the pitting criteria of 25% of nominal thickness and are therefore not reportable.

Figure 5.3. UT Data from Tank 241-AY-101 Primary Tank Riser 89

Figure 5.4. UT Data from Tank 241-AY-101 Primary Tank Riser 89 cont.

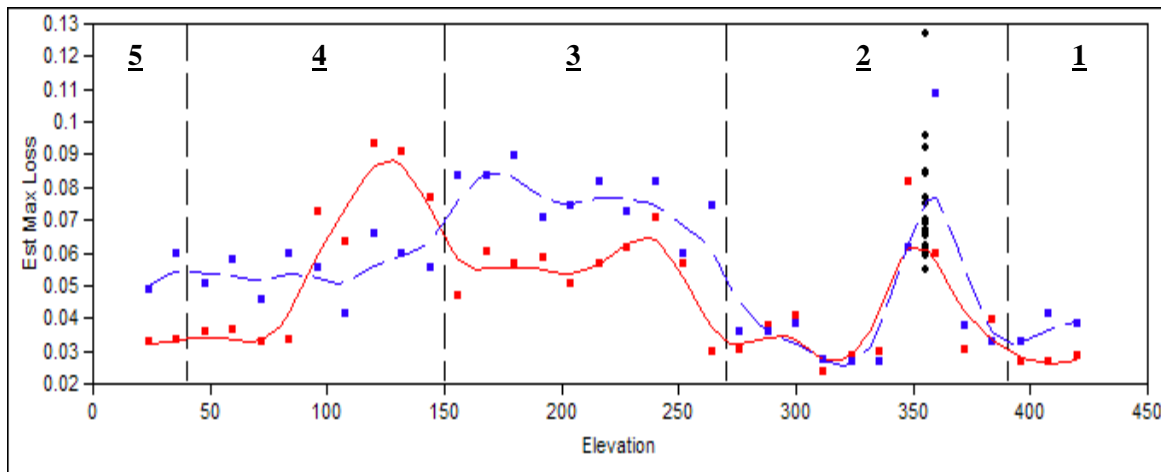
**Figure 6.2.** Estimated Maximum Wall Thickness Loss by Riser Path

Maximum wall thickness loss results obtained in the manner described above are shown for each riser in Figure 6.2. Red points with the solid red curve are for Riser 88, while blue points with the dashed blue line are for Riser 89. Numbered sections of the graphs represent the different plate courses; note that the top of the tank is to the right on the figure. Within Plate #2 the increased corrosion associated with the LAI is readily apparent. The greater corrosion in the LAI was addressed in Weier, Anderson, Berman 2005 where LAI measurements were treated separately for extreme value estimation.

Additional UT inspection was done along the LAI in the current efforts. Three horizontal paths about 20 feet long were measured generating about 20 images per path. But since the paths were “stacked” vertically, the minimum value for each linear foot from the three paths was used to represent the minimum wall thickness at that point of the LAI. The resulting values are the vertical set of black points at an elevation of about 355 on the figure.

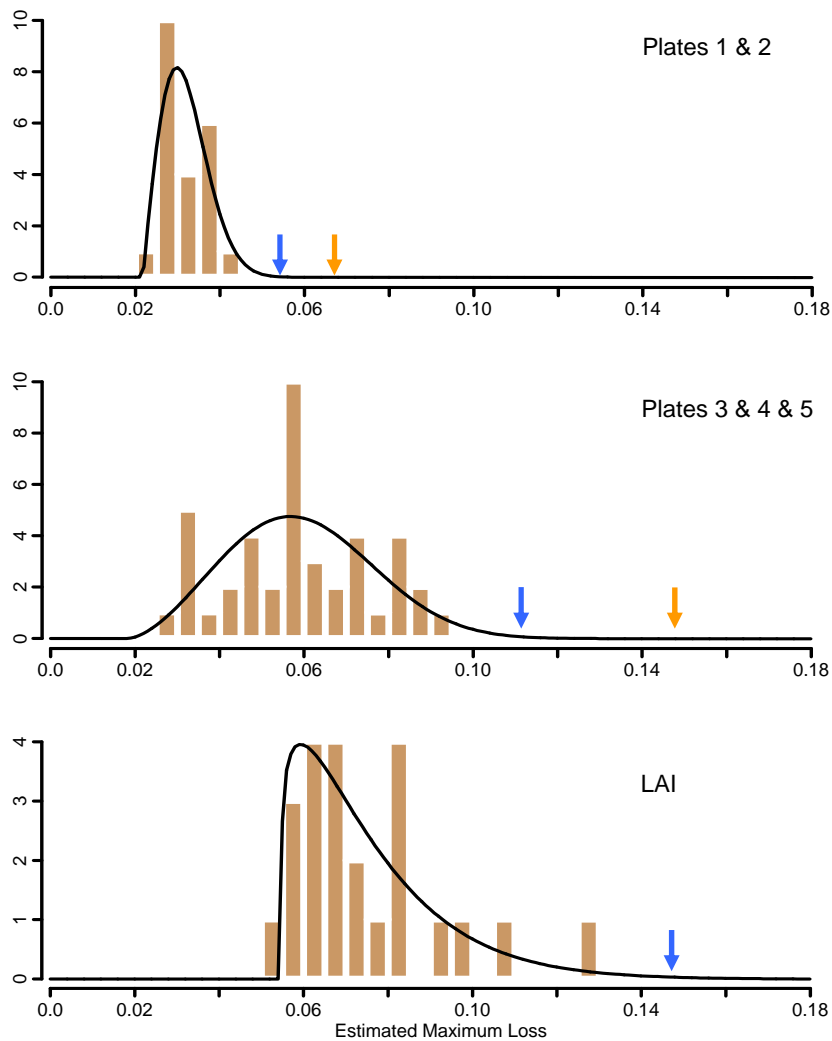
**Figure 6.3.** Weibull Distribution Fits to UT Maximum Wall Thickness Loss

The histograms in Figure 6.3 show such wall thickness loss data for the indicated plate groupings. Three parameter Weibull distributions are fit to these histograms and are shown as the smooth curves. The total surface area of a plate course combination, and thus the number of 15-in. by 12-in. UT images needed to 100% inspect the entire plate course combination, is computed. The percentile of the distribution that then corresponds to the maximum expected loss among this many UT images, based on the distribution fit to the histogram, is considered as the estimated worst case loss. For the LAI, the linear feet inspected were used analogously with the required worst case percentile based on the total circumference of the tank at the LAI.
