# Ultrasonic Examination of Double-Shell Tank 241-AY-102 Examination Completed January 2007

AF Pardini  
DR Weier

May 2007

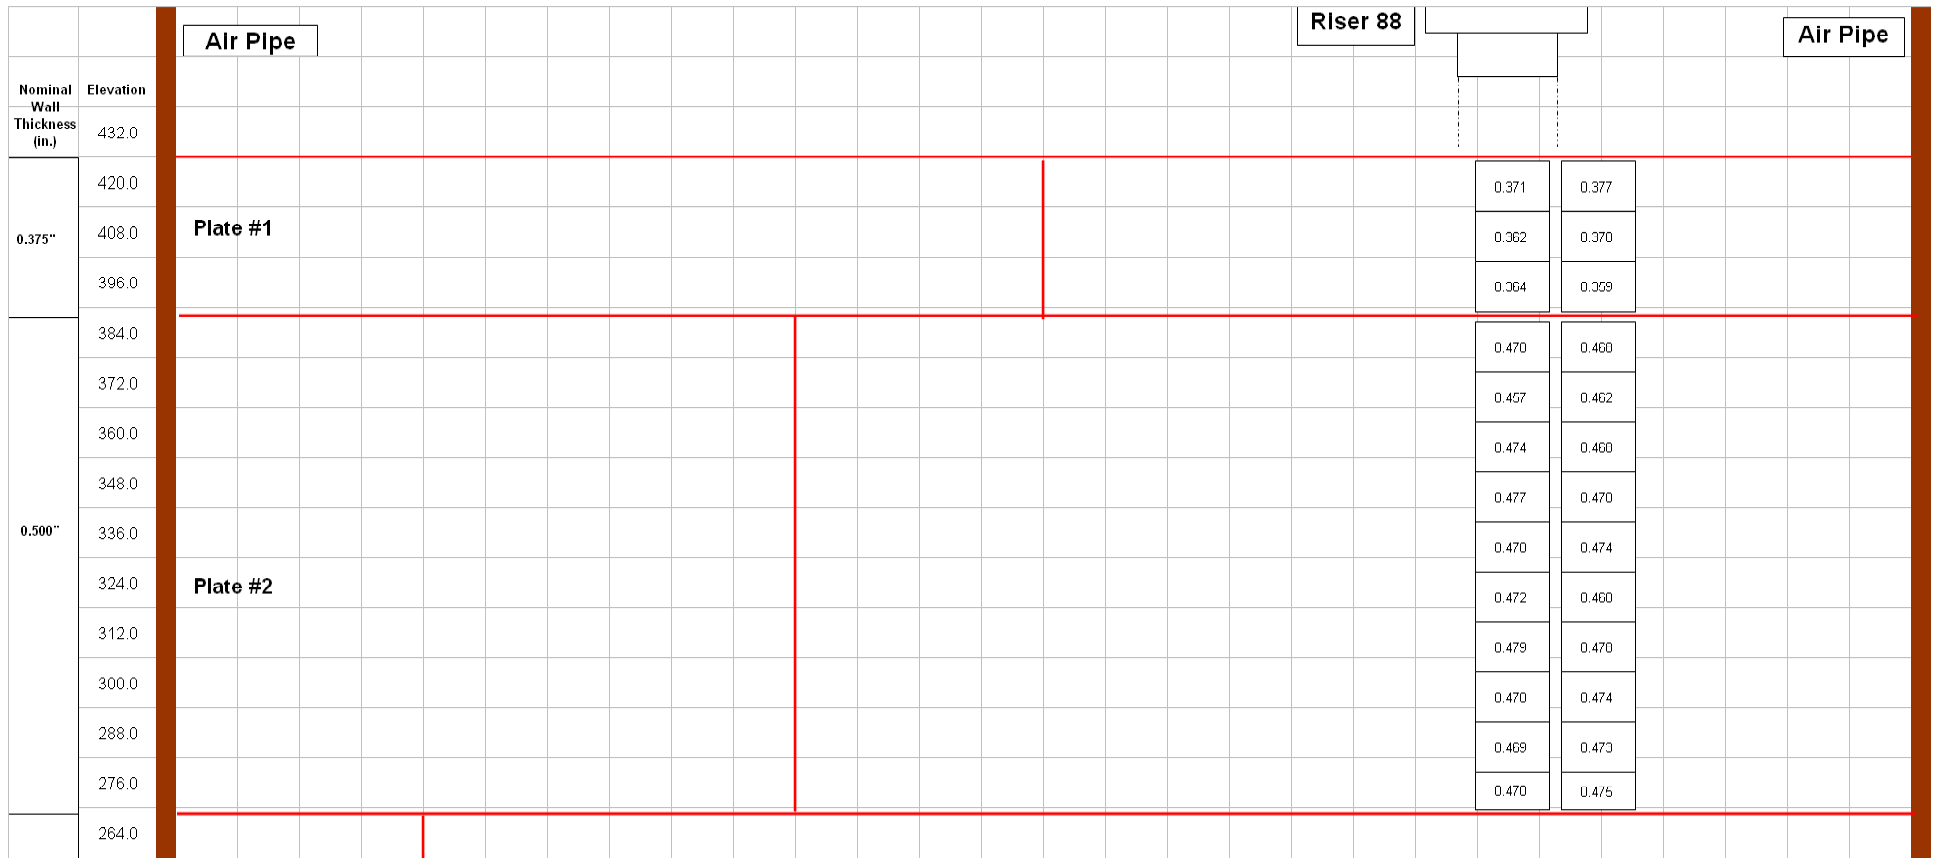
Figure 5.1. UT Data from Tank 241-AY-102 Primary Tank Riser 88

Figures 5.1 and 5.2 show the wall thickness examination results for the primary tank wall from Riser 88. The examination consisted of two vertical paths beneath the 24-in. diameter riser. Vertical scan #1 was 15-in.-wide on Plates #1, #2, #3, #4, and #5 near the centerline of the 24-in. riser. Vertical scan #2 was adjacent to vertical scan #1 and was also 15-in.-wide on Plates #1, #2, #3, #4, and #5. Vertical scans were conducted in the downward direction. Figures 5.1 and 5.2 display the minimum readings taken in each 15-in.-wide by 12-in.-long area of the scan.

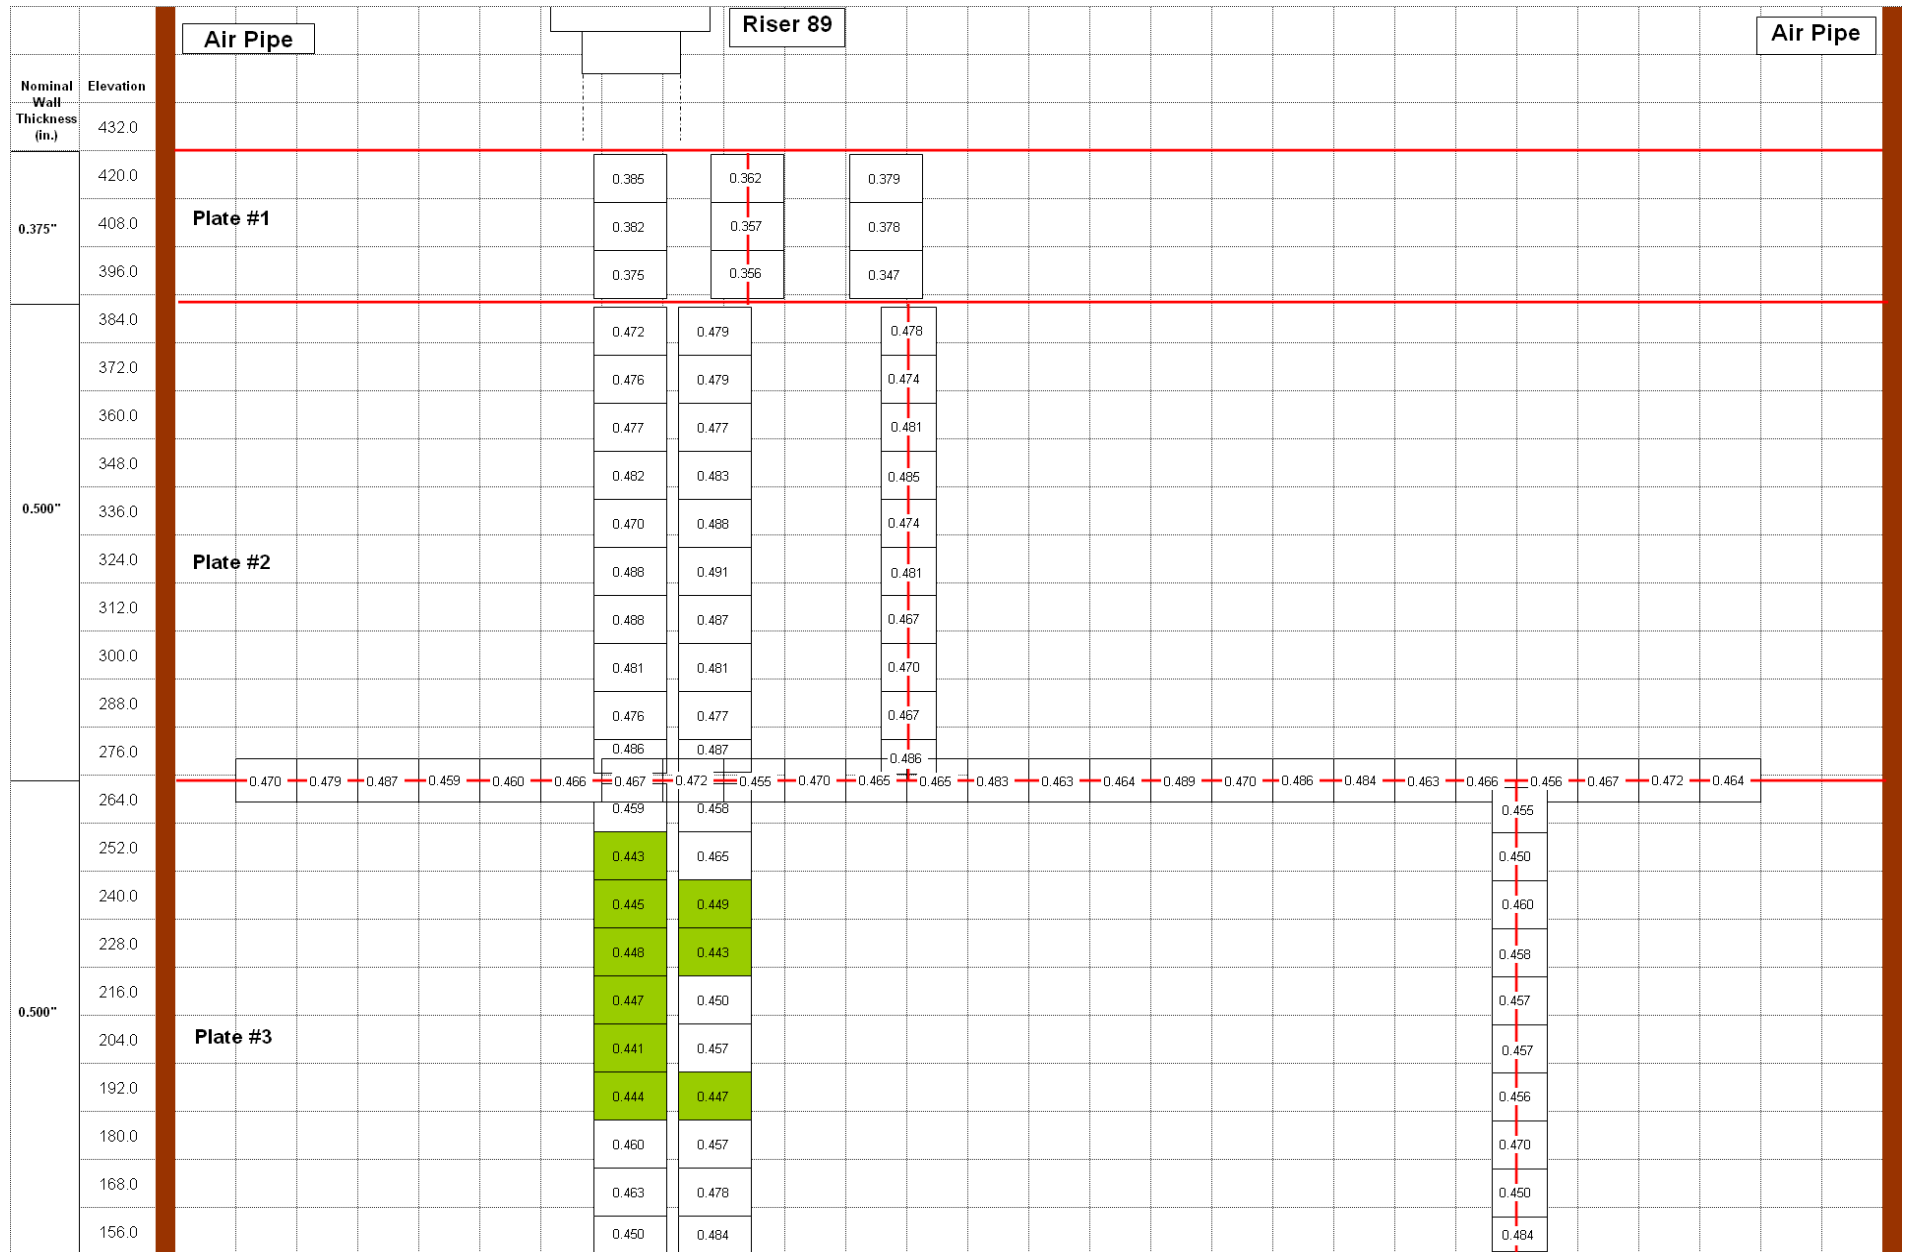
Figure 5.3. UT Data from Tank 241-AY-102 Primary Tank Riser 89

Figures 5.3, 5.4, and 5.5 show the wall thickness examination results for the primary tank wall, the HAZs of both vertical and horizontal welds, and a portion of the knuckle from Riser 89. The examination consisted of two vertical paths beneath the 24-in. diameter riser and an additional short vertical path on Plates #4 and #5. Vertical scan #1 was 15-in.-wide on Plate #1, #2, #3, #4, and #5 near the centerline of the 24-in. riser. Vertical scan #2 was adjacent to vertical scan #1 and was also 15-in.-wide on Plates #1, #2, #3, #4, and #5. Vertical Scan #3 was a few feet to the south of vertical scan #2 and was only performed on Plates #4 and #5. Vertical scans were conducted in the downward direction. The HAZs of vertical welds in Plates #1, #2, #3, #4, and #5 were examined and the HAZ in the horizontal weld between Plate #2 and Plate #3 was also examined. Weld area exams include approximately 5-in. on each side of the weld. Approximately 3-ft. circumferentially was examined on the upper portion of the knuckle. Areas in the figures that show two measurements in the same box are the result of the vertical scan paths overlapping the horizontal scan paths. Figures 5.3 and 5.4 display the minimum readings taken in each 15-in.-wide by 12-in.-long area of the scan. Figure 5.5 displays the minimum readings taken in each 9-in.-wide by 12-in.-long area of the scan. In the overlapping areas, both minimum readings from each vertical and horizontal scan paths are given. The gray highlighted areas indicate that the minimum wall thickness exceeded the reportable level of 10% of the nominal wall thickness. The green highlighted areas indicate that the minimum wall thickness exceeded the 10% level, but the UT Level III has characterized these as pit-like indications. None of these pit-like indications exceed the pitting criteria of 25% of nominal thickness and are therefore not reportable.

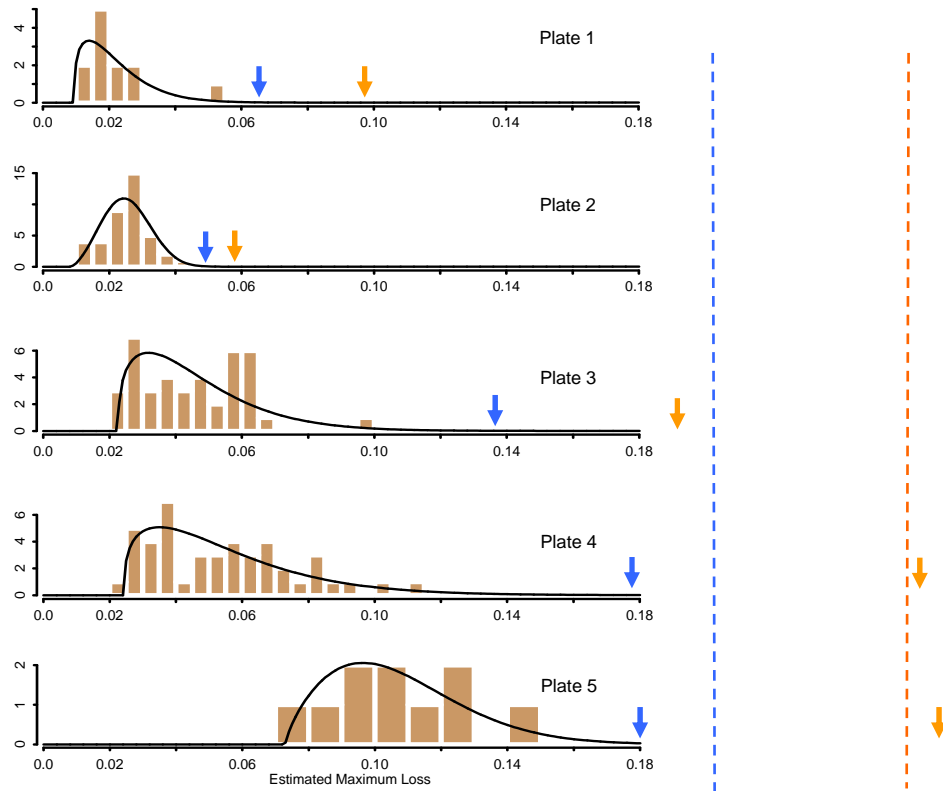
**Figure 6.2.** Weibull Distribution Fits to UT Maximum Wall Thickness Loss by Plate Course

The histograms in Figure 6.2 show such wall thickness loss data grouped by plate course. That is, the UT image maximum losses from the four paths, two per riser, within each plate course are combined. Three parameter Weibull distributions are fit to these histograms and are shown as the smooth curves. Three parameter Weibull distributions are fit to these histograms and are shown as the smooth curves.

The obvious characteristic of the Tank 241-AY-102 histograms in Figure 6-2 is that grouping the measurements across plates is inappropriate. The deeper into the tank (that is, going from Plates #1 to #5), the more wall thickness loss that has apparently been realized. If all plates were indeed grouped, the

Therefore the wall thickness losses are considered separately across all five plate courses for Tank 241-AY-102, and shown both by the arrows in Figure 6.2 and the tabled values in Figure 6.3. But in so doing, the tendency to have fairly abrupt left-hand tails, with outlying values to the right for Plates #3, #4, and #5 give quite heavy-tailed distributions and resulting extreme values estimates and bounds considerably larger than any of the observed results. These characteristics of the distributions fit, and the minimal number of measurements per plate, result in the extremely large values. It is questionable if they are of practical use.

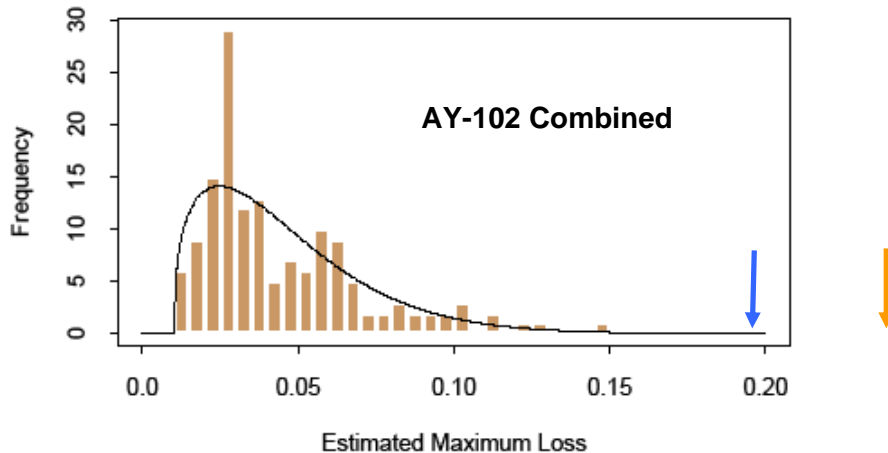
**Figure 6.4.** Weibull Distribution Fit to Wall Thickness Loss Combined over Plate Courses

“Combined” numbers from the table in Figure 6.3, and denoted by the vertical dotted lines in Figure 6.2 and the arrows in Figure 6.4, show an estimated worst case loss of 0.198-in. with a confidence bound of 0.231-in. Such losses obviously cannot be applied appropriately to Plate #1 with a drawing nominal of 0.375-in., which would result in obviously unrealistic losses. Also note that the combined distribution in Figure 6.4 appears to have a “double-hump”, again suggesting that grouping the measurements into a single distribution is inappropriate.

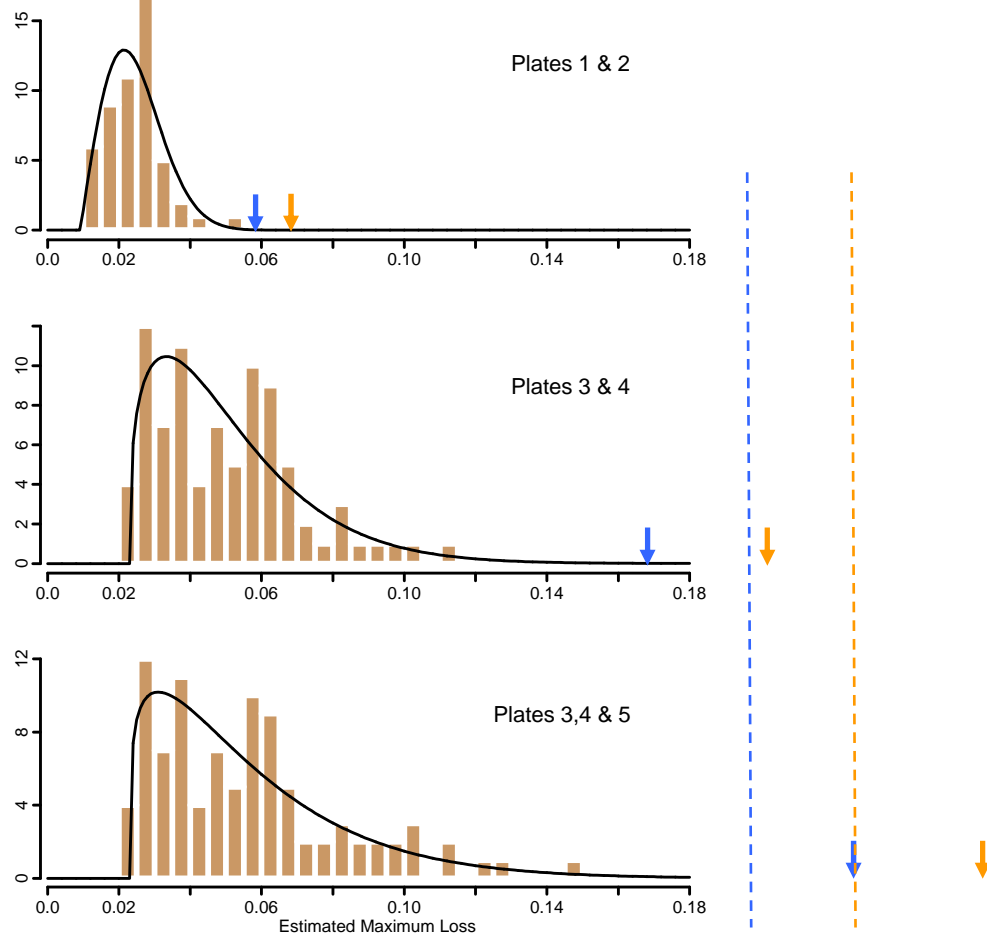
**Figure 6.6.** Weibull Distribution Fits to Wall Thickness Loss for Plate Course Combinations

These combinations of plates give much more reasonable estimates for Plates #1 and #2, and even for the Plates #3 and #4 combination, but little can be done to avoid the problems caused by including Plate #5, either individually as before, or here grouped with Plates #3 and #4. The estimates and bounds simply become very extreme. Note the vertical dotted lines on Figure 6.6 are still those from the combination of all five plates as before in Figure 6.2.

While extreme value results have been relatively straightforward to interpret for previous tanks, Tank 241-AY-102 is obviously more problematical. It is suggested that the reader consider the tabled values in Figures 6.3 and 6.5, and interpret them appropriately. Preferred estimates for Plates #1 and #2 and for Plates #3 and #4 are probably those listed in Figure 6.5. But the methodology simply doesn't lend itself to application to the minimal amount of data in Plate #5 alone. And when Plate #5 measurements

are incorporated with those of other plates, many of the Plate #5 values become outlying values considerably greater than those for the other plates. They then unduly influence the estimates for the other plates as well.
