ORNL/TM-2005/34

Field Testing of Energy-Efficient Flood-Damage- Resistant Residential Envelope Systems Summary Report

June 2004

Buildings Technology Center, Residential Buildings Group

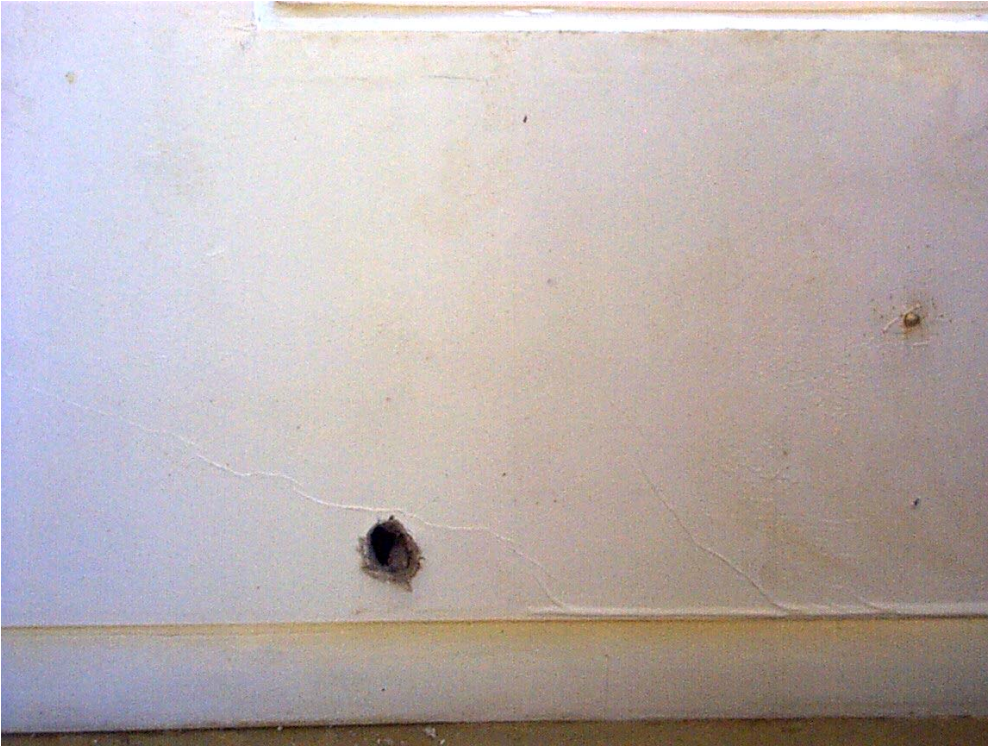
Figure 4-5 Module S-1 (Wall 1) Post-flood, Day 8 - Before washing. Hole punched in lower wall to aid cavity draining; walls are stained; paint is sagging and rippling.

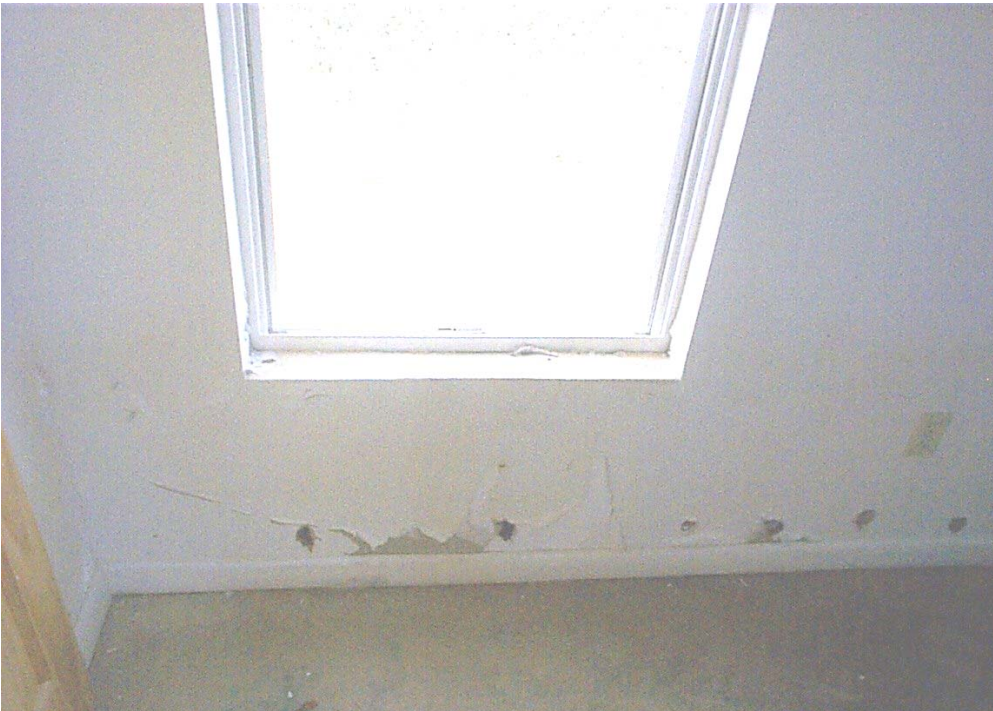
Figure 4-6 Module S-1 (Wall 1) Post-flood, Day 15. Walls stained and paint peeling; no mold growth

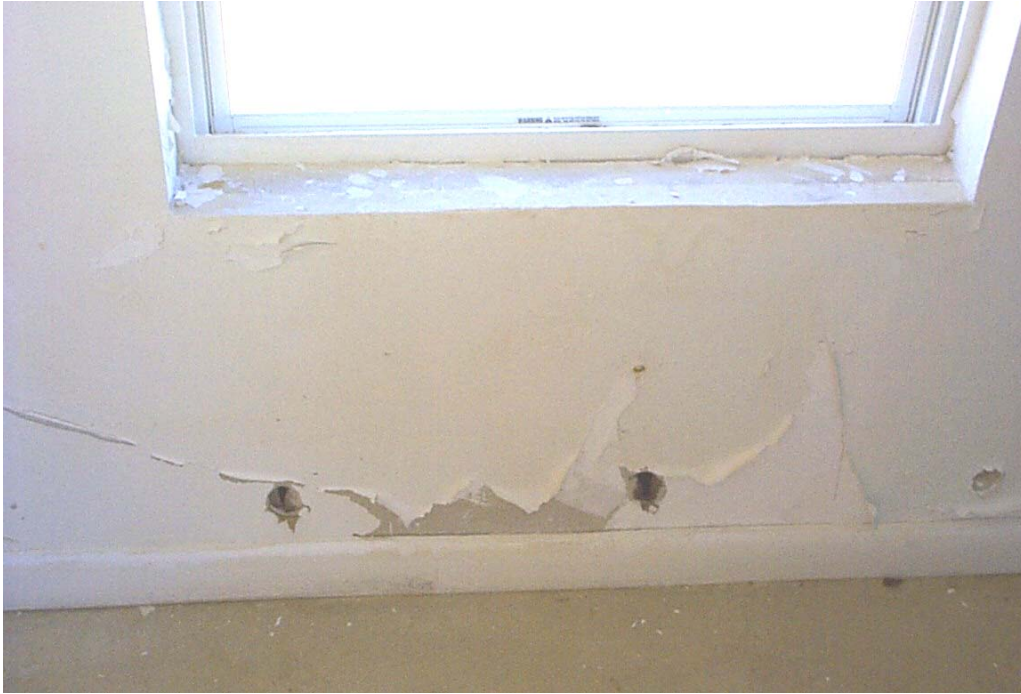
Figure 4-7 Module S-1 (Wall 1) Post-flood, Day 29. Little change in wall staining and paint peeling has occurred.

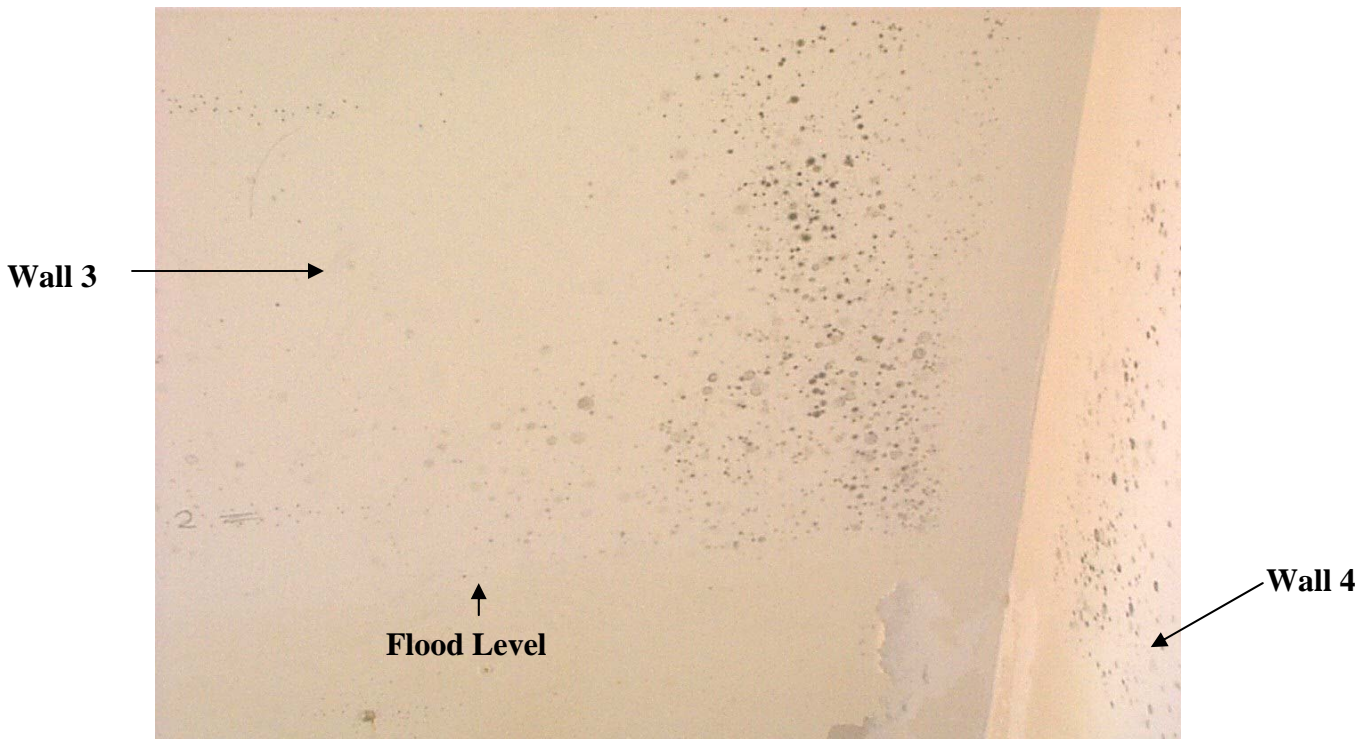
Figure 4-8 Module S-1 (Walls 3 & 4) Mold growth above the water line on Day 29. No mold growth occurred in Module C-1.

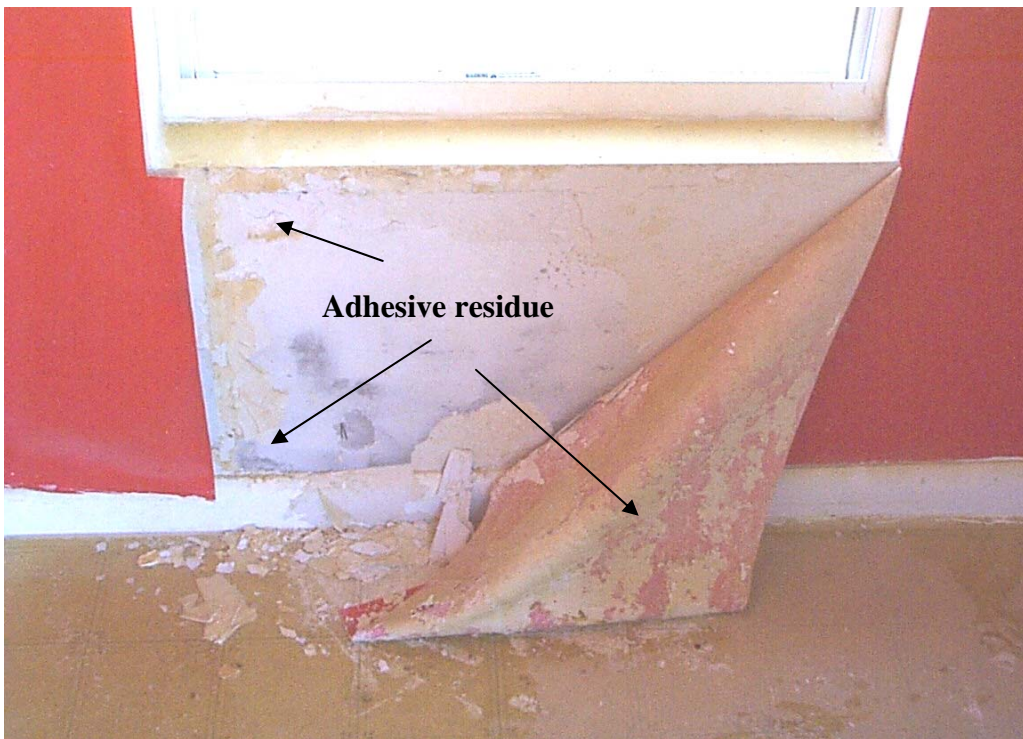
Figure 4-10 Module C-1 (Wall 1) Post-flood, Day 8 (before washing). Vinyl wall covering debonded and gypsum wallboard paper facing delaminated.

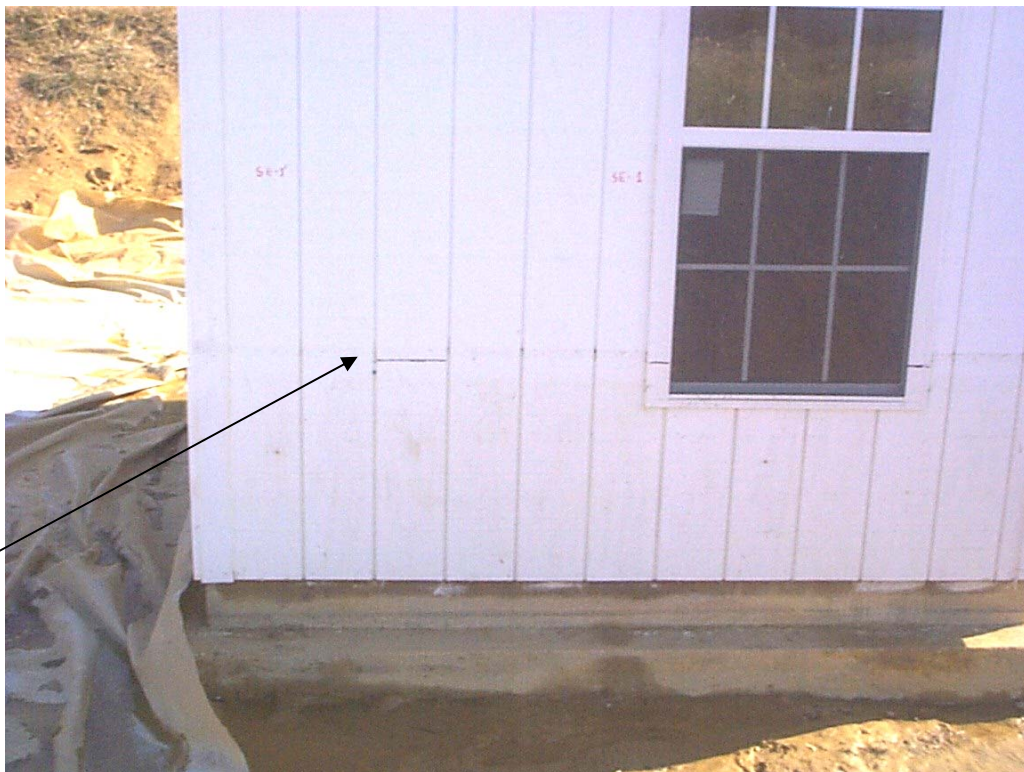
Figure 4-14 Module S-1 (Wall 1, North Exterior Wall) Post-flood, Day 4. Walls are stained below flood level.

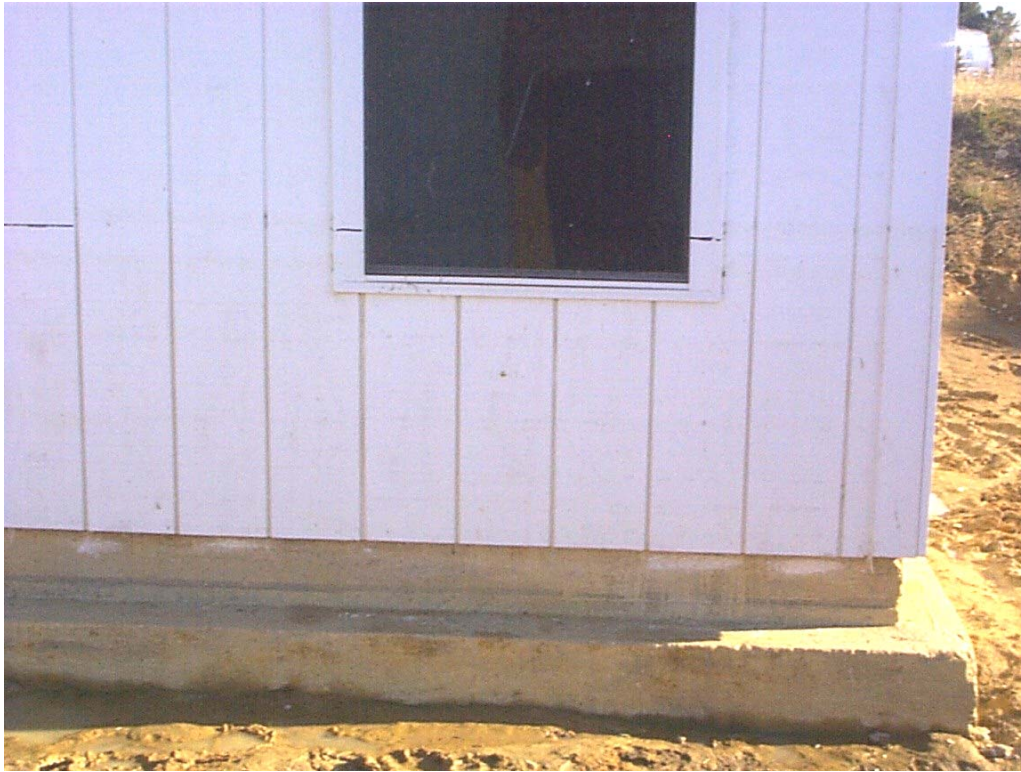
Figure 4-15 Module S-1 (Wall 1, North Exterior Wall) Post-flood, Day 8 (before washing).
Walls are stained below flood level.

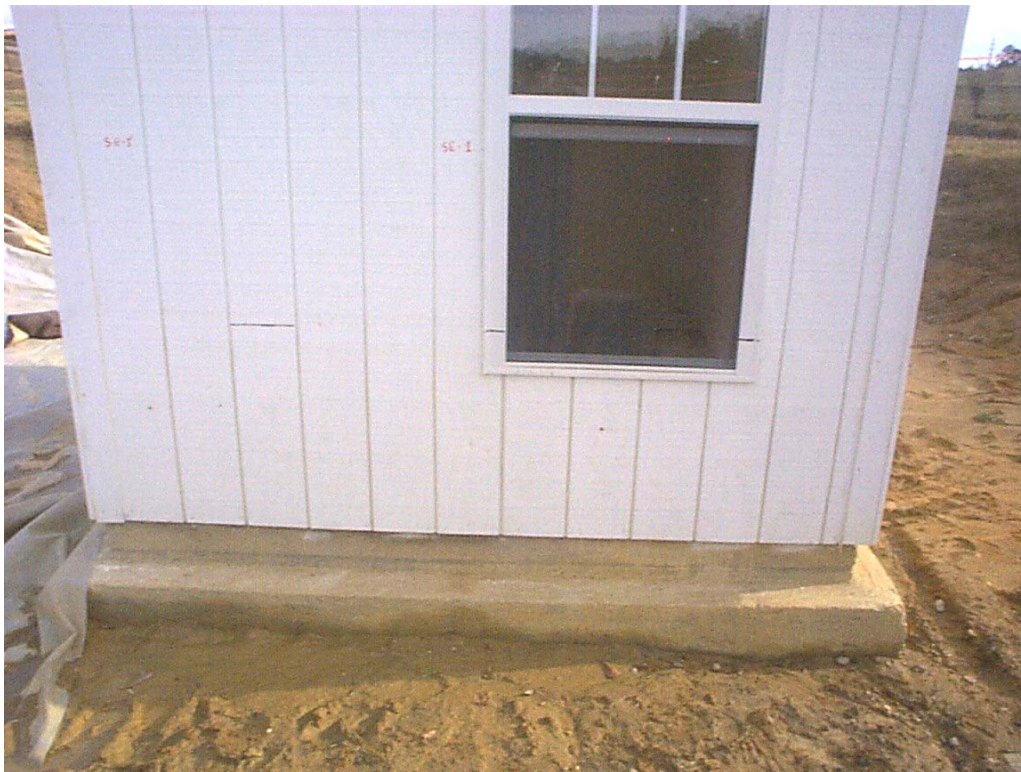
Figure 4-16 Module S-1 (Wall 1, North Exterior Wall) Post-flood, Day 15 (after washing).
Wall remains slightly stained.

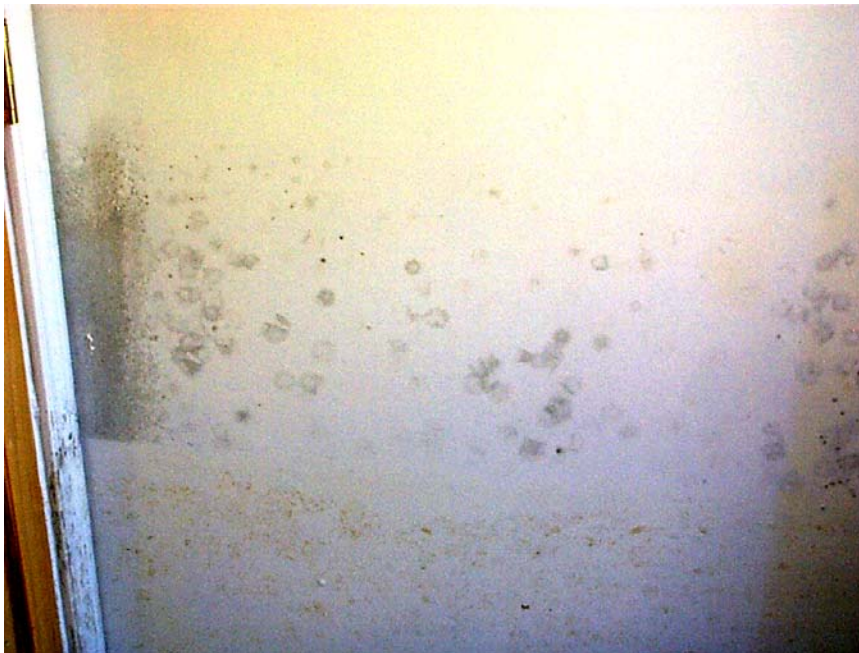
Figure 5-5 Module S-2 (Wall 4) Day 8. Mold growth and staining on walls

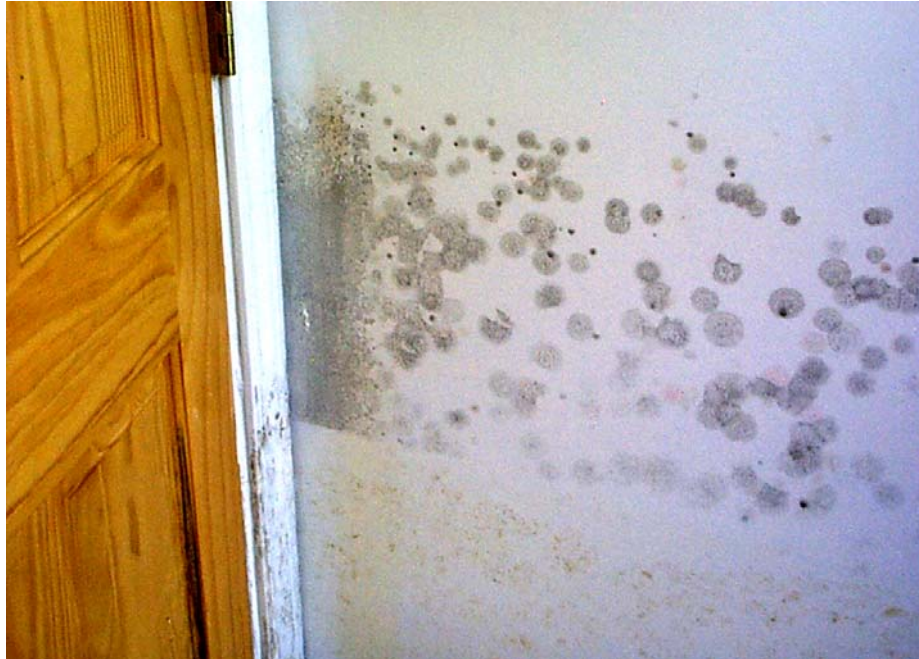
Figure 5-6 Module S-2 (Wall 4) Day 10 - After washing with water. Mold growth and staining on walls

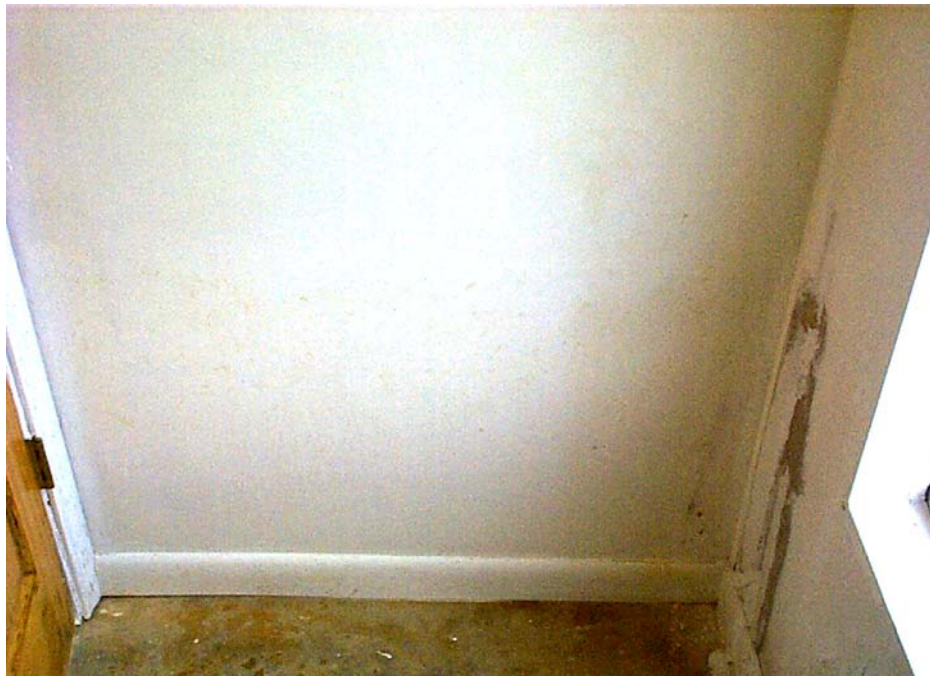
Figure 5-7 Module S-2 (Wall 4) Day 15 - After sanitizing. Mold discoloration gone, some staining remains

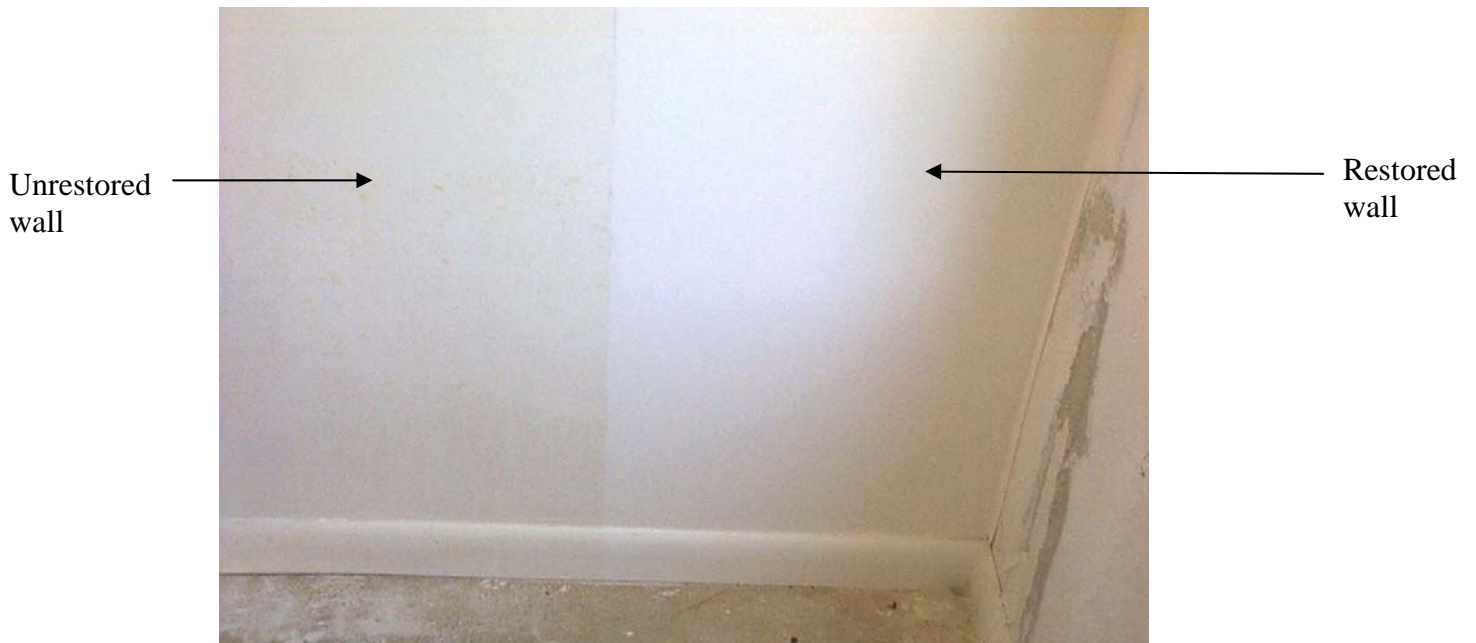
Figure 5-8 Module S-2 (Wall 4) After Restoration. Wall is restorable. Although the fiber reinforced gypsum interior panels shown here on Wall 4 of Module S-2 supported mold growth due to flooding, sanitization and restoration efforts have brought the general appearance back to almost its original state.

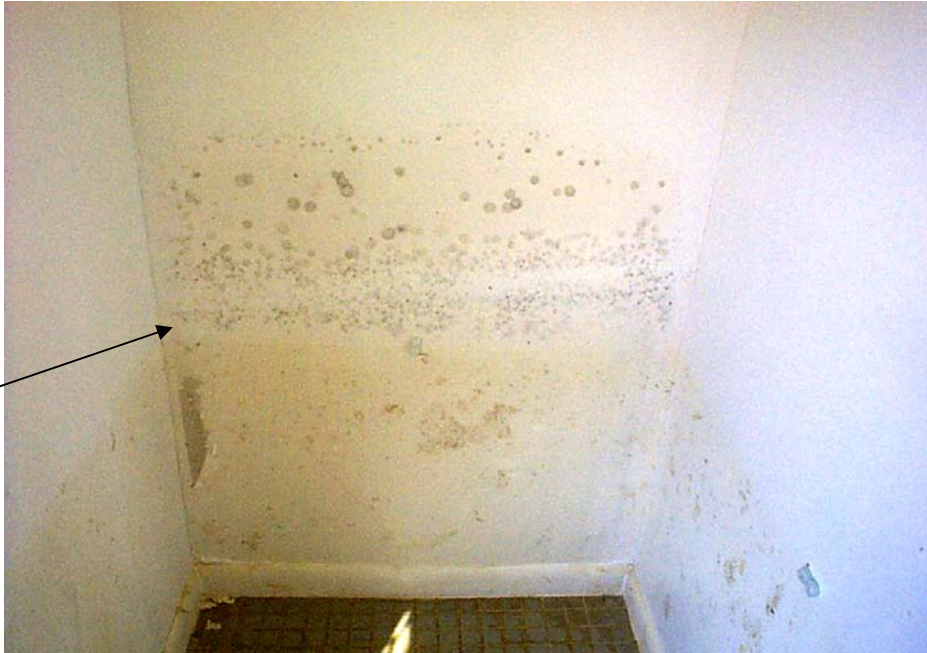
Figure 5-10 Module C-2 (Wall 2) Day 8 at re-entry. Wall is stained and mold growth observed

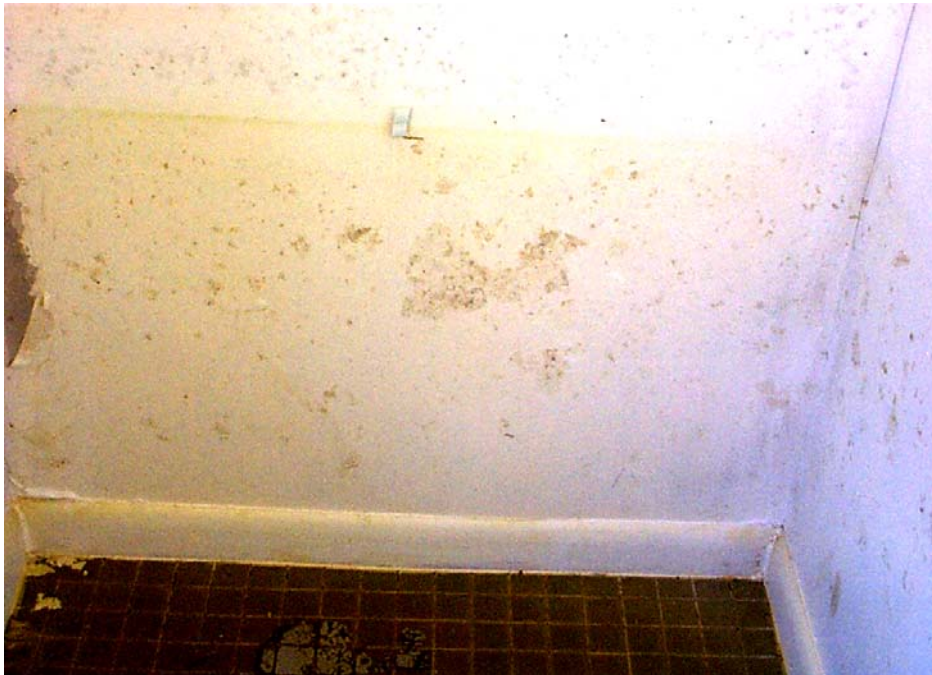
Figure 5-11 Module C-2 (Wall 2) Day 10 after washing with water. Staining and mold growth remain

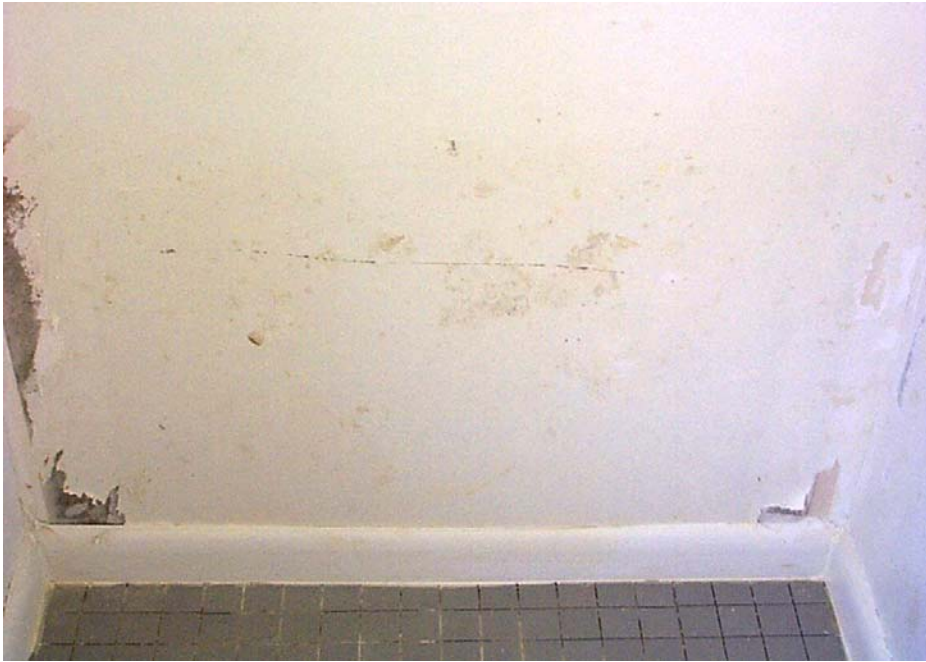
Figure 5-12 Module C-2 (Wall 2) Day 15 after sanitizing. Staining remains, mold growth disappears

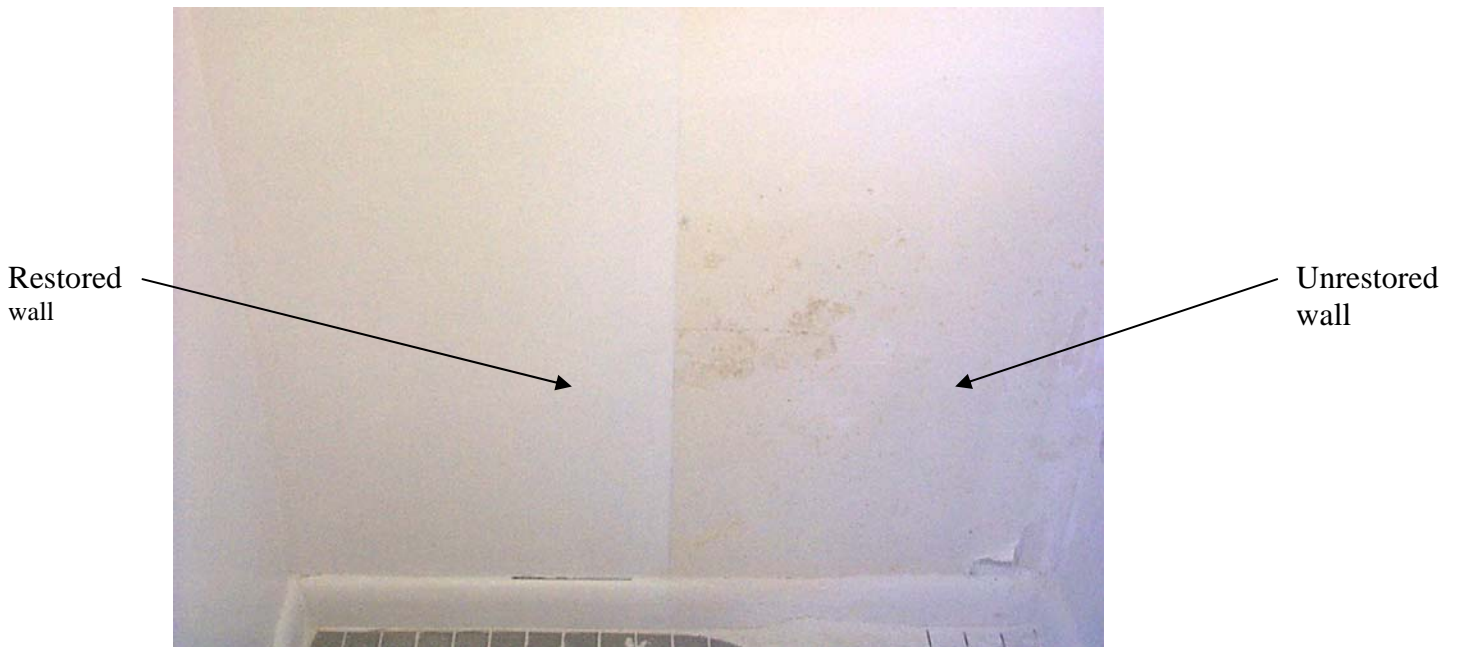
Figure 5-13 Module C-2 (Wall 2) After restoration. Wall is restored. Although the fiber reinforced gypsum interior panels shown here supported mold growth due to flooding, sanitization and restoration efforts have brought the general appearance back to almost its original state.

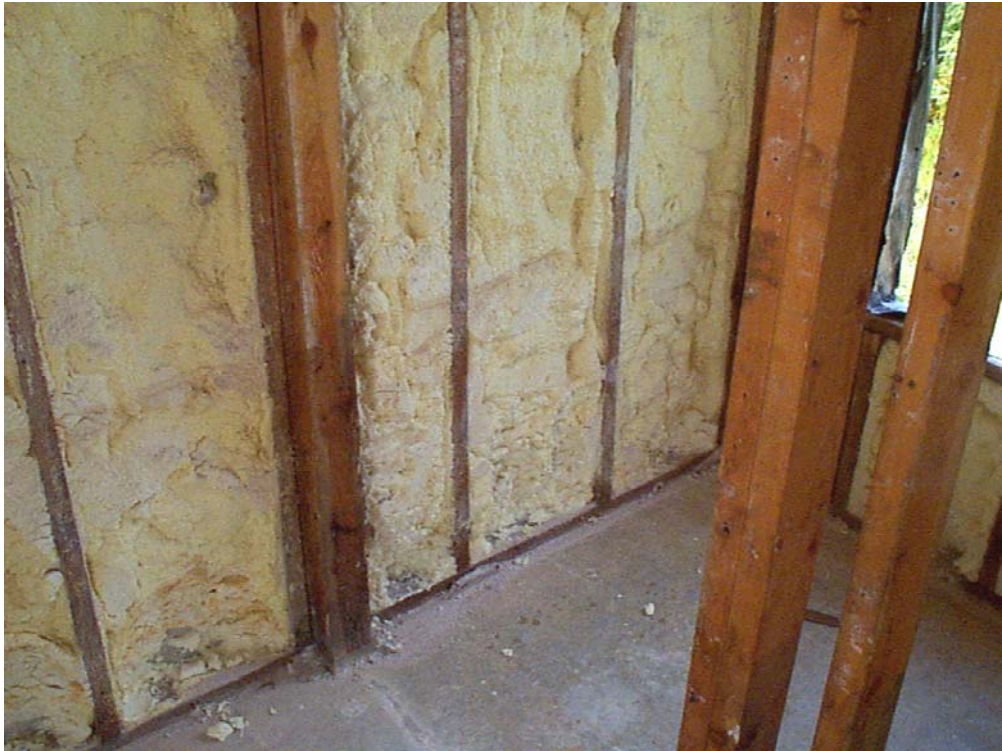
Figure 6-17 Inside of Module S-2 (Wall 4) at autopsy. Insulation and wall cavities are dry and in good condition

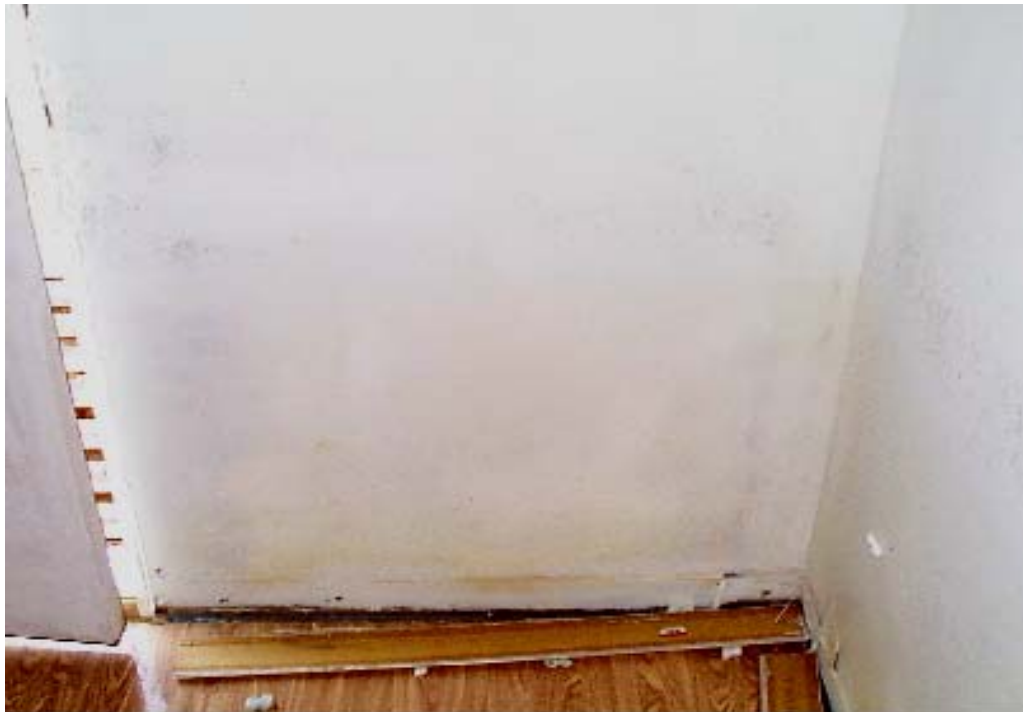
Figure 6-8 Module S-3 (Wall 3) Day 8 – Before washing. Wall is stained and there is mold growth.

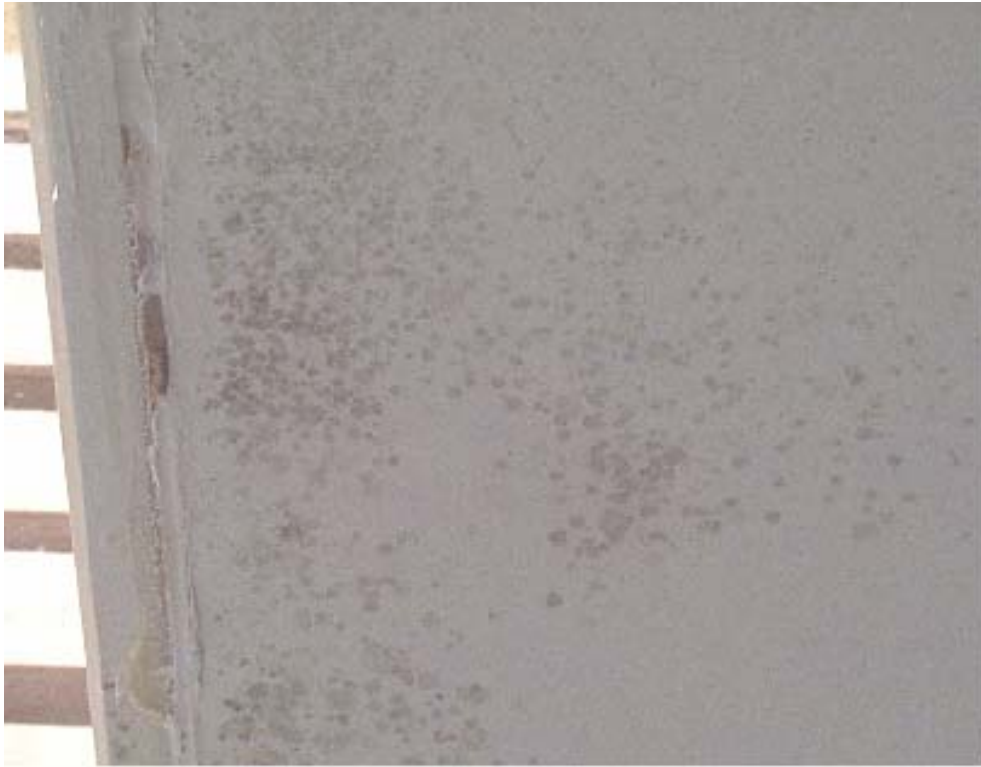
Figure 6-9 Module S-3 (Wall 3) Day 10 - After washing with water. Mold remains

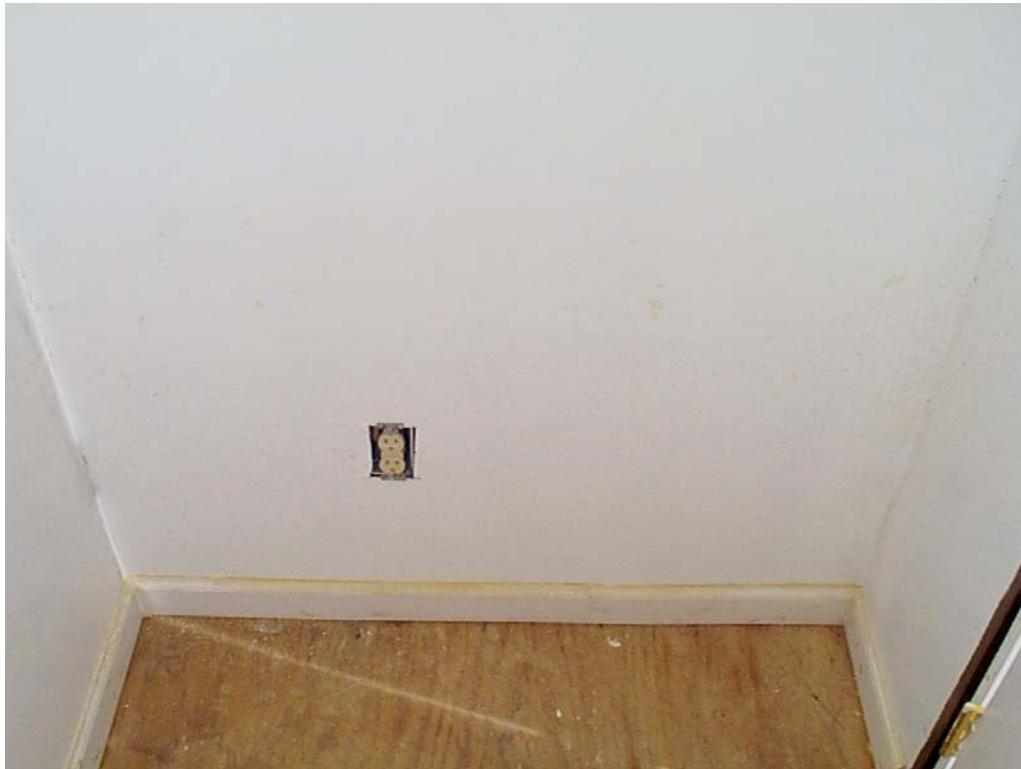
Figure 6-13 Module C-3 (Wall 2) Day 10 - After washing with water. No visible mold stains.

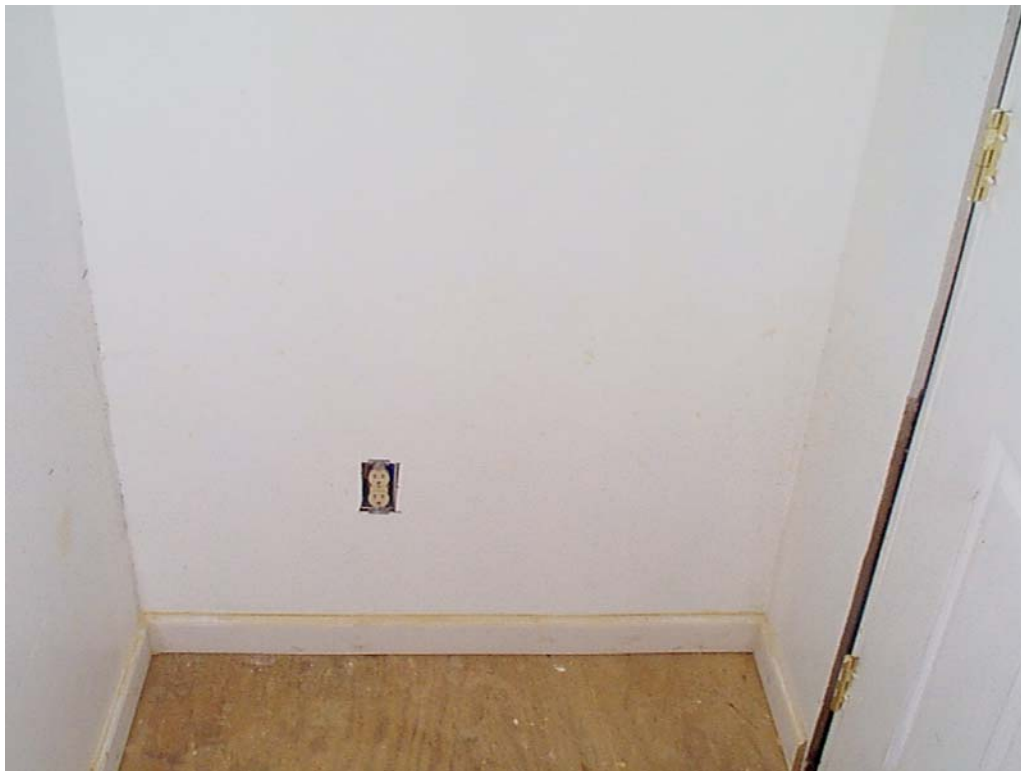
Figure 6-14 Module C-3 (Wall 2) Day 15. No sanitization occurred and no mold growth appeared; wall is restorable.

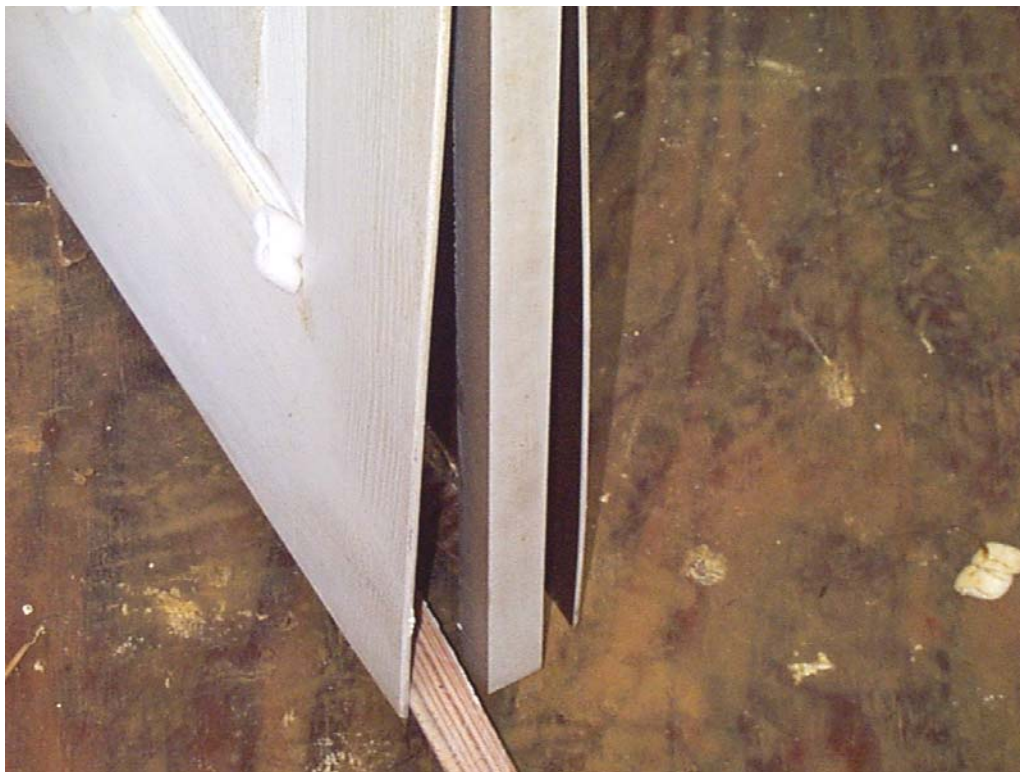
Figure 6-16 Module C-3 Interior door – Day 8. Door surface is delaminating.
