RPP-RPT-32425, Rev. 0

Final Analytical Results from the Examination of Corrosion on Sections of Corrosion Probe Removed from Tank 241-AN-107 on August 10, 2006

G. A. Cooke and J. B. Duncan
CH2M Hill Hanford Group, Inc.
Richland, WA 99352
U.S. Department of Energy Contract DE-AC27-99RL14047

Date Published
March 2007

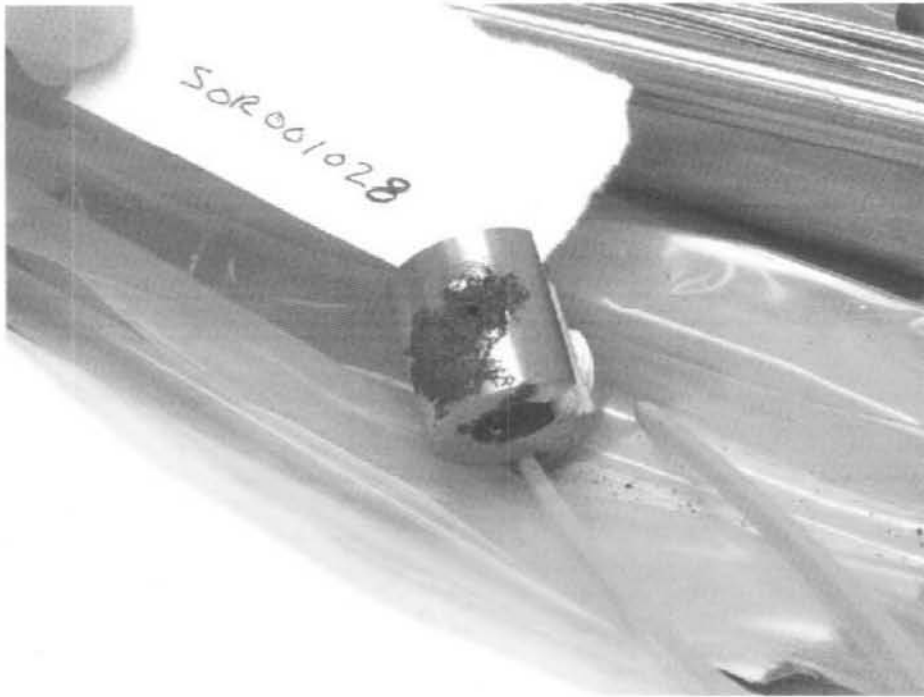
Cleaned specimens were examined by OM and SEM. Several features of note were documented before any further preparation. Specimen S06R001028, a nonstressed C-ring from detector 1 (in the vapor space) showed significant corrosion where the threads of the bolt came through the top of the C-ring (Figure 14). After cleaning, SEM examination of that region revealed that only a portion of the corrosion-covered area had significant pitting (Figure 15).

Figure 14. Macrophotograph of the Top of Vapor Space Nonstressed C-Ring S06R001028.

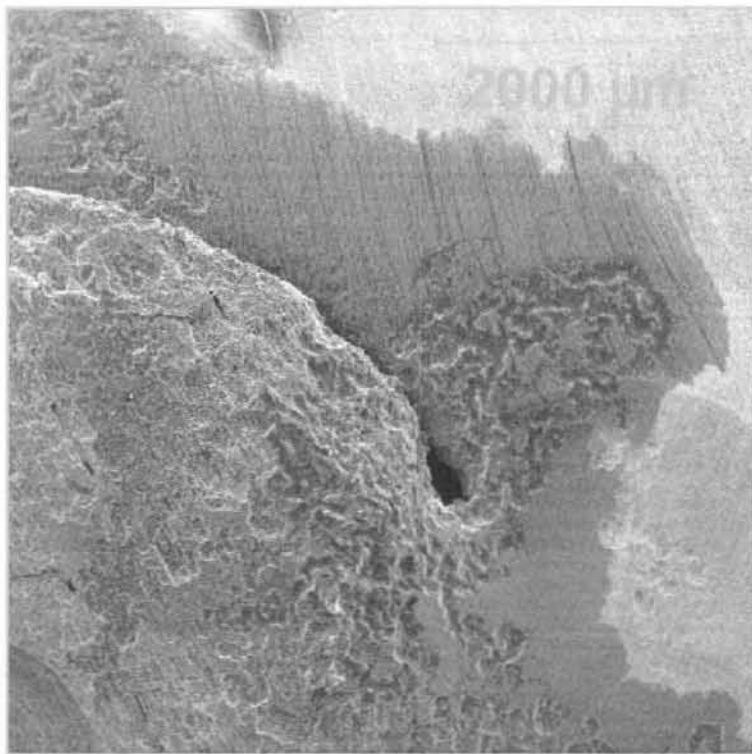
Figure 15. SEM Microphotograph of the Top of Vapor Space Nonstressed C-Ring S06R001028.

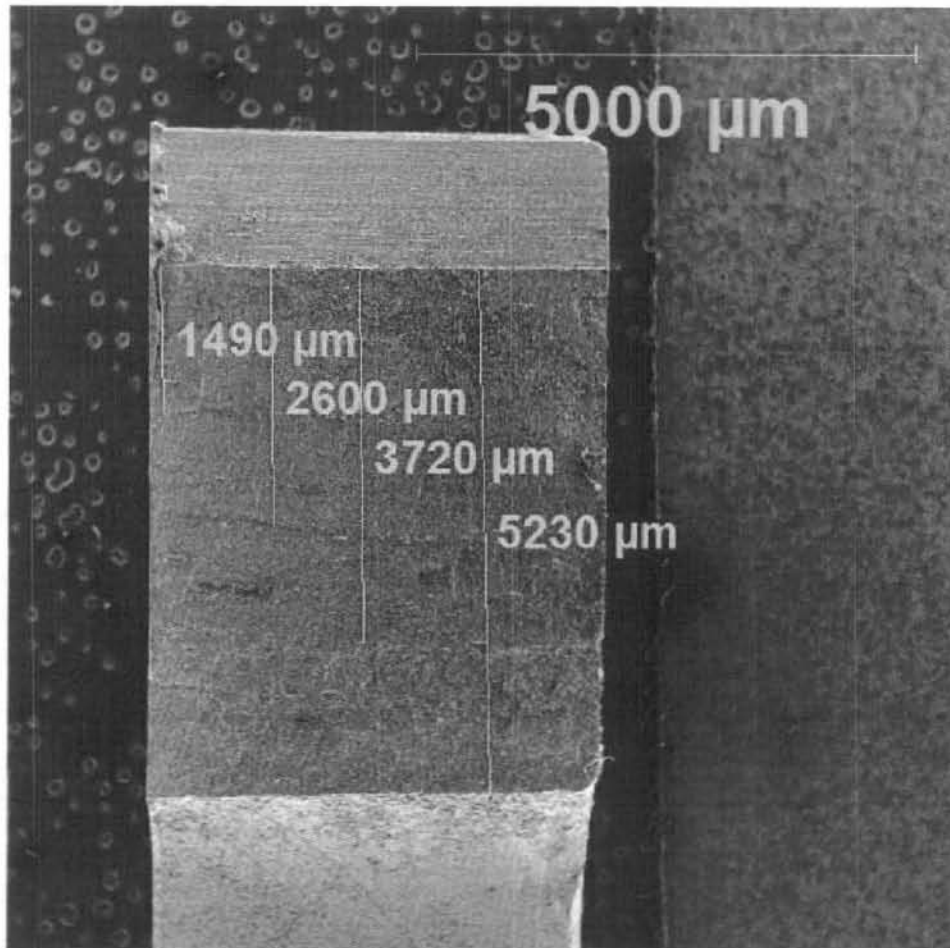
Following cleaning, the selected specimens were prepared for examination in several ways. Cross sections of the specimens were sliced using a low-speed saw with a diamond-impregnated blade. The stressed C-rings were prepared for examination of the stress-cracked section by slicing a thin section of the C-ring. The thin (about 4-mm thick) portion of the stressed C-rings was submerged in liquid nitrogen (LN2) and then struck lightly, on edge, with a mallet, to complete the fracture into two pieces. These two pieces were mounted side-by-side for OM and SEM examination of the fractured surfaces. Figure 16 is an SEM photomicrograph of one of the fractured surfaces from S06R001027, the vapor space stressed C-ring. All measurements in Figure 16 start at the top where the v-notch ends and the pre-crack begins. The entire length of the pre-crack after recovery and preparation is 3720 μm . The region from 3720 μm to 5230 μm is the LN2 fractured surface. Figure 17 through Figure 19 show example SEM photomicrographs of the three stressed C-ring LN2 fractured surfaces. In these three figures, the right-hand image is a magnified view of the area in the yellow box of the left hand image and the LN2 fractured portion is toward the bottom of the images. These right-hand images are all taken from the region where the pre-crack ends and the LN2 fracture surface begins.

Figure 16. SEM Photomicrograph of the Face of Pre-stressed Crack, Specimen S06R001027.

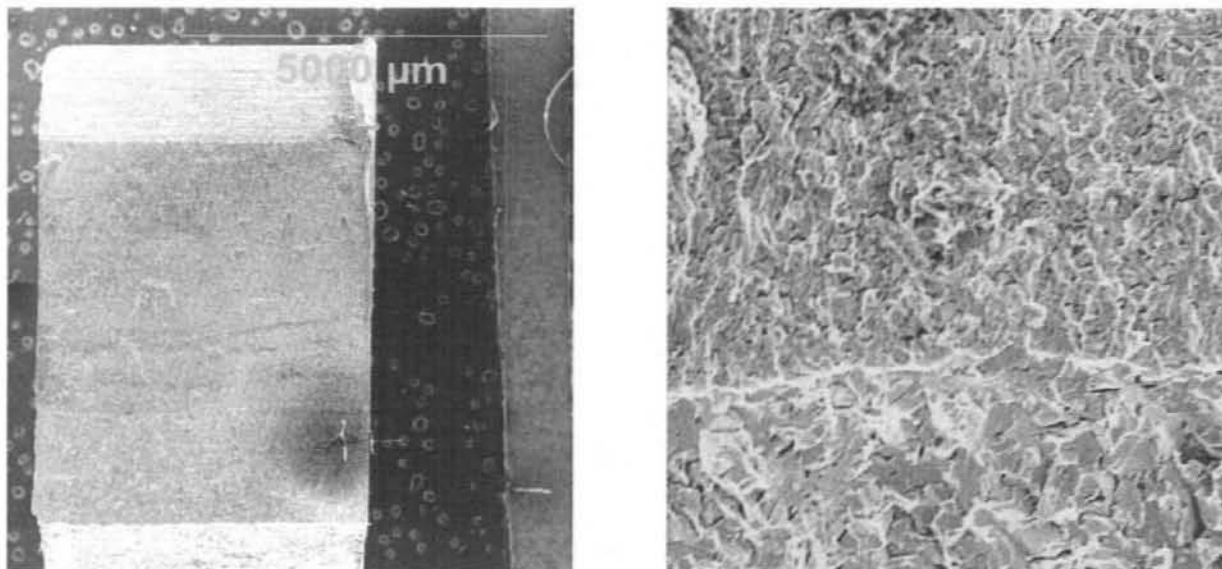
Figure 17. SEM Photomicrograph of the Face of Pre-stressed Crack, Specimen S06R001027.

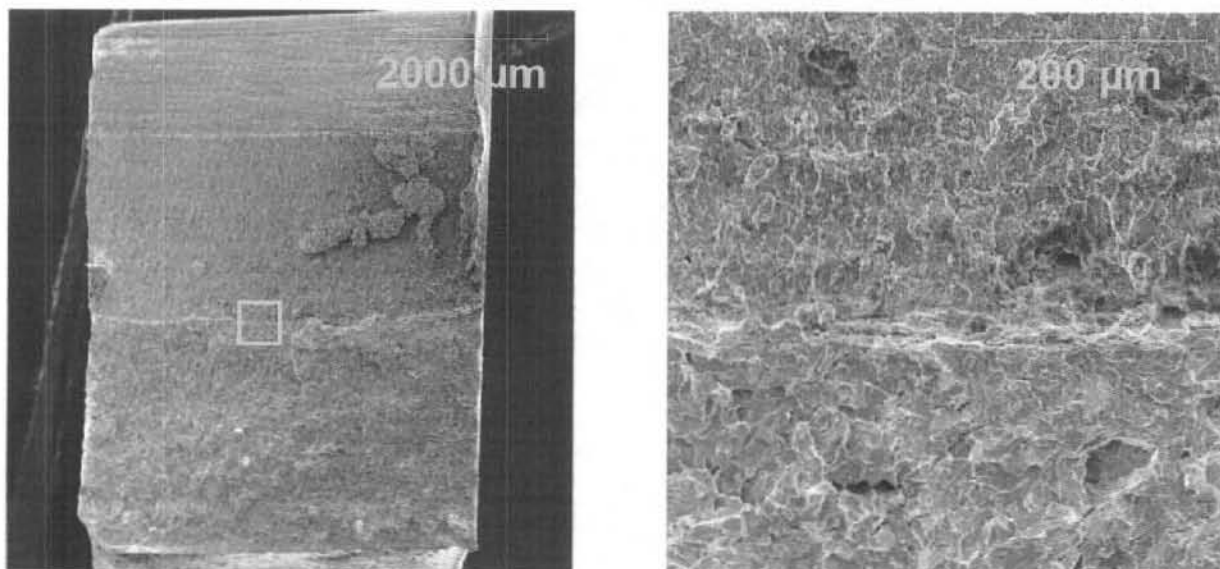
Figure 18. SEM Photomicrograph of the Face of Pre-stressed Crack, Specimen S06R001033.

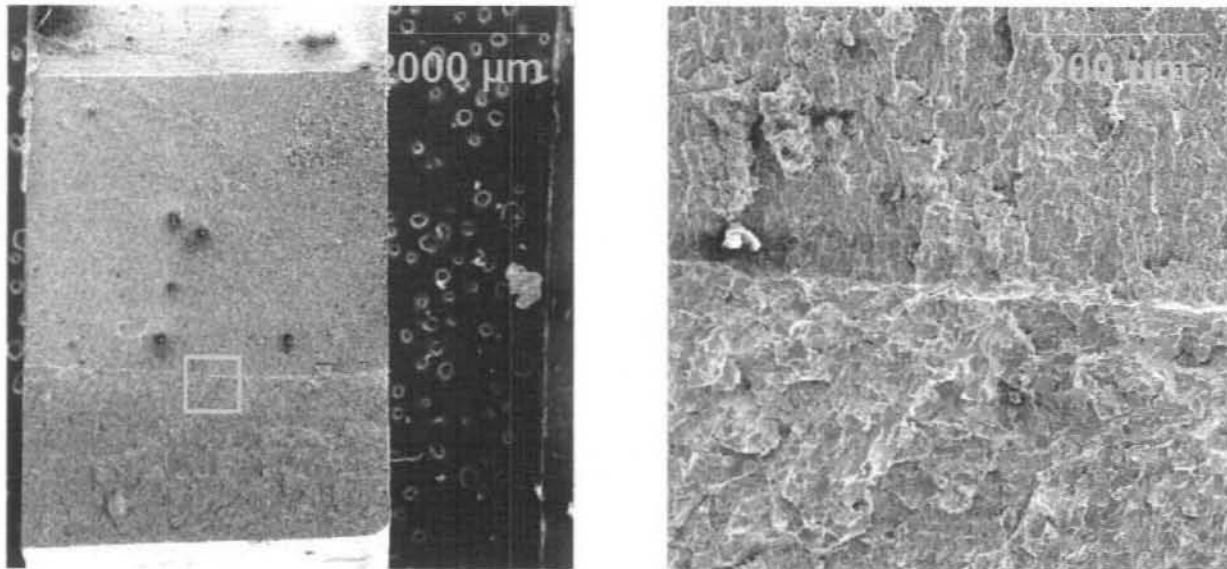
**Figure 19. SEM Photomicrograph of the Face of Pre-stressed Crack,
Specimen S06R001045.**

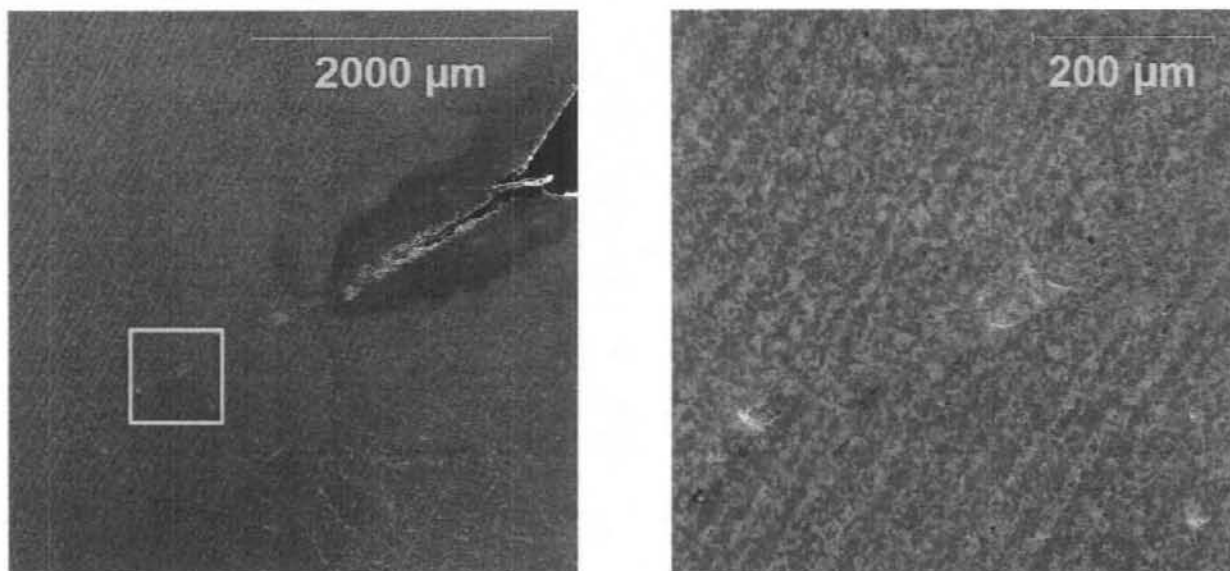
The larger cut sections of two of the pre-stressed C-rings were polished with successively finer polishing grits with a 10- μm final polish. The cut and polished surfaces were then etched with 3% nitric acid in methanol (ASTM E-407-99, *Standard Practice for Microetching Metals and Alloys*). The polished and etched surfaces of the pre-cracks were again examined by OM and SEM. Figure 20 and Figure 21 show SEM photomicrographs of the polished and etched surfaces at the tips of each of the pre-cracks in the two stressed C-rings that were examined.

Figure 20. SEM Photomicrograph of the Polished and Etched Surface of Pre-stressed Crack, Specimen S06R001027.

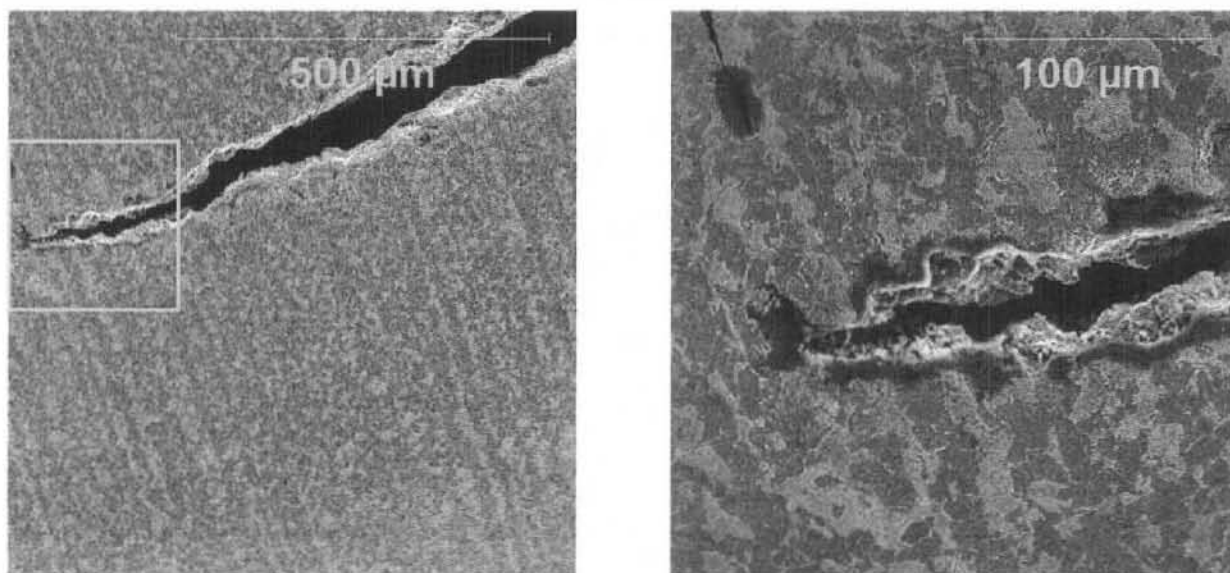
Figure 21. SEM Photomicrograph of the Polished and Etched Surface of Pre-stressed Crack, Specimen S06R001045.

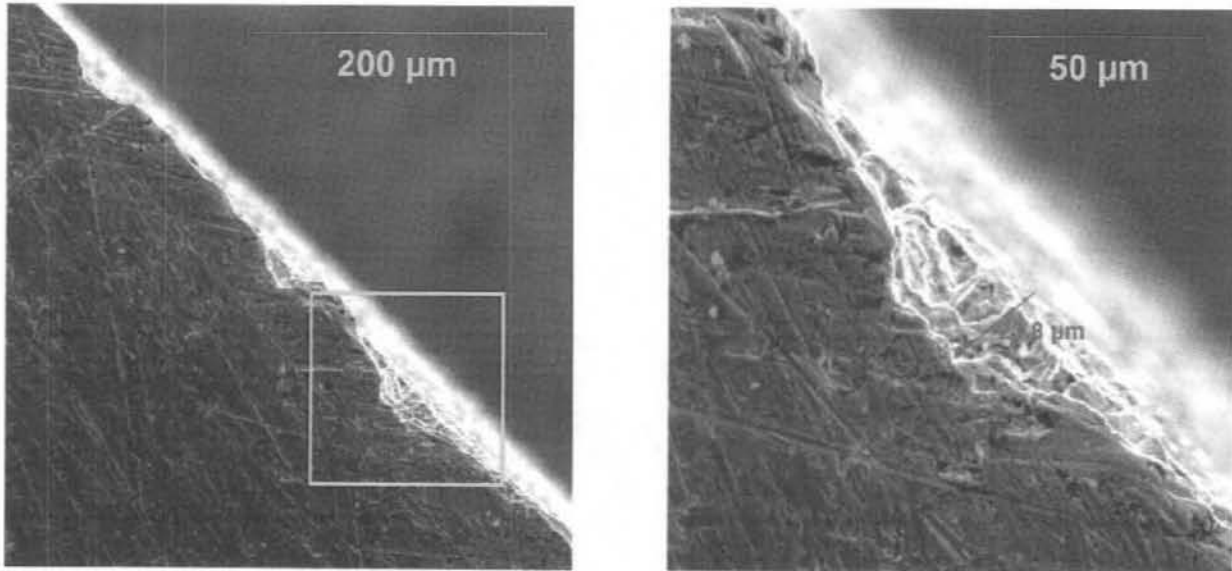
Finally, a number of specimens were examined for corrosion pit size, depth, and shape. These samples were prepared by cutting cross-sections using the low-speed saw and polishing the surfaces to 600 grit. The resulting specimens were examined by OM and SEM. Representative images of the largest pits observed in these samples are shown in Figure 22 through Figure 26.

Figure 22. SEM Image of Pitted Area on Outer Surface of Sample S06R001024.

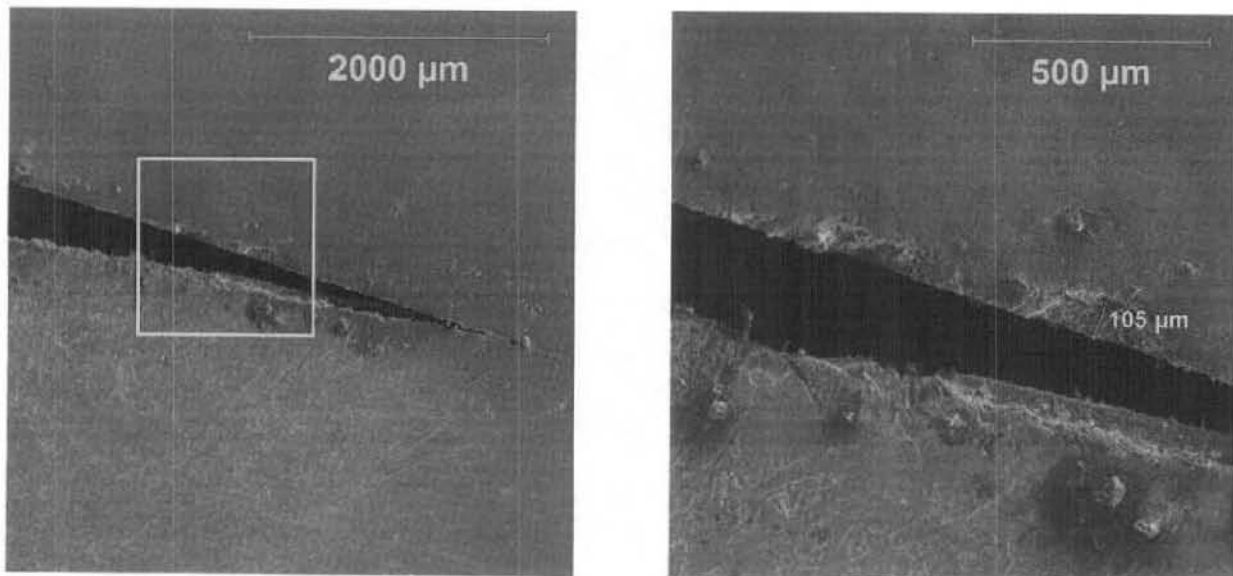
Figure 23. SEM Image of Pitted Area Near Crevice Between C-Ring and Bolt Head on Sample S06R001027.

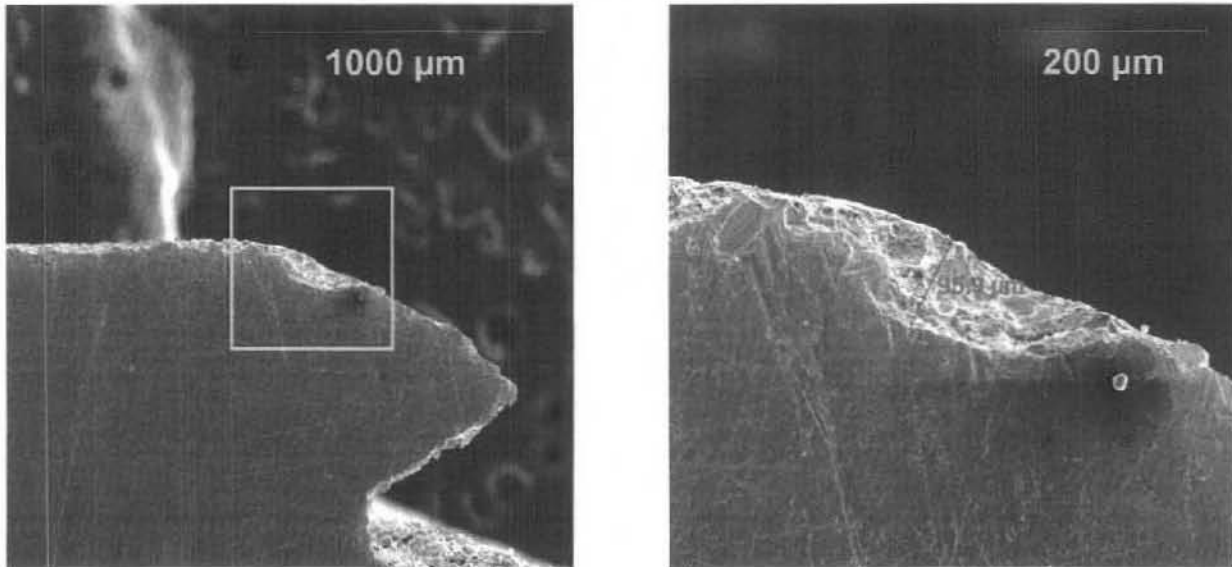
Figure 24. SEM Image of Pitted Area from End of Bolt on Sample S06R001028.

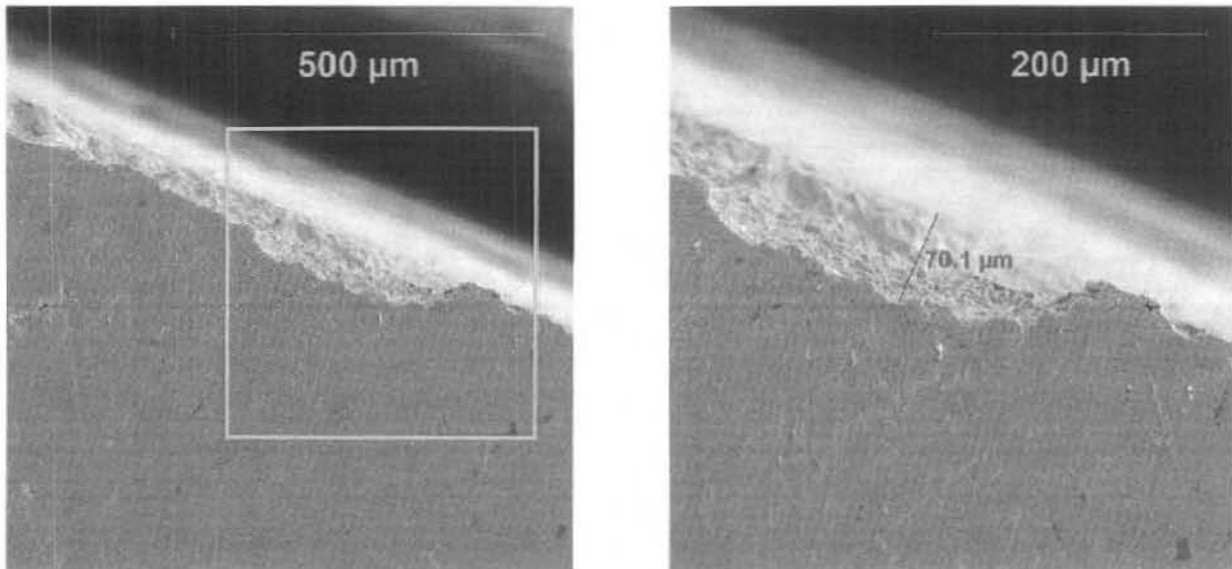
Figure 25. SEM Image of Pitted Area on Base of Sample S06R001042.

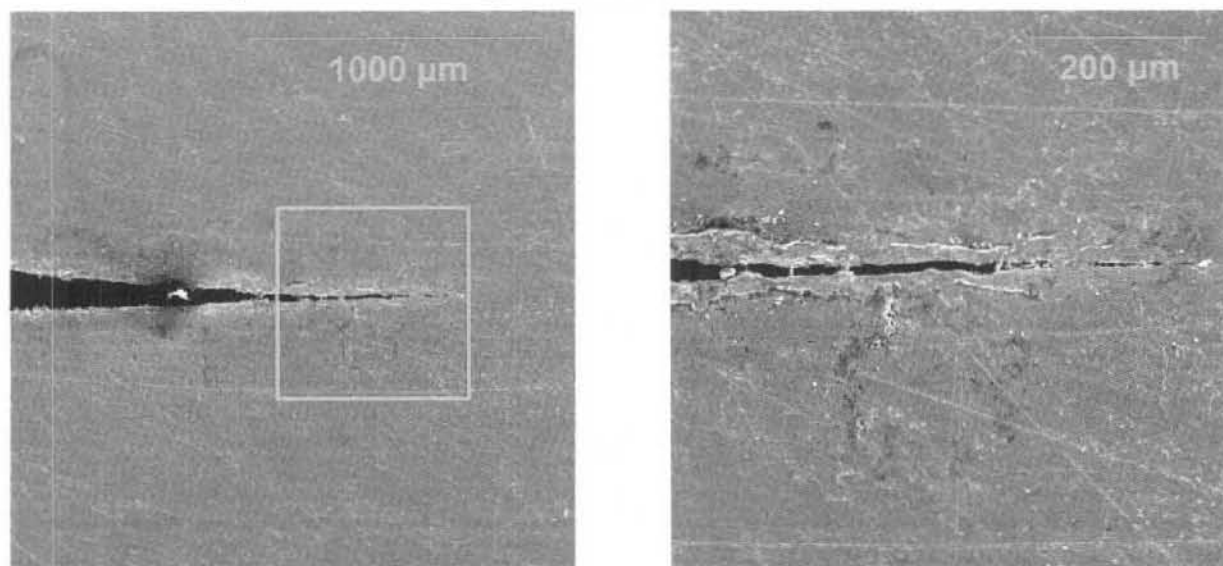
Figure 26. SEM Image of Pitted Area on Sample S06R001045.

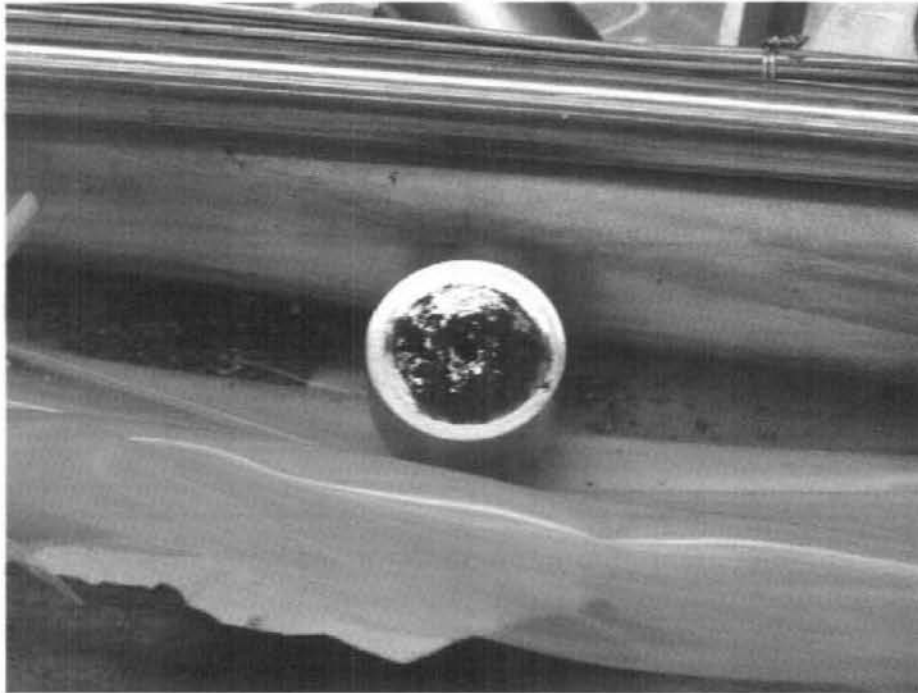
Detector 1 was disassembled in a fume hood and all six specimens were removed and examined during rinsing and transfer to the dessicator. During this process, it was noted that the pre-stressed C-ring S06R001027 had a noticeable crack extending from the tip of the v-notch (Figure 7). In addition, significant patches of corrosion were seen on several of the other specimens on detector 1. Of note were a patch of surface corrosion on bullets S06R001024 and S06R001025 (Figure 1 and Figure 6) and a large patch of corrosion on the top of nonstressed C-ring S06R001028 where the bolt extended through the C-ring (Figure 14). It was also noted that all of the specimens removed from detector 1 had significant corrosion on the underside, beneath, and behind the region that was protected by the O-ring (Figure 27).

Figure 27. Bullet Sample S06R001023. (Bottom region, behind O-ring.)
