**FIELD SURVEY  
OF  
CACTUS CRATER STORAGE FACILITY  
(RUNIT DOME)**

**REPORT A08**

The US Department of Energy, Office of Health and Safety (DOE/HS-10), requested that National Security Technologies, LLC, Environmental Management directorate (NSTec/EM) perform a field survey of the Cactus Crater Storage Facility (Runit Dome), similar to past surveys conducted at their request. This field survey was conducted in conjunction with a Lawrence Livermore National Laboratory (LLNL) mission on Runit Island in the Enewetak Atoll in the Republic of the Marshall Islands (RMI). The survey was strictly a visual survey, backed up by digital photos and a written description of the current condition.

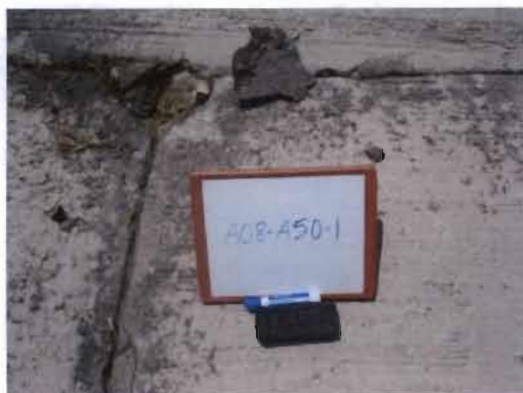
Spalling at panel corner

The spalling is probably related to thermal expansion and contraction of the concrete. There is no indication that any provision was made during construction for movement of the panels over time. When the concrete cools, debris may be entering the joints and cracks, which would contribute to the potential for spalling as the concrete warms. This situation is similar to the highway blowups that are common in hot areas within the US.

1. Implementation of an aggressive program of vegetation control to keep roots out of the construction joints and cracks.
2. Clean and fill existing spalls. There are many suitable bagged materials that could be specified for this task. An "add water only" type product would minimize site difficulties. This step would be appropriate only for the larger spalls.
3. Addressing the water movement through the cracks and joints, only if reduction of moisture ingress is determined to be important to serviceability of the dome. If determined to be necessary, this could be a major exercise given the size of the dome, and the number of joints and cracks.

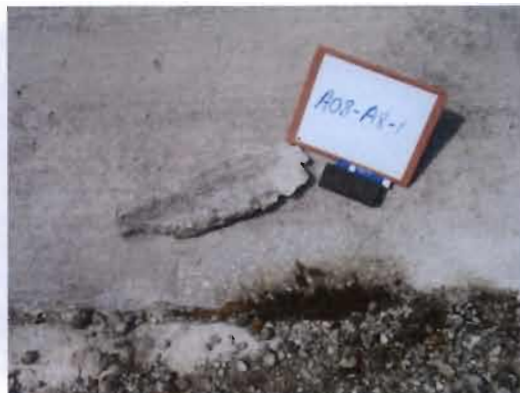
Spalling at panel edge.

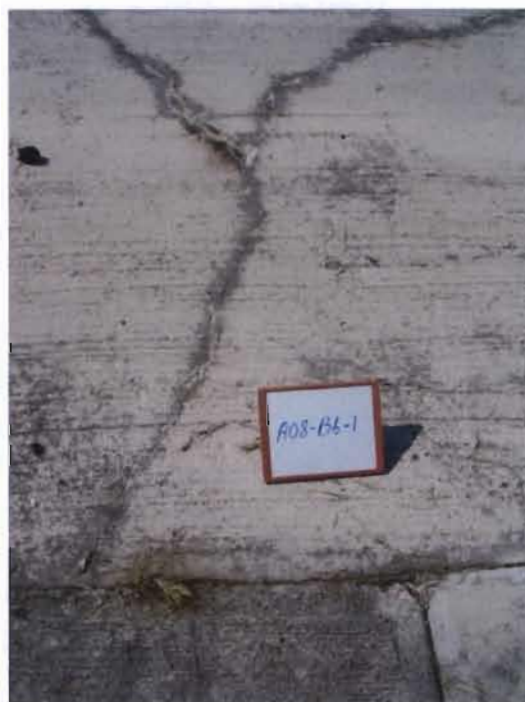
Spalling along interior crack.

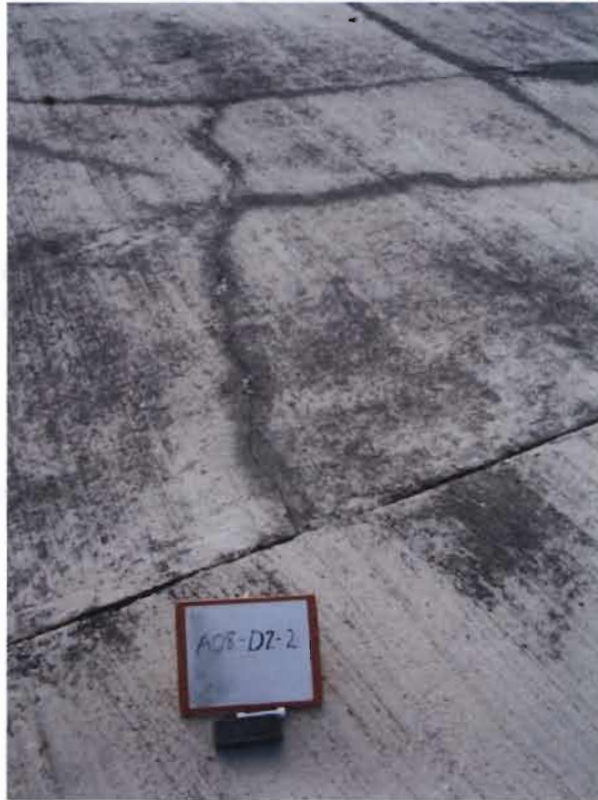
Cracking for the most part would be considered hairline, although some were approximately 1/64 to 1/16 of an inch wide. Cracks tended to run vertical versus horizontal, and most ran from panel edge to panel edge.

Vertical and horizontal cracks.

Most of the cracking is probably related to long-term drying shrinkage. Such shrinkage is inevitable with portland cement concrete.

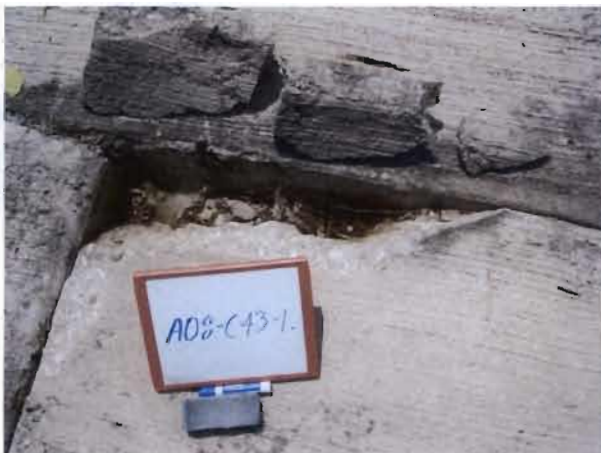
Breaking/chipping occurred in two locations at the panel corner and were about 6" deep.

6" deep broken corner #1.

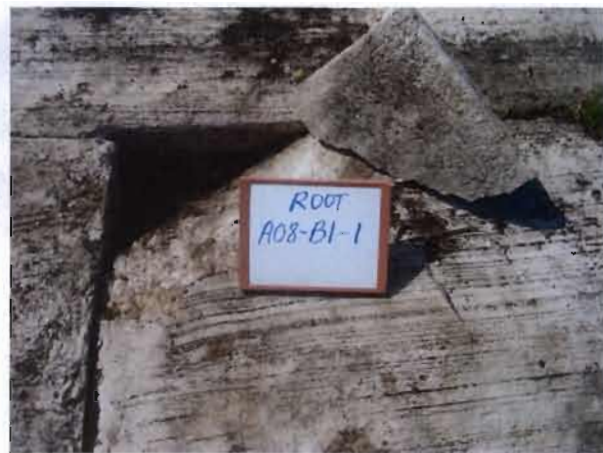
6" deep broken corner #2.

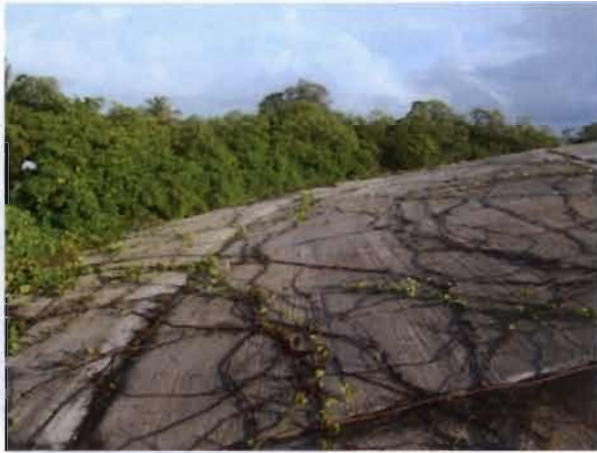
Vines at higher elevations.

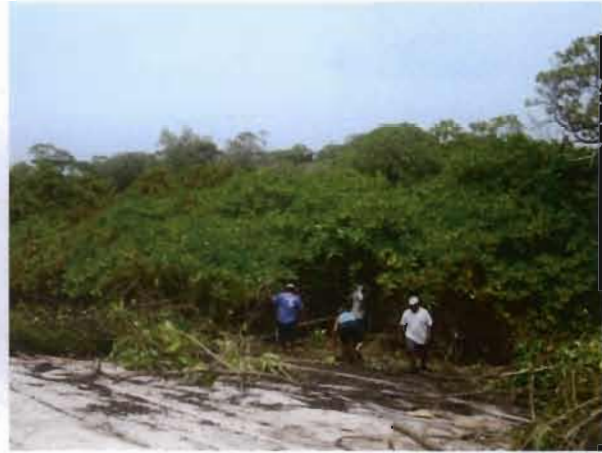
Brush at lower elevations.

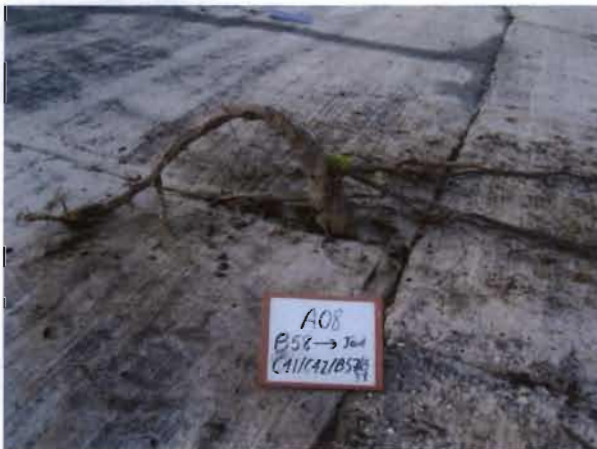
Vegetation taking root in joints occurred in 4 to 5 locations, but did not appear to have penetrated the concrete panels.

Vine #1 rooted in joint.

The most significant threat to the long-term durability of the concrete is the growth of vegetation. Roots are penetrating joints and cracks. As the roots become larger, the joints and cracks will open and spall. As they open, additional debris will enter and the cycle will feed upon itself.

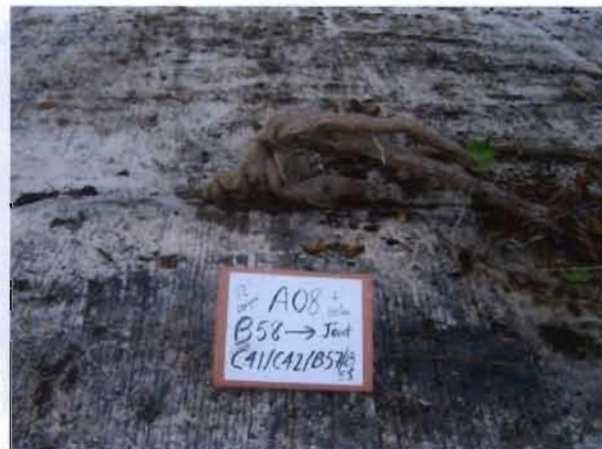
Vine #2 rooted in joint.

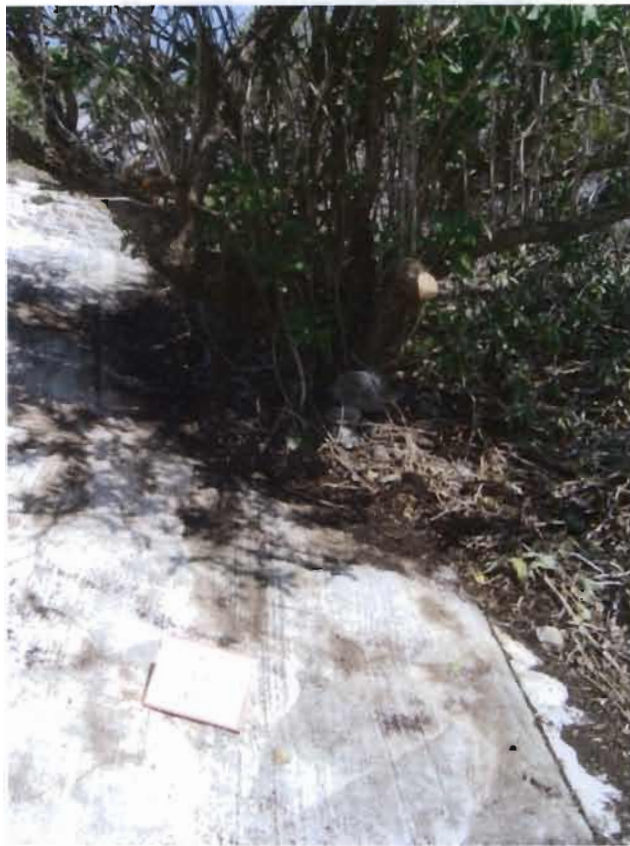
Vegetation overtaking the panels occurred in a couple places, but did not penetrate the concrete panel.

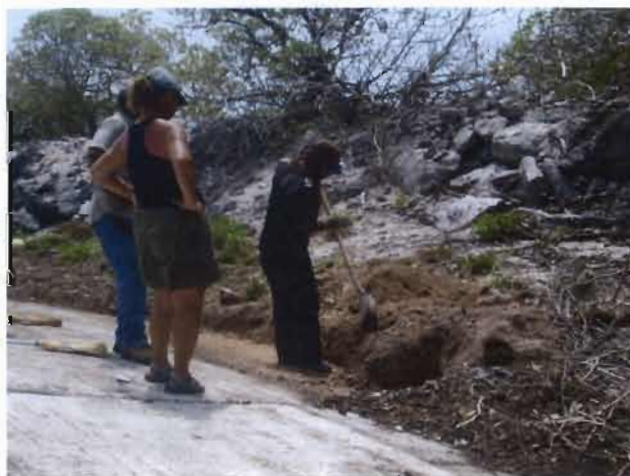
Debris covered 2' to 4' of the bottom of numerous panels. Time did not allow all this debris to be cleared for an unobstructed view of the bottom panels.
