SANDIA REPORT

SAND2005-3429
Unlimited Release
Printed June 2005

Pulse-Echo Ultrasonic Inspection System for In-Situ Nondestructive Inspection of Space Shuttle RCC Heat Shields

Dennis Roach, Phil Walkington, and Kirk Rackow

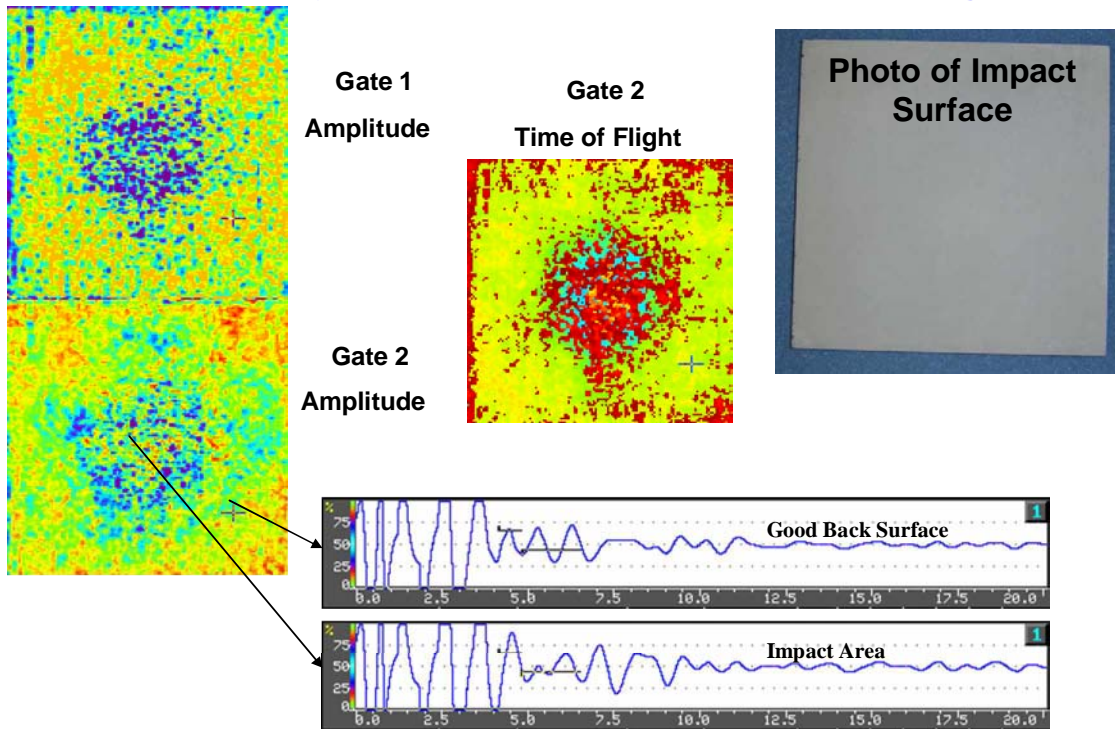
NASA Impact Panel T8015-3

Impact velocity of 1717 ft/s with no visible impact damage

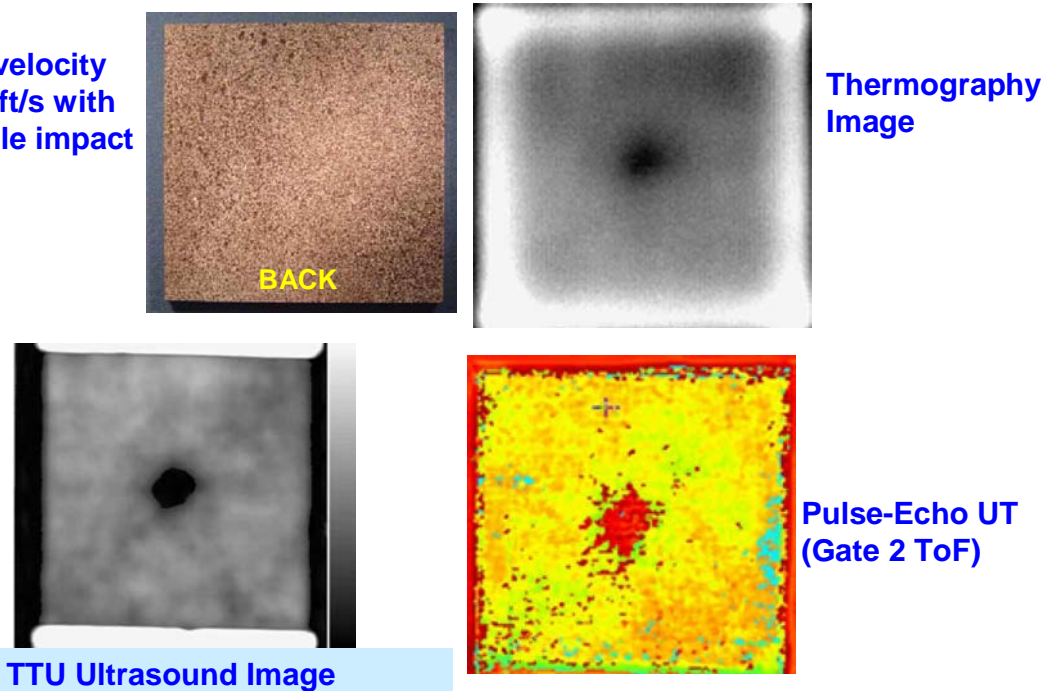
NASA Impact Panel 8015-4

Impact velocity of 1720 ft/s with no visible impact damage

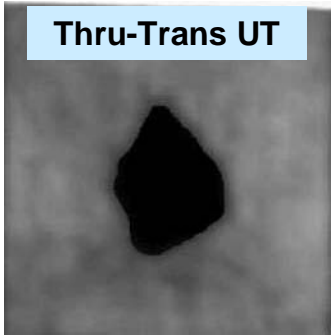
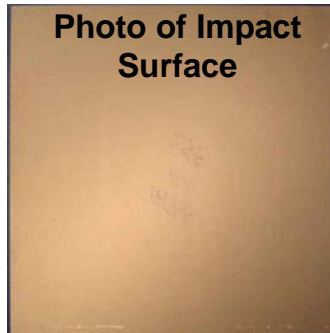
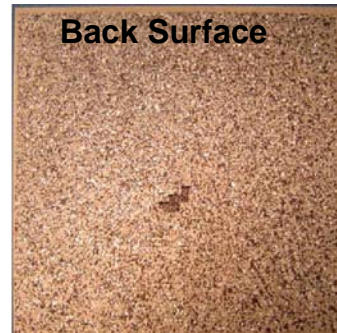
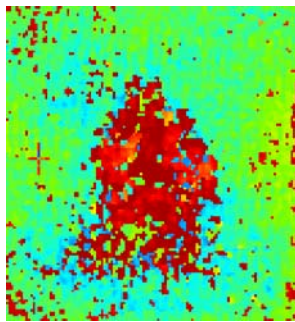
NASA Impact Panel 284-20

45 degree impact
at 2230 fps –
visible damage on
backside only

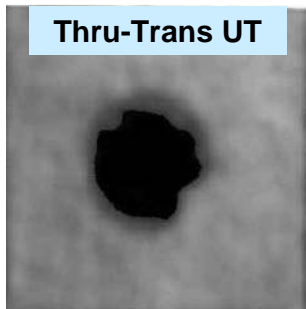
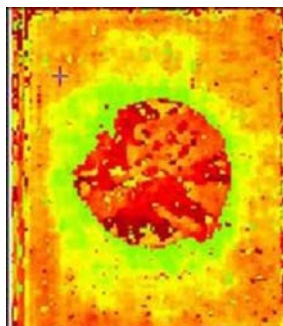
NASA Impact Panel 20L-23

90 degree impact
at 2077 fps – no visible
damage on front;
small cracks visible
on back side

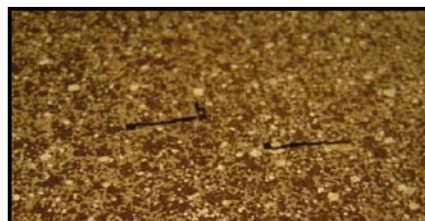
Impact Test - OV105 Panel 16R

Photo of Crack at Apex

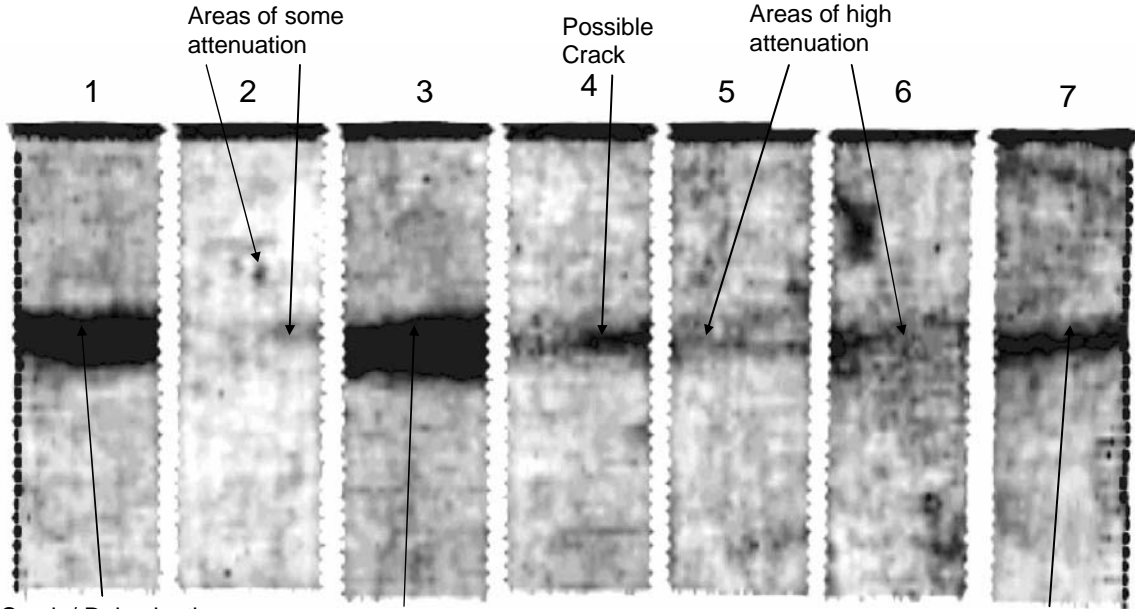
Validation Results, Phase 2 Specimen 9L – 3 Pt. Bend

Crack / Delamination
Mean 63.7751 dB
Total Area: 1.2000 Sq In

Crack / Delamination
Mean 60.9639 dB
Total Area: 1.3536 Sq In

Crack / Delamination
Mean 53.0924 dB
Total Area: 0.4608 Sq In

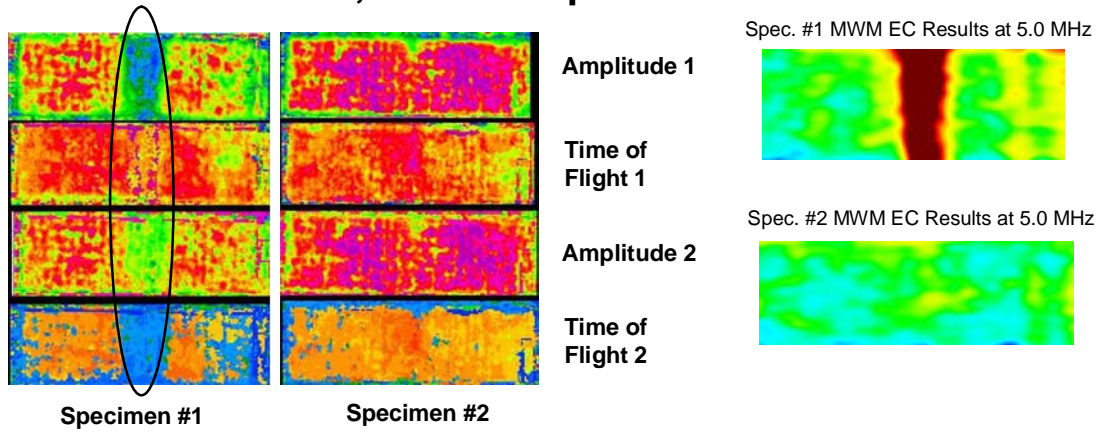
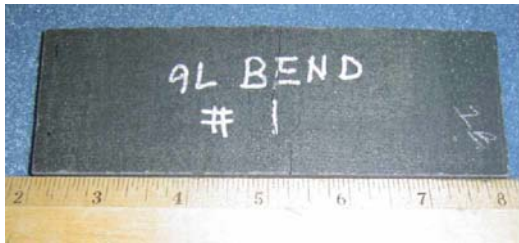
Validation Results, Phase 2 Specimen 9L – 3 Pt. Bend

Specimen 1 (side view showing crack)

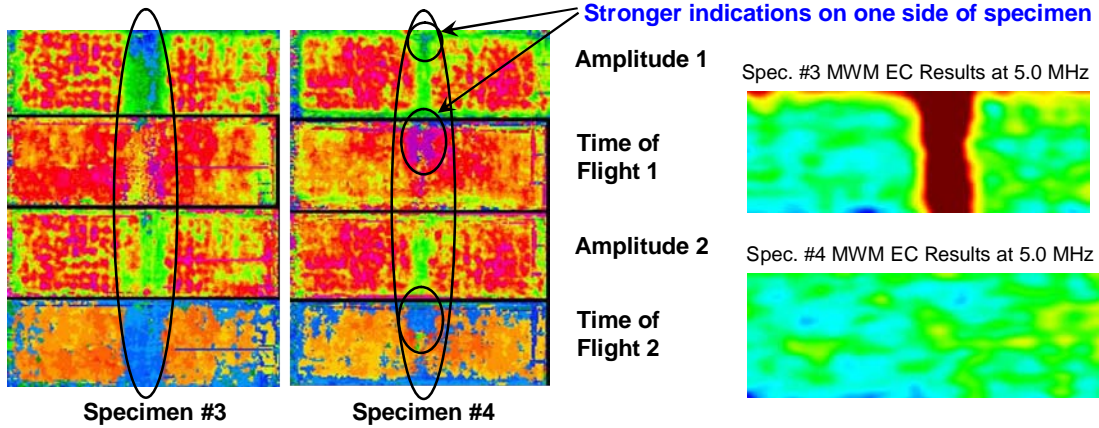
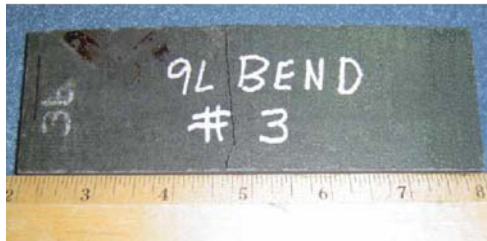
Validation Results, Phase 2 Specimen 9L – 3 Pt. Bend

Specimen 3 (side view showing crack)

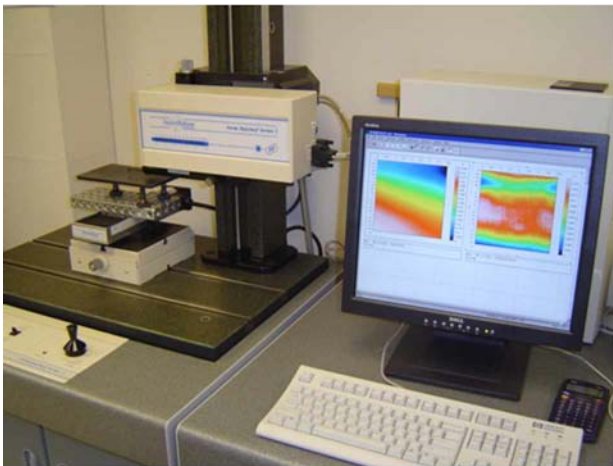
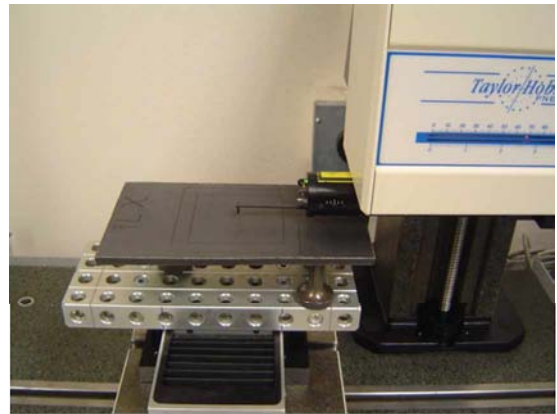
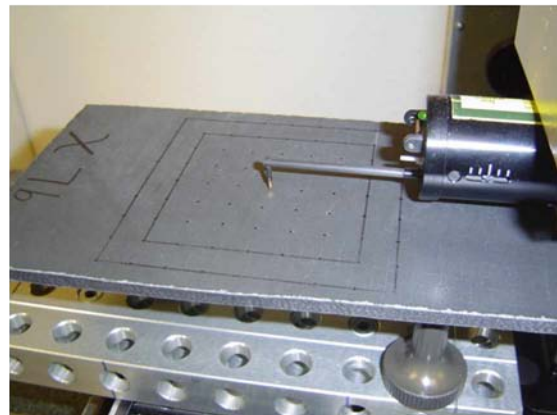
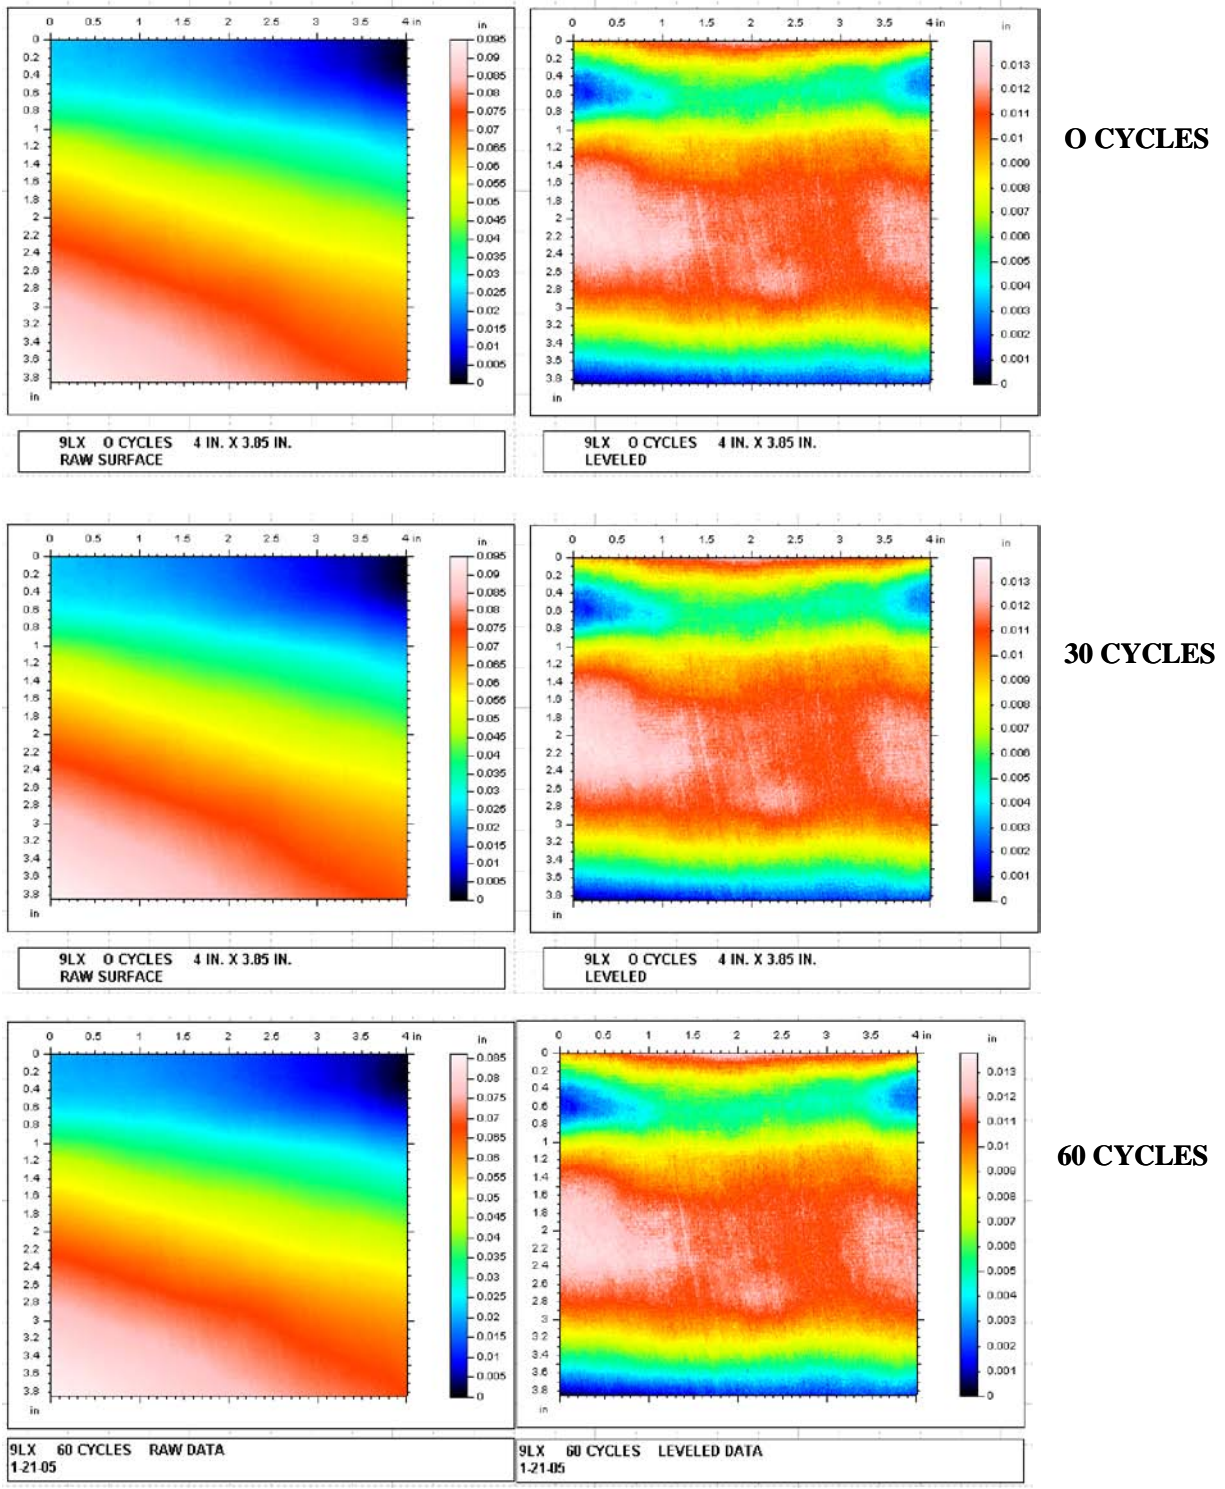
Surface Contour Plots of Entire Specimen Before and After UT Scanning - No Removal of RCC Material Measured

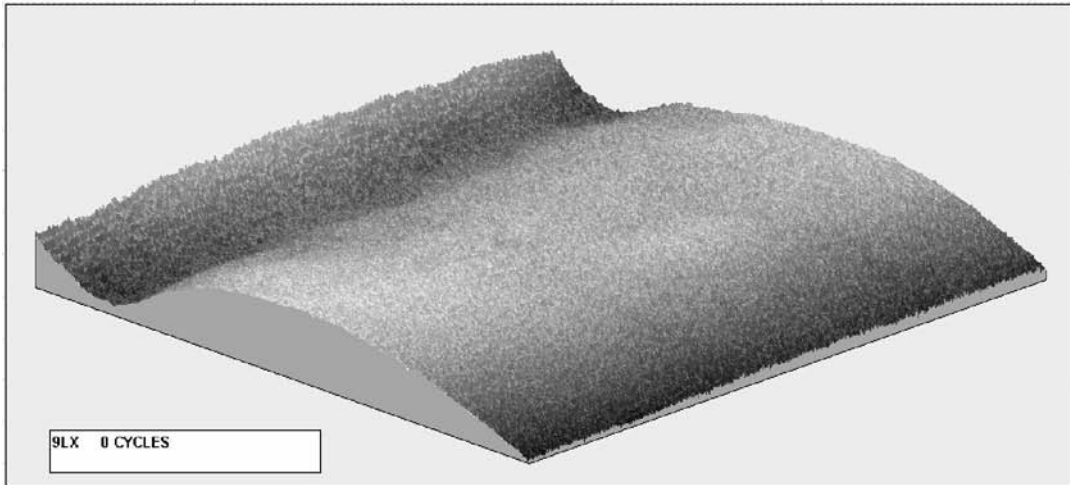
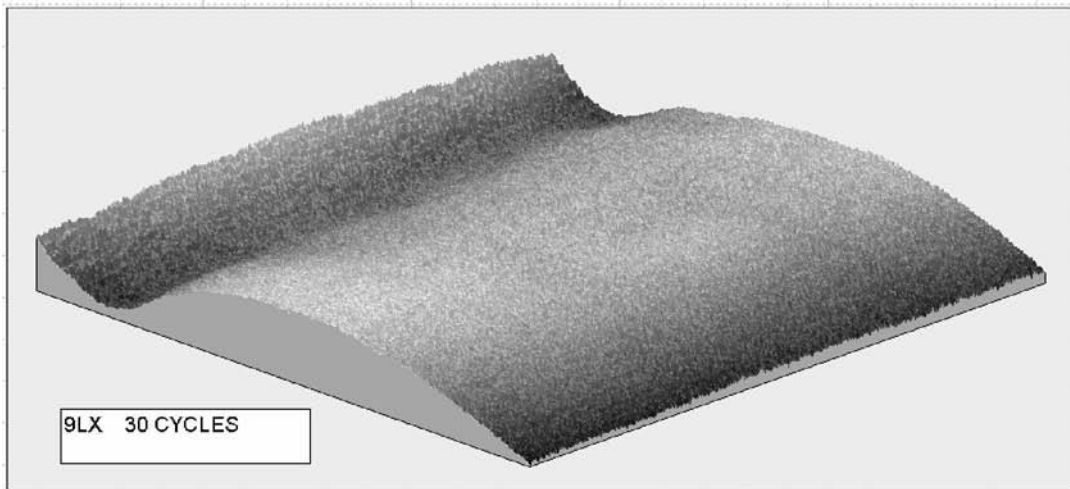
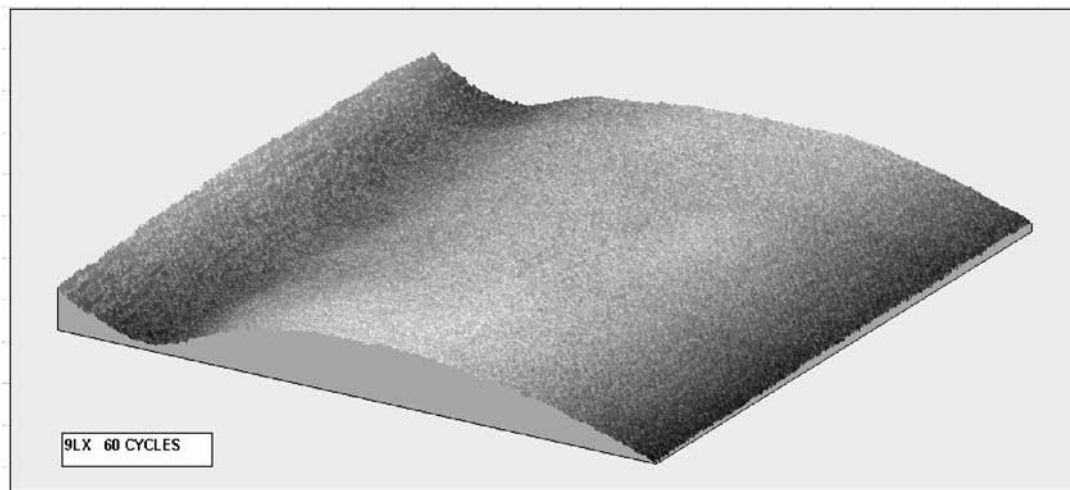
**Three Dimensional Contour Plots of Entire Specimen Before and After UT Scanning -
No Removal of RCC Material Measured**
