**SRNS-STI-2008-00028**

# **A Structural Impact Assessment of Flaws Detected During Ultrasonic Examination of Tank 15**

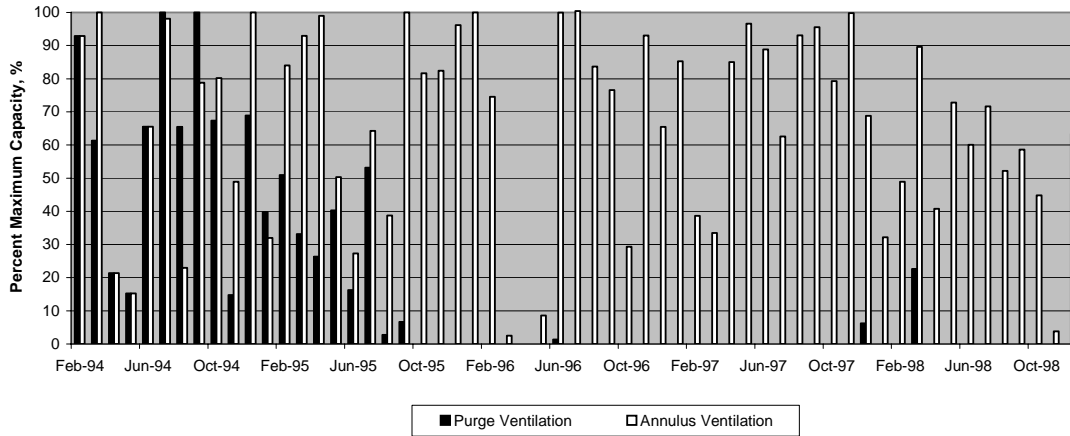
**Figure 1. Operational capacity of the Tank 15 annulus and purge ventilation.**

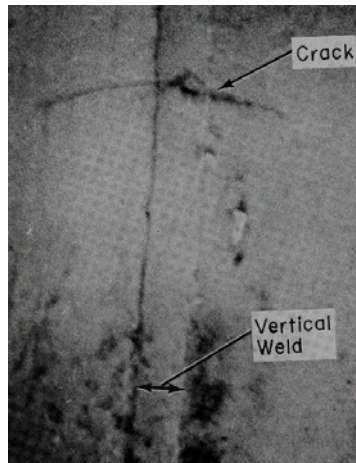
Figure 4. Dye-penetrant testing of stress corrosion crack on vertical weld in Tank 16 [12].

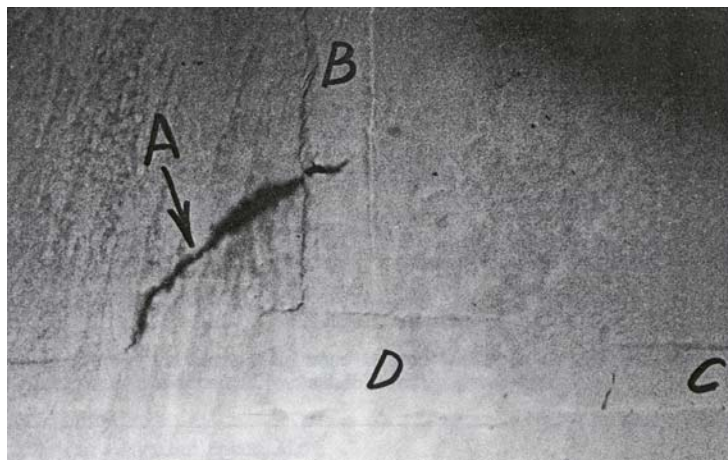
Figure 5. Dye-Penetrant testing at the intersection of vertical and middle horizontal weld in Tank 16: A) crack, B) vertical weld, C) middle horizontal weld, D) repair weld [12].

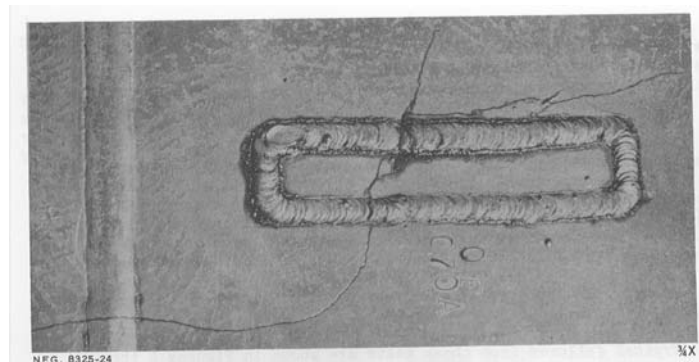
**Figure 6. Stress corrosion cracking in area near weld attachment [15].**

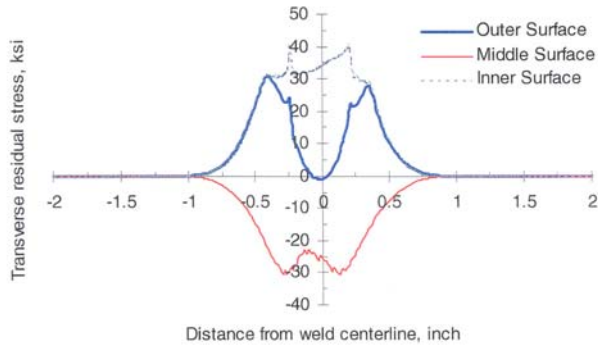
Figure 8. Tensile transverse residual stress at a seam weld [16].

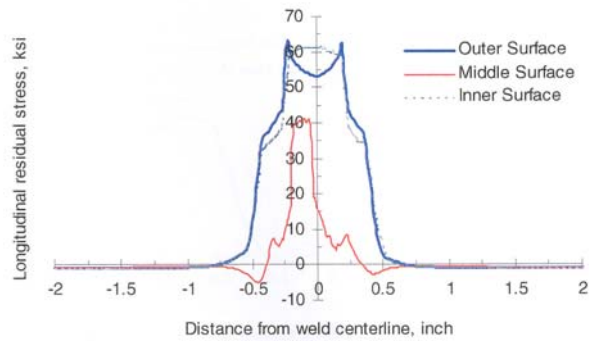
Figure 9. Tensile longitudinal residual stress at a seam weld [16].

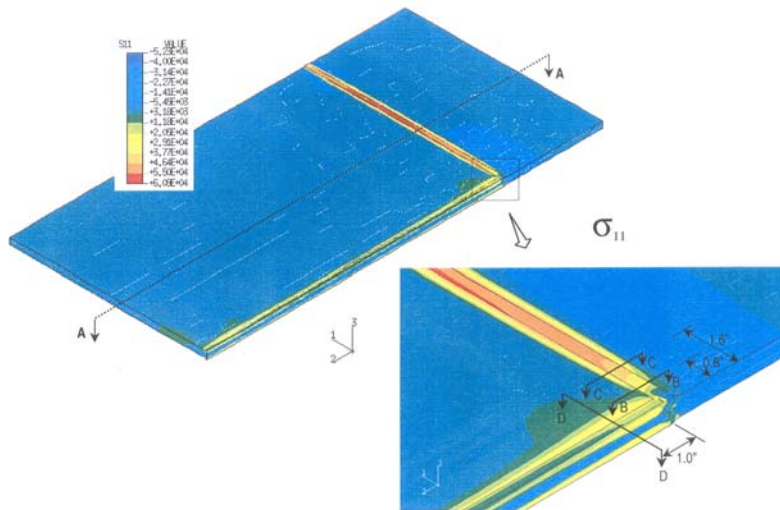
**Figure 10. Contour plot of longitudinal stress distribution at the horizontal weld and transverse stress at the vertical weld. Horizontal weld is indicated by cross-sections B-B and C-C, while the vertical weld is indicated by cross-section D-D [17].**

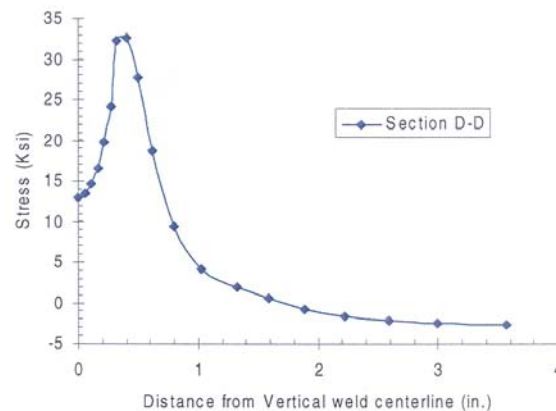
**Figure 12. Magnitude of transverse residual stress at the vertical weld at section D-D [17].**

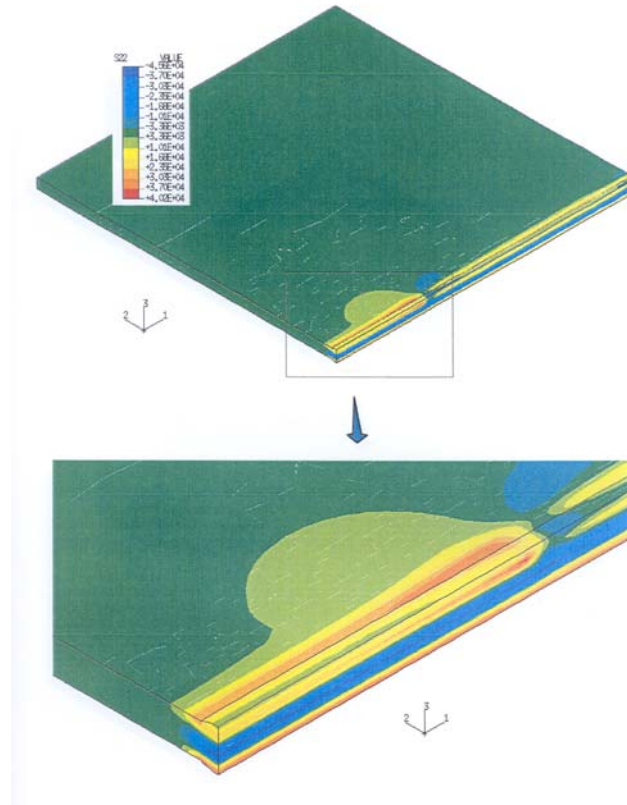
Figure 13. Transverse residual stress distribution after repair [18].

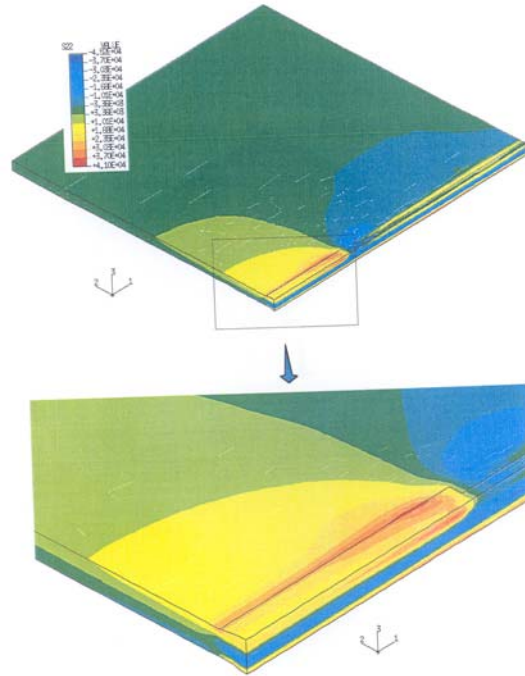
Figure 14. Effect of width of repair on the transverse residual stress distribution. The exterior surface is shown in the figure [18].

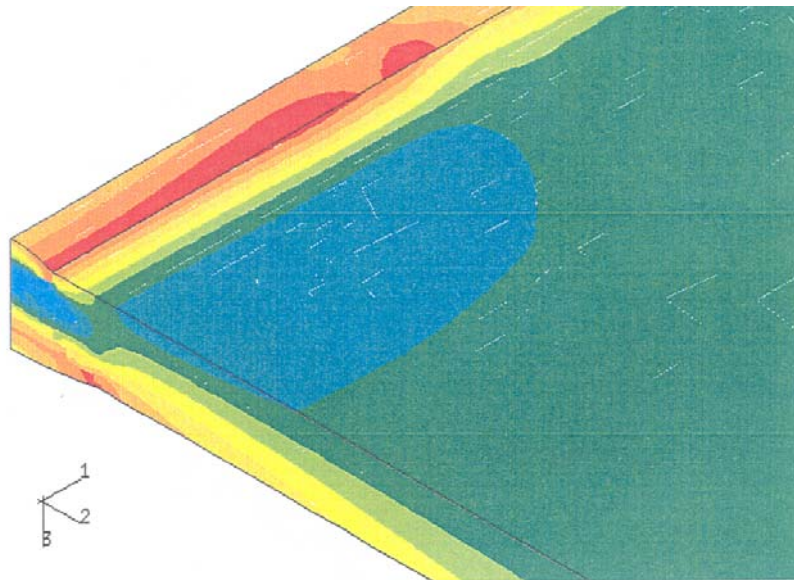
Figure 15. Effect of width of repair on the transverse residual stress distribution. The interior surface is shown in the figure [18].

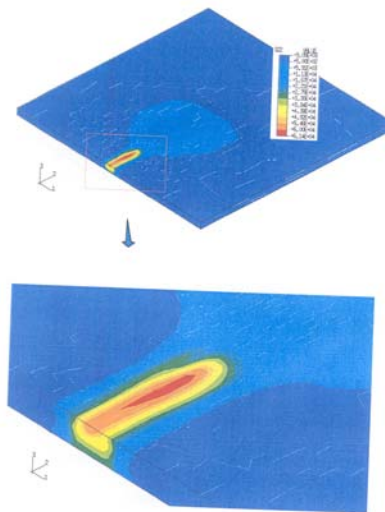
**Figure 16. Longitudinal residual stress distribution near an attachment weld [17].**

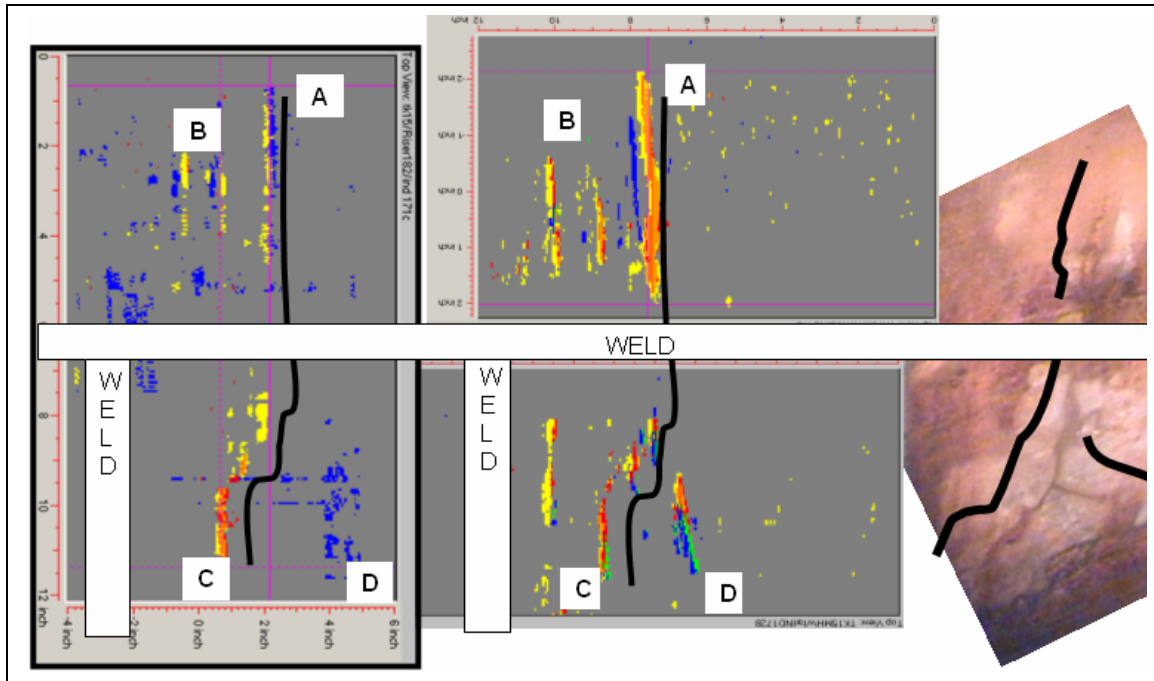
**Figure 17. Images from crack # 3 2002 (left) and 2007 (center and right)**

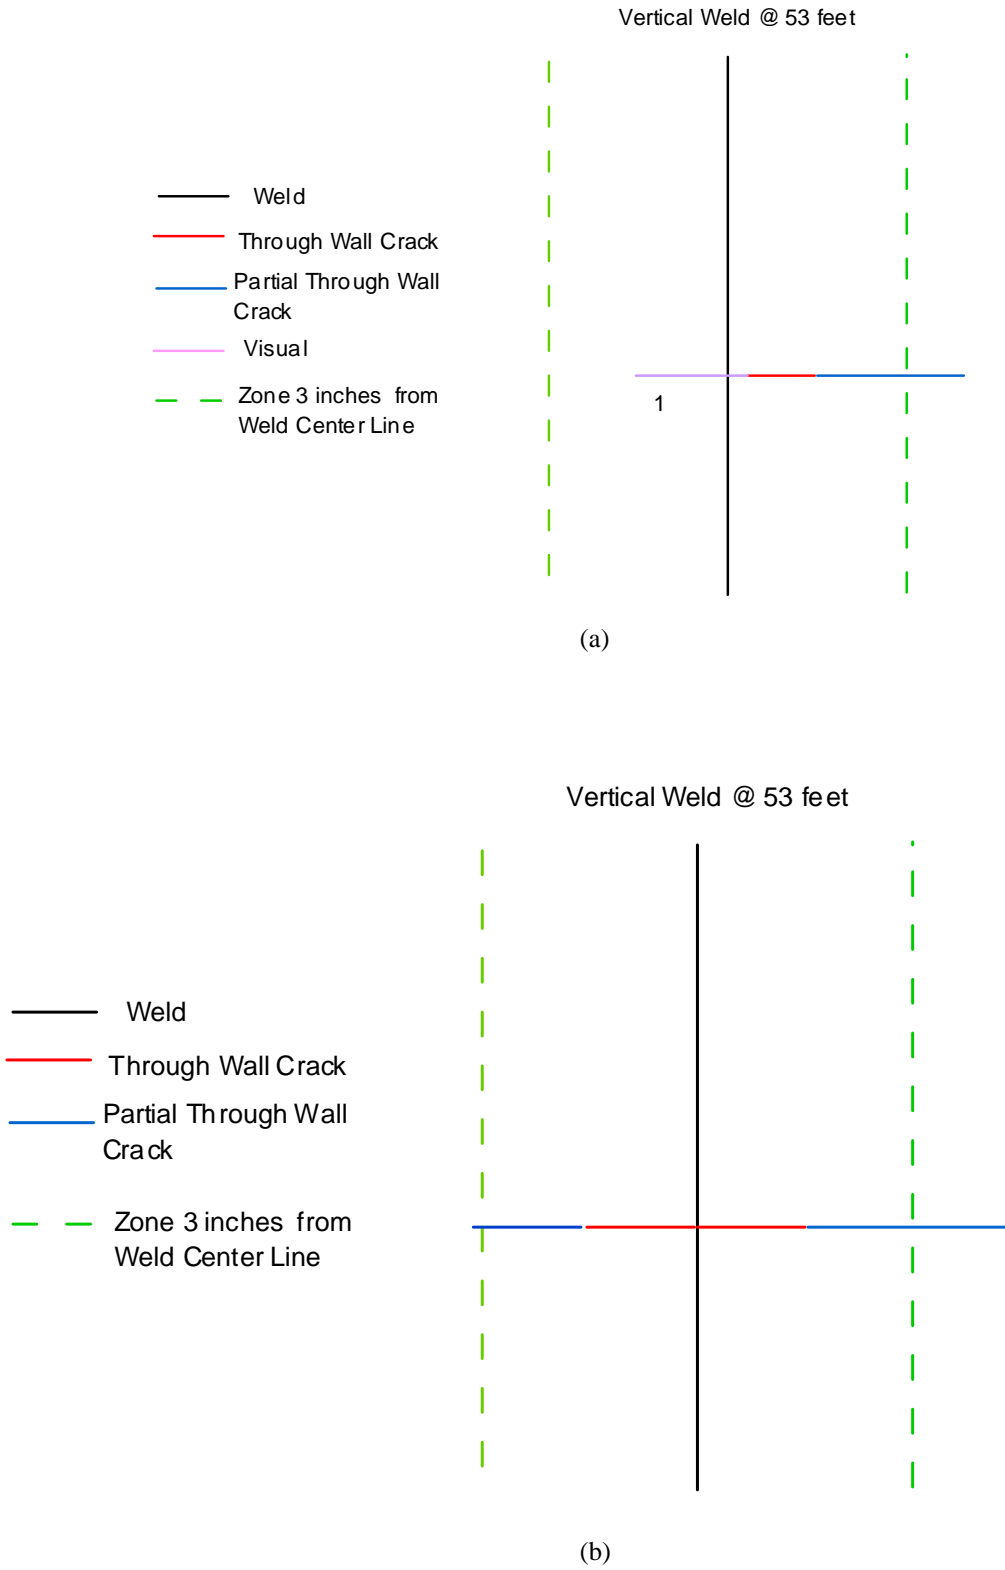
**Figure 18. Rudimentary drawing showing crack # 1 (a) 2002 and (b) 2007.**

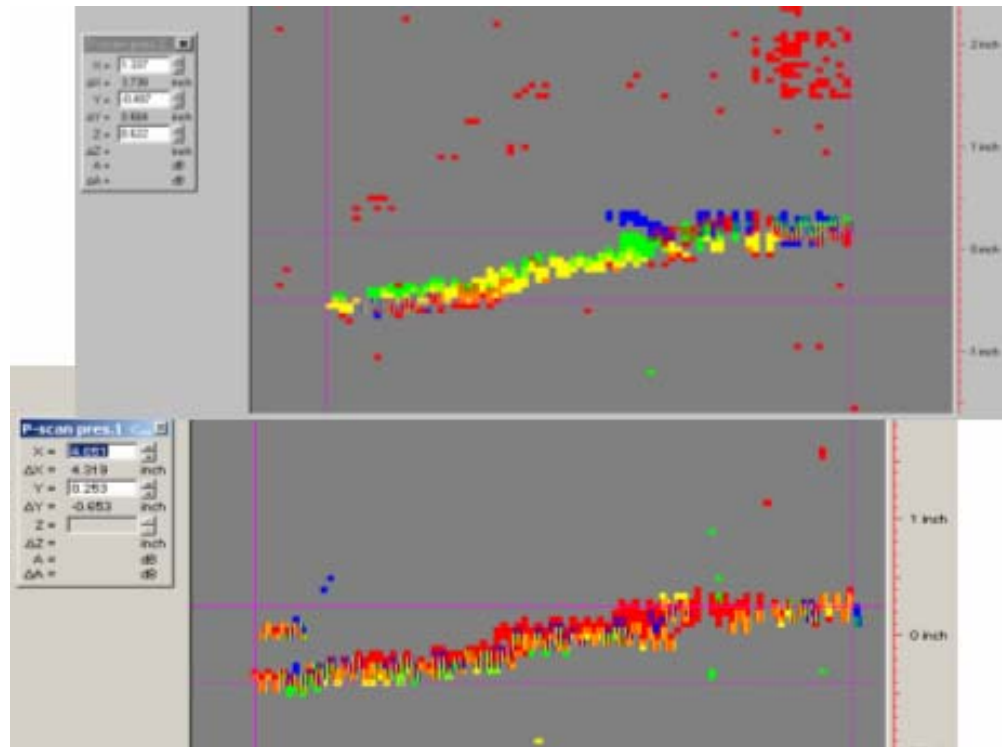
**Figure 19. UT data from Crack #1 demonstrating crack growth measurement.**

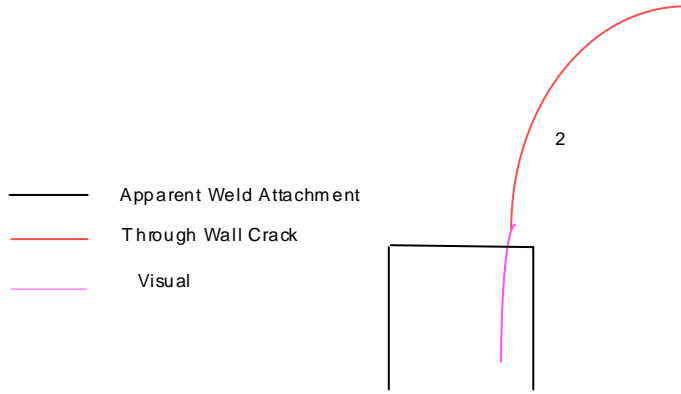
**Figure 20. Rudimentary drawing showing crack #2.**

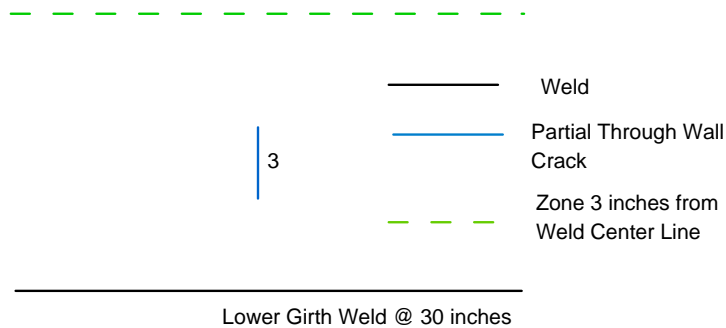
**Figure 21. Rudimentary drawing of crack # 3.**

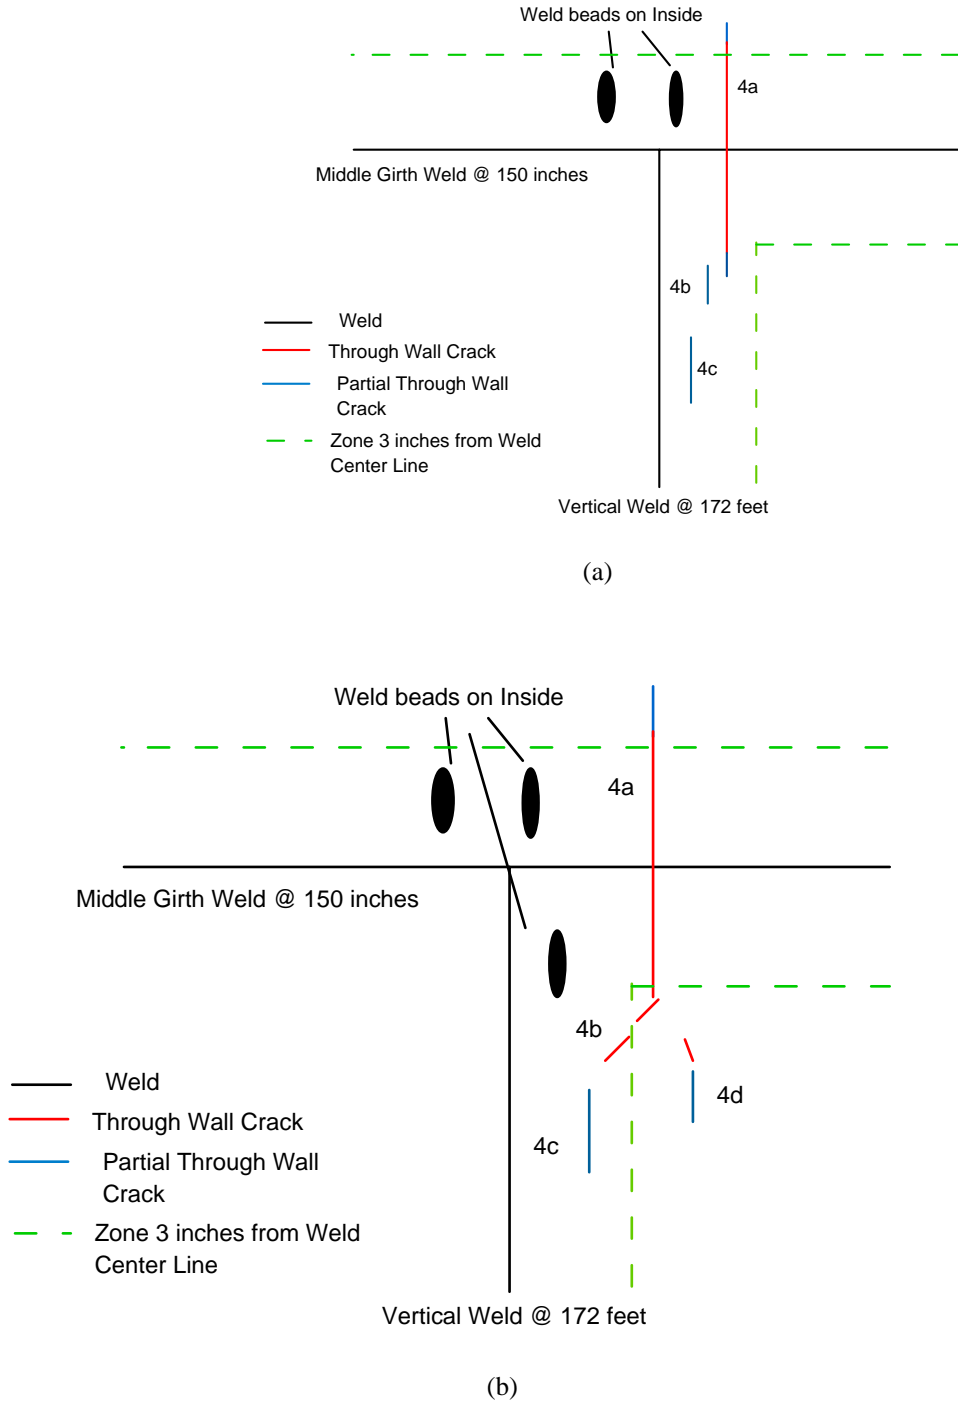
Figure 22. Rudimentary drawing of crack #4 (a) 2002 and (b) 2007.

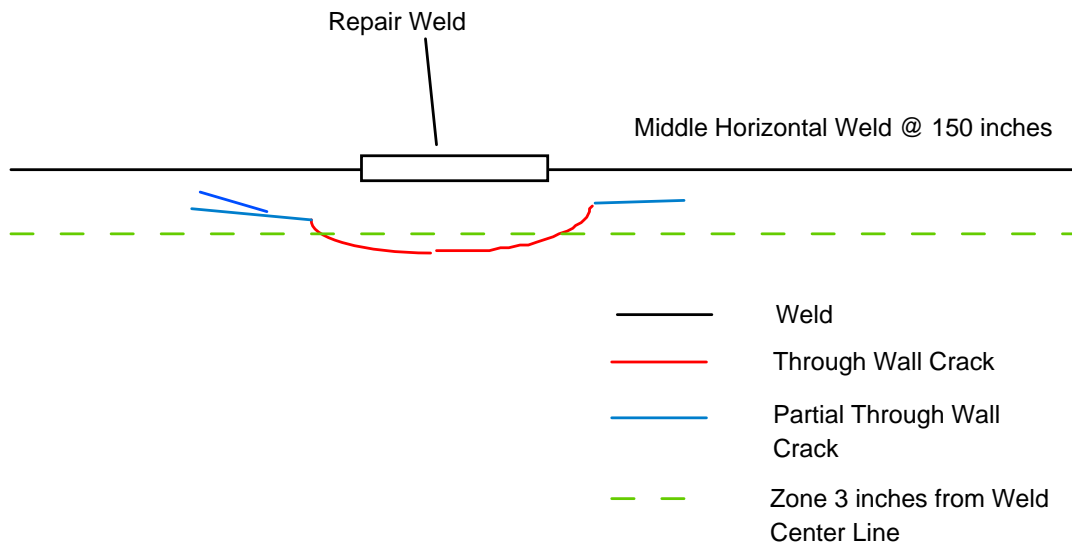
Figure 23. Rudimentary drawing of Crack #5.

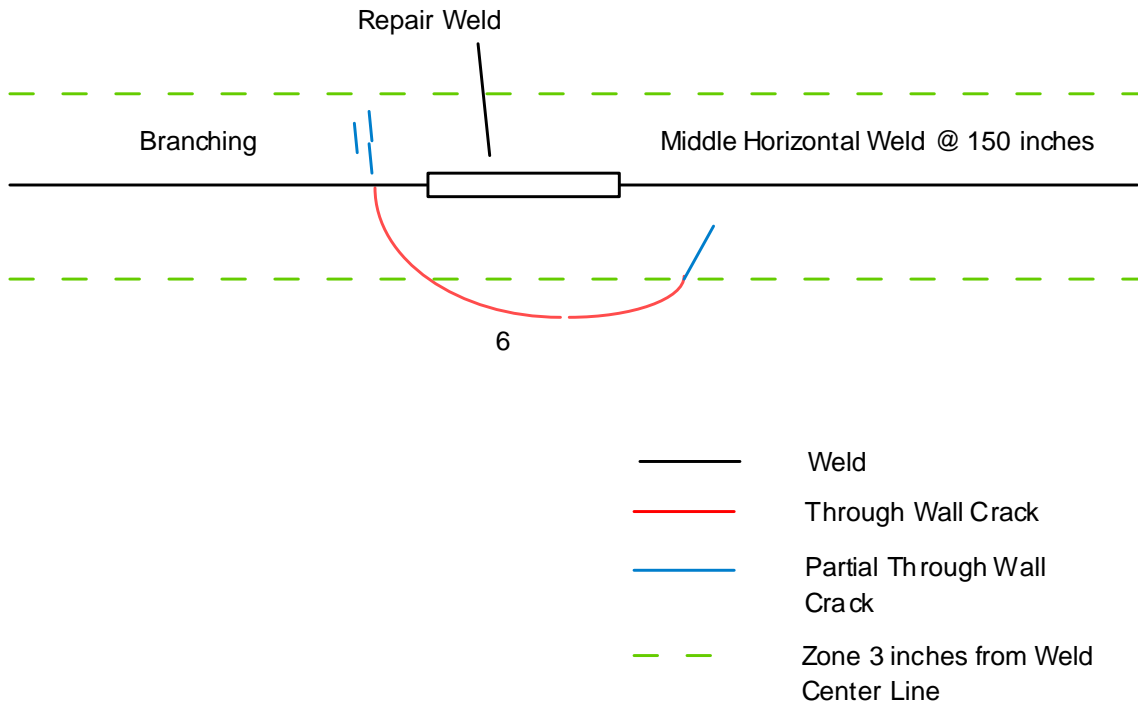
Due to a lack of significant driving forces, either hydrostatic or residual stresses, the crack currently does not impact either the structural stability or the leak tightness of the tank. This statement is confirmed by the finite element fracture analysis previously performed on the crack (assuming that it was 15 inches) [21]. The analysis showed that the hydrostatic stresses were not sufficient to drive the crack to instability. The horizontal orientation of the crack means that hydrostatic stresses in the hoop direction will not have a significant impact on further crack growth. Therefore, from a structural stability perspective the crack is not anticipated to be significant during waste removal. If the waste is raised above this level, leakage may occur. Procedures to handle the leakage are in place.

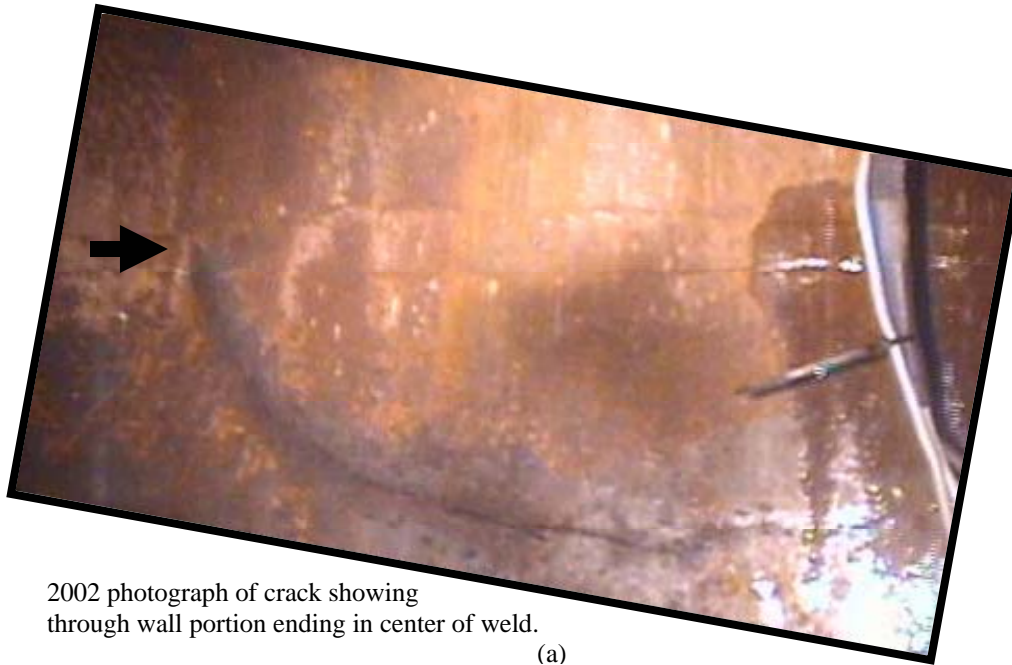
2002 photograph of crack showing through wall portion ending in center of weld.

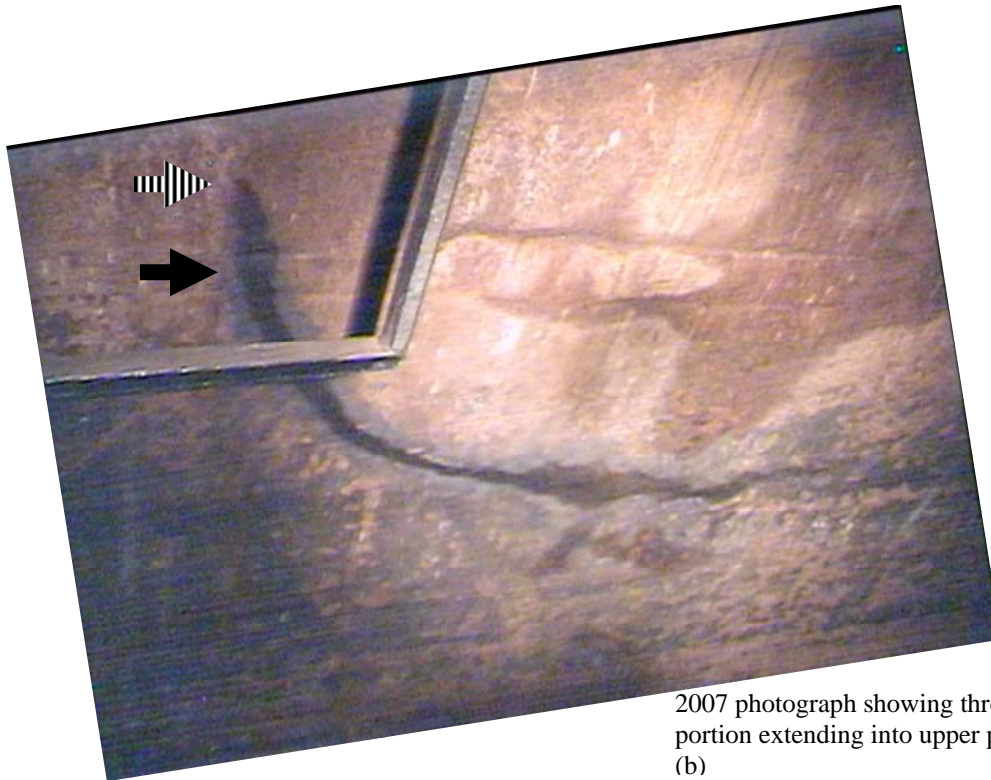
2007 photograph showing through wall portion extending into upper plate  
(b)

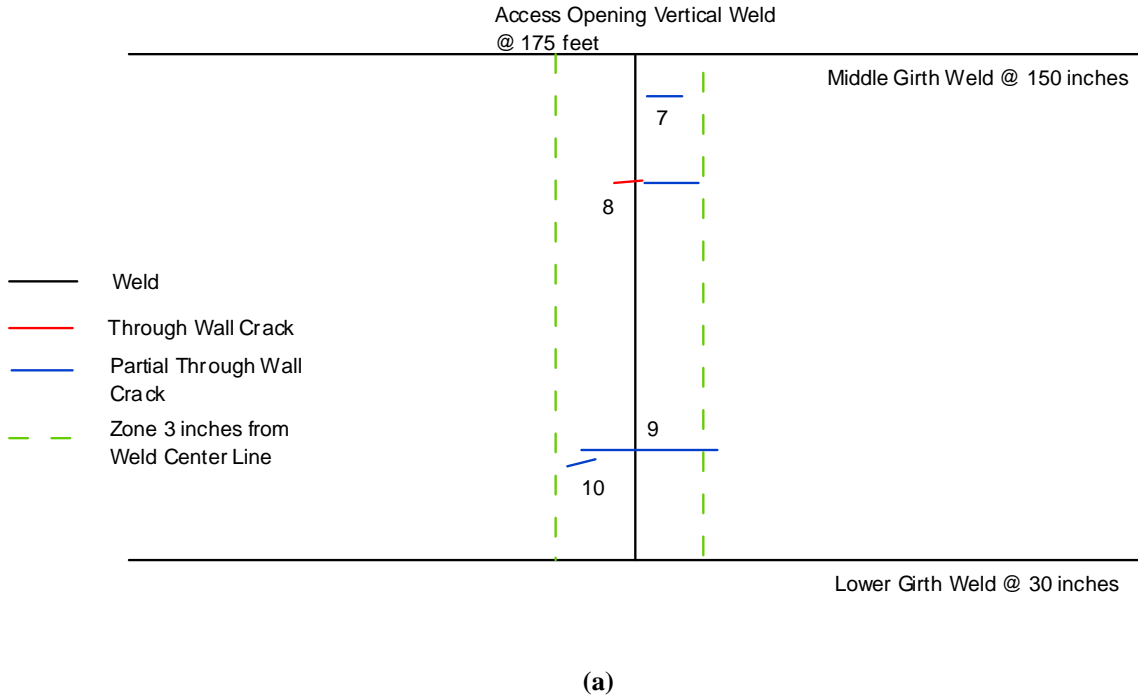
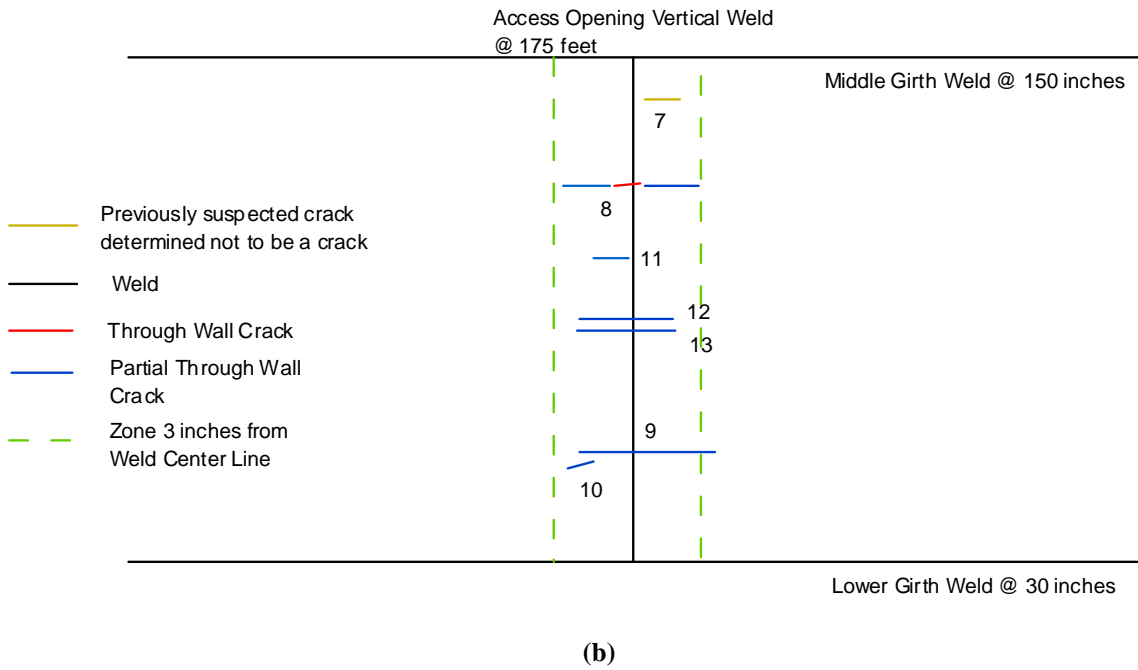
Figure 26. Rudimentary drawing of cracks #7-13 (a) 2002 and (b) 2007.
