WSRC-STI-2008-00228

L-Area Wastewater Storage Drum Evaluation

P. R. Vormelker, D. Z. Nelson, C. N. Foreman, D. J. Hathcock, and D. W. Vinson
Savannah River National Laboratory
Materials Science and Technology

Publication Date: November 2007

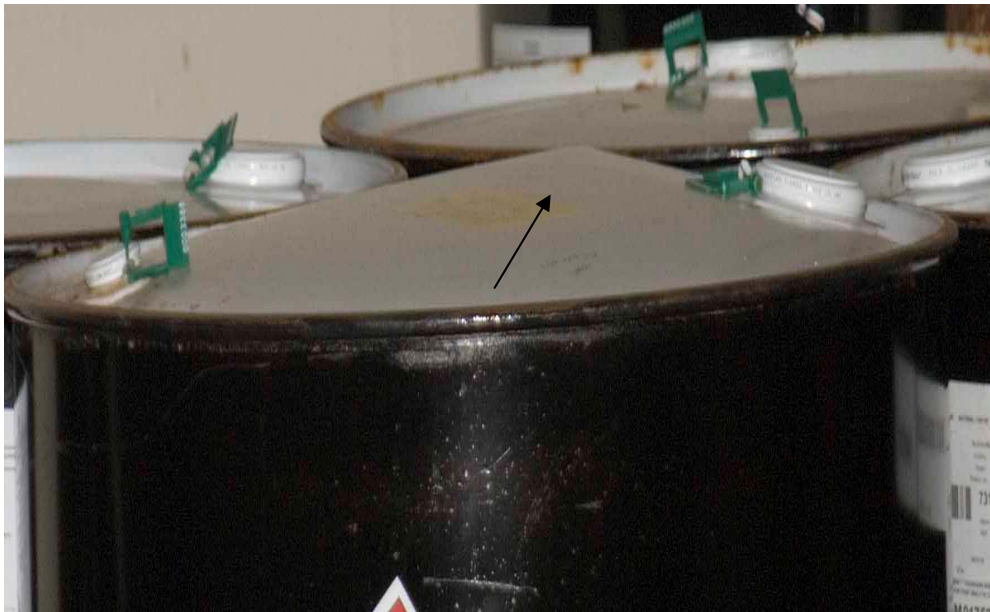
This report documents the determination of the cause of pressurization that led to bulging deformation of a 55 gallon wastewater drum stored in L-Area. Drum samples were sent to SRNL for evaluation. The interior surface of these samples revealed blistering and holes in the epoxy phenolic drum liner and corrosion of the carbon steel drum. It is suspected that osmotic pressure drove permeation of the water through the epoxy phenolic coating which was weakened from exposure to low pH water. The coating failed at locations throughout the drum interior. Subsequent corrosion of the carbon steel released hydrogen which pressurized the drum causing deformation of the drum lid.

Figure 1. Bulged lid of 55 gallon wastewater drum stored in L-Area.

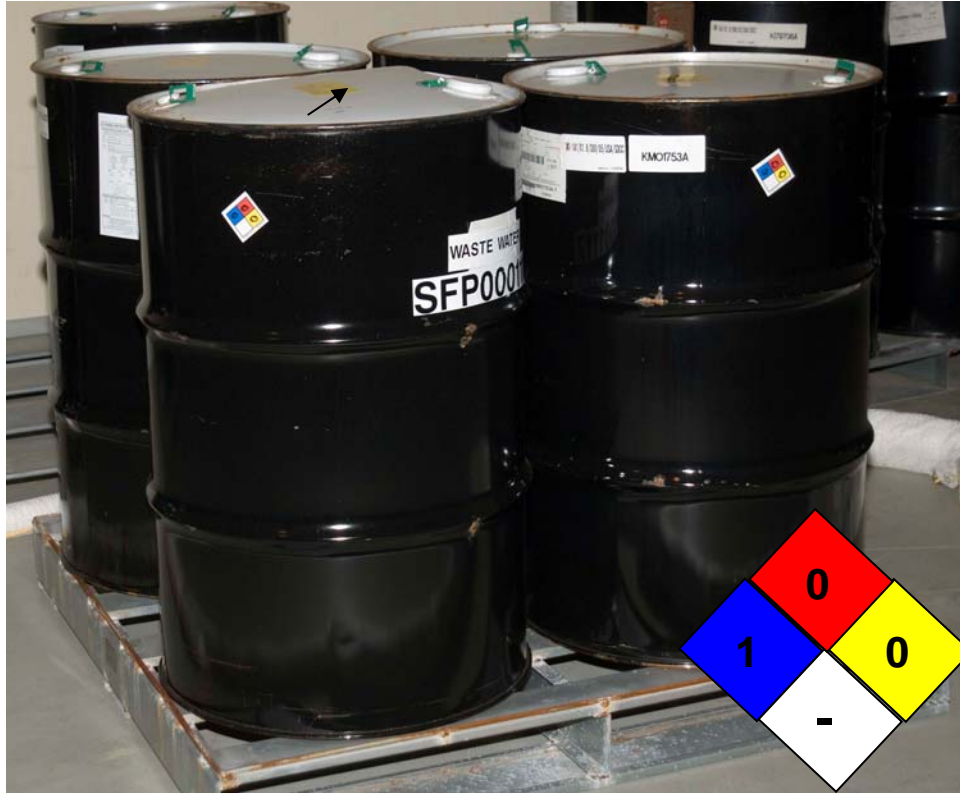
Routine inspection is performed by Operations on a weekly basis in all liquid waste storage areas in L-Area. During weekly rounds on August 15, 2006, no unusual drum features were found. Approximately one week later, a bulge on one drum (No. SFP0001117) was found within a four drum pallet assembly and was reported during weekly rounds on August 22 (8 weeks storage). The drum was punctured at the top for pressure relief with wastewater remaining in the drum for approximately 7 months prior to liquid transfer to a new drum (1117(II)) per the timeline of events in Table 1. The pH was adjusted in all the drums at this time to 4.5<pH<8 (field measurements). The top of the deformed drum and adjacent drums are visible in Figure 1 to Figure 4. The NFPA hazard label was not visible in Figure 2 and therefore was reproduced in the lower right corner. A number one was indicated in the blue health hazard diamond which designates that a NFPA hazard determination was made for the wastewater in these drums.

Figure 2. Bulged drum (A) on pallet along with three additional drums containing wastewater. The NFPA hazard label is reproduced in lower right corner.

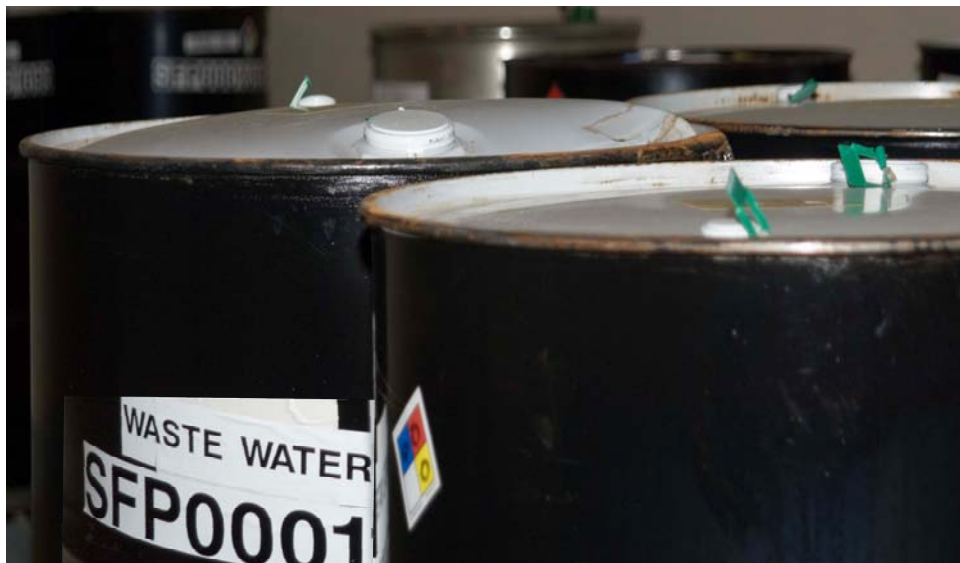
Figure 3. Close-up view of normal depressed lids on two adjacent drums compared with bulged drum lid to the left. Bulged drum number is SFP000117.

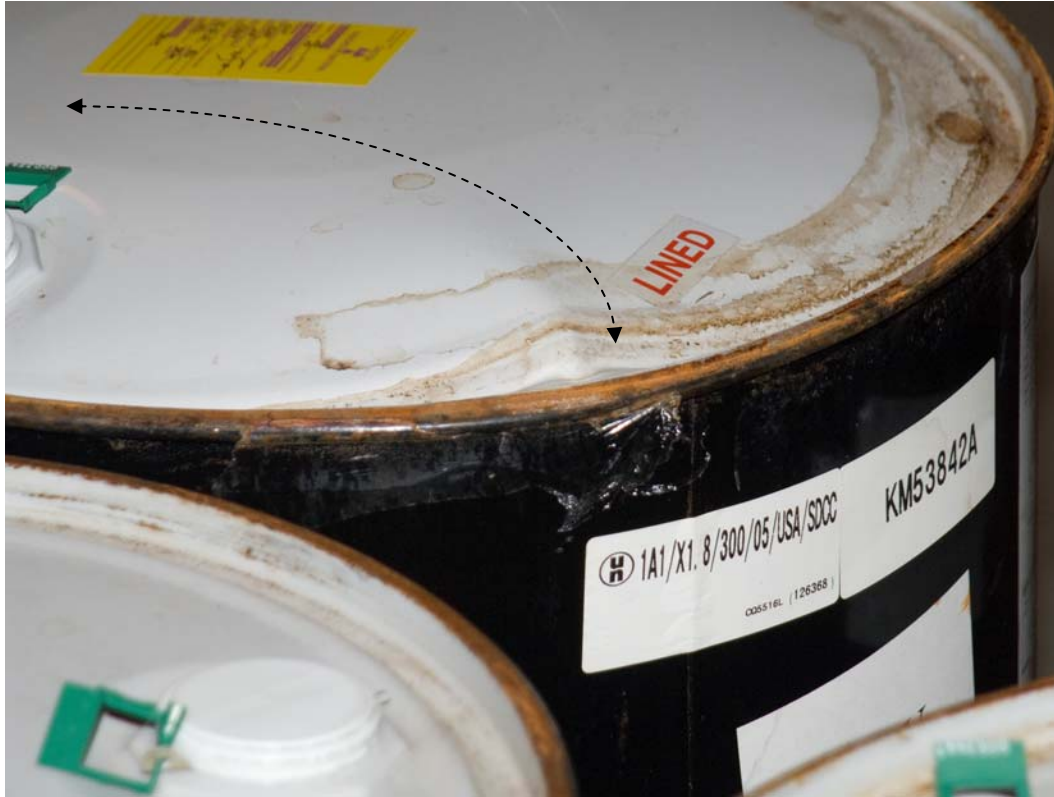
Figure 4. The drum lid crease is shown below dotted line. Drum Label reveals PO No. KM53842A” with the United Nations uniform drum designation “1A1/X1.8/300/05/USA/SDCC.” The designation “SDCC” identifies Skolnik Industries as the manufacturer.

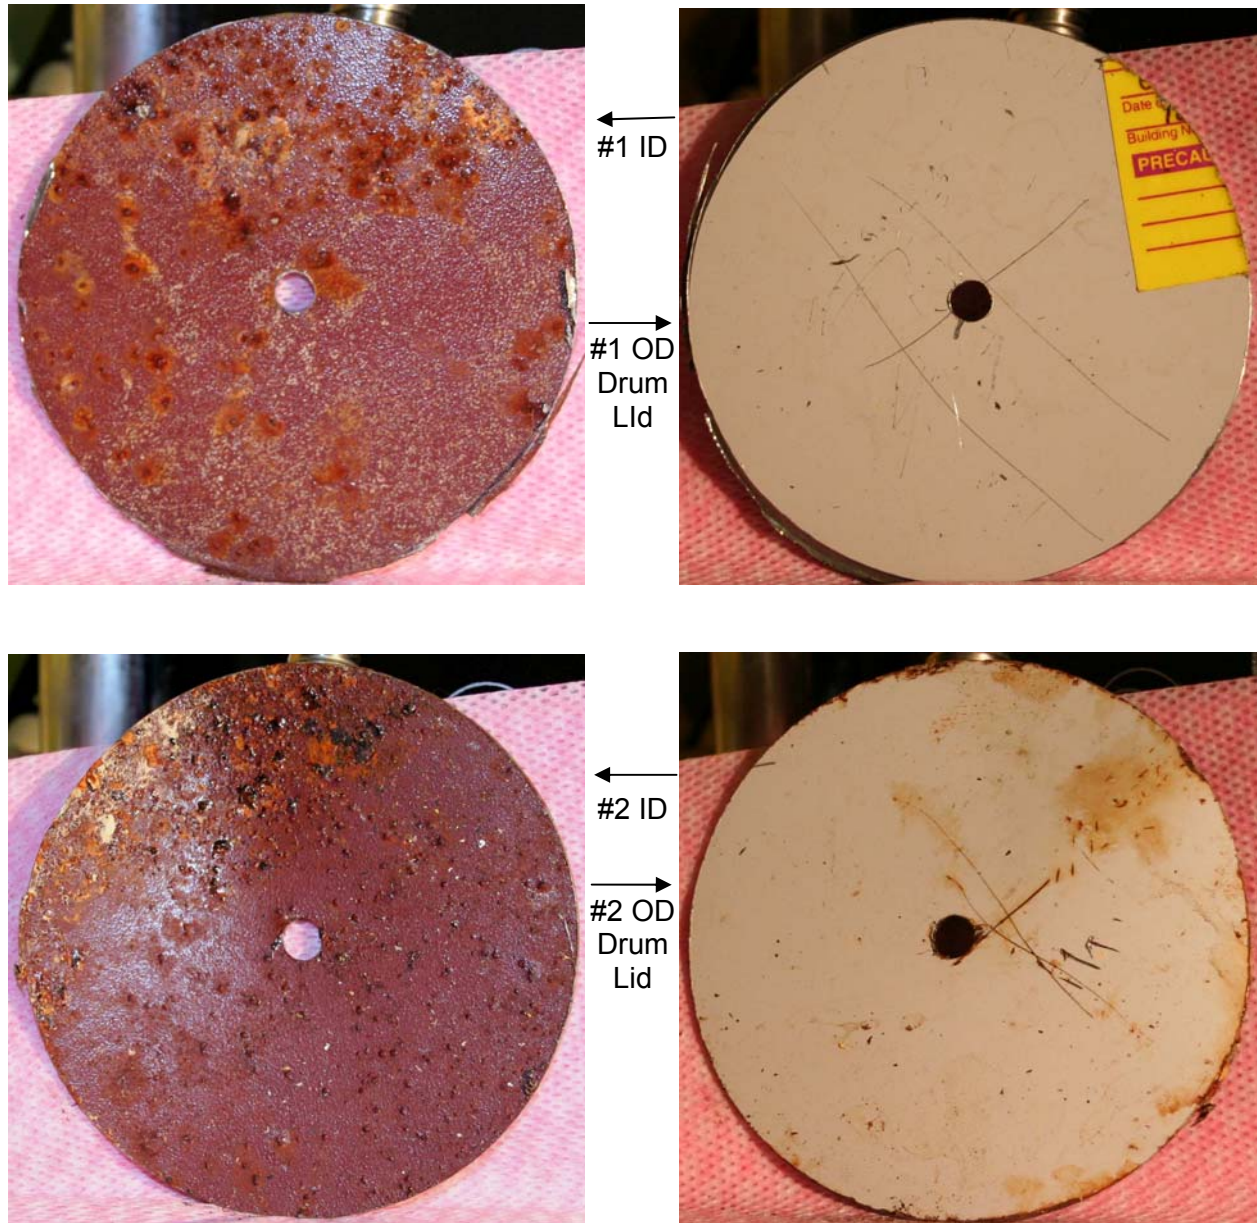
The approximately 4 ½ inch diameter disks were cut from the bulged drum in positions indicated in Figure 6. The outside and inside surfaces of these disks are shown in Figure 7. Corrosion is very evident on the interior surface of the two lid samples. Corrosion was preceded by blistering which is shown on the sidewall sample shown in Figure 8. Additional samples were cut from the sample in Figure 8 where the cut lines are indicated. These samples were used for close-up metallography and XRD (X-ray diffraction) analysis (Figure 9). XRD analysis revealed the presence of hematite (Fe_2O_3), magnetite (Fe_3O_4), talc, $\text{Fe}(\text{OH})_2$ and the carbon steel base metal. Hematite is visible in sample 1 and 2 (Figure 7) with the normal rust color while magnetite is black and is visible in sample 2. Talc is probably from the gloves used to handle the samples. Close-up photos are shown in Figure 10 where the black oxide is clearly visible in the center of a burst blister.

Figure 7. ID and OD of two disks cut from drum head revealing visible corrosion in ID surface of both samples. Minor corrosion was visible on the OD of the number 2 sample, from Figure 6.

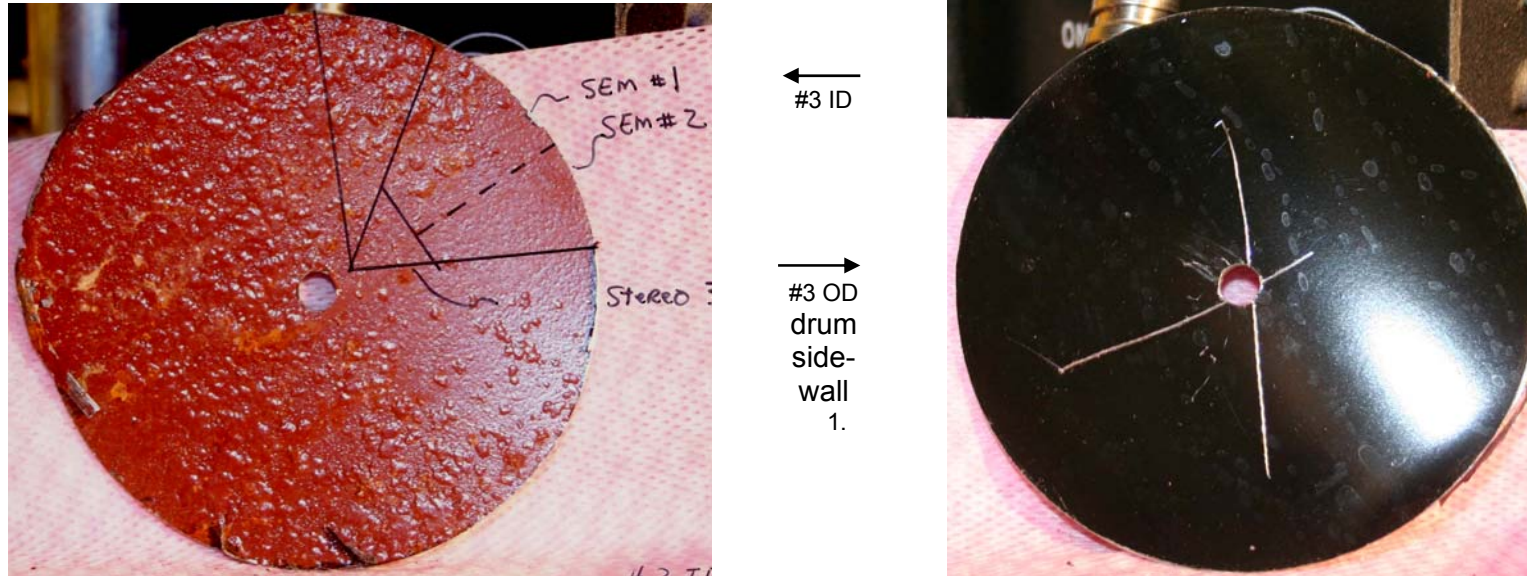
Figure 8. ID and OD surfaces of the number 3 disk (See Figure 6) cut from the drum sidewall. The ID surface also reveals the areas cut from the disk for SEM evaluation.

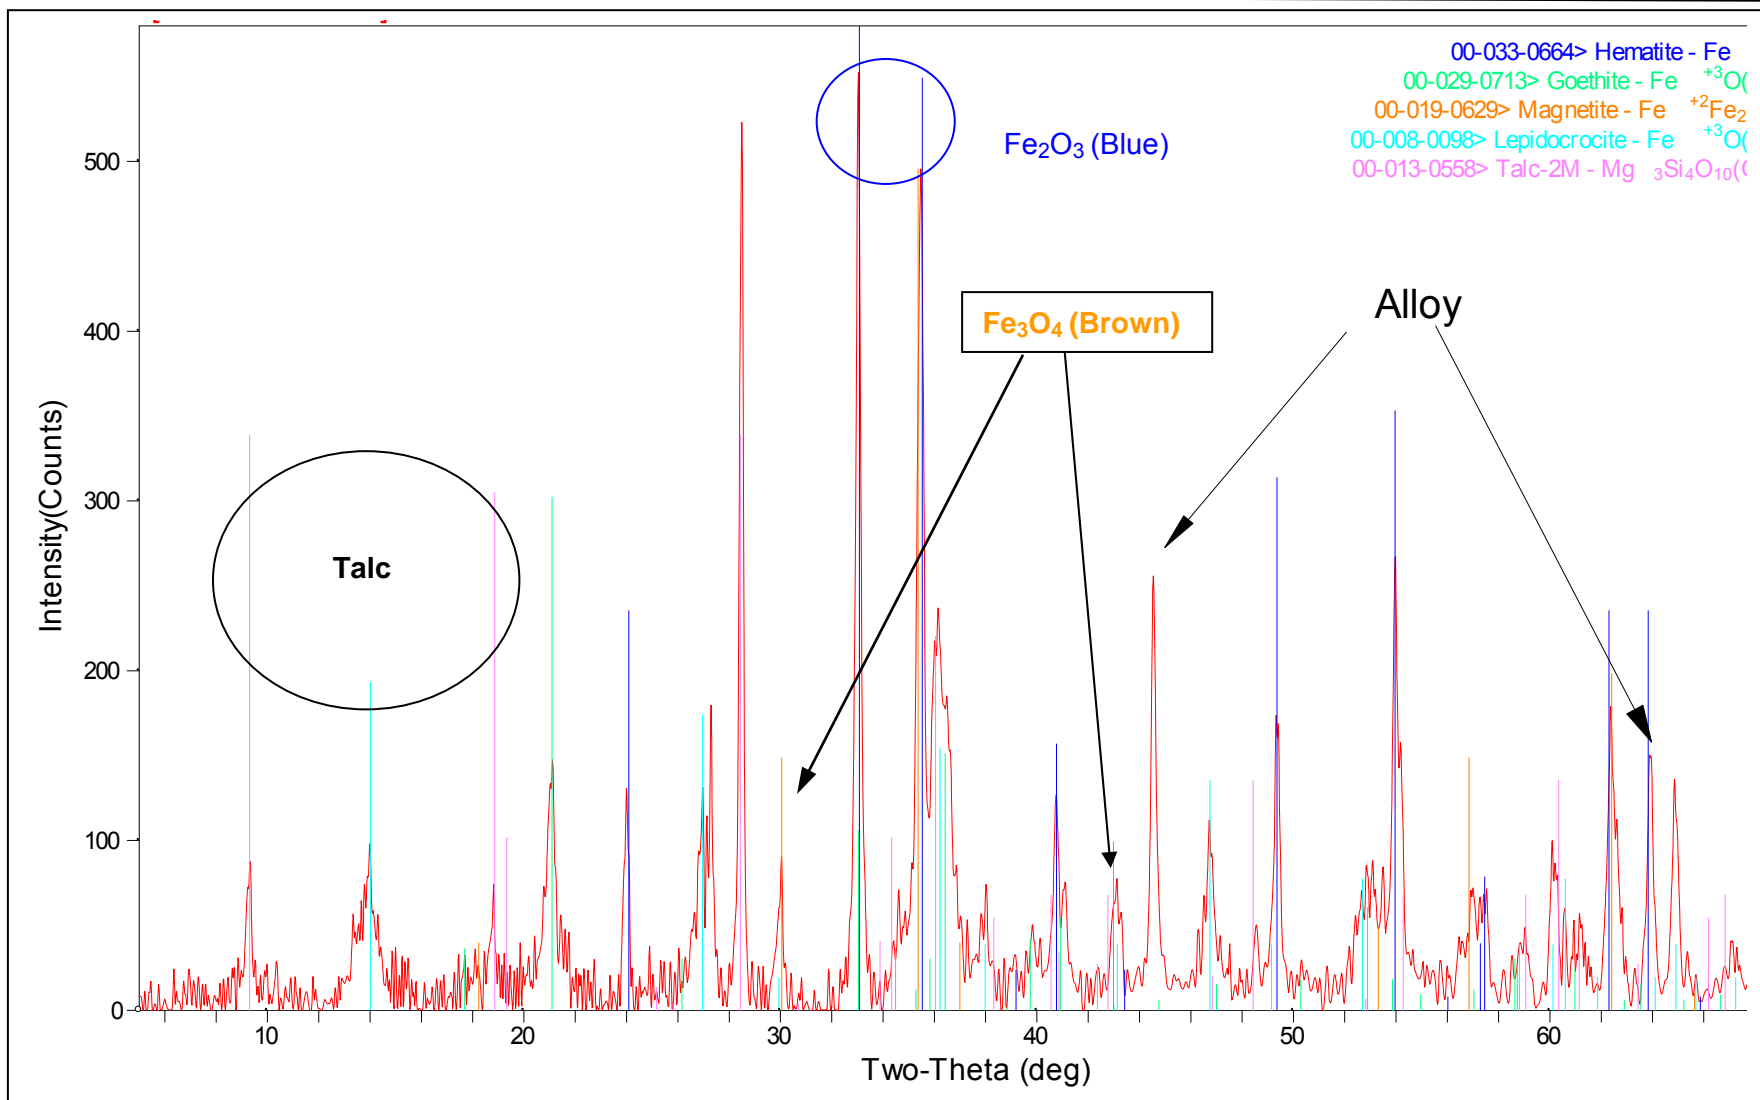
Figure 9. XRD analysis of the surface from sample 2 revealing the presence of Fe₂O₃, Fe₃O₄, Talc, FeOH, and the FeC base carbon steel.

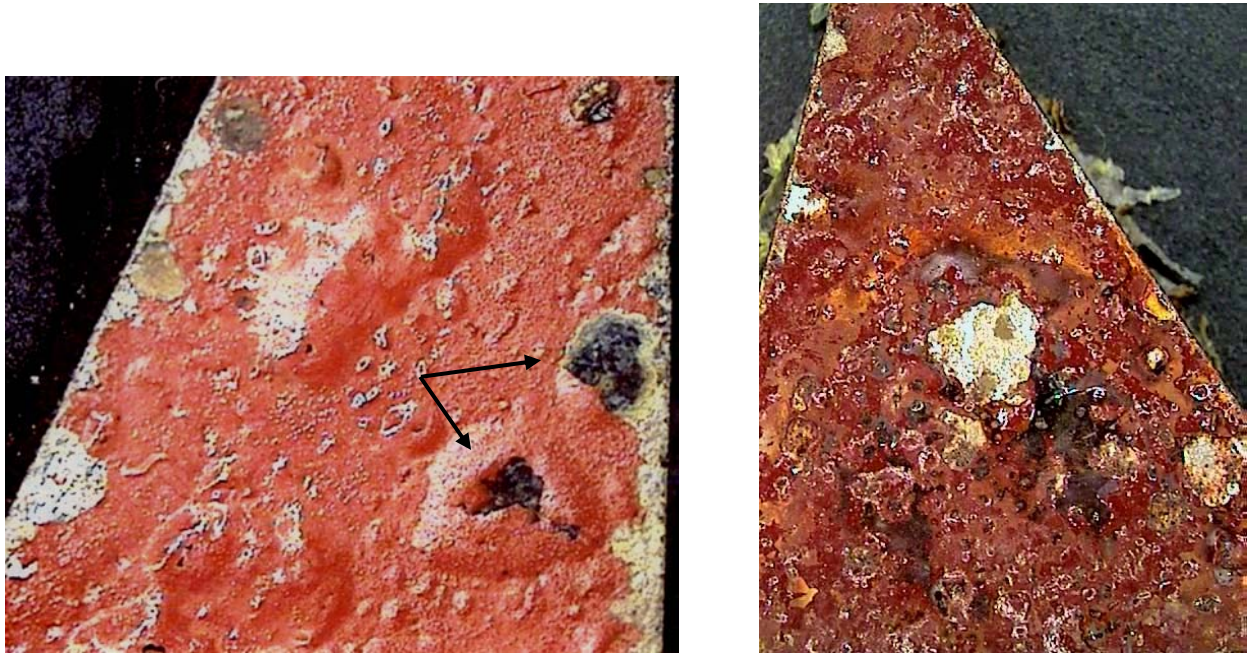
Blistering is caused in paint coatings by water permeating through the coating and locating at the coating metal interface. Osmotic pressure drives water molecules to permeate through the coating.[2-5] The presence of micro-voids in the coating can also cause water molecules and acidic and/or caustic ions to penetrate through the coating. When the coating is penetrated, pressure builds up until pressure is equalized with that in the liquid. The result is a blister. At the same time, corrosion occurs in the base metal upon reaction with the unprotected carbon steel. The metal dissolution reaction, or anodic reaction, results in the loss of electrons, while

Figure 10. Close-up of surface of cut samples from the ID of Figure 8 revealing blisters that burst with black oxide in the middle.

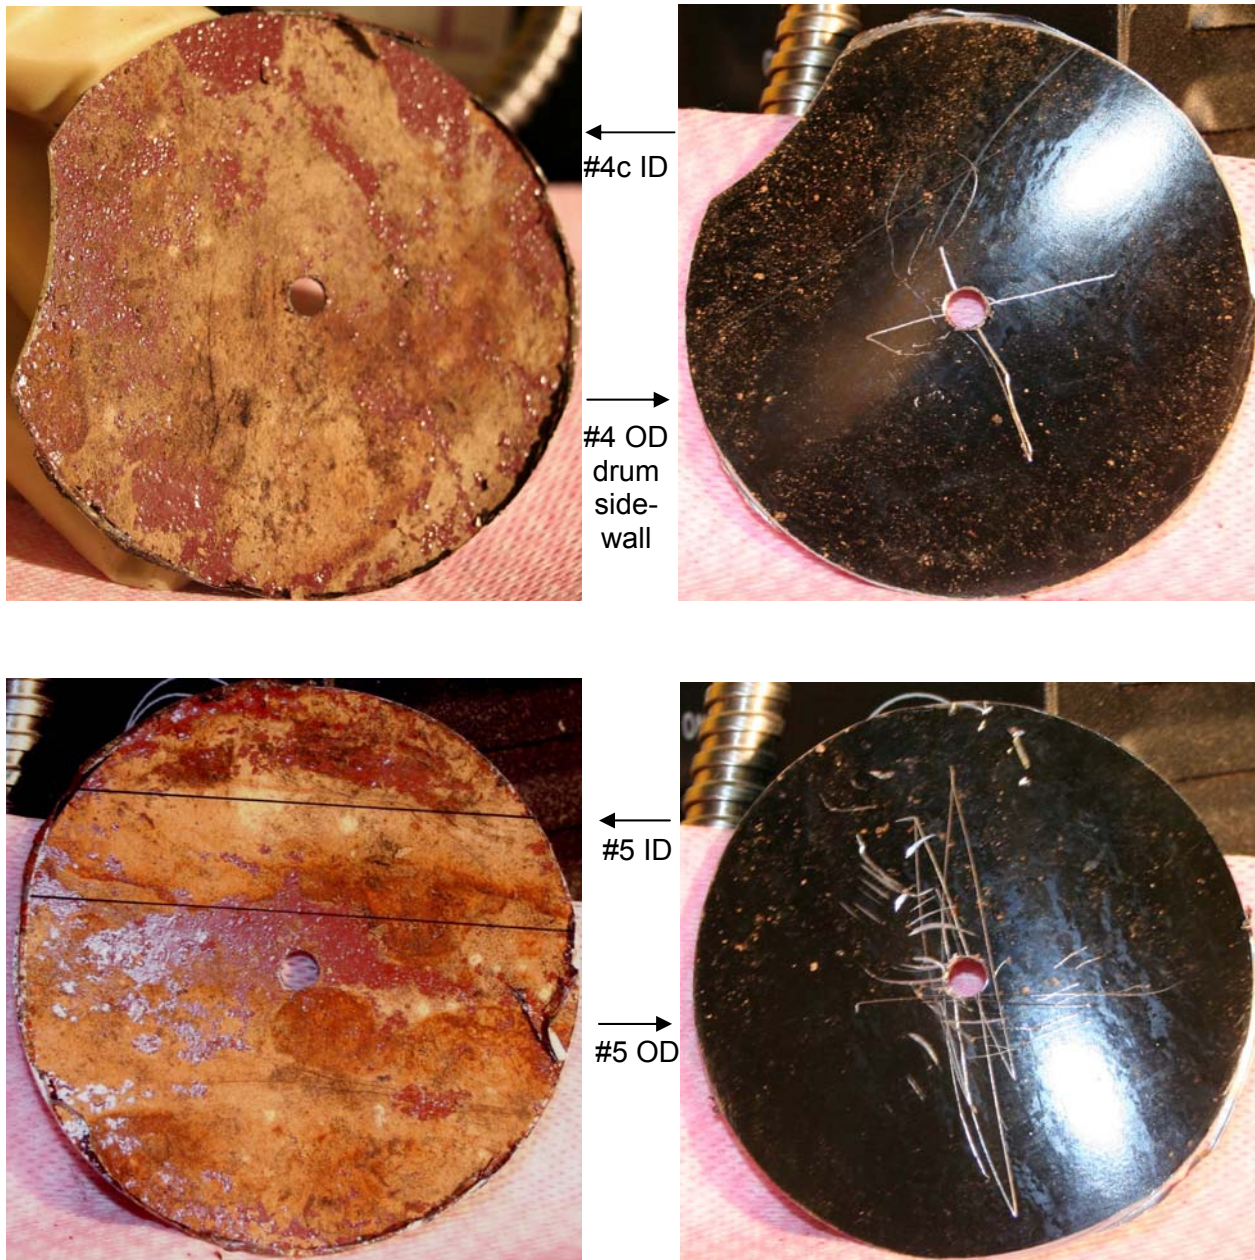
Material was scraped from the surface of disk 5 (Figure 11) and analyzed by gas chromatograph mass spectroscopy (GC/MS). The results, shown in Table 4, reveal significant surface deposits from oil with smaller amounts from branched alkyl benzenes and tributyl phosphate. Oil in the original Tuff Tank was known to exist, the alkyl benzenes are probably from a scintillation cocktail, and the TBP (tributylphosphate) may be from the oil or from other contaminants from sampling of the water during analytical procedures. TBP is used to enhance oil film strength in lubricants.

Figure 11. ID and OD surfaces of the number disk numbers 4 and 5 (see Figure 6) which were also cut from the drum sidewalls. Disk number 5 has two parallel lines within which the surface was scraped for analysis. The ID surface on both disks is blistered but is not as visible in these photographs (compared to previous photos) due to surface deposits.

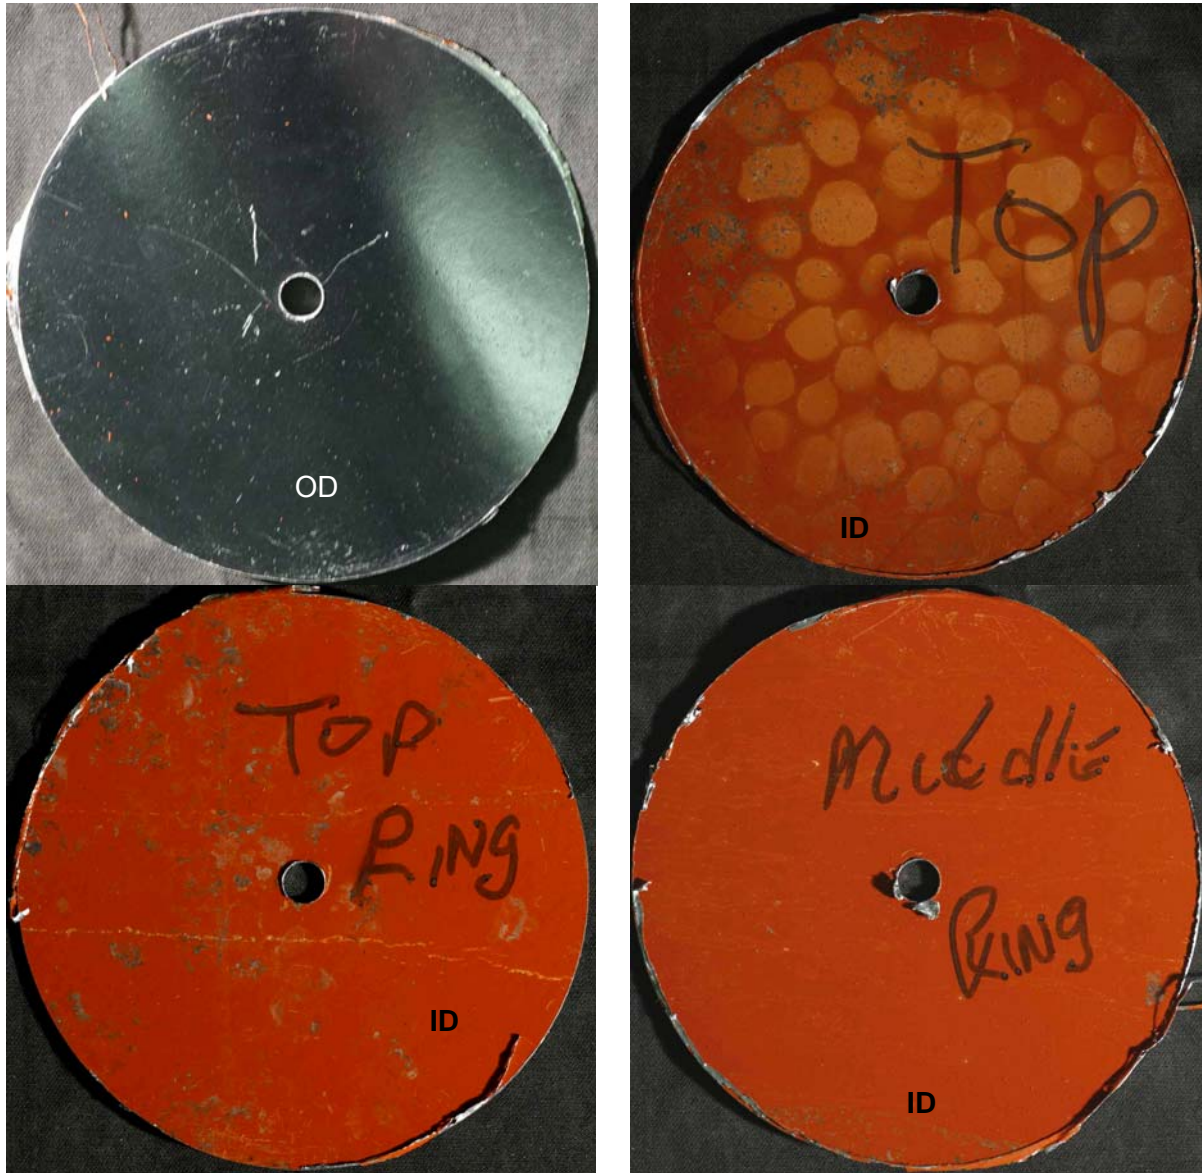
Samples were cut from a clean spare drum (same design and manufacturer as the bulged drum) and are shown in Figure 12. The top ring and middle ring samples were cut from the upper sidewall and middle sidewall section, respectively, as shown in Figure 6. Both sides of the lid are shown in the upper photos in Figure 12. The top ID surface shows surface stains that may be the result of condensation. The sidewall samples appear to be clean. Coating thickness measurements were performed with an Elcometer (model No. 246F) dry film thickness gauge and are shown in Table 7. Exterior coating thicknesses on the three samples averaged 0.37 mil while the interior coating thickness averaged 1.2 mils. Skolnik's interior coating process calls for a 1 mil nominal coating thickness. Coating vendors such as Carboline, Heresite Protective Coatings, International Protective Coatings, and Sherwin Williams prescribe a minimum of a 2 mil primer coat with a 2- 4 mil final coat for two coat coverage or 5 mils for single coat coverage per an internet search for epoxy phenolic type coatings. Based on vendor guidelines, Skolnik's interior drum coating nominal thickness of 1 mil may be insufficient for corrosion protection of carbon steel immersed in an acidic wastewater. This thin coating may contain too many holidays (coating defects) to be protective in immersion service.

Figure 12. Photos of samples cut from a spare drum of same type as bulged drum and was unused prior to sample cutting. Some cutting debris are visible on the surface of the Top Ring sample.

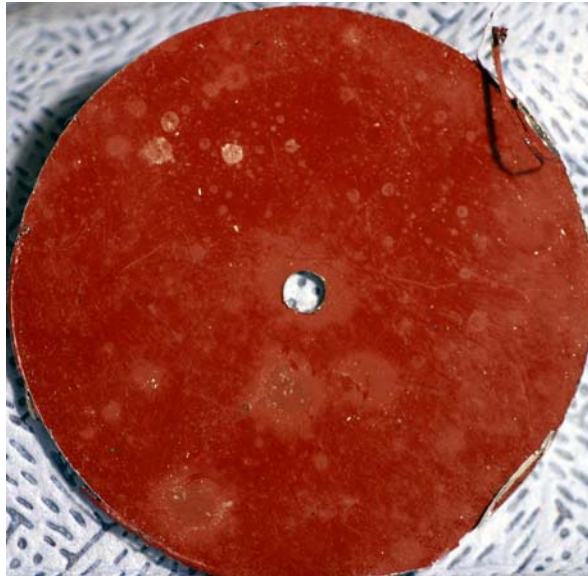
Figure 13. ID of Lid sample from drum 1114. This is also typical of lid samples from drums 1115, 1116, and 1117-2. Some staining is visible.

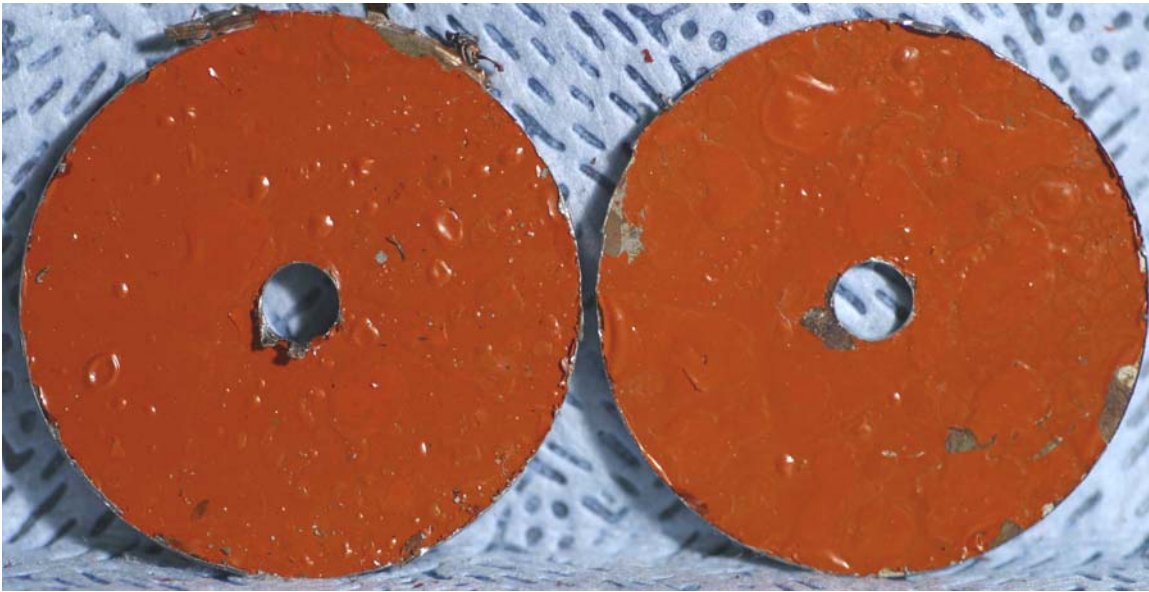
Figure 17. Drumwall ID samples from drum 1117 (II).

The contents of each of the three original drums from the pallet and the new drum (SFP0001117(II)) were neutralized to pH levels shown in Table 8, prior to draining and then filling a new set of drums. This draining operation was performed to allow sample cutting of the original drums. The content in the new drums was further neutralized to higher pH levels shown in Table 9. Samples were cut from the three original drums to characterize the effects of wastewater on the ID coating of the drums. In addition, samples were also removed from the second drum (SFP0001117 (II)), which held the original contents of the bulged drum. The ID of the lid from drum SFP0001114 is shown in Figure 13. Staining is visible which is typical of the lids from the other two drums. The location of drum sidewall samples was chosen by SRNL to show typical surfaces within the drum. Figure 14 reveals the interior drum coating from drum SFP0001114 which appears to have been easily scraped from the surface during sample removal. The coating appears to be sufficiently softened by the wastewater to allow it to be scraped off. In Figure 15, the coating from drum SFP0001115 was also scraped off in the right photograph while blistering or shrinkage in the coating is visible in the left photo. A liquid/air interface is visible in the sample (right photo) from drum SFP0001116 (Figure 16). The sample on the left reveals more blistering/shrinkage than the right photo. Blistering is clearly visible in Figure 17 which showed samples from drum SFP0001117(II). Drum SFP0001117(II) was only exposed to wastewater with a pH of 3.76 (Table 8) for approximately 7 months per Table 1 and still blistered.
