Failure Analysis: Wastewater Drum Bulging

P. R. Vormelker
Savannah River National Laboratory
PO Box 616 Building 773-41A
Aiken, South Carolina
Phone: (803) 725-4469
Fax: (803) 725-4553
e-mail: phil.vormelker@srnl.doe.gov

Abstract

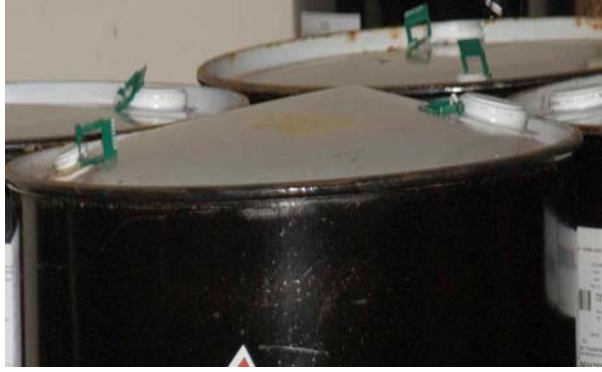
Figure 1. Bulged lid of stored 55 gallon wastewater.

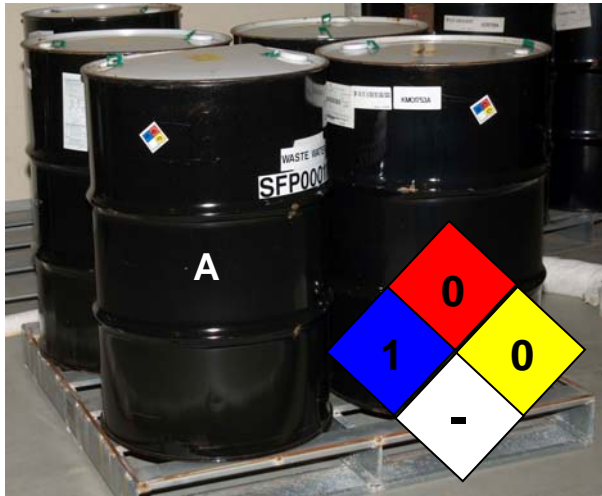
Figure 2. Bulged drum (A) on pallet along with three additional drums containing wastewater. The NFPA hazard label is reproduced in lower right corner.

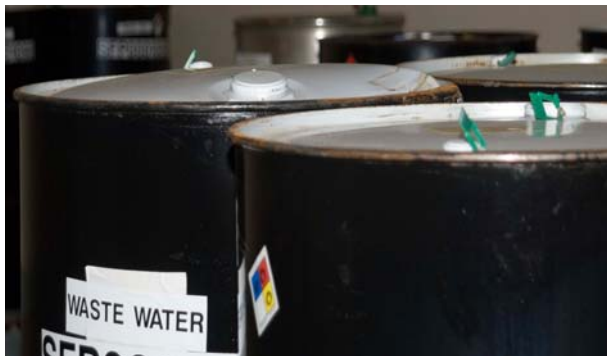
approximately 6 psi internal pressure.[9] Bulging in tight head (also known as closed head) drums should occur at similar pressure values. Vertical movement of the top head of the bulged drum was estimated at 2 cm based on Figure 3. When compared to pressure testing data generated on both closed and open head drums (Figure 10), a vertical deformation of 2 cm results from drum pressures ranging from 10 to 15 psi for a closed head drum. These results are very similar to the calculated values from corrosion. Thus, bulging in drum 1117 likely resulted from pressures generated by hydrogen released from corrosion.

Figure 3. Close-up view of normal depressed lids on two adjacent drums compared with bulged drum lid to the left. Bulged drum number is 1117.

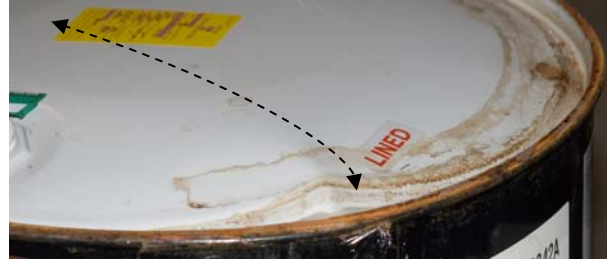
Figure 4. The drum lid crease is shown below dotted line. Drum Label reveals the United Nations uniform drum designation, 1A1/X1.8/300/05/USA.

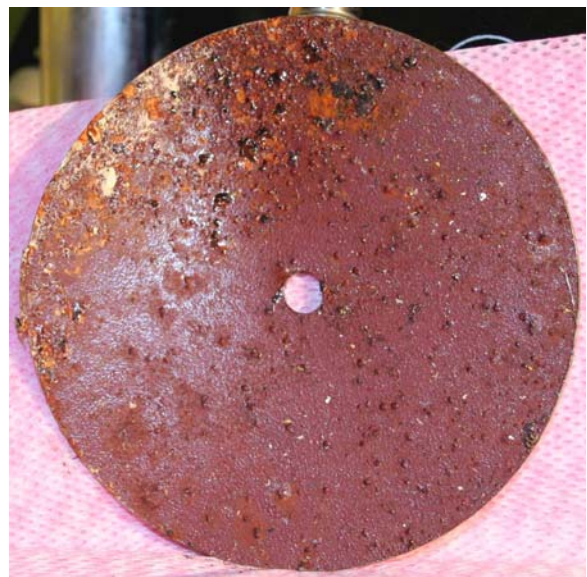
Five 4 ½ inch diameter disks were cut from the bulged drum in both head and sidewall positions. A typical surface of the drumhead ID is shown in Figure 6. The sidewall ID surface is shown in Figure 7. Corrosion is very evident on the interior surface of the drumhead samples. Corrosion was preceded by blistering which is shown on the sidewall sample shown in Figure 8. Samples were cut from the sample in Figure 7 where the cut lines are indicated. These samples were used for close-up metallography and XRD (X-ray diffraction) analysis. XRD analysis revealed the presence of hematite (Fe_2O_3), magnetite (Fe_3O_4), talc, $\text{Fe}(\text{OH})_2$ and the carbon steel base metal. Hematite is visible in Figure 8 with the normal rust color while magnetite is black and is also visible. Talc is probably from the gloves used to handle the samples.

Figure 6. ID surface cut from bulged drum head revealing visible corrosion.

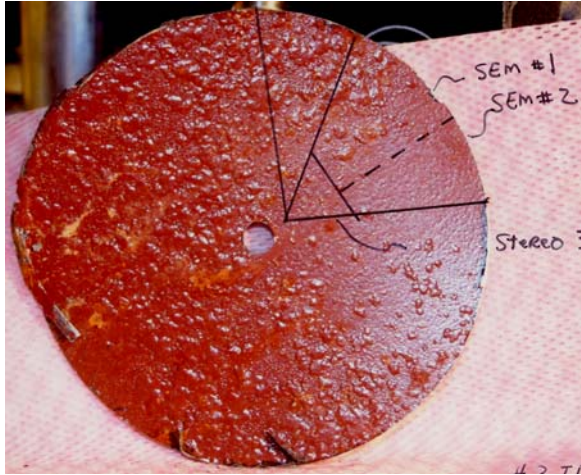
Figure 7. ID surface of sample cut from bulged drum sidewall showing areas cut from disk for SEM evaluation.

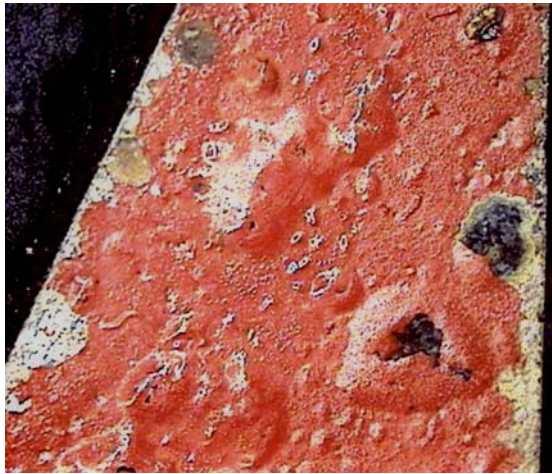
Figure 8. Close-up of surface cut from Figure 7 revealing blisters that burst with black oxide in the middle.

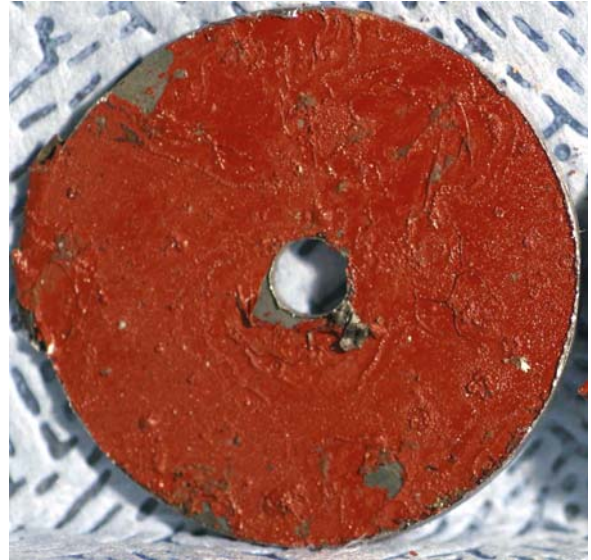
Figure 9. ID surface from non-bulged 1115 drum side-wall.
