Experimental Breeder Reactor I Preservation Plan

Julie B. Braun

October 2006

INL/EXT-06-11909

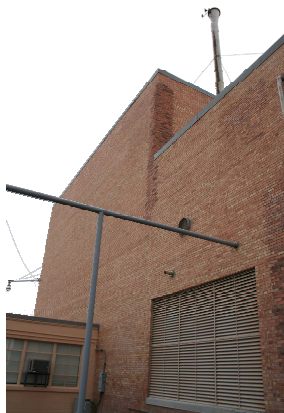
Figure 2. EBR I Reactor Building North Elevation.

Issue	Probable Cause	Testing and Investigation	Impact on the Structure	Mitigation and Repair
Diagonal cracks in the parapet wall. Likely also present at other parapet corners (Figure 2)	Unequal settlement leading to uneven loads; insufficient bond; Thermal movement and moisture expansion, freeze/thaw cycles. ¼” steel reinforcement rods and no expansion or contraction joints in the parapet walls.	1980 project drawings; Visual inspection	Deterioration of parapet corners leading to possible failure of parapet walls.	Employ Structural Engineer with professional experience in historic structures to: analyze stress, strain, and torsion related to dead and live loads and the environment; and to recommend treatment options. Contract with Conservator with professional experience in historic masonry, to work with Structural Engineer and Landlord and to conduct or oversee repair.

Issue	Probable Cause	Testing and Investigation	Impact on the Structure	Mitigation and Repair
Mismatched brick (Figure 2)	Initial damage caused by broken waterline and resulting flood. Problem fixed; 1980 brick repair and replacement overseen and completed by persons with no historic building or materials experience.	Project drawings; conduct brick dye test on small section of brick on west/south “nonpublic” side of building	Detracts from historic appearance	Contract with Conservator with professional experience in historic masonry to oversee or conduct masonry work including repointing replacement with materials that match original in composition, color, and size.

Findings for the north elevation of the EBR I Reactor Building are summarized below (Figure 2, Table 1). The Building warrants continued monitoring so that any future flooding issues, which have adversely affected the structure in the past, are corrected quickly. Assessment and future repair under the direction of qualified professionals are also recommended.

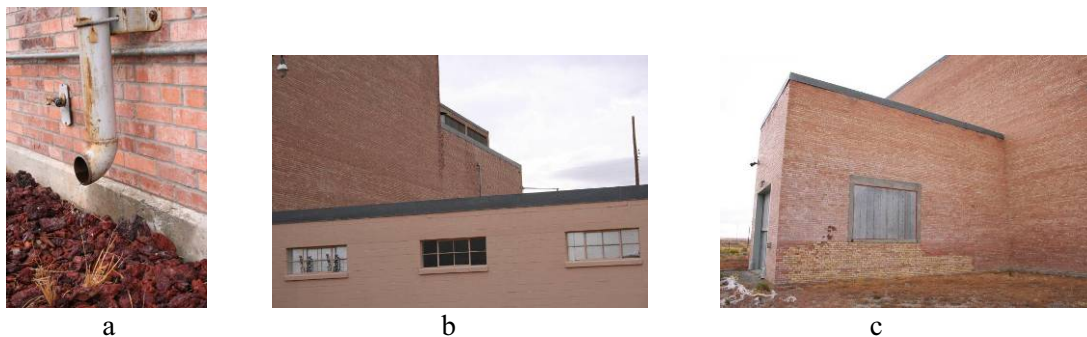
Findings for the east elevation of the EBR I Reactor Building are summarized below (Figure 3, Table 2). A faulty drainage system has adversely affected the building on this side and repairs are recommended to halt further deterioration.

Figure 3. EBR I Reactor Building East Elevations: a) faulty drainage system, b) mismatched brick, c) spalled, mismatched brick and stucco patches.

Issue	Probable Cause	Testing and Investigation	Impact on the Structure	Mitigation and Repair
Wet masonry; Spalling Concrete, (Figure 3a)	Faulty drainage; exterior drainpipe does not carry water away from building, causes splashing from rock onto concrete; saturates soil	1980 project drawings; visual inspection and damp concrete	Weakened foundation; create pathway for additional water	Contract with Structural Engineer to work with Mechanical Systems Engineer to determine if original interior cavity drain system is operational. Determine

Issue	Probable Cause	Testing and Investigation	Impact on the Structure	Mitigation and Repair
	causing capillary action (rising damp).			<p>functionality of external system and recommend treatment.</p> <p>Contract with Master Craftsman to oversee repair/replacement of drainage system and components.</p>
Mismatched brick on “public” reactor building wall (Figure 3b)	Clogged drainbody or downspout at this corner of the roof replaced with external drain pipe. Problem fixed.	1980 Project drawings; conduct brick dye test on small section of brick on west/south “nonpublic” side of building	Detracts from historic appearance	Contract with Conservator with professional experience in historic masonry to oversee or conduct masonry work by Master Craftsmen including repointing replacement, with materials that match original in composition, color, and size.
Mismatched brick on “nonpublic” vault room wall (Figure 3c)	2003 brick repair and replacement overseen and completed by persons with no historic building or materials experience.	2003 Project drawings; conduct brick dye test on small section of brick on this wall	Detracts from historic appearance	Contract with Conservator with extensive historic masonry experience to oversee or conduct masonry work including repointing replacement, with materials that match original in composition, color, profile, texture, and size.

Stucco patches pulling away and removing brick rendering; spalled brick on “nonpublic” vault room wall (Figure 3c)	<p>Moisture penetrating brick from opening lap joint in the coping.</p> <p>Lawn watering on lee side of building caused brick deterioration and persons with no experience with historic buildings or materials oversaw or completed 1980 repair project.</p>	1980 project drawings; interview with EBR I retiree; site visit during rain storm, visual inspection	Spalled brick, mortar deterioration. Loss of rendering will leave soft brick face exposed; missing brick will allow further moisture penetration and materials deterioration.	<p>Contract with Structural Engineer to determine extent of coping issue. Under supervision of Structural Engineer with professional historic masonry experience, have Master Craftsman remove lower side metal coping and reinstall after masonry is repaired.</p> <p>Contract with Conservator with extensive historic masonry experience to oversee or conduct masonry work by Master Craftsmen including repointing replacement, with materials that match original in composition, color, and size.</p> <p>Lawn has been replaced by red cinders and watering is no longer a problem.</p>

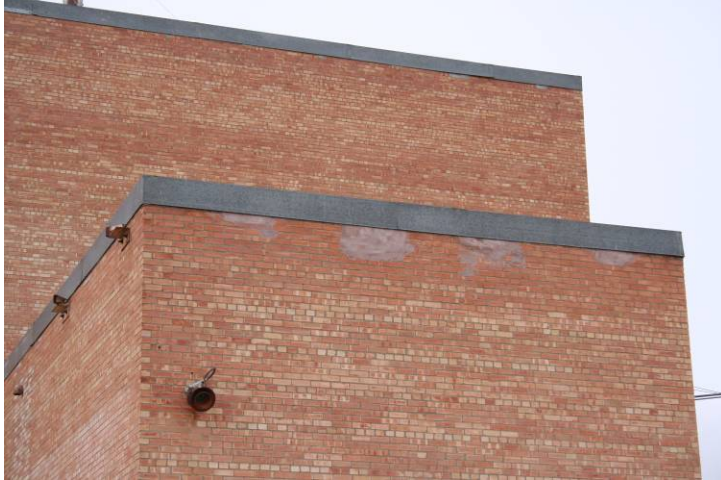
Figure 4. EBR I Reactor Building South Elevation.

Issue	Probable Cause	Testing and Investigation	Impact on the Structure	Mitigation and Repair
Stucco patches cover spalled brick on “nonpublic” reactor building walls (Figure 4)	Moisture penetrating the brick from an opening in the lap joint in the coping.	1980 project drawings; Site visit during rain storm, visual inspection; stucco patches in good condition	Detracts from historic appearance	Monitor joints in metal coping and stucco for cracking; Consult Structural or Systems Engineer with experience regarding historic drainage systems to determine if drainage system is plugged and where.

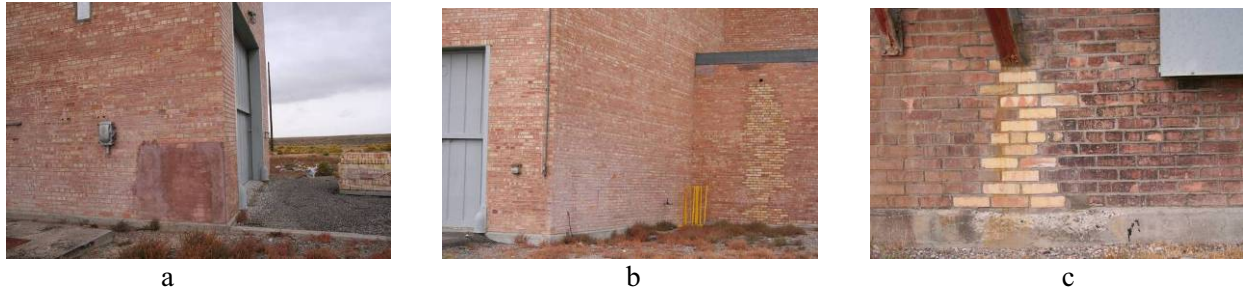
Figure 5. EBR I Reactor Building West Elevation: a) stucco patch removal area, b) efflorescence, c) mismatched brick.

Issue	Probable Cause	Testing and Investigation	Impact on the Structure	Mitigation and Repair
Removal of stucco patch left stains and soft brick beneath. (Figure 5a). Salt leaching from brick Reactor Building wall (efflorescence) (Figure 5b); Wet masonry. Mismatched brick on “nonpublic” vault room wall (Figure 5c)	Wall located on windward side of Exterior pipe is missing and water is draining directly onto wall. Persons with no experience with historic buildings or materials oversaw or completed 2003 masonry repair project.	2003 Project drawings; conduct brick dye test on small section of brick on this wall	Spalled brick, mortar deterioration; missing brick will allow further moisture penetration and materials deterioration.	Contract with Structural Engineer to work with Mechanical Systems Engineer to determine if original interior cavity drain system is operational. Determine functionality of external system and recommend treatment. Contract with Master Craftsman to oversee repair/replacement of drainage system and components. Contract with Conservator with professional historic masonry experience to oversee or conduct masonry work by Master Craftsmen

Issue	Probable Cause	Testing and Investigation	Impact on the Structure	Mitigation and Repair
				including repointing replacement, with materials that match original in composition, color, and size.
Missing and spalled brick on rowlock brick sill (Figure 6a, b)	Deteriorating mortar joints on brick sill; moisture and freeze/thaw;	Visual Inspection	Rowlock brick sill is deteriorating and will worsen if no intervention.	Contract with Structural Engineer to determine if there may be other causes (i.e., steel reinforcement at corner of window) and Conservator with professional historic masonry experience to oversee or conduct masonry work by Master Craftsmen including repointing replacement, with materials that match original in composition, color, and size.
Peck marks and cracks in windows; bird droppings on window sill and down masonry wall (Figure 6b)	Birds attracted to reflective film on windows	Visual Inspection	Potential for broken windows and entry of birds into building interior. Droppings may cause materials to decay.	Remove reflective film, install one-way interior shades to allow visitors to look out while reducing glare and heat. Apply black nylon thread about 1” above sills and other landing edges to discourage perching birds.

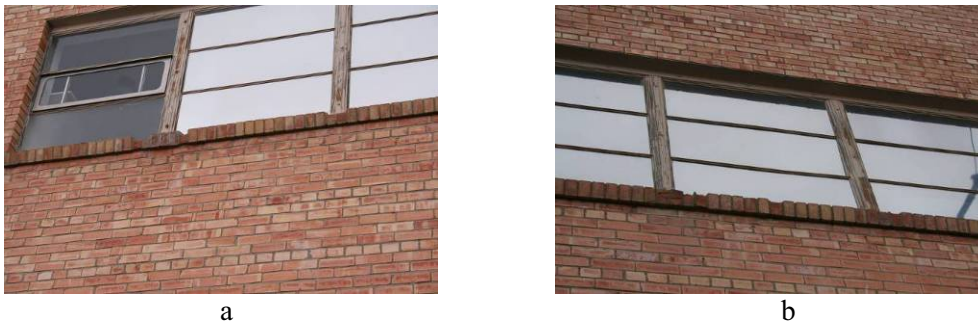
Figure 6. EBR I Reactor Building West Elevation: a) missing and spalled brick on sill, b) reflective windows and bird damage.

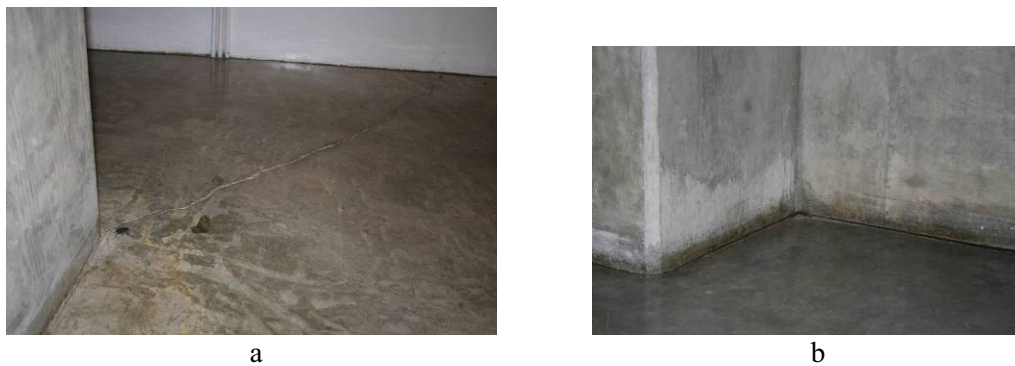
Figure 7. EBR I Reactor Building Basement: a) floor crack, b) stains.

Issue	Probable Cause	Testing and Investigation	Impact on the Structure	Mitigation and Repair
Crack in concrete floor of basement (Figure 7a)	Compression soon after construction or when adjacent building removed	Crack gauge to evaluate movement	Crack may spread causing pathway for moisture penetration	Continued monitoring
Stains on floor and walls of basement (Figure 7b)	Water seepage on Westside of Reactor Building	Surveillance after rain and snow melt	Stains and deterioration of concrete	Some drainage problems have been fixed; monitor to see if moisture is present after rains and snows; if water is present, track on exterior of building and identify cause (i.e., coping gaps)

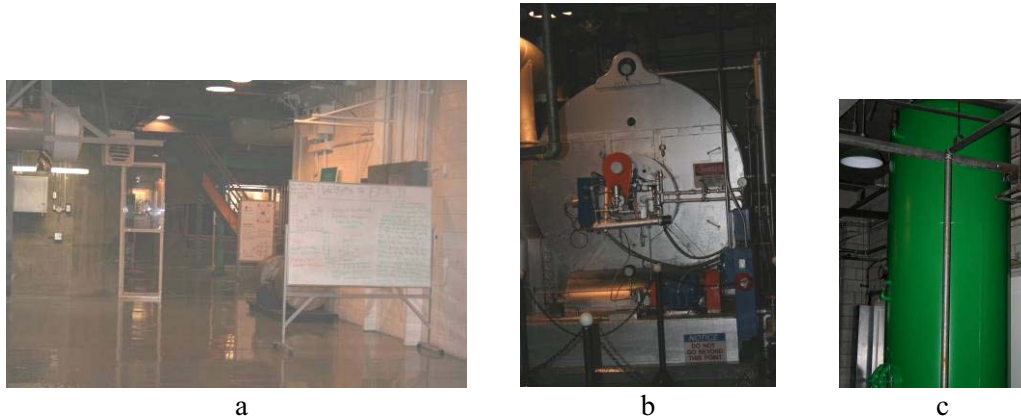
Figure 8. EBR I Reactor Building Ground Floor: lack of age related patina on a) floors, b) equipment, and c) newly painted equipment.

Issue	Probable Cause	Testing and Investigation	Impact on the Structure	Mitigation and Repair
Shortage of age-related patina (Figure 8a, 8b, 8c)	Over-zealous maintenance	Visual Inspection	Detracts from historic appearance and feel	Allow materials to reveal their age without impacting their fabric
Stains on floor and walls of Service Room (Figure 9a)	Water penetration on windward side of Reactor Building	Surveillance after rain and snow melt	Stains and deterioration of brick and concrete	Some drainage problems have been fixed; monitor to see if moisture is present after rains and snows. If water is present, track on exterior of building and identify cause (ie., coping gaps); replace concrete and brick or repoint, as needed under supervision of qualified professionals.
Stains on floor near garage door and wall near Hot Cell (Figure 9b, 9c)	Water seepage on Westside of Reactor Building	Surveillance after rain and snow melt	Stains and deterioration of brick and concrete	Some drainage problems have been fixed. Monitor to see if moisture is present after rains and snows. If water is present, track on exterior of building and identify cause (ie., coping gaps); replace concrete and brick or repoint, as needed under supervision of qualified professionals.

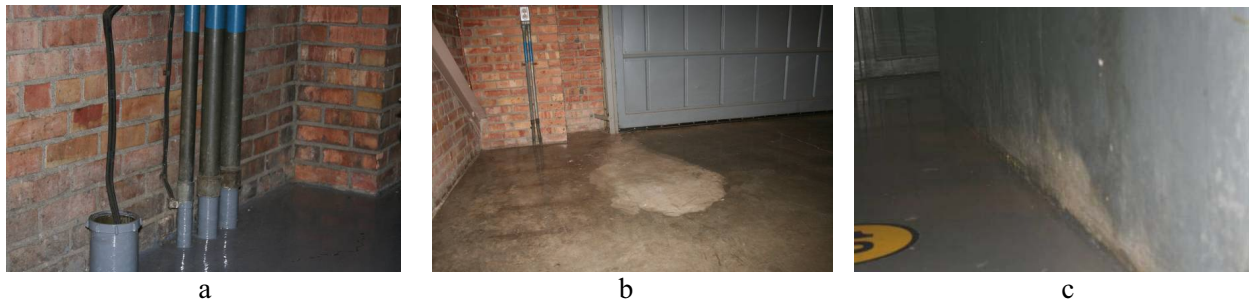
Figure 9. EBR I Reactor Building Ground Floor: stains on floors and walls in a) Service Room, b) near roll up door, and c) exterior wall of Hot Cell.

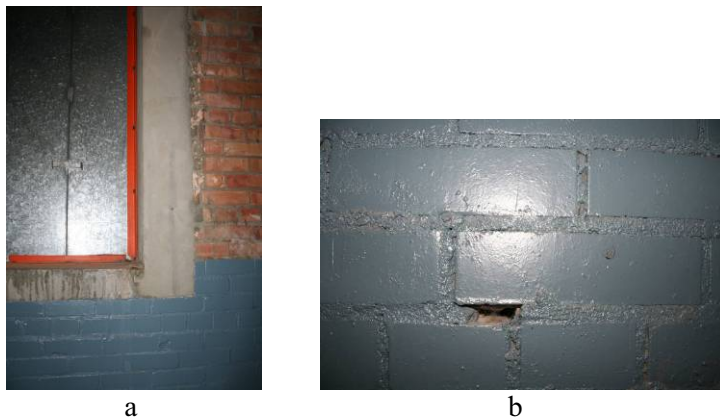
Figure 10. EBR I Reactor Building Ground Floor: brick and mortar damage masked by a) patches and b) painting.

Painted brick and concrete patches on wall near Hot Cell hide brick and mortar deterioration (Figure 10a, 10b)	Water penetration into Hot Cell area, freeze/thaw	Surveillance after rain and snow melt	Brick and mortar deterioration	Some drainage problems have been fixed. Monitor to see if moisture is present after rains and snows. If water is present, track on exterior of building and identify cause (ie., coping gaps); replace concrete and brick or repoint, as needed under supervision of qualified professionals.
