HANFORD SITE LOW EXPOSURE PIPELINE REPAIR USING A NON- METALLIC COMPOSITE SYSTEM

R. J. Huth
CH2M HILL Plateau Remediation Company

Date Published
November 2009

**HANFORD SITE LOW EXPOSURE PIPELINE REPAIR
USING A NON-METALLIC COMPOSITE SYSTEM - 10154**

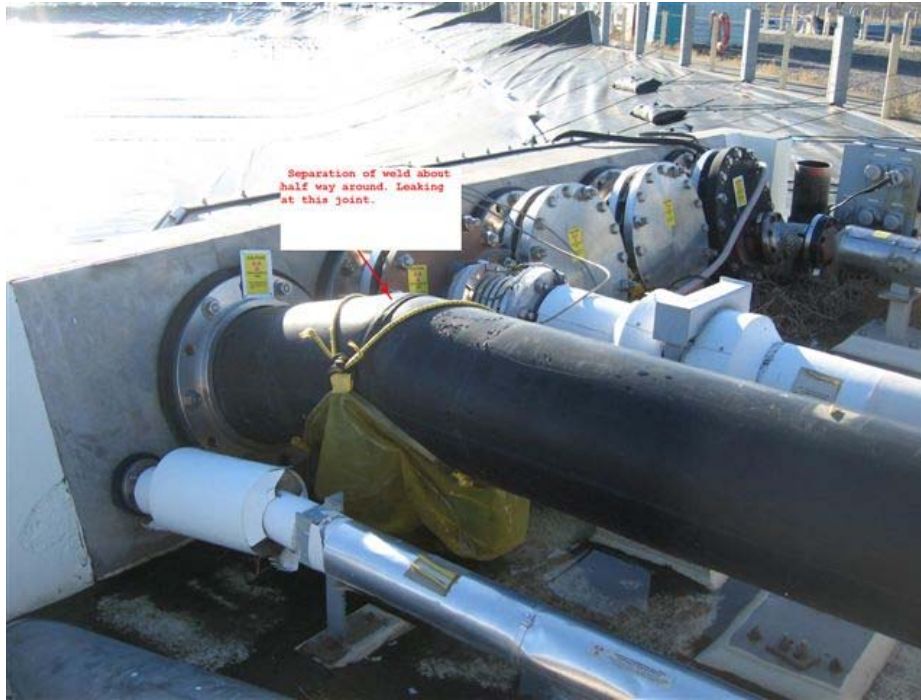
The hot-gas bonded joint failed at the bond fusion zone. The failure was completely through-wall for about 50 percent of the circumference of the pipe.

Fig. 1 – Location of bond failure on HDPE recirculation pipe

Cyclical thermal pipe expansion overstressing the vulnerable bond fusion zone is considered the most likely cause of the failure. Thermal expansion of HDPE was an original design concern and was accounted for in the design of supports. The pipe up and downstream of the elbow is well supported. An axially and radially fixed support is located about two feet downstream of the elbow, and two radially fixed pipe supports are located immediately upstream and five feet upstream. An expansion joint is also installed upstream of the two upstream supports. The pipe is therefore free to expand thermally upstream. However, day to night temperature swings on the Hanford site average 17° C (30°F), and much larger differentials exist between summer and winter temperatures. The daily and seasonally cyclic nature of the expansion is likely to have fatigued the bonded joint at the elbow, resulting in a failure of the bond. Based on the appearance and location of the failure, it is also likely that the original bonded joint did not have adequate adhesion.

An additional likely contributor was additional live loads applied to the pipe by personnel clambering over the line during work evolutions at the basin.

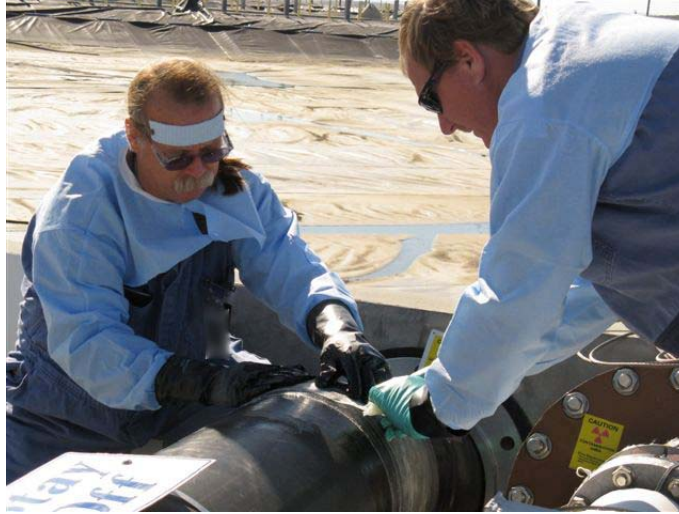
Fig. 2 – Application of epoxy impregnated base matrix to HDPE elbow

The pipe was primed with a “Standard Matrix” epoxy for a distance of 10 to 13 cm (4 to 5 inches) on either side of the failed bond, and 14 meters (45 feet) (about three layers) of the epoxy impregnated base matrix was wrapped tightly around the pipe joint. A temporary band of plastic wrap was applied around the installed base matrix during curing. This plastic wrap aids in adhesion by compressing the fabric matrix against the HDPE pipe, and helps form a smooth exterior finish. After the base matrix was fully cured, the plastic wrap was removed, and the matrix was lightly sanded and buffed to remove any sharp edges.

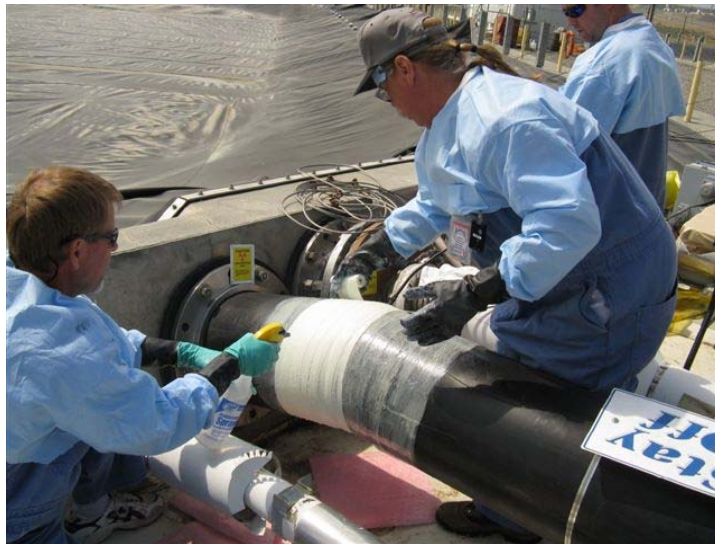
Fig 3 – Application of final layer as water activated fabric is wetted

In preparation for the application of the wetted final layer, a specific primer was applied to the repair area out to about 30 cm (one foot) past the base matrix wrapped area on each side. The water-activated fabric was wetted and wrapped over and beyond the base matrix, four layers thick.

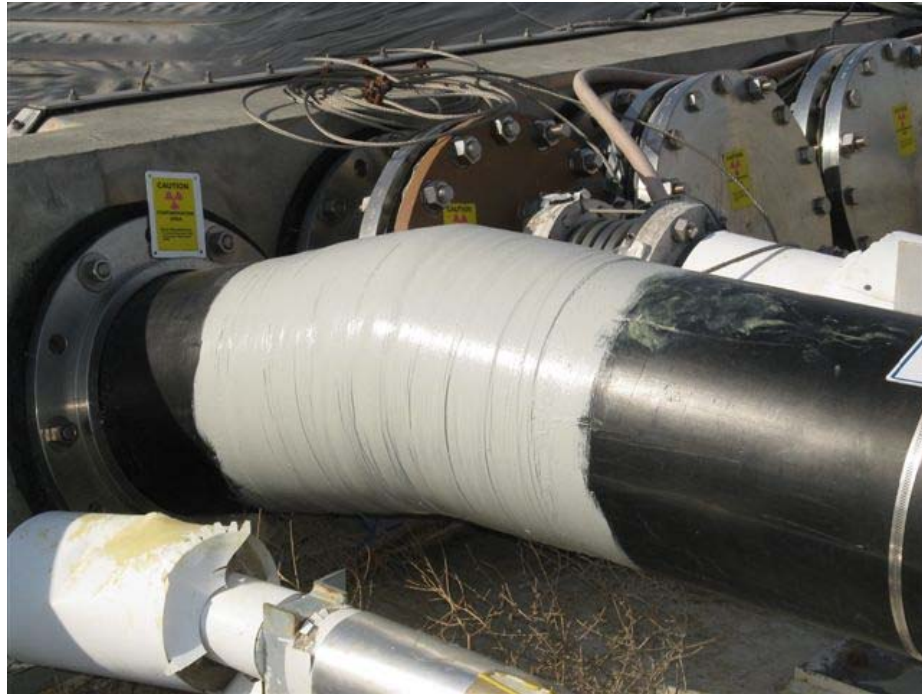
Fig. 4 – Final repair after paint coating

Plastic wrap was again used, and removed after curing, about 24 hours later. Rough areas were sanded smooth, and a final compatible paint coating was applied over the entire area, as a protection against damage from UV. An initial service leak test was successfully performed and the recirculation line was returned to service in June of 2009.

In addition to applying a coating for UV protection, the repaired area was covered with ceramic fiber blanket insulation for additional UV protection. “Stay Off” signs have been placed on the piping to limit “personnel” loading on the line. Four times a year, the insulation will be removed and a formal inspection for signs of failure or leakage will be performed.
