PVP2009-78053

**FITNESS-FOR-SERVICE ASSESSMENT FOR A RADIOACTIVE WASTE TANK THAT
CONTAINS STRESS CORROSION CRACKS****Bruce J. Wiersma**Savannah River National Laboratory
Aiken, SC 29808**James B. Elder**Savannah River National Laboratory
Aiken, SC, 29808**Rodney W. VandeKamp**Savannah River National Laboratory
Aiken, SC 29808**Charles A. McKeel**Savannah River Nuclear Solutions
Aiken, SC, 29808**ABSTRACT**

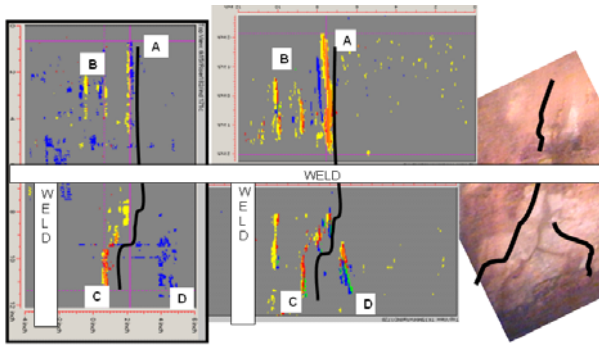
Figure 3. UT scan of stress corrosion crack.

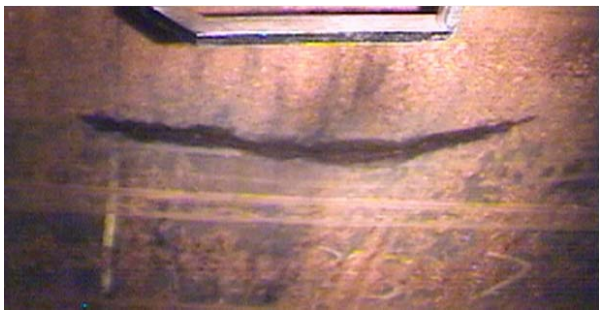
Figure 4. Example of through-wall bleedout.

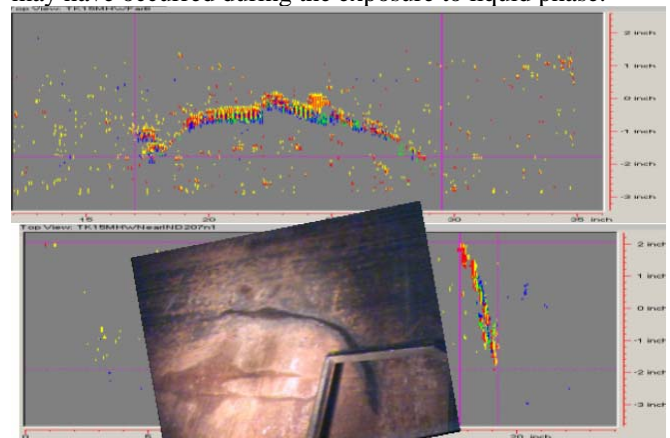
An example of a crack that grew is shown in Figure 5. The crack was first observed in 1994 and had only a limited amount of leakage. During the first 21 years of service the crack was exposed to nitrate-rich liquid, while for the past 25 years it has been in the vapor space. Though the exact date is unknown, visual inspection results and the limited amount of leakage indicate that through-wall penetration occurred during the past 25 years of vapor exposure. However, initiation of the crack may have occurred during the exposure to liquid phase.

Figure 5. Stress corrosion crack near repair weld in tank.

The crack is located near a repair weld in the middle horizontal weld. In 2007, it was determined that the length of the crack was approximately 19 inches. The visible portion of the crack begins at the left edge of the repair weld and then arcs so that it becomes parallel to the horizontal weld. According to the residual stress modeling, the maximum transverse tensile stress occurs at this location [3-5]. The distance of the parallel portion of the arc is approximately 6 inches from the center of the weld. This distance is further than that observed for other cracks in the tank, however, the effect of a nearby vertical weld may influence the residual stress pattern as well. The through wall portion of the crack is approximately 14.4 inches. At each end of the through-wall section of the crack are part through-wall sections (see Figure 5 for UT scan of crack). In the plate above the weld, a primarily vertical branched crack extends tangentially from the repair weld approximately 3.7 inches above the middle horizontal weld. Approximately 1 inch of this segment is through-wall, whereas in 2002, all of this segment was part through-wall. There has been approximately

1.7 inches of crack extension into the base plate since 2002. The segment that has extended is part through-wall. The part through-wall crack in the plate beneath the weld arcs back toward the middle horizontal weld. The arc-like pattern of the crack adjacent to the weld repair is consistent with laboratory results [6]. The behavior also agrees with the residual stress model for a narrow weld repair in that the crack is located a short distance from the weld repair fusion line [5].

Due to a lack of significant driving forces, either hydrostatic or residual stresses, the crack currently does not impact either the structural stability or the leak tightness of the tank. This statement is confirmed by the finite element fracture analysis previously performed on the crack (assuming that it was 15 inches) [7]. The analysis showed that the hydrostatic stresses were not sufficient to drive the crack to instability. The horizontal orientation of the crack means that hydrostatic stresses in the hoop direction will not have a significant impact on further crack growth. Therefore, from a structural stability perspective the crack is not anticipated to be significant to facility operations.
