Title: **The U. S. NHMFL 60 T Long Pulse Magnet Failure**

¹Abstract—The 60 T long pulse magnet operated by the U. S. National High Magnetic Field Laboratory at Los Alamos National Laboratory, Los Alamos, New Mexico failed catastrophically on July 28, 2000. The failure was investigated and the cause was determined to be unusually low toughness in the nitrogen strengthened manganese stainless steel (Nitronic-40™) reinforcing material. The source of the reduced toughness condition was a sigma phase conversion in the microstructure. The magnet failure, failure investigation and results of the investigation are described. Plans for the construction of the successor magnet, the 60 tesla long pulse Mark II, are described.

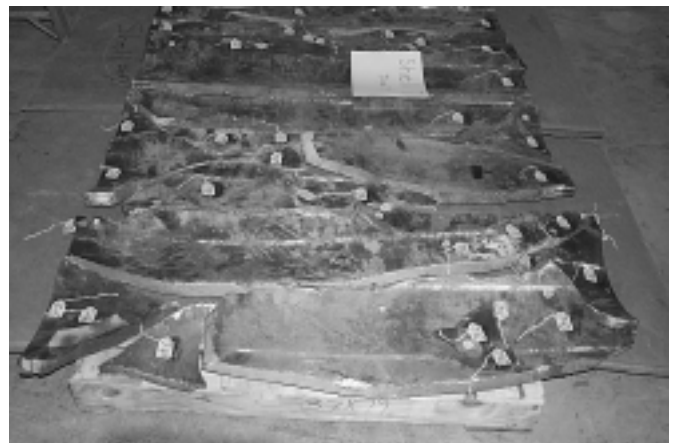
The reinforcing shell fragments, pieces of conductor and sections of winding from each magnet coil were located and sorted. Reinforcing shell fragments were positioned back together. Fig. 2 is a photograph of the shell fragments of coil seven positioned together. It was noted that the ruptures of the reinforcing shells from coils one through four exhibited a full thickness shear lip. Fig. 3 is a photograph of the shear lip of the coil four shell fracture. In contrast, the many fractures of reinforcing shells from coils five through eight all exhibited very small shear lips. The fracture of the reinforcing shell of coil nine had a full thickness shear lip.

Fig. 2: Photograph of reassembled coil 7 shell fragments.

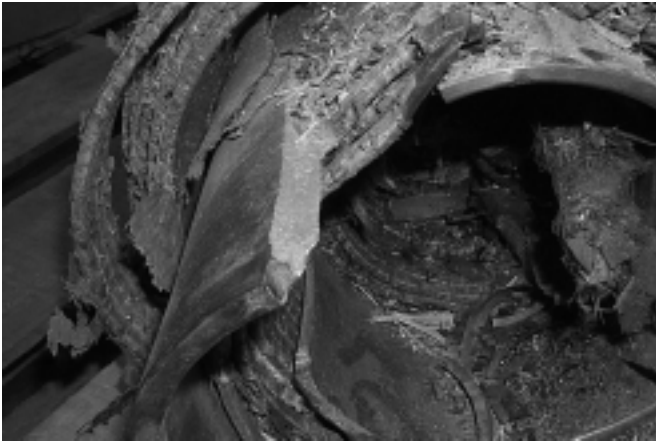
Fig. 3: Photograph of coil 4 fracture shear lip.

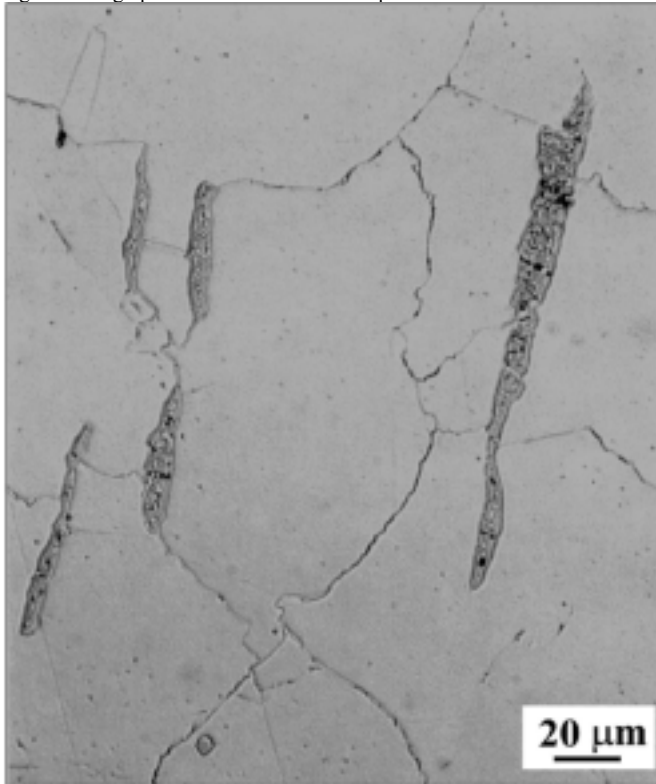
The chemical analyses were nominal and within specification limits (ASTM A314 for type XM-10 UNS S21900), but it was noted that constituents promoting delta ferrite formation, such as molybdenum, were present. Stringers of delta ferrite and the brittle inter-metallic sigma phase were noted in the Nitronic-40 shells. Fig. 4 is a photograph of converted sigma phase stringers as observed in shell material from coil eight. The 77 K Charpy impact tests of material from shells five through seven produced results that were approximately 10% of expected values. For example: in the shell of coil seven, values ranging from 5.4 to 9.5 J were produced instead of the expected 81 J. By contrast, normal Charpy impact energies were produced when material from the shell of coil four was tested.

Fig. 4: Photograph of sigma phase stringers in coil 8 shell material.

A new 60 T LP magnet system (Mark II) will be built using more carefully specified, manufactured and quality tested Nitronic-40 shell material. Chemistry and processing will be more tightly controlled to minimize the presence of delta ferrite and its conversion to sigma phase. These additional quality assurance measures are also being followed for the Nitronic-40™ being ordered for the US 100 T MS magnet project [5]. There will also be minor improvements in coil insulation systems and shell mechanical features. Conductor for the replacement coil set and a spare coil set has been ordered. This conductor will be approximately 5 to 10 % stronger than what was available at the time of the construction of the original 60 T LP magnet. The 60 T LP magnet pits and the adjacent 100 T MS magnet pit are being provided with additional blast and fragment containment shielding to reduce damage caused by magnet failures that will surely occur when future pulsed magnets reach their fatigue life. The 60 T LP Mark II magnet is scheduled to be

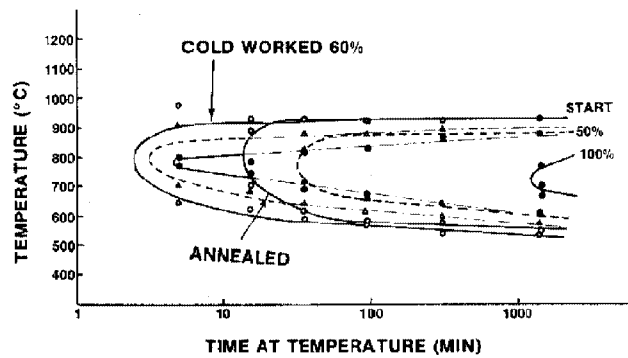
The production and inspection records of the shells were obtained and reviewed. It was noted that the Nitronic-40™ steel for the shells of coils one through four was processed and heat treated following specification temperature recommendations. The steel for the shells of coils five through eight was processed and heat treated at or near 840 °C which is far from the recommended temperature of 1065 °C. Heat treating Nitronic-40™ at 840 °C converted delta ferrite material to the brittle sigma phase. The presence of delta ferrite and its conversion to brittle sigma phase embrittled the shells of coils five through eight [3]. Fig. 5 shows the rate of delta ferrite conversion to sigma phase[4] as a function of annealing temperature, time and cold work.

Fig. 5: Graph showing the conversion rate of delta ferrite to sigma phase.
