**Pacific Northwest
National Laboratory**

**Ultrasonic Examination of
Double-Shell Tank 241-AN-102
Examination Completed July 2008**

AF Pardini
DR Weier
KK Anderson

August 2008

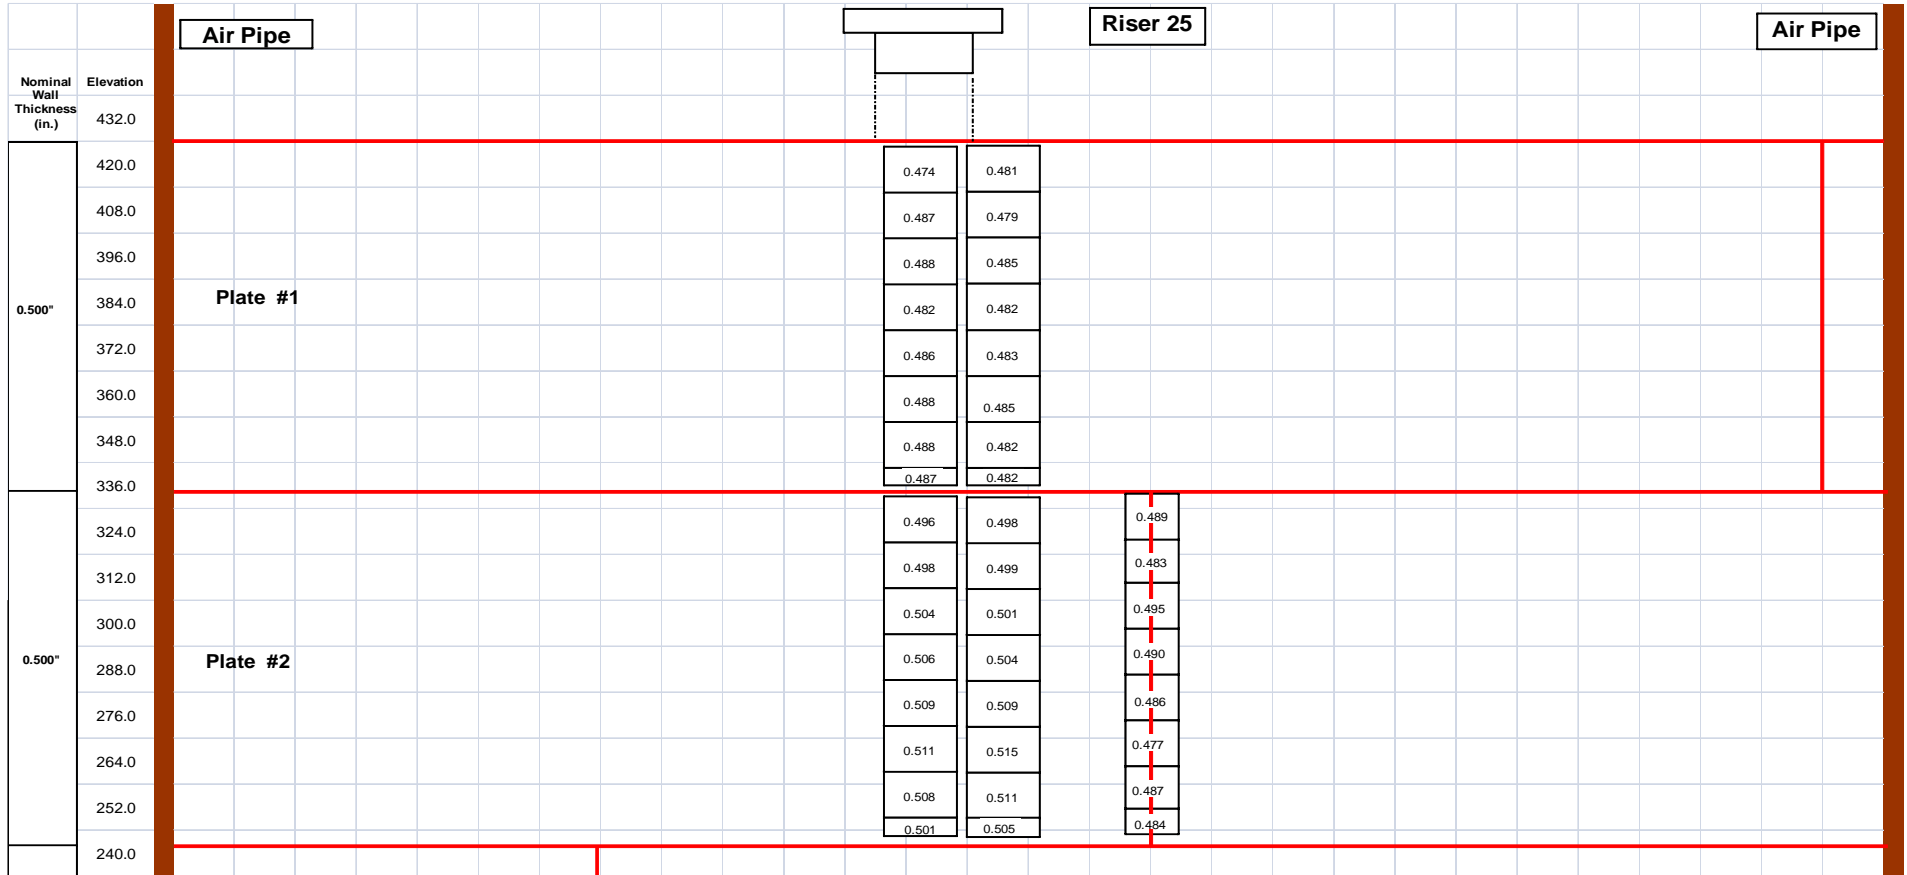
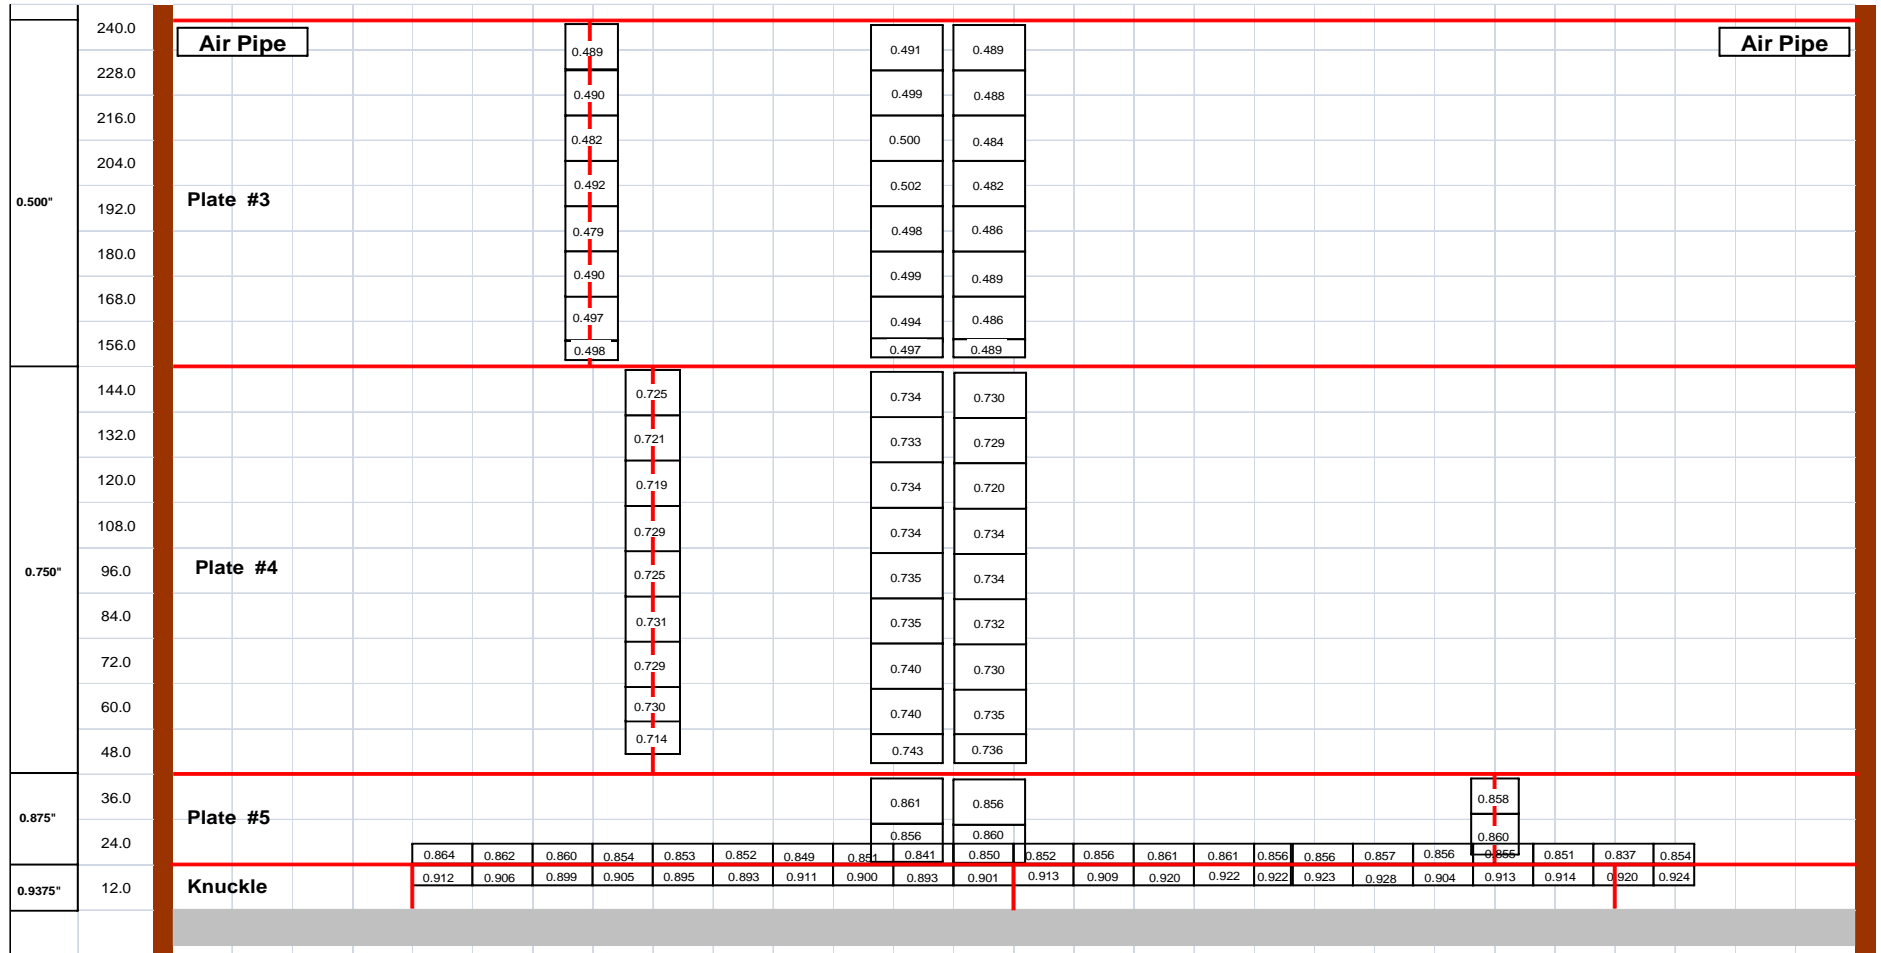
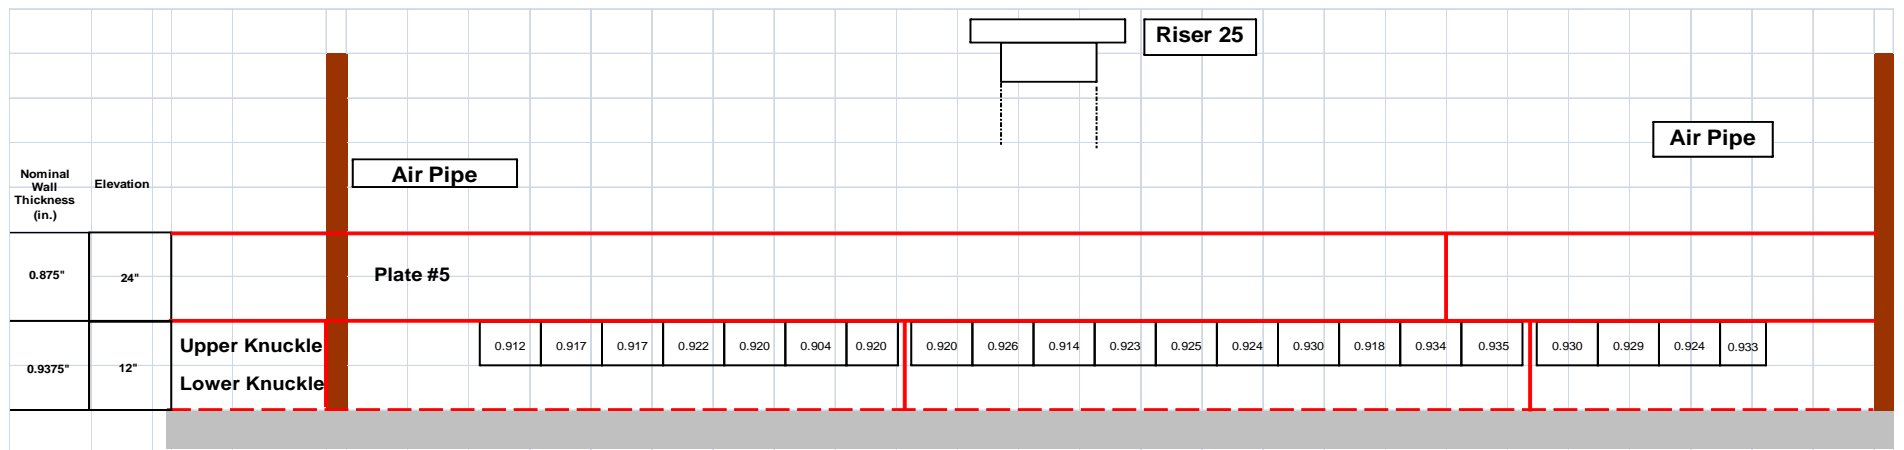
Figures 5.1, 5.2, and 5.3 show the wall thickness examination results for the primary tank wall and the HAZs of both vertical and horizontal welds taken below Riser 25. The examination consisted of two vertical paths beneath the 24-in. diameter riser. Vertical scan #1 was 15-in.-wide on Plate #1, #2, #3, #4, and #5 near the centerline of the 24-in. riser. Vertical scan #2 was adjacent to vertical scan #1 and was also 15-in.-wide on Plates #1, #2, #3, #4, and #5. Vertical scans were conducted in the downward direction. Figures 5.1 and 5.2 display the minimum readings taken in each 15-in.-wide by 12-in.-long area of the scan. The HAZs of vertical welds in Plates #2, #3, #4, and #5 were examined and the HAZ in the horizontal weld between Plate #5 and the knuckle section was also examined. Weld area exams include approximately 5-in. on each side of the weld and figures 5.1 and 5.2 display the minimum readings taken in each 5-in.-wide by 12-in.-long area of the scan. Areas in the figures that show two measurements in the same box are the result of the vertical scan paths overlapping the horizontal scan paths. In the overlapping areas, both minimum readings from each vertical and horizontal scan paths are given. Figure 5.3 shows the areas scanned on the knuckle portion of the primary tank. Figure 5.3 displays the minimum readings in each 15-in.-wide by 8-in.-long area of the scan.

Figure 5.1. UT Data from Tank 241-AN-102 Riser 25

Figure 5.2. UT Data from Tank 241-AN-102 Riser 25 cont.

Figure 5.3. UT Data from Tank 241-AN-102 Riser 25 cont.

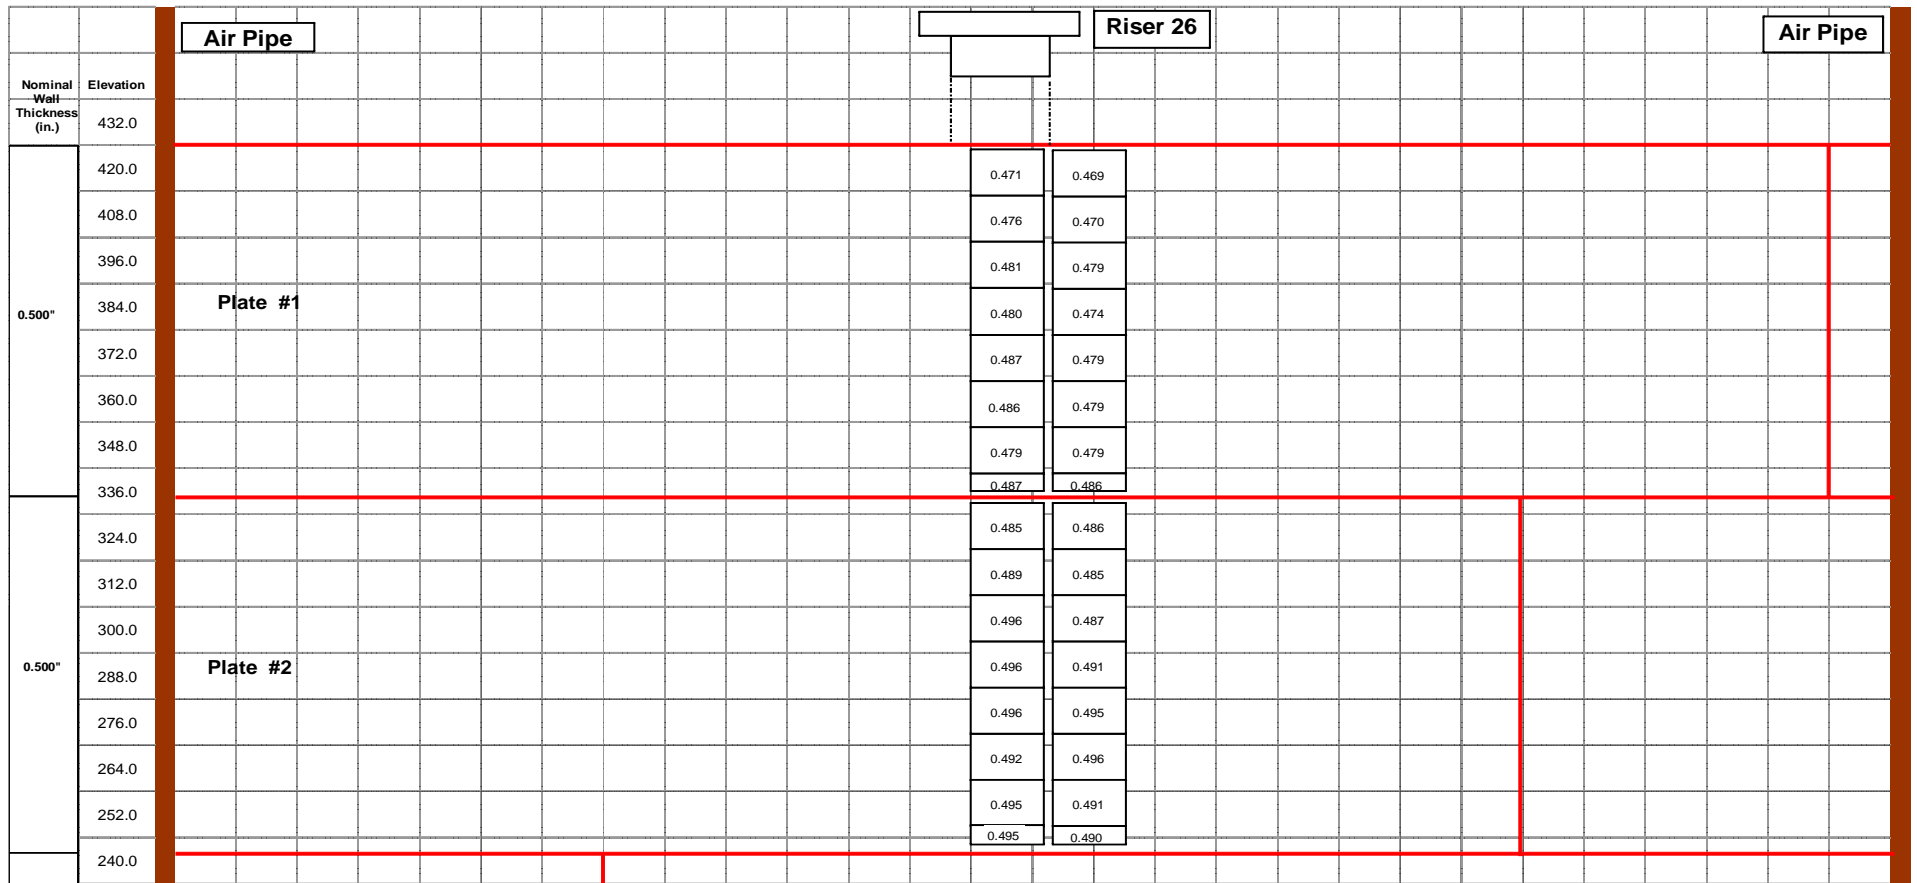
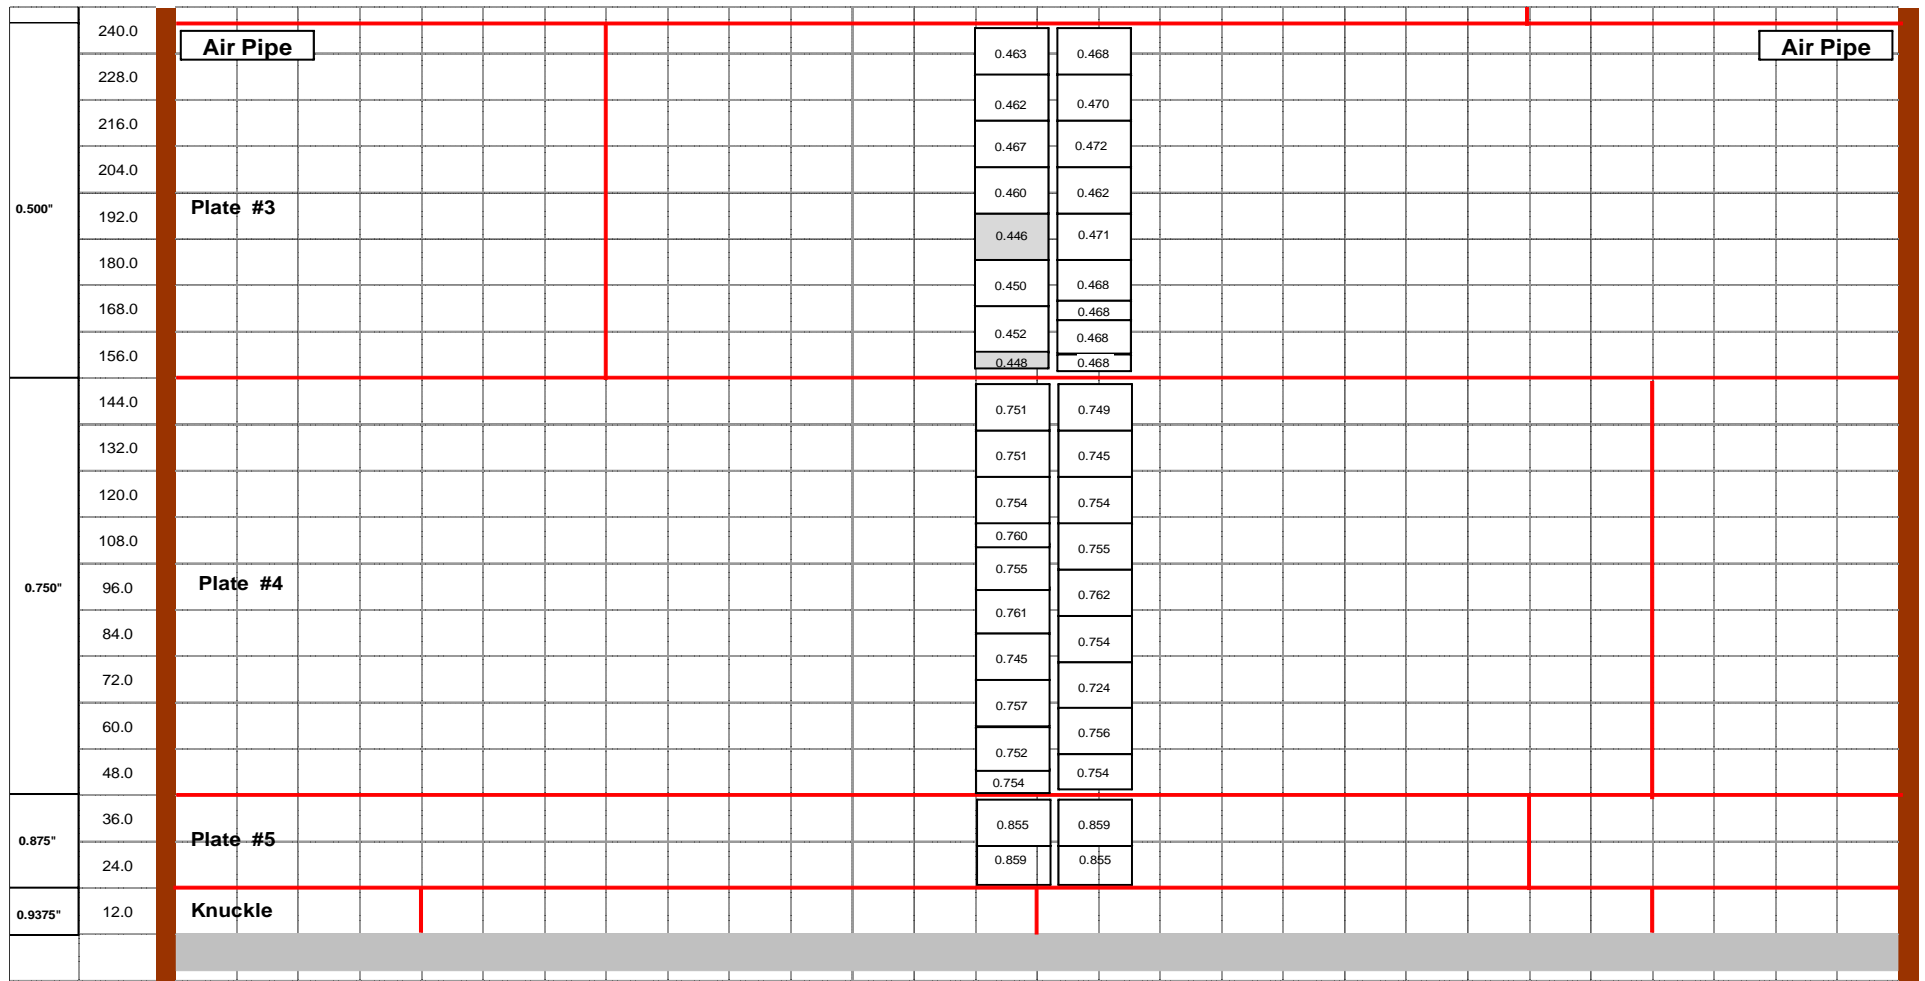
Figures 5.4 and 5.5 show the wall thickness examination results for the primary tank wall taken below Riser 26. The examination consisted of two vertical paths beneath the 24-in. diameter riser. Vertical scan #1 was 15-in.-wide on Plate #1, #2, #3, #4, and #5 near the centerline of the 24-in. riser. Vertical scan #2 was adjacent to vertical scan #1 and was also 15-in.-wide on Plates #1, #2, #3, #4, and #5. Vertical scans were conducted in the downward direction. Figures 5.4 and 5.5 display the minimum readings taken in each 15-in.-wide by 12-in.-long area of the scan. The gray highlighted areas indicate that the minimum wall thickness exceeded the reportable level of 10% of the nominal wall thickness.

Figure 5.4. UT Data from Tank 241-AN-102 Riser 26

Figure 5.5. UT Data from Tank 241-AN-102 Riser 26 cont.

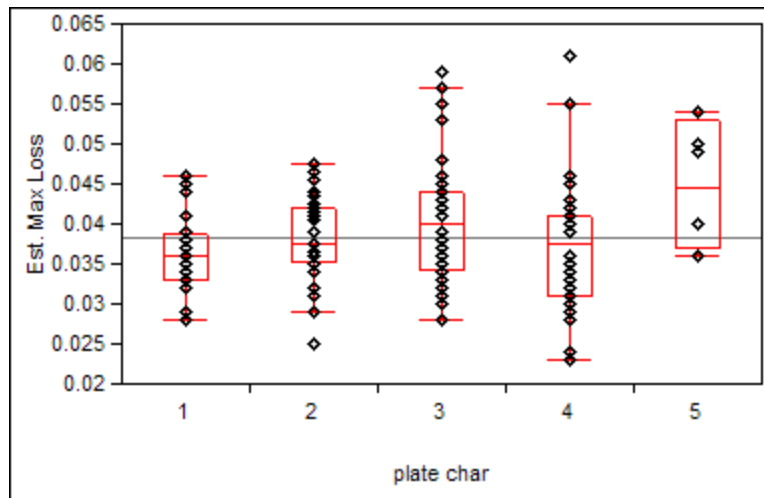
Figure 6.2. Estimated Maximum Loss by Plate

The estimated wall thickness maximum losses for Tank 241-AN-102 are shown across plates in Figure 6.2. Box-plots are used to indicate the vertical extent of the measurements within each plate course; the rectangles within each box-plot represent the middle 50% of the measurements. If significant differences are shown between the plates, groupings of like plates are made rather than just combining the losses across all plates. Here the plates deeper in the tank (plates 3 through 5) have all of the most severe losses, that is the larger values towards the top of the figure. In estimating extreme values, consideration could therefore be given to combining the measurements across plates by using two groups, Plates #1 and #2 and Plates #3,#4, and #5. Results are given for these groupings, for the individual plates, and for all plates combined.

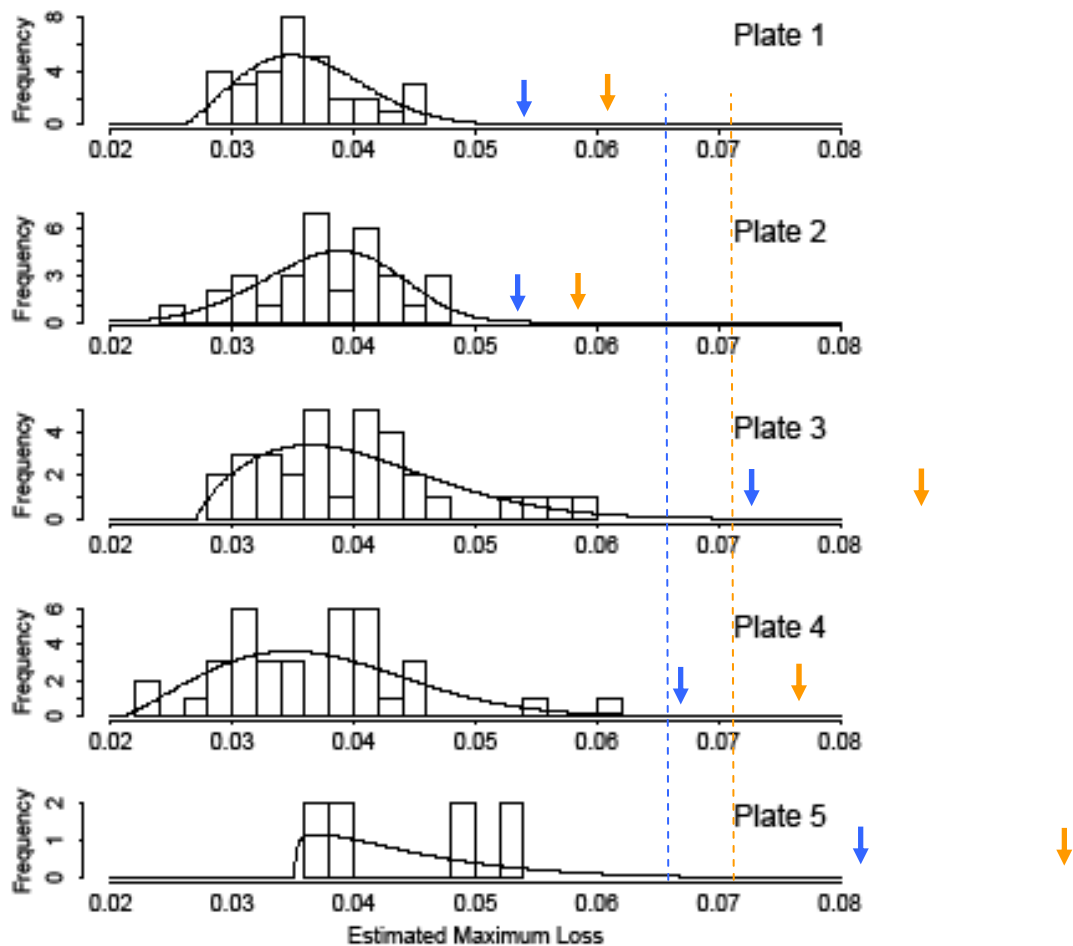
Figure 6.3. Weibull Distribution Fits to UT Maximum Wall Thickness Loss by Plate Course

The histograms in Figure 6.3 show estimated maximum wall thickness loss data for the individual plate courses. Three-parameter Weibull distributions are fit to these histograms and are shown as the smooth curves. The total surface area of a plate course, and thus the number of 15-in. by 12-in. UT images needed to 100% inspect the entire plate course is computed. The percentile of the distribution that then corresponds to the maximum expected loss among this many UT images, based on the distribution fit to the histogram, is considered as the expected estimated worst case loss in that plate course.

The values indicated by the arrows on the histograms are the estimated worst case losses per plate course (blue, to the left) and their associated 95% confidence bounds (orange, to the right). The Plate #5 bound is particularly large due to the few measurements available. More measurements are needed to do practical distribution fittings.

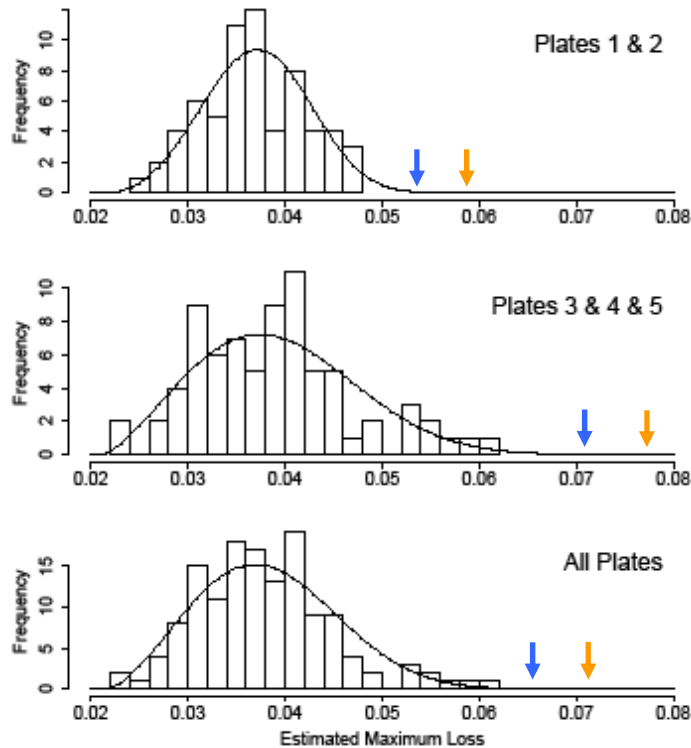
Figure 6.5. Weibull Distribution Fits to UT Maximum Wall Thickness Loss for Plate Course Combinations

To better fit a distribution by using a larger number of measurements, and thereby reducing the uncertainty due to a minimal number of measurements for distribution fitting, the plate courses were combined as well as mentioned earlier. The resulting Weibull fit to the combined measurements over all plates is shown in the bottom of Figure 6.5. However, the preferred fits for this tank are likely given as the top two cases in the figure as previously discussed. The indicated estimates and bounds for the particular plate course combinations then correspond to the final columns in the table in Figure 6.4.

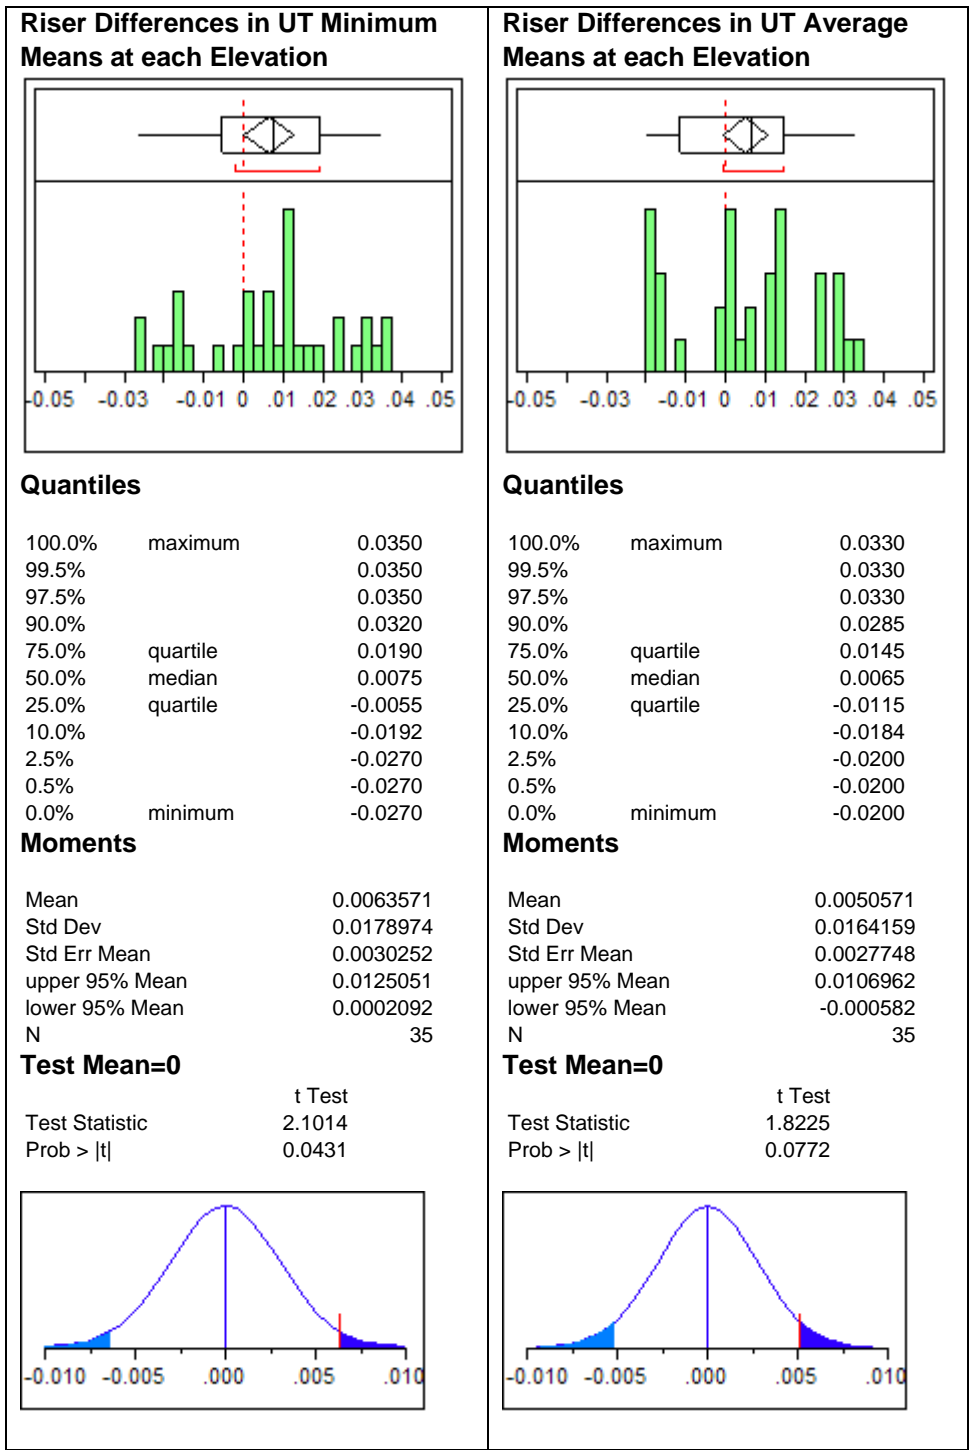
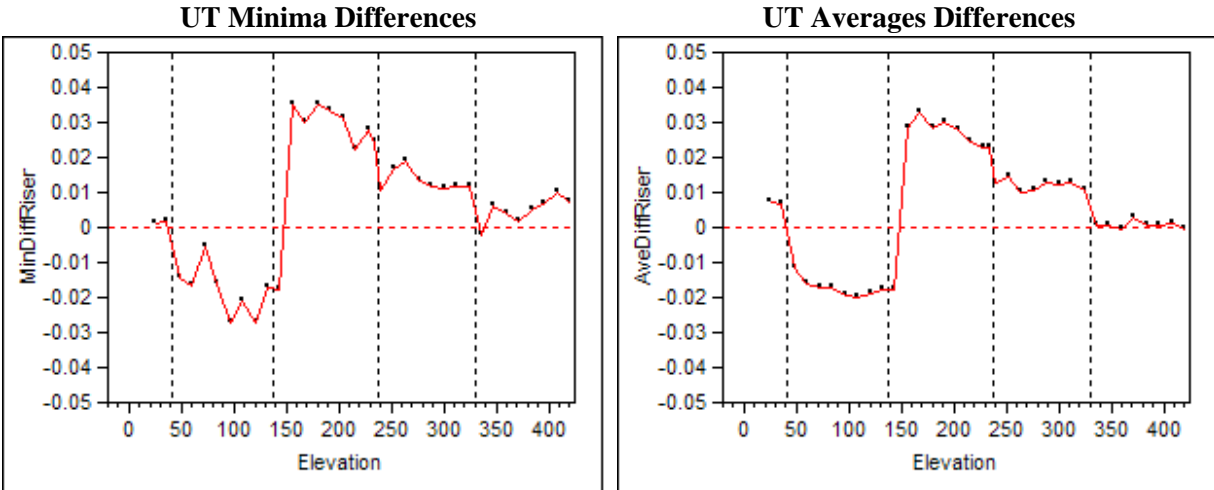
Marginally significant statistical differences are indicated between risers for UT minimum and average values with Riser 25 more often exceeding Riser 26 over the various elevations. Histograms centered at zero at the top of the figure indicate this along with statistical tests below them. Note as would be expected the greater variability in the riser differences in UT image minima than in UT image averages. Information below the histograms gives the t-test results for the differences. The blue shading in the bottom figures show how marginal statistical differences were observed for both UT averages and for UT minima. With more statistically significant riser differences, virtually no blue area would show in those bottom figures.

The marginal differences for UT averages and UT minima, in combination with results from other recently inspected tanks that show no differences in either, continue to suggest that UT inspections using single risers may prove sufficient. However, an interesting comparison is shown in Figure 6.7. Here the riser differences (Riser 25 minus Riser 26) are plotted by elevation. What is shown is considerable variability by plate. The separation by plates is shown by the vertical dashed lines. The considerably changing differences between the two risers can be seen to change from plate to plate. This could suggest some type of measurement calibration effect that is having an impact on results.

Figure 6.6. Riser Differences in UT Measured Wall Thickness

Figure 6.7. Riser 25 minus Riser 26 Differences

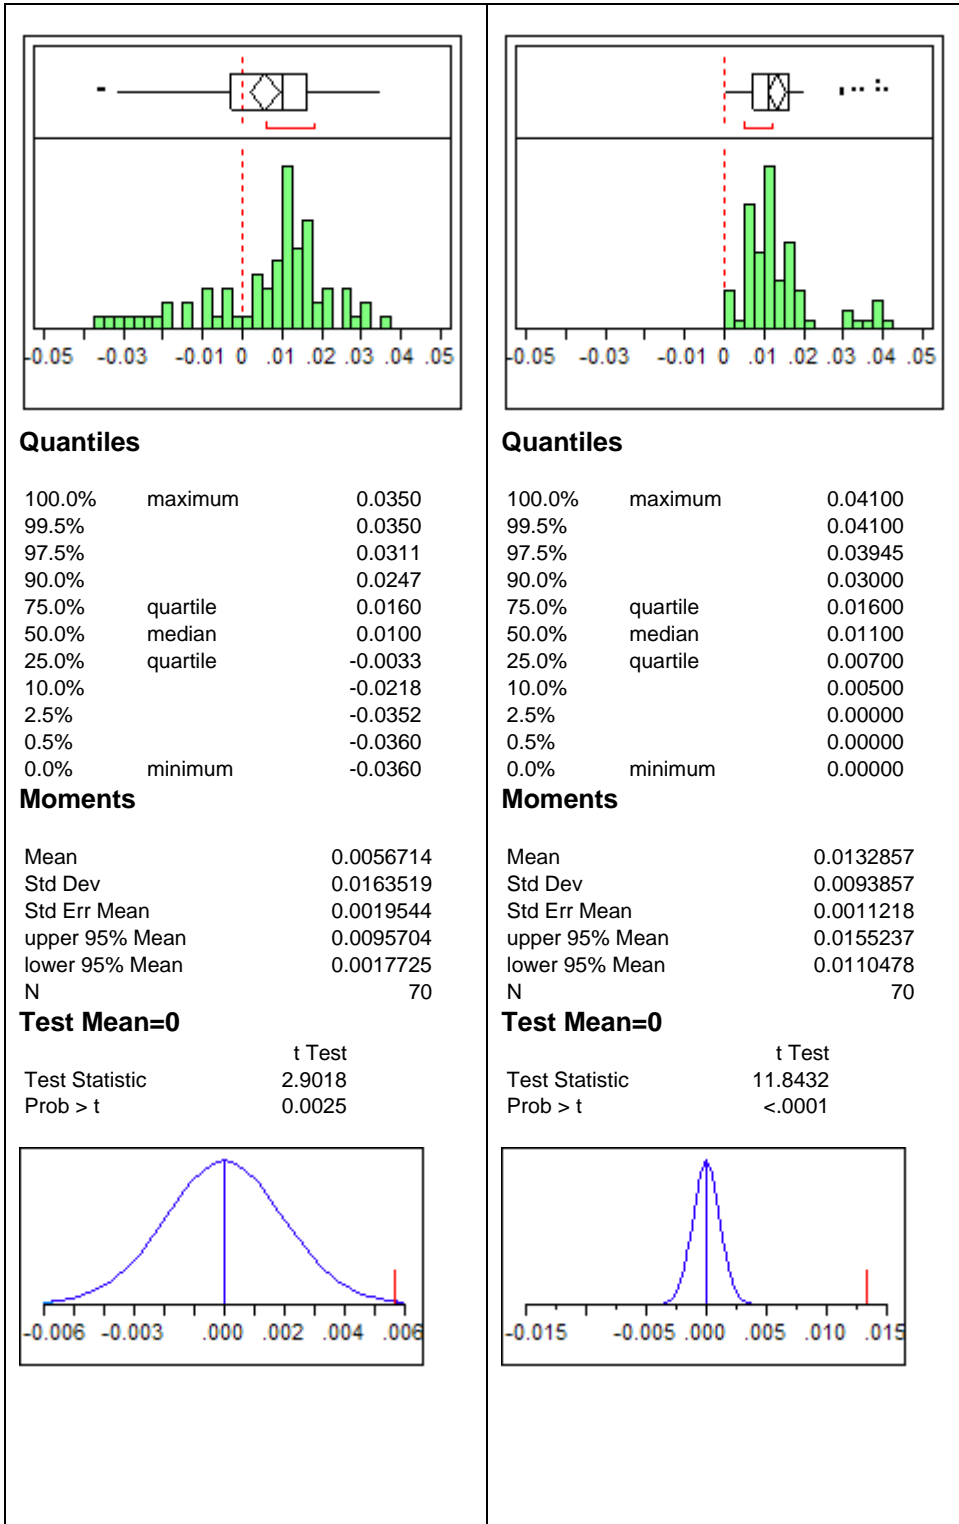
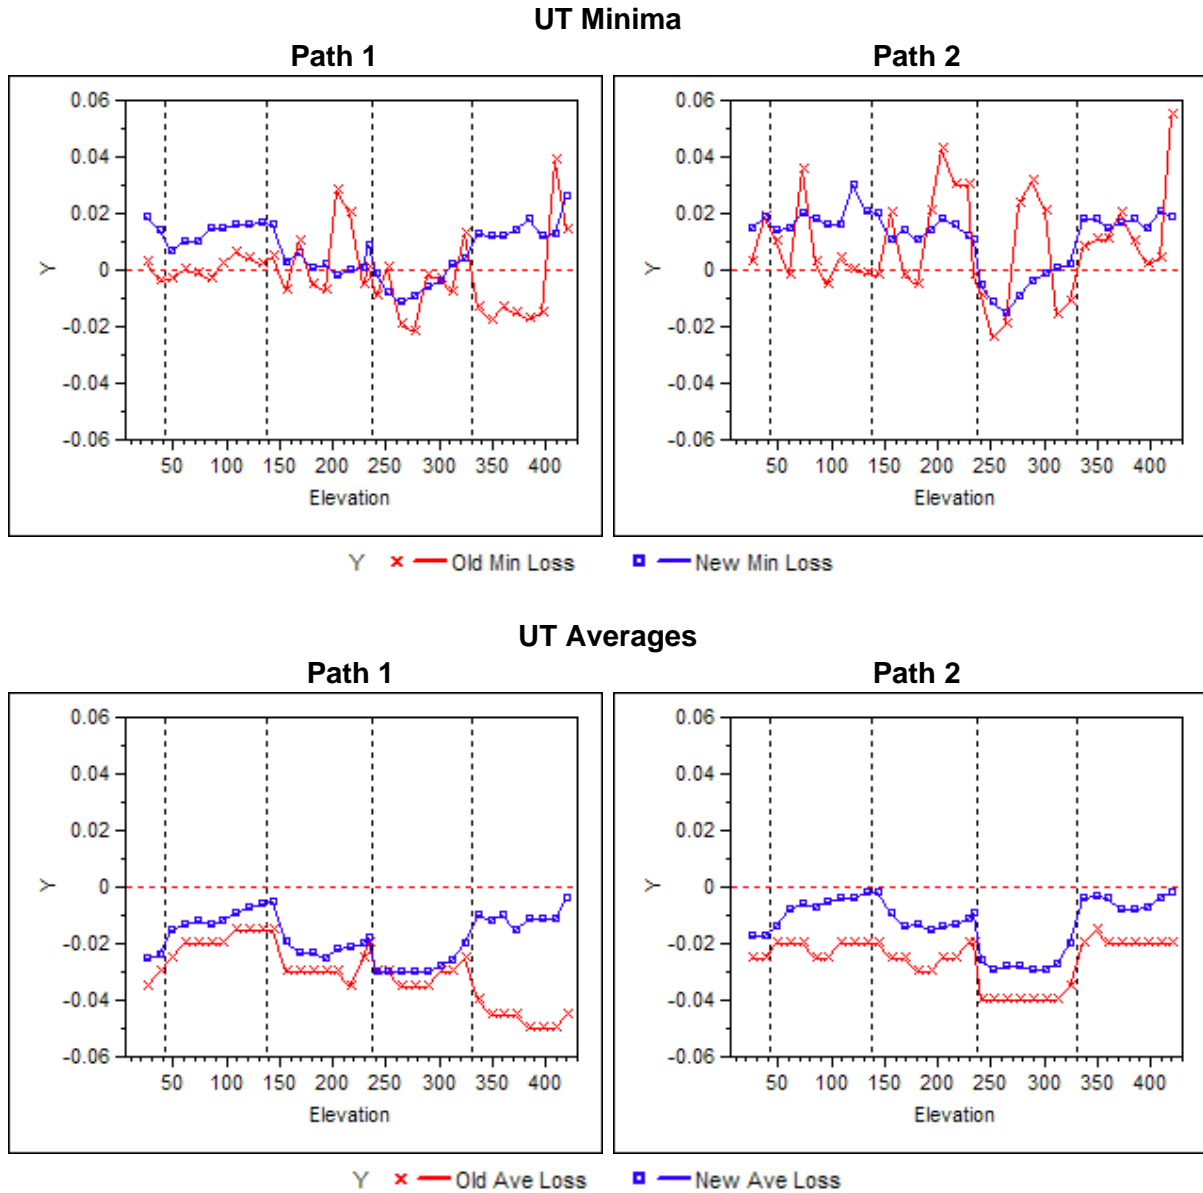
Figure 6.8. Year 2001 minus Year 2008 Differences

magnitudes of these changes between the year 2001 and 2008 measurements are relatively minimal to those that have been found for other tanks.

Figure 6.9. Year 2001 versus Year 2008 Measurement Paths

If the Path 1 / Plate #1 case is again removed, the difference between the 2001 and 2008 results are very close to halved for path 1 relative to those for path 2. This is especially evident in the average loss plots in the bottom of Figure 6.9. This is unlikely a real difference in corrosion effects in the adjacent paths due to their close proximity in the tank, but rather some type of measurement calibration issue instead.

Special studies of UT wall thickness measurement capability have been proposed that seek to identify the source of such systematic measurement errors so that it can be better controlled. This will better support comparisons of today's measurements with those taken in the future so that these UT inspections can be used to make meaningful studies of wall thickness corrosion.
