COAL ASH CORROSION RESISTANT MATERIALS TESTING

Topical Report: Removal of Section "C"

THE BABCOCK & WILCOX COMPANY

The “Coal Ash Corrosion Resistant Materials Testing Program” is being conducted by The Babcock & Wilcox Company (B&W), the U.S. Department of Energy (DOE) and the Ohio Coal Development Office (OCDO) at Reliant Energy’s Niles plant in Niles, Ohio to provide full-scale, in-situ testing of recently developed boiler superheater materials. Fireside corrosion is a key issue for improving efficiency of new coal fired power plants and improving service life in existing plants.

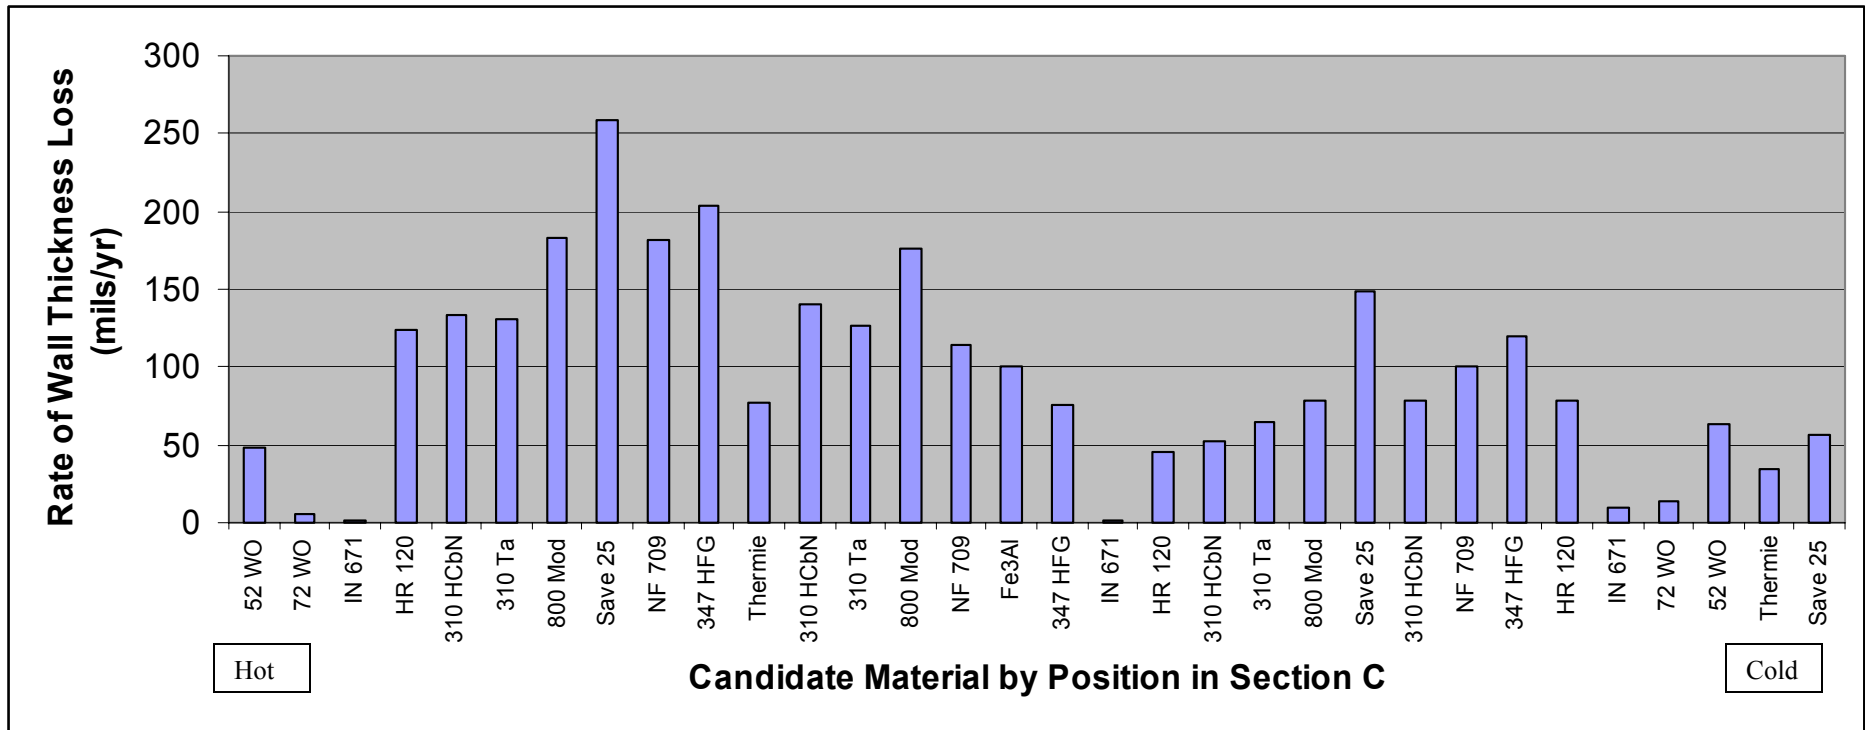
Figure 14: Maximum Wastage Rate as a Function of Position within Section C

*** The calculated rate is based solely on wall thickness measurements and does not take into account that corrosion had removed sufficient material to connect an underlying weld crack with the surface.

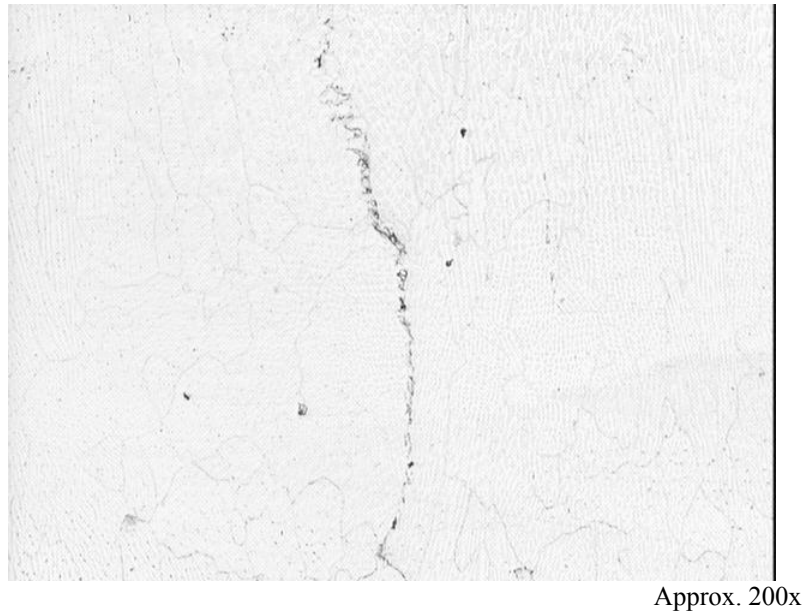
Figure 20: Internal Cracking in 72 Weld Overlay Archive Material

cracking phenomenon that may impact its service life. Preliminary investigations suggest that the cladding may have contained small, and difficult to detect, internal cracks prior to service exposure. Preliminary investigations also suggest that the extent of cracking within the IN 72 Weld Overlay may increase in quantity and in length as a function of time at temperature. This issue however has not yet been fully resolved. So, at this point, for the sake of comparison, the data illustrated in the charts above only take corrosion wastage into account. If the wall thickness lost due to the observed cracking had been included in the wastage rate calculations, then the wastage rate would have increased by about 50%. However, if this additional 50% were taken into account, the total wall thickness lost for the IN 72 Weld Overlay still would be small relative to some of the other materials. Nonetheless, it must be remembered that the IN 72 Weld Overlay samples initially had only 80 mils of cladding to act as a corrosion barrier. Once the cladding is breached, as was noted for the IN 52 Weld Overlay, the wastage rate is expected to increase considerably.

Of particular concern regarding the damage found in IN 72 Weld Overlay, is the fact that, while these samples are in service, the surface deposit and scale may hide the fact that the underlying metal is not sound. The extent of damage is normally monitored by visual inspection and dimensional measurements in situ within the boiler without disturbing the surface condition of the tubes. If the cladding is breached by a cracking mechanism, and the underlying metal is corroding away beneath the cladding, then, this condition may not be discernable by standard inspection methods. Obviously, this could lead to a false sense of security regarding the soundness of a test section. Given this concern, the otherwise good corrosion resistance of this material, and the usefulness of weld cladding as an inexpensive means of achieving this corrosion resistance, suggests that elimination of this cracking is an area worthy of further study.

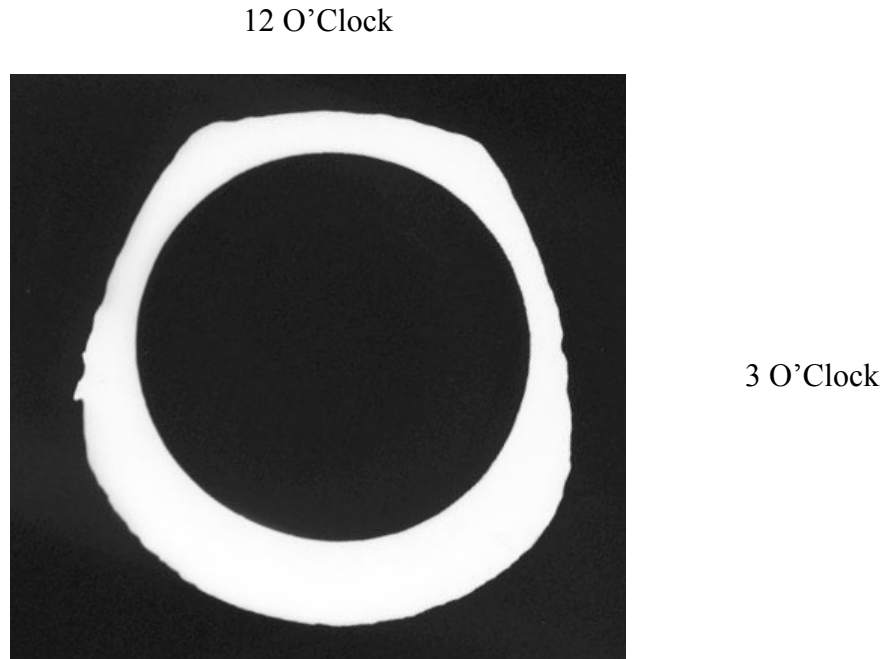
Material: NF 709
Sample Location: C-D
Maximum Rate: 114 mils/yr
Maximum Loss Orientation: Approx. 2:30 o'clock
Average metal Temperature: 1153 F

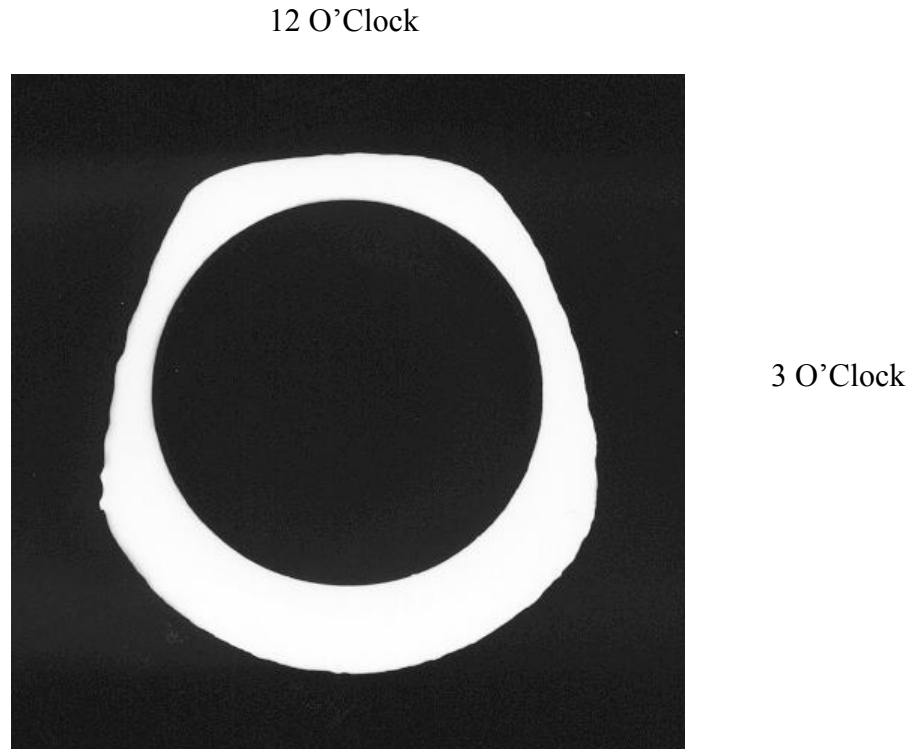
Material: NF 709
Sample Location: BB-CC
Maximum Rate: 100 mils/yr
Maximum Loss Orientation: Approx. 9:30 o'clock
Average metal Temperature: 1088 F

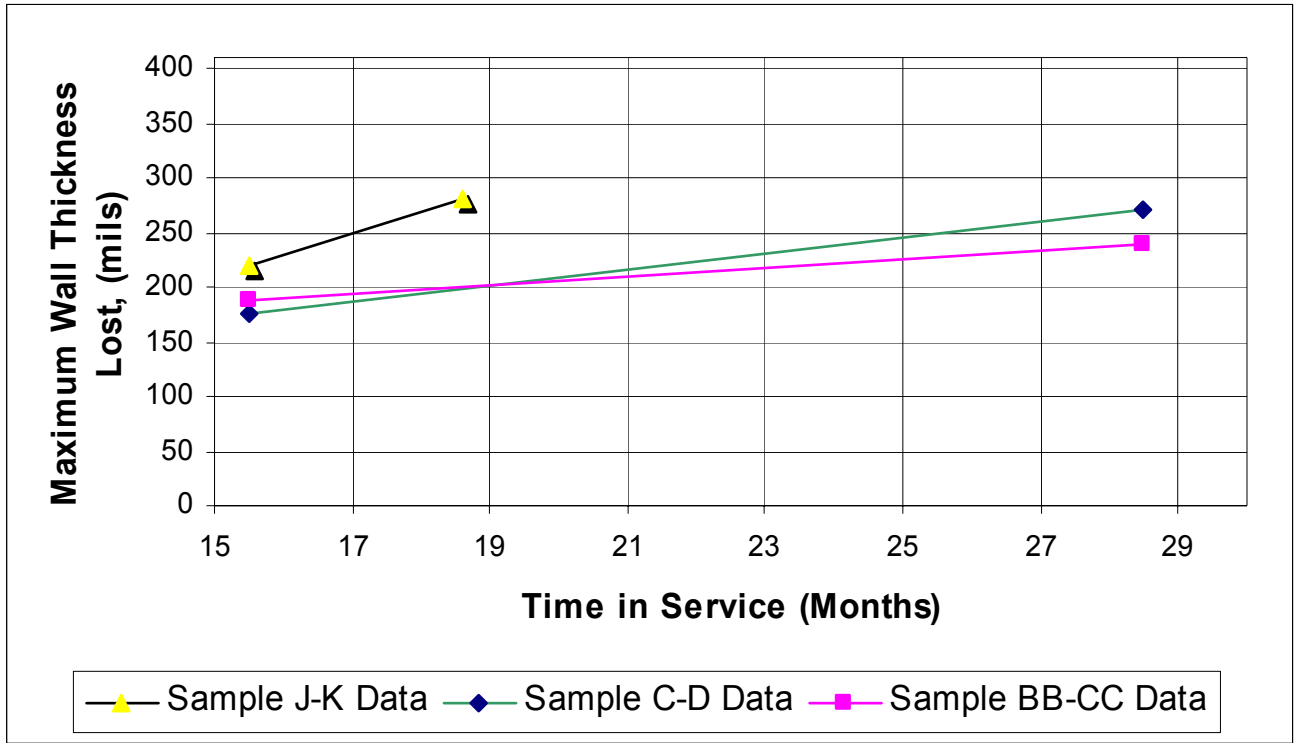
Figure B-14: Metal Loss as a Function of Time

Note: In analyzing these data it is important to understand that the one of the three Section C samples was removed early due to excessive corrosion losses. Sample J-K (1178 F) was removed in November 2001, shortly after Section A was removed for analysis. Sample C-D (1153 F) and Sample BB-CC (1088 F) were removed with the remaining Section C samples in May 2003.

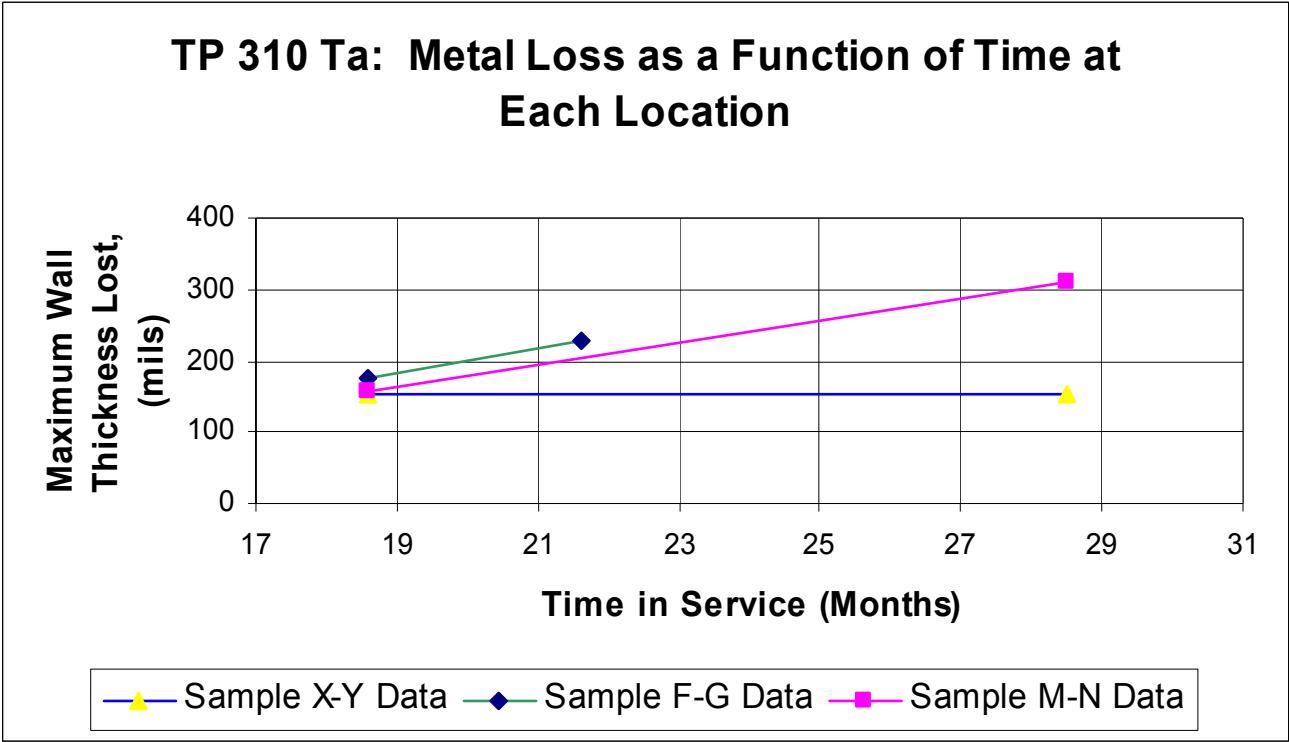
Figure F-13: Metal Loss as a Function of Time

Note: In analyzing these data it is important to understand that the one of the three Section C samples was removed early due to excessive corrosion losses. Sample F-G (1166 F) was removed in June 2002. Sample M-N (1188 F) and Sample X-Y (1103 F) were removed with the remaining Section C samples in May 2003.

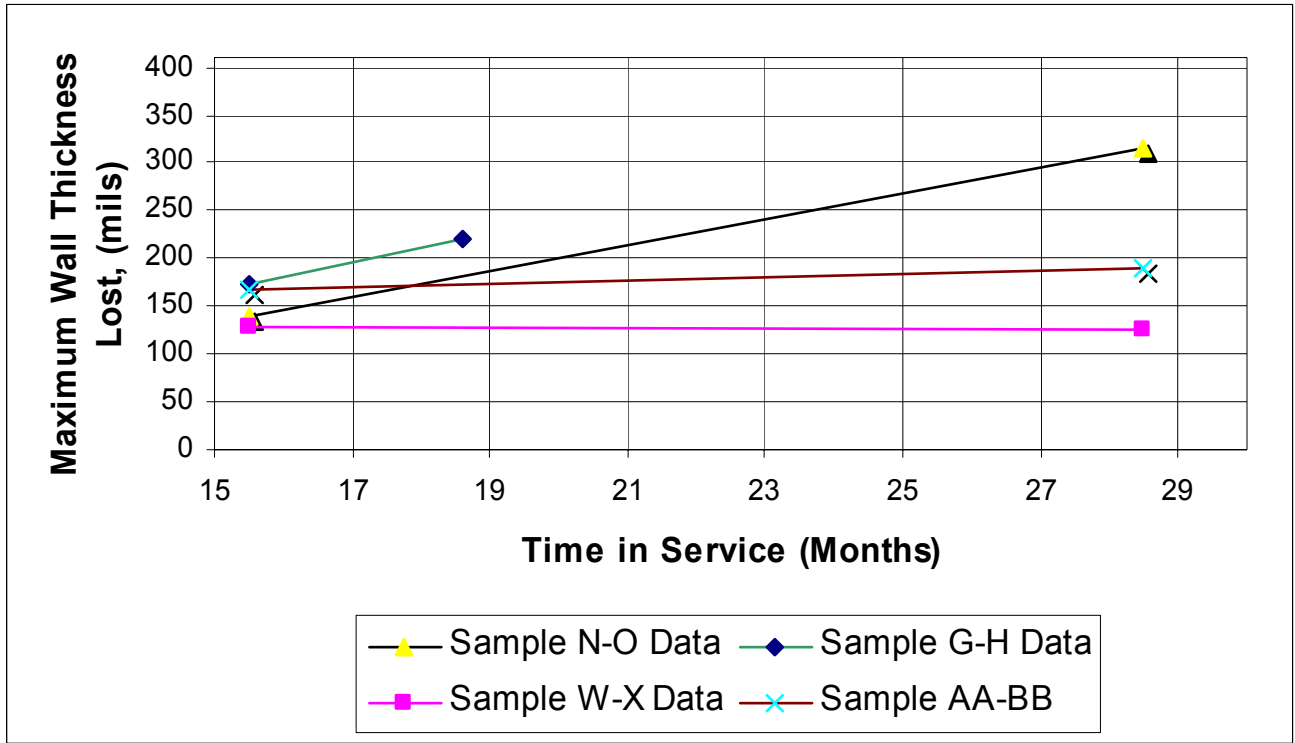
Figure G-17: Metal Loss as a Function of Time

Note: In analyzing these data it is important to understand that the one of the three Section C samples was removed early due to excessive corrosion losses. Sample G-H (1167 F) was removed in November 2001, shortly after Section A was removed for evaluation. Sample N-O (1190 F), Sample W-X (1106 F), and Sample AA-BB (1092 F) were removed with the remaining Section C samples in May 2003.

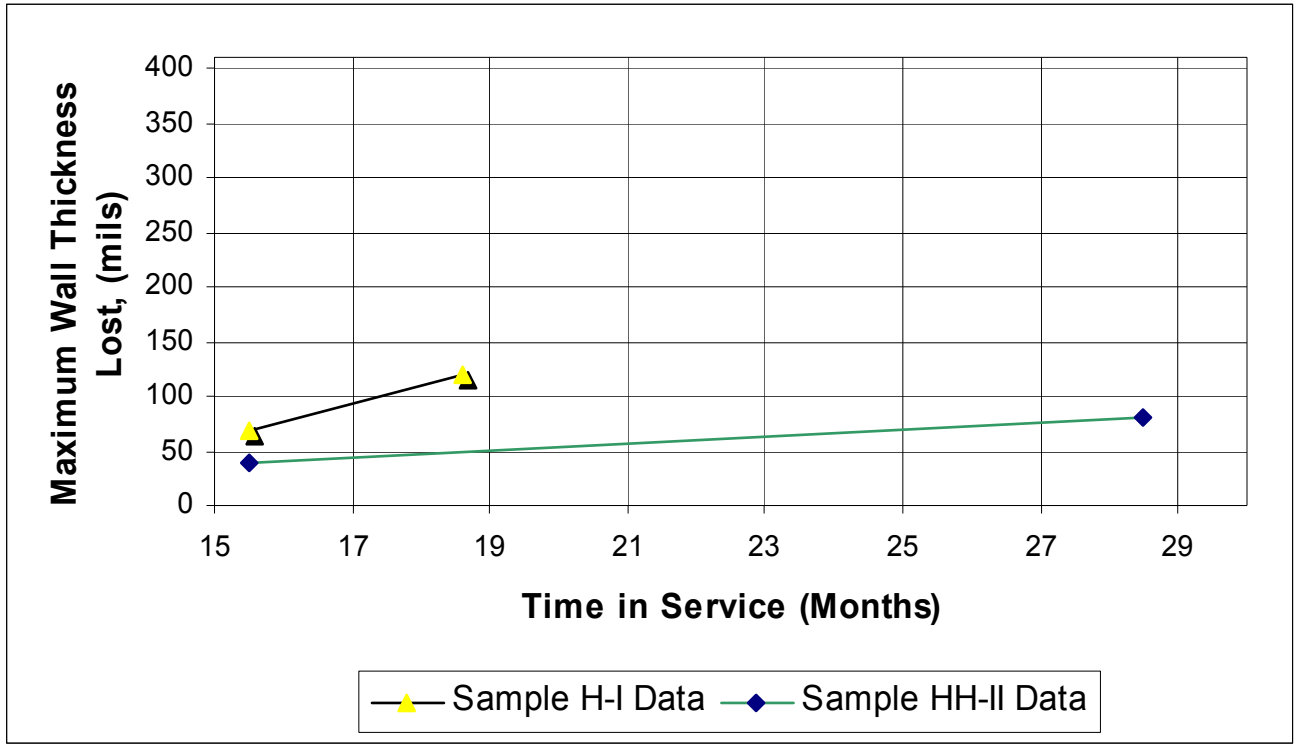
Figure I-10: Metal Loss as a Function of Time

Note: In analyzing these data it is important to understand that the one of the two Section C samples was removed early due to excessive corrosion losses. Sample H-I (1171 F) was removed in November 2001. Sample HH-II was removed with the remaining Section C samples in May 2003.
