**ARCHAEOLOGICAL INVESTIGATION OF THE SAN JUAN DAM,
41 BX 266, BEXAR COUNTY, TEXAS**

**Center for Archaeological Research
The University of Texas at San Antonio
Archaeological Survey Report, No. 179**

1989

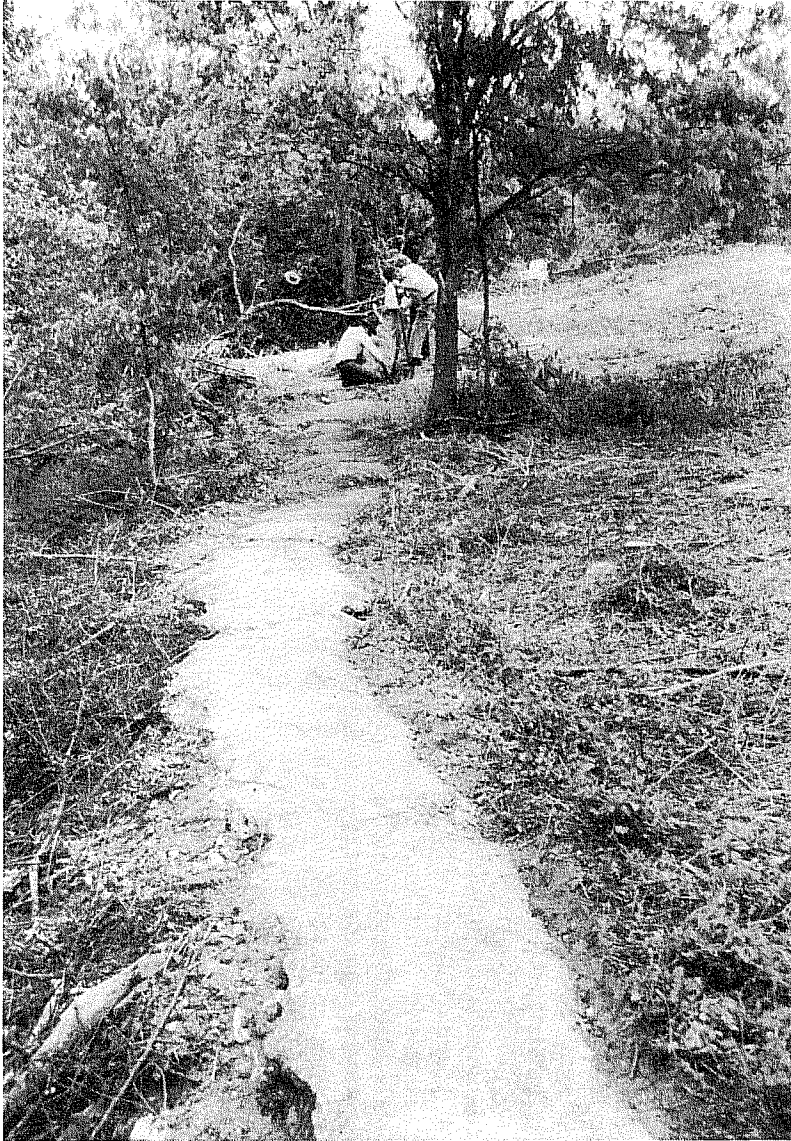
**a**

The first area exposed was the midsection of the dam. Trench 1 was located perpendicular to the dam structure and extended across the dam, exposing both sides of the structure. The upstream (eastern) face appears to be composed of river gravel and a caliche and lime mortar forming an early type of concrete. The top of the dam in this area has been capped with a modern cement (Fig. 2,a). Below (underneath) the modern cement cap the original dam can be seen. The western portion of this trench exposed the downstream (western) surface of the dam. With this portion cleared, it is possible to see that the modern concrete cap extends only six to eight inches below the top of the dam.

Figure 2. *Views of Excavations.* a, cement cap on dam looking south; b, end view of dam (Trench 5) showing construction.

The modern concrete cap that is present in Trenches 1, 2, and 6 appears to have been put on in an effort to preserve the original dam structure and prevent any additional deterioration. This modern work may have been done in conjunction with the improvements made in 1966 when the area became part of a park.

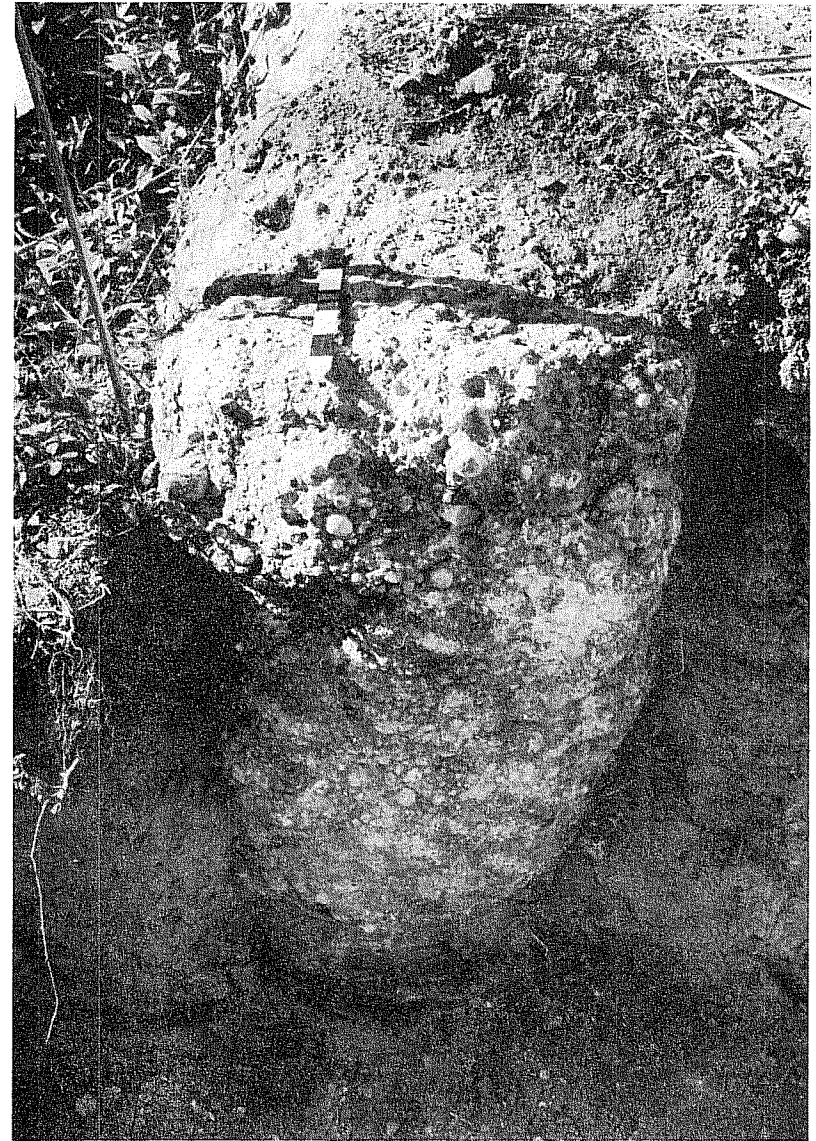
**b**

Trench 5 was located about 1 m to the south of Trench 4 and exposed the northern end of the original dam structure in its southern profile (Fig. 2,b). The soil deposits in this trench seem to differ somewhat from those of the first two trenches (Fig. 5). The first layer (A) in Trench 5 seems to be a continuation of the fill associated with the rechannelization of the river.

The original construction of the dam can be seen clearly from this trench. The front (upstream) side of the dam appears to have been straight, while the back (downstream) side seems to have sloped back from top to bottom. The material used in construction seems to have been the same as previously noted – a caliche and lime mortar with gravel forming an early type of concrete. The modern concrete cap visible in the first two trenches is not present in this profile.

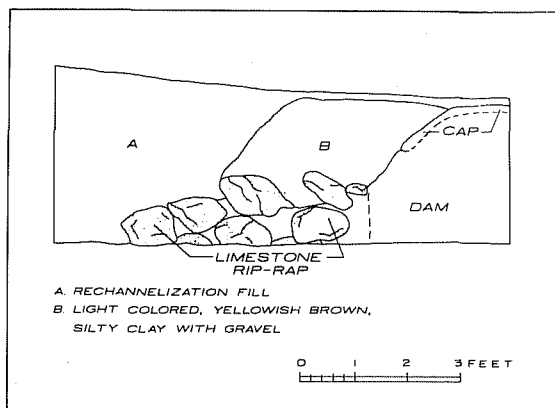
Figure 3. Trench 1, South Wall Profile.

The top of the dam currently lies two to four inches below the ground surface in Trench 1 (Fig. 3). At this point, below the ground surface, there is a distinct soil change. Above this point is a very dark gray brown clay (2.5Y 3/2) with large gravel. This soil deposit (A) is associated with the

rechanneling of the river that took place in the late 1950s. When the river was rechanneled and widened, the dirt that was removed was used to fill and raise this area. This deposit contained debris such as a plastic cigarette lighter, clear glass, screw top bottle fragments, shoe leather, and bricks. These are all artifacts that could have been deposited during the dredging of the river.

The soil layer (B) beneath is a light colored, yellowish brown silty clay (2.5Y 6/4) with some gravel. This layer appears to be associated with the overrun of the dam. Soil was carried downstream by the river and deposited in front of the dam. This soil continued to be deposited year after year causing this layer to be built up. Some of the artifacts found in this layer were ceramic sewer tile, fragments of a composition battery case, and clear glass.

A small lens (C) of a very compact, dark gray clay (10YR 3/1) was encountered next. Since there were no artifacts recovered from this deposit, and it did not appear to continue either north or south along the dam, it is difficult to be certain of the exact origin of this lens; however, it did appear to be sedimentary. It is possible that this lens is also associated with an earlier period of overrun of the dam. The lens is above a layer of large limestone boulders. The stones do not seem to be shaped and appear to be random in their placement, and also appear to be associated with the original construction of the dam. They form a foundation and rear rip-rap formation. These stones would have helped support the dam structure against the rushing water.

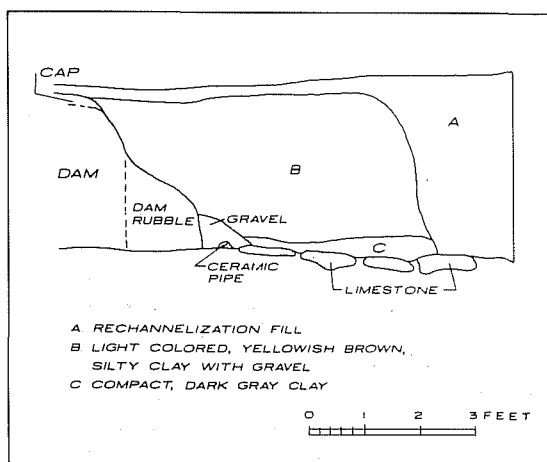
Figure 4. Trench 2, North Wall Profile.

the downstream (western) face of the dam (Fig.4). The dam structure and soil deposition here appear to be very similar to that in the first trench. The first two soil layers (A and B) are still present in this trench in very much the same configuration as in Trench 1. The third soil layer (C) in the first trench, however, does not seem to have continued this far south along the dam. Trench 2 does, however, provide a much better view of the limestone rip-rap support than does Trench 1. The modern concrete cap can also be clearly noted in this trench. Similar artifacts as noted in the first two layers of Trench 1 were also present in the corresponding layers of Trench 2.

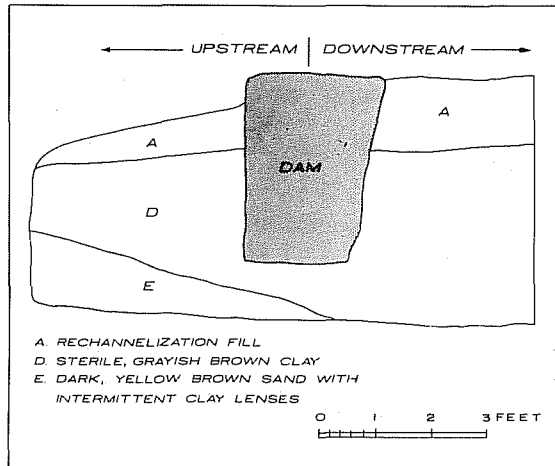
Figure 5. Trench 5, South Wall Profile.

Below this fill layer, however, is a thick layer (D) of sterile, grayish brown clay (10YR5/2). Since this clay is present on both sides of the dam and appears to be *in situ*, it is possible that when the dam was originally constructed it was cut down into this clay to provide additional support to the leading end of the dam. Below this thick layer (D) is dark, yellow brown sand (10YR 4/6) with several intermittent lenses of clay (E). This layer (E) is thought to represent the original riverbed in the channel. The intermittent lenses of sand and clay in this layer represent the periods of meandering and silting common to this part of the river. No artifacts were recovered from any of the layers in this trench, giving further support to the idea that layers D and E are intact soil deposits.

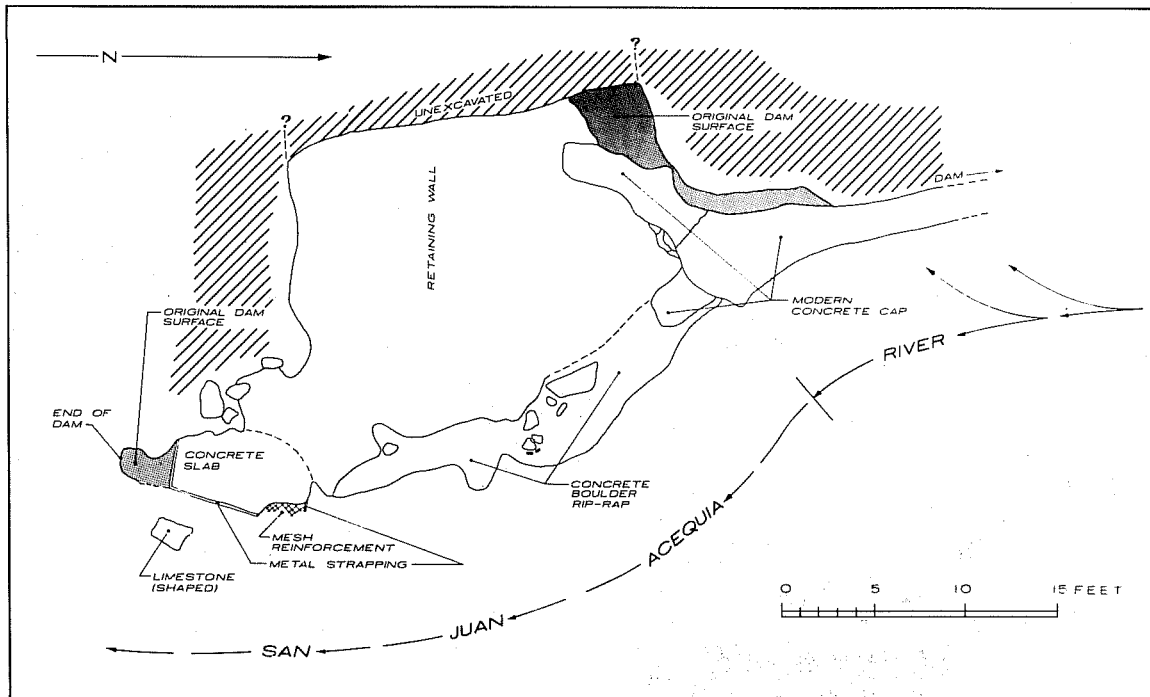
Figure 6. *Plan of Trench 6.*

Trench 6 was located approximately 20 m to the south of Trench 2 and exposed the southern end of the dam. This end of the dam varies a great deal more in its construction than the other areas previously exposed (Fig. 6). This section flared out to a much wider dimension than the rest of the dam. Partially exposed, it appeared that the end of the dam branched off in a westerly direction.

Modern support and reinforcement are obvious in this section of the dam. Along the eastern edge, a concrete boulder rip-rap is visible. Several of the concrete boulders still have imprints of the burlap bags in which they were formed. On the southern edge is a portion of a concrete slab with metal strapping and wire mesh reinforcement. The modern concrete cap that was noted in the first two trenches can be followed along the ground surface to the northern end of this area. All of the soil that overlies this end of the dam seems to resemble the fill associated with the rechannelization of the river.

The large formation partially exposed by Trench 6 appears to have been used as a retaining wall. This part of the structure was designed to make sure that all of the water coming over the dam was forced back into the river channel. It prevented the area between the acequia and the river channel from becoming a swamp. This also prevented the water from running around the south end and undercutting the dam, and kept the acequia and river from joining together below the dam.

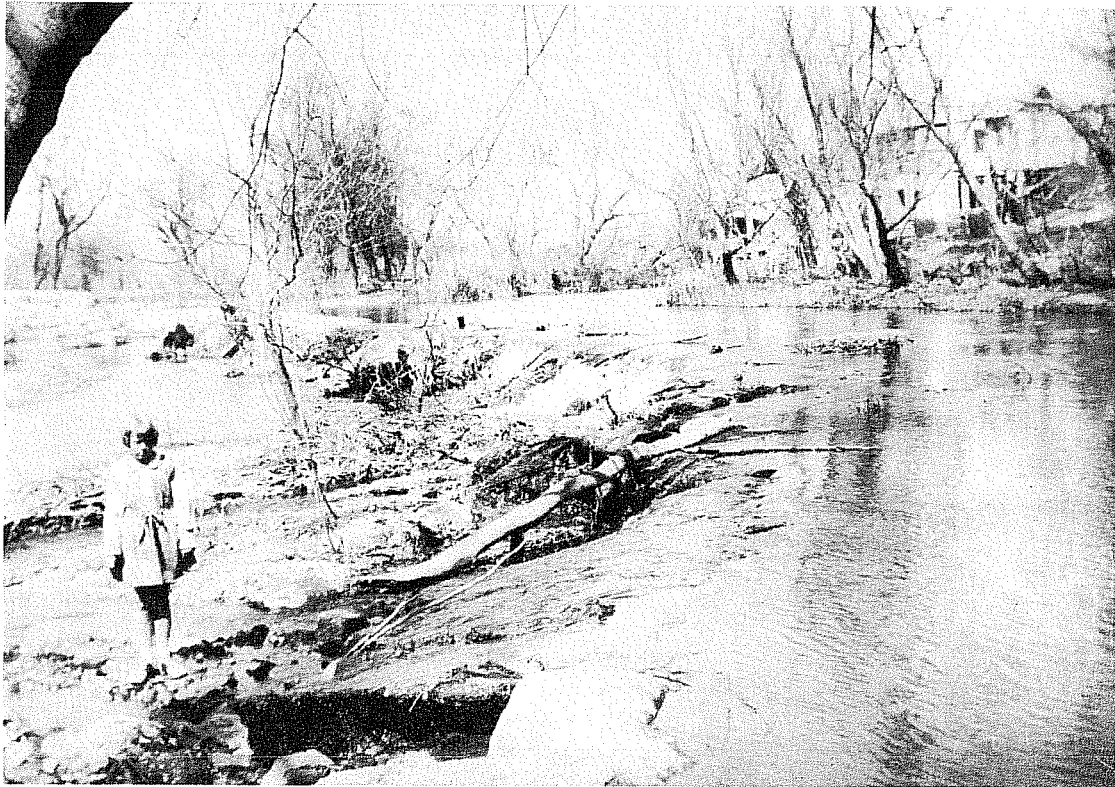
a

Figure 7. *Views of the San Juan Dam in 1940.* a, water flowing over the San Juan dam in 1940, looking north; b, looking south into the acequia from the same location, 1940. Photographs taken from the Schuchard collection at the Daughters of the Republic of Texas Research Library, The Alamo.

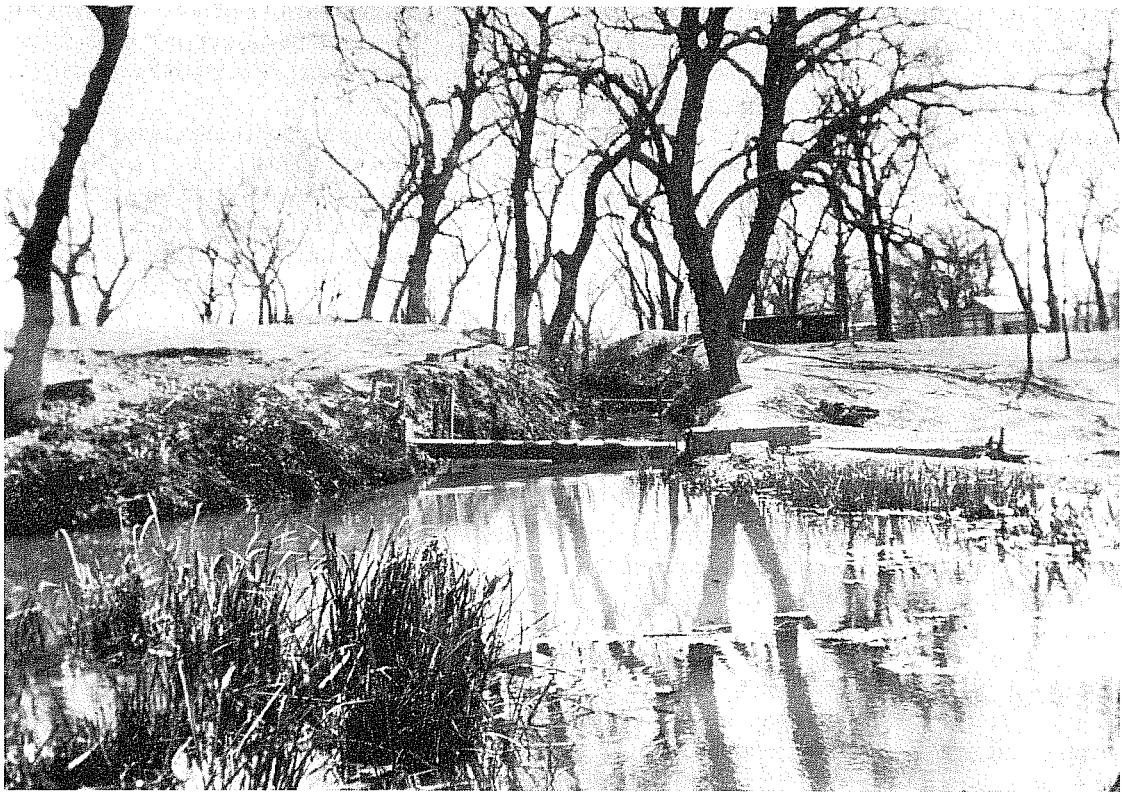
b

As it turns out, the area first thought to be part of the old river channel is actually the original route of the acequia. Heading southwest, from the dam structure, the river took a route to the south of the dam. The existing ditch to the southeast of the dam is actually the acequia. The dam structure was used to divert water from the San Antonio River into the acequia. Only when the water in the river was over the height of the dam was water put back into the river channel (Fig. 7,a). All of the water that was lower than the top of the dam was directed into the acequia (Fig. 7,b).
