§ 3. Balance Voltage of LHD Poloidal Coils

Takahata, K.

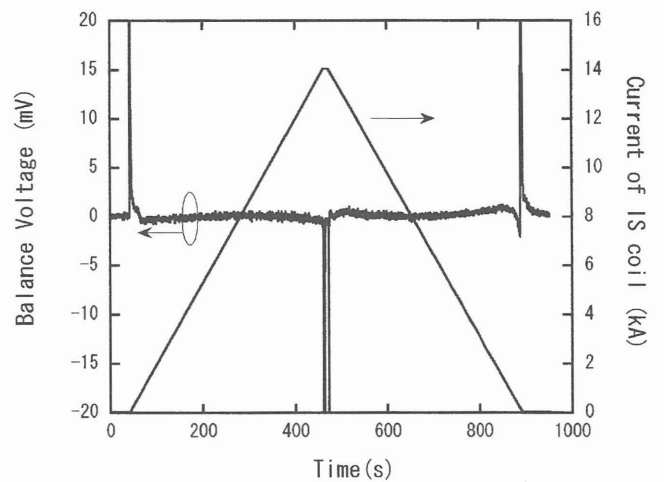
Initial adjustment was performed in the individual operation of the IS coils. The maximum current of the IS coils was 14 kA and the ramp rate was 33 A/s. The current of the OV coils, 4.6 kA, is required for reduction of stray field. The balance voltage after the initial adjustment is shown in Fig. 2. The voltage was well-balanced. Then, the balance voltage was monitored in the normal operation (Mode #1-d-a) with the current of the helical coil, 6 kA. Figure 2 shows the balance voltage of the IS coils. The off-balance voltage of 15 mV was observed. This indicates that the upper and lower IS coils differ from each other in the mutual inductance between the IS coil itself and the other coils.

Fig. 2. Balance voltage of the IS coils in the individual operation. (IV 50 A, IS 14000 A, OV -4600 A, HC 50 A, Sweep time 420 s)

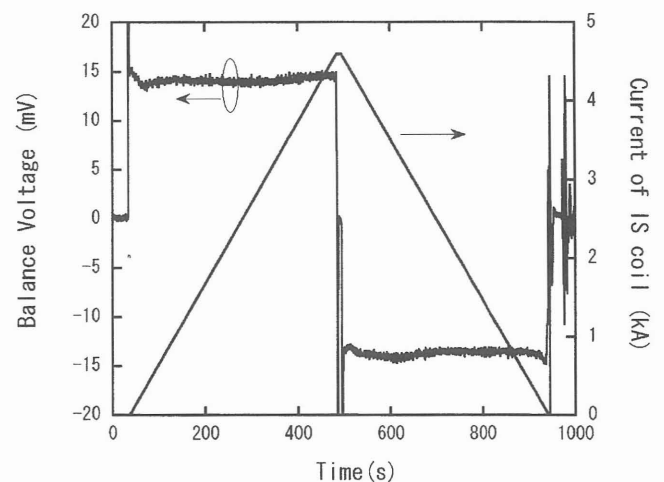
Errors of installation of the coils can cause the off-balance voltage. For instance, a vertical error of 1 mm only for the upper coil creates the off-balance voltage of 3 mV. The observed voltage of 15 mV corresponds to the error of 5 mm. However the error of 5 mm is not conceivable because the poloidal coils were installed within an error of 0.5 mm by using scribed lines.¹⁾ We must consider another cause in parallel with the installation error. The magnetization of structures and superconductors may cause the off-balance voltage.

Fig. 3. Balance voltage of the IS coils in the normal operation. (Mode #1-d-a 0% 1.5 T at 3.6 m, IV 4615 A, IS 3680 A, OV -11020 A, HC 6000 A, 0.2 T/min)

To investigate the cause of the off-balance, Hall probes were installed on the surface of the IS coils after the sixth experimental campaign. We then plan to measure the magnetic field accurately. The accuracy of 0.001 T is required to confirm the installation error of 5 mm. The effect of the magnetization can also be investigated by the observations of residual magnetization after operations.
