Electrical and Material Characterization of Field-aged 400 kV Silicone Rubber Composite Insulators

This paper presents the electrical and material characteristics of field-aged silicone rubber composite insulators, which have been deployed for 15 years on a 400 kV transmission line in a coastal region of the UK. There were no indications of reduced performance in service. Observations indicate non-uniform aging of the insulators on the different surfaces of the insulator sheds and core, along the insulator string length and in the different compass orientations. A uniquely large number of contact angle measurements, made on each of the insulators' different surfaces, confirm the visual aspect of non-uniform aging. Electrical investigations of the insulators have been performed in terms of leakage current analysis, ac flashover / withstand and switching-surge impulse flashover. A correlation is seen between the ac leakage current and the hydrophobicity measurements. Energy dispersive X-ray (EDX) and Fourier transform infrared spectroscopy (FTIR) analysis of the changes of the materials' surface chemistry is presented. The role of solar radiation and organic growth appears critical

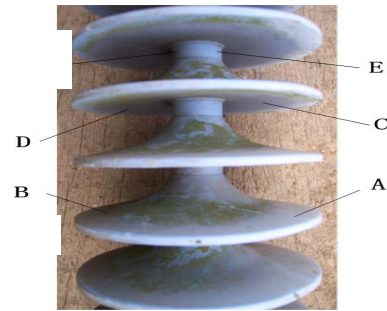
Figure 1. Visual aging observations are typified by regions A - E.

The bottom area near the high voltage (HV) end was covered by thicker contaminant than other areas along the string. The contaminant created a robust 'skin' on the original surface.

Visual observations indicate rotational asymmetry. Southern facing shed surfaces, (labeled A in Figure 1) which have been exposed to the sunlight, have become bleached, whilst northern facing surfaces, (labeled B and D in Figure 1) have a high degree of organic contamination on the surfaces. More obvious pollution layers are evident near HV and low voltage (LV) end-fittings. White rings (labeled C in Figure 1) on the outer bottom surfaces of sheds have been observed on several of the insulators. Discoloration of the insulator core (labeled E in Figure 1) has not occurred, however signs of a white residue are evident.

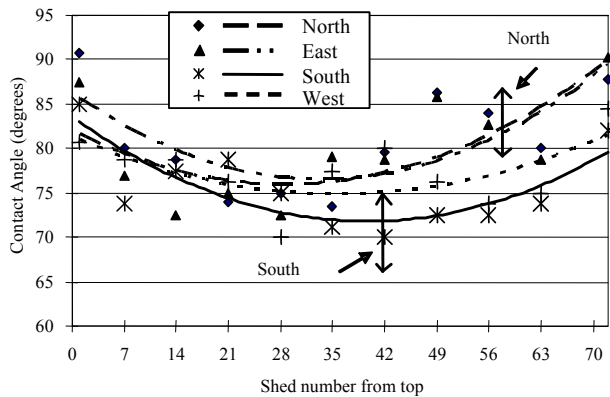
To assess the degree of hydrophobicity on the different insulator surfaces, contact angle measurements were carried out on all 18 strings. Measurements were made on 11 of the 72 sheds evenly distributed along the strings. For each shed, measurements were made on both the bottom and top surfaces in the four compass orientations. Contact angle analysis was performed with the insulator in a vertical orientation (upside down for the bottom surfaces). The receding angle of inclination of the top and bottom surfaces of the sheds were determined to be 10.6° and 7.4° respectively. Figures 2 and 3 show the average contact angle on the top and bottom shed surfaces along the insulator strings, respectively. The lines in these figures represent best fit second order polynomials. The arrows indicate the typical spread of results (max and min) around the average values plotted. These figures illustrate lower contact angle measurements on the exposed southern top and bottom surfaces of the insulator sheds than on northern facing surfaces. Shed surfaces in the mid-section of the string also indicated lower contact angles than the sections near the LV and HV ends.

Comparing top and bottom shed surfaces, the lowest hydrophobicity values measured were on the southern-facing shed top surfaces. This is indicative of a greater degree of aging on the top surfaces of the sheds. The highest values of contact angles were seen at the bottom, north-facing, HV end of the string, and associated with

Figure 2. Average contact angle on the top surface along the strings.

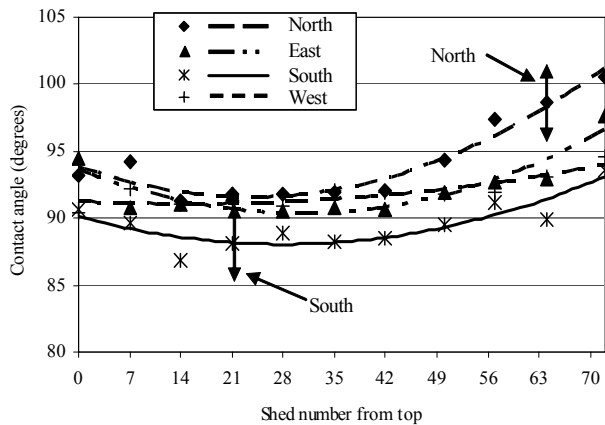
Figure 3. Average contact angle on the bottom surface along the strings

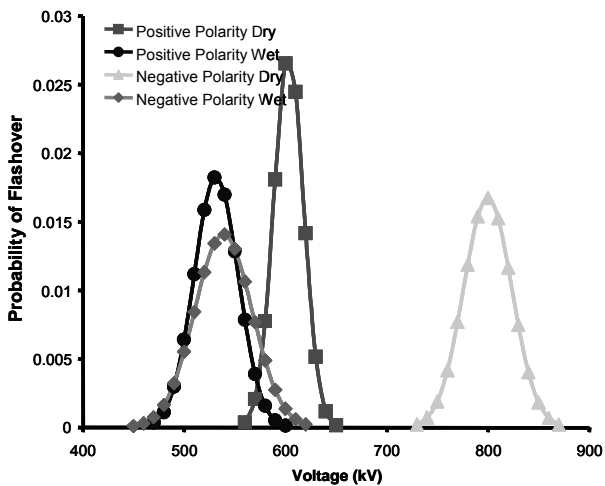
For field-aged insulators, however, the positive and negative polarity impulse flashover voltages under wet conditions are approximately the same, due to a significant percentage drop in the negative polarity impulse level. The probability distribution of the V_{50} impulse flashover levels for aged insulator string sections is shown in Figure 6. Comparing Figures 5 and 6, the main change with aging can be seen to be the decrease of negative polarity flashover voltages, to the level of positive polarity values. As shown in Table 1, the ratio of the difference in negative and positive wet impulse values over the difference in negative and positive dry impulse values become markedly reduced after aging.

Figure 6. Statistical variation in impulse flashover levels for field-aged insulators.

For the field-aged insulators, the absence of any difference between the positive and negative polarity impulse level may be attributed to the loss in hydrophobicity of the material surface. It follows that flashover is due to conduction through a continuous water path, rather than through the air. No correlation between the hydrophobicity measurements and the distribution of impulse flashover levels could be determined with the location of the tests along the string (i.e. the top middle or bottom $\frac{1}{3}$).

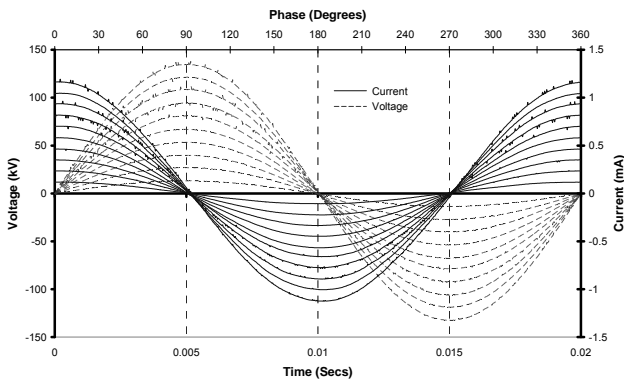
Figure 7 shows voltage and current waveforms for a field-aged insulator mid-1/3 section, under dry test conditions. From this figure, it is apparent that the insulator presents a capacitive load, with about a 90° phase shift between the current and voltage waveforms. The magnitude of the currents is determined both from the capacitive load of the insulator and also from stray capacitively coupled currents from supporting frameworks. Similar

Figure 7. Current and voltage for a field-aged insulator section under dry test conditions.

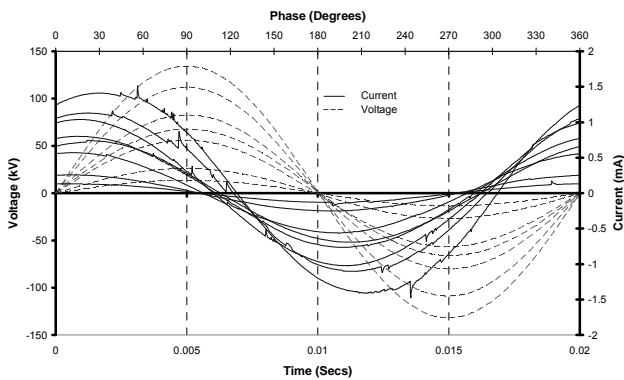
Figure 9. Current and voltage for a field-aged insulator top-1/3 section under wet test conditions.

Figure 9 shows a top-1/3 section of a field-aged string, tested under wet conditions, and indicates that at low voltages, the current waveform is about 90 degrees out of phase with the voltage waveform. However, at voltages higher than 30 kV, a phase shift in the current waveform is evident, with a small degree of harmonic distortion. The magnitudes of the currents, however, are similar to those which were observed for the new insulator string.

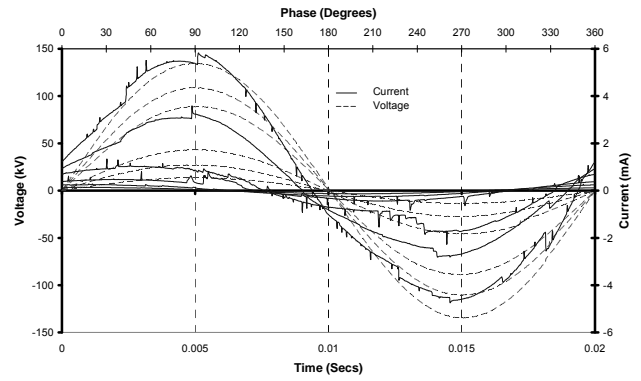
Figure 10. Current and voltage for a field-aged insulator mid-1/3 section under wet test conditions.

Figure 10 shows the voltage and current waveforms for a mid-1/3 section of a field-aged insulator string, tested under wet conditions. In this section, it is evident that higher active currents (i.e. currents in-phase with the voltage) are flowing across the surface of the insulator string. At very low voltages, of around 10 kV the current waveform is approximately 60° out of phase with the voltage waveform. As the voltage is increased, the phase difference between the current and voltage waveform is decreased and the magnitude of the current increases non-linearly. At a voltage of 100 kV the magnitude of the current flowing across the surface of the insulator is approximately 2.5 times the magnitude of the current of either the top or bottom-sections of the field-aged insulator. Erratic harmonic distortions to the current waveform are also present indicating that the current flow is not constant and some form of dry-band arcing process is taking place.

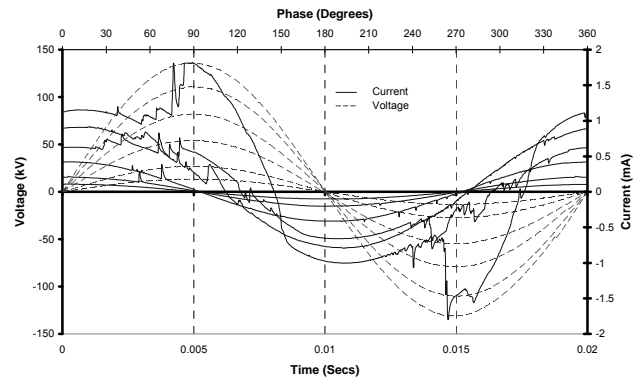
Figure 11. Current and voltage for a field-aged insulator bottom-1/3 section under wet test conditions.

Figure 11 shows the current and voltage waveforms of a bottom-1/3 section of a field-aged insulator string. Similar to the top section, the current waveforms are approximately 90° out of phase with the voltage waveforms at low voltages of up to 30 kV, with a small phase shift at voltages above 30 kV. Harmonic distortions to the current waveforms, associated with arcing, are present at voltages of 30 kV and above, the degree of which increase as the voltage is increased. The magnitude of the currents are again similar to that of a new insulator string.
