Damage Assessment and Refurbishment of Steam Turbine Blade/Rotor Attachment Holes

D G Hattingh ^{*1}, M N James ^{*1,2}, M Newby ³, R Scheepers ³ and P Doubell ³

³ Eskom Holdings SOC Ltd,
Rosherville Johannesburg, SOUTH AFRICA
newbym@eskom.co.za

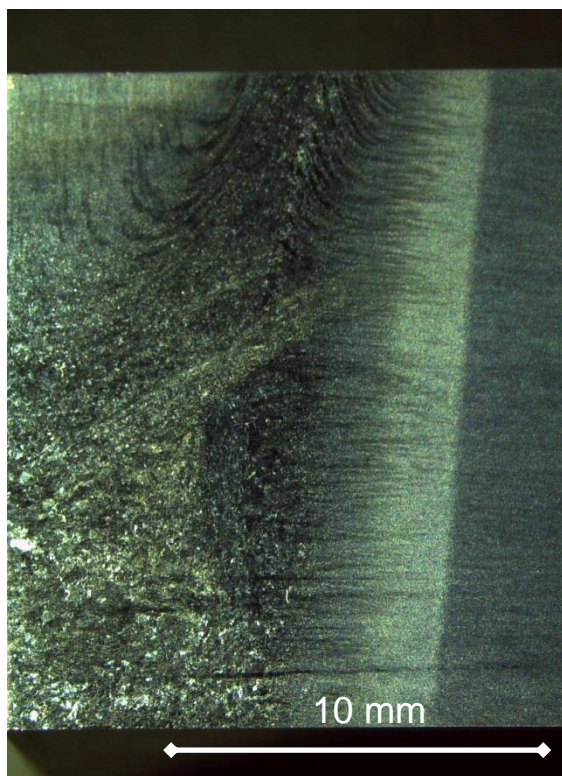
FHPP leads to relatively complex macrostructures as shown in Figure 10 for the W2 (as-welded, undrilled) specimen that shows approximately half of the FHPP weld zone. The flow lines are indicative of the mixed forging and rotation nature of the process and Figures 11 and 12 give typical micrographs of the HAZ and tool core regions in W2 (as-welded) while Figure 13 demonstrates that PWHT produces a microstructure similar to that observed in the parent plate and hence the microhardness values would also be expected to be similar. Microstructures appear to be very similar in the two Cartesian coordinate directions in which hardness and residual stress measurements were made (z and x - see Figure 14). Measurements were made in these two directions at three depths below the top surface – 3 mm, 9 mm (mid-depth) and 15 mm. Figure 15 shows mid-depth Vickers hardness data in both coordinate directions for all specimens measured under a 500 gf load. Only slight differences are apparent in the hardness values between the two directions or between the two as-welded (W2 and W3) or the two PWHT (W4 and W5) specimens. As would be expected the as-welded specimens (W2 and W3) show a much higher hardness value (by some 200 H_v) than those that were subject to PWHT (W4 and W5). These high values extend out to the edge of the TMAZ at around 10 mm from the centreline of the specimens, when hardness values drop sharply to those representative of the parent steel (\approx 280-300 H_v). Hardness values in W4 and W5 remain fairly constant at around 300 H_v in the x-direction and drop slightly from the weld zone to the parent steel in the z-direction.

Figure 10 Macrograph of specimen W2, as-welded and undrilled

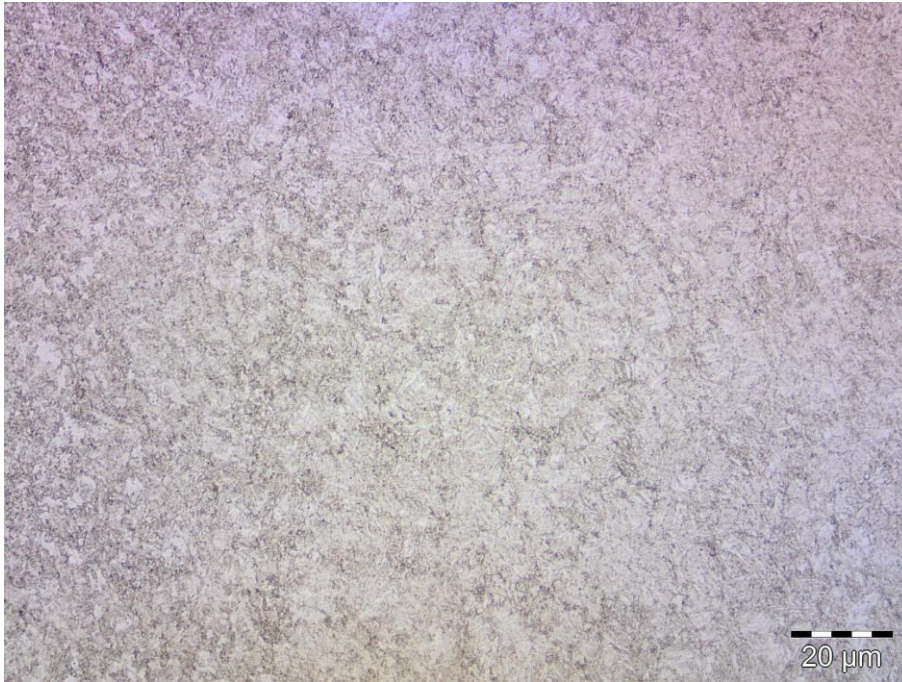
Figure 11 HAZ region in specimen W2; the microstructure is little changed from the parent plate and hardness values in the two regions would be expected to be similar.

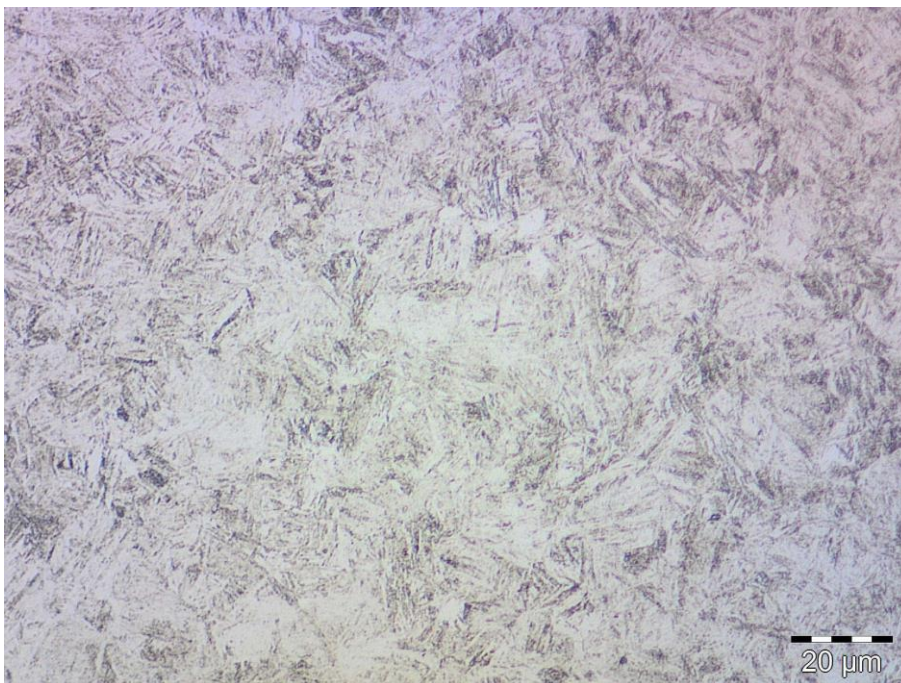
Figure 12 Tool core zone in specimen W2; the micrograph shows evidence of a fast cooling rate and hence a higher hardness than the parent plate.

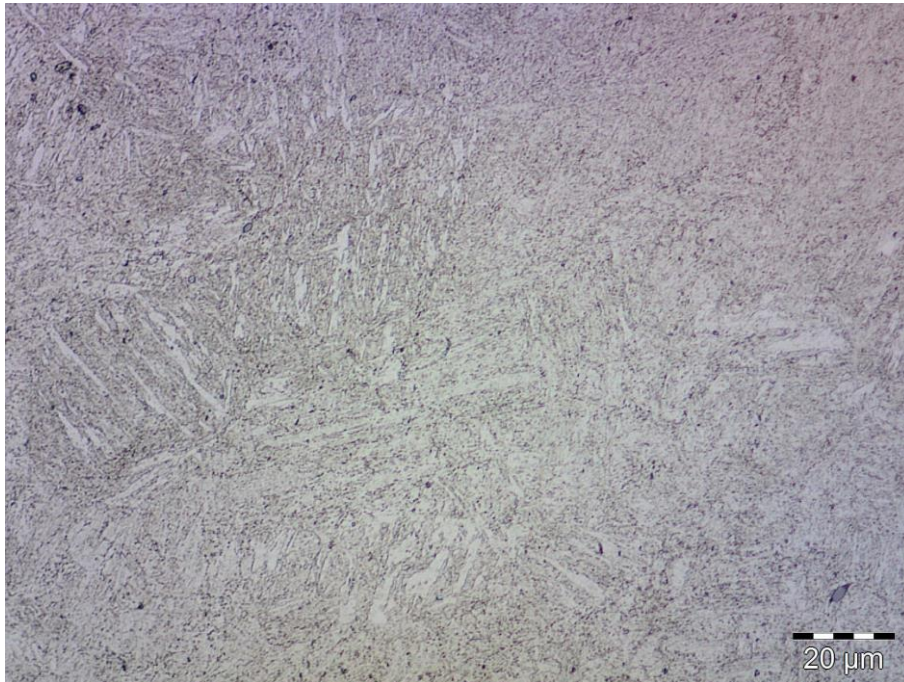
Figure 13 Tool core region in specimen W4 after PWHT at 680°C; there is little discernible difference between this microstructure and the parent plate.

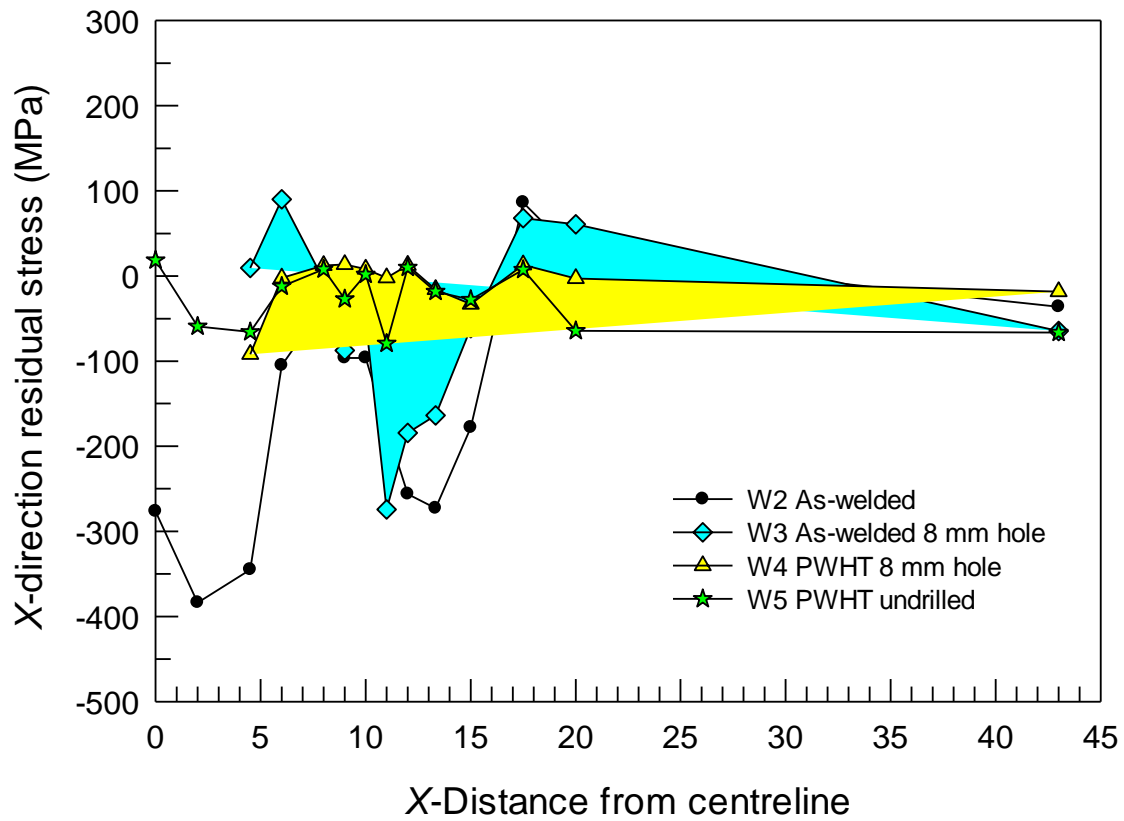
The calculated residual stress values for all three coordinate directions are given in Figure 17 for the various measurement positions in the x -direction. The key coordinate directions for crack initiation and growth are x and z and the data show that the PWHT process is very effective in relaxing the substantial residual stress peaks in the weld zone. Reductions are achieved in the x -direction stress (Figure 17a) from peak values around -380 MPa near the HAZ boundary in specimens W2 and W3 to values below 100 MPa at similar positions in specimens W4 and W5. In the case of the z -direction stresses (Figure 17b) the reduction is even more marked, from peak tensile values of circa 500 MPa in W2 and W3 to values close to zero in W4 and W5. It is also apparent that drilling an 8 mm diameter hole in the as-welded specimen leads to a positive residual stress near the edge of the hole in the x -

direction (Figure 17a - W3). PWHT of a specimen with an 8 mm hole substantially decreases the magnitude of the residual stress at all positions (W4).

Figure 17a Mid-depth residual stress ($y = 9$ mm) in the x -coordinate direction for all specimens.

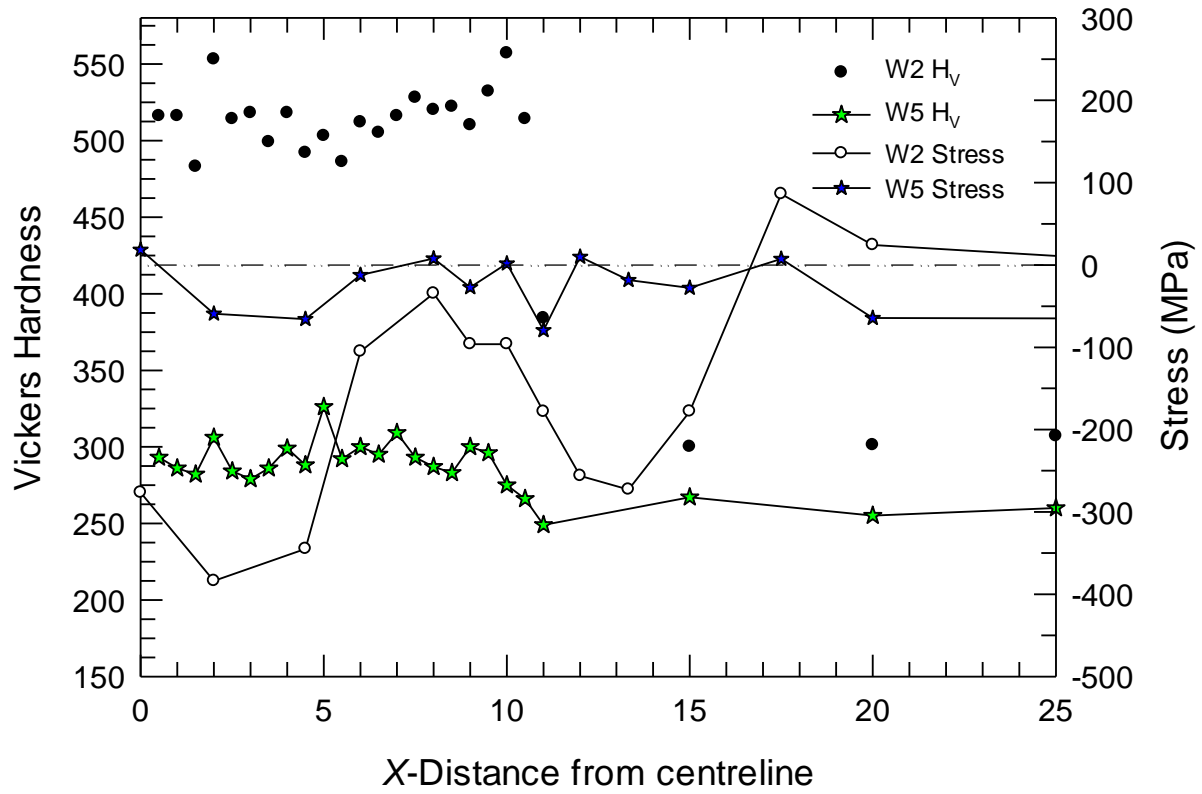
Figure 19 shows a comparison between hardness and *x*-coordinate direction stress at the mid-depth in W2 (as-welded) and W5 (undrilled PWHT). It shows that whilst in W2 there is a reasonable correlation between the extent of high hardness (≈ 15 mm) and the zone of high residual stress values, there is no direct comparison between the various peaks in hardness and residual stress. The zone of slightly elevated hardness values in W5 does not appear to be reflected in elevated residual stress values over the same region.

Figure 19 Comparison between mid-depth hardness and x-coordinate direction stress in W2 (as-welded) and W5 (undrilled PWHT).
