# Forensic Engineering

## Geotechnical case studies: emphasis on collapsible soil cases

### **Geotechnical case studies: emphasis on collapsible soil cases**

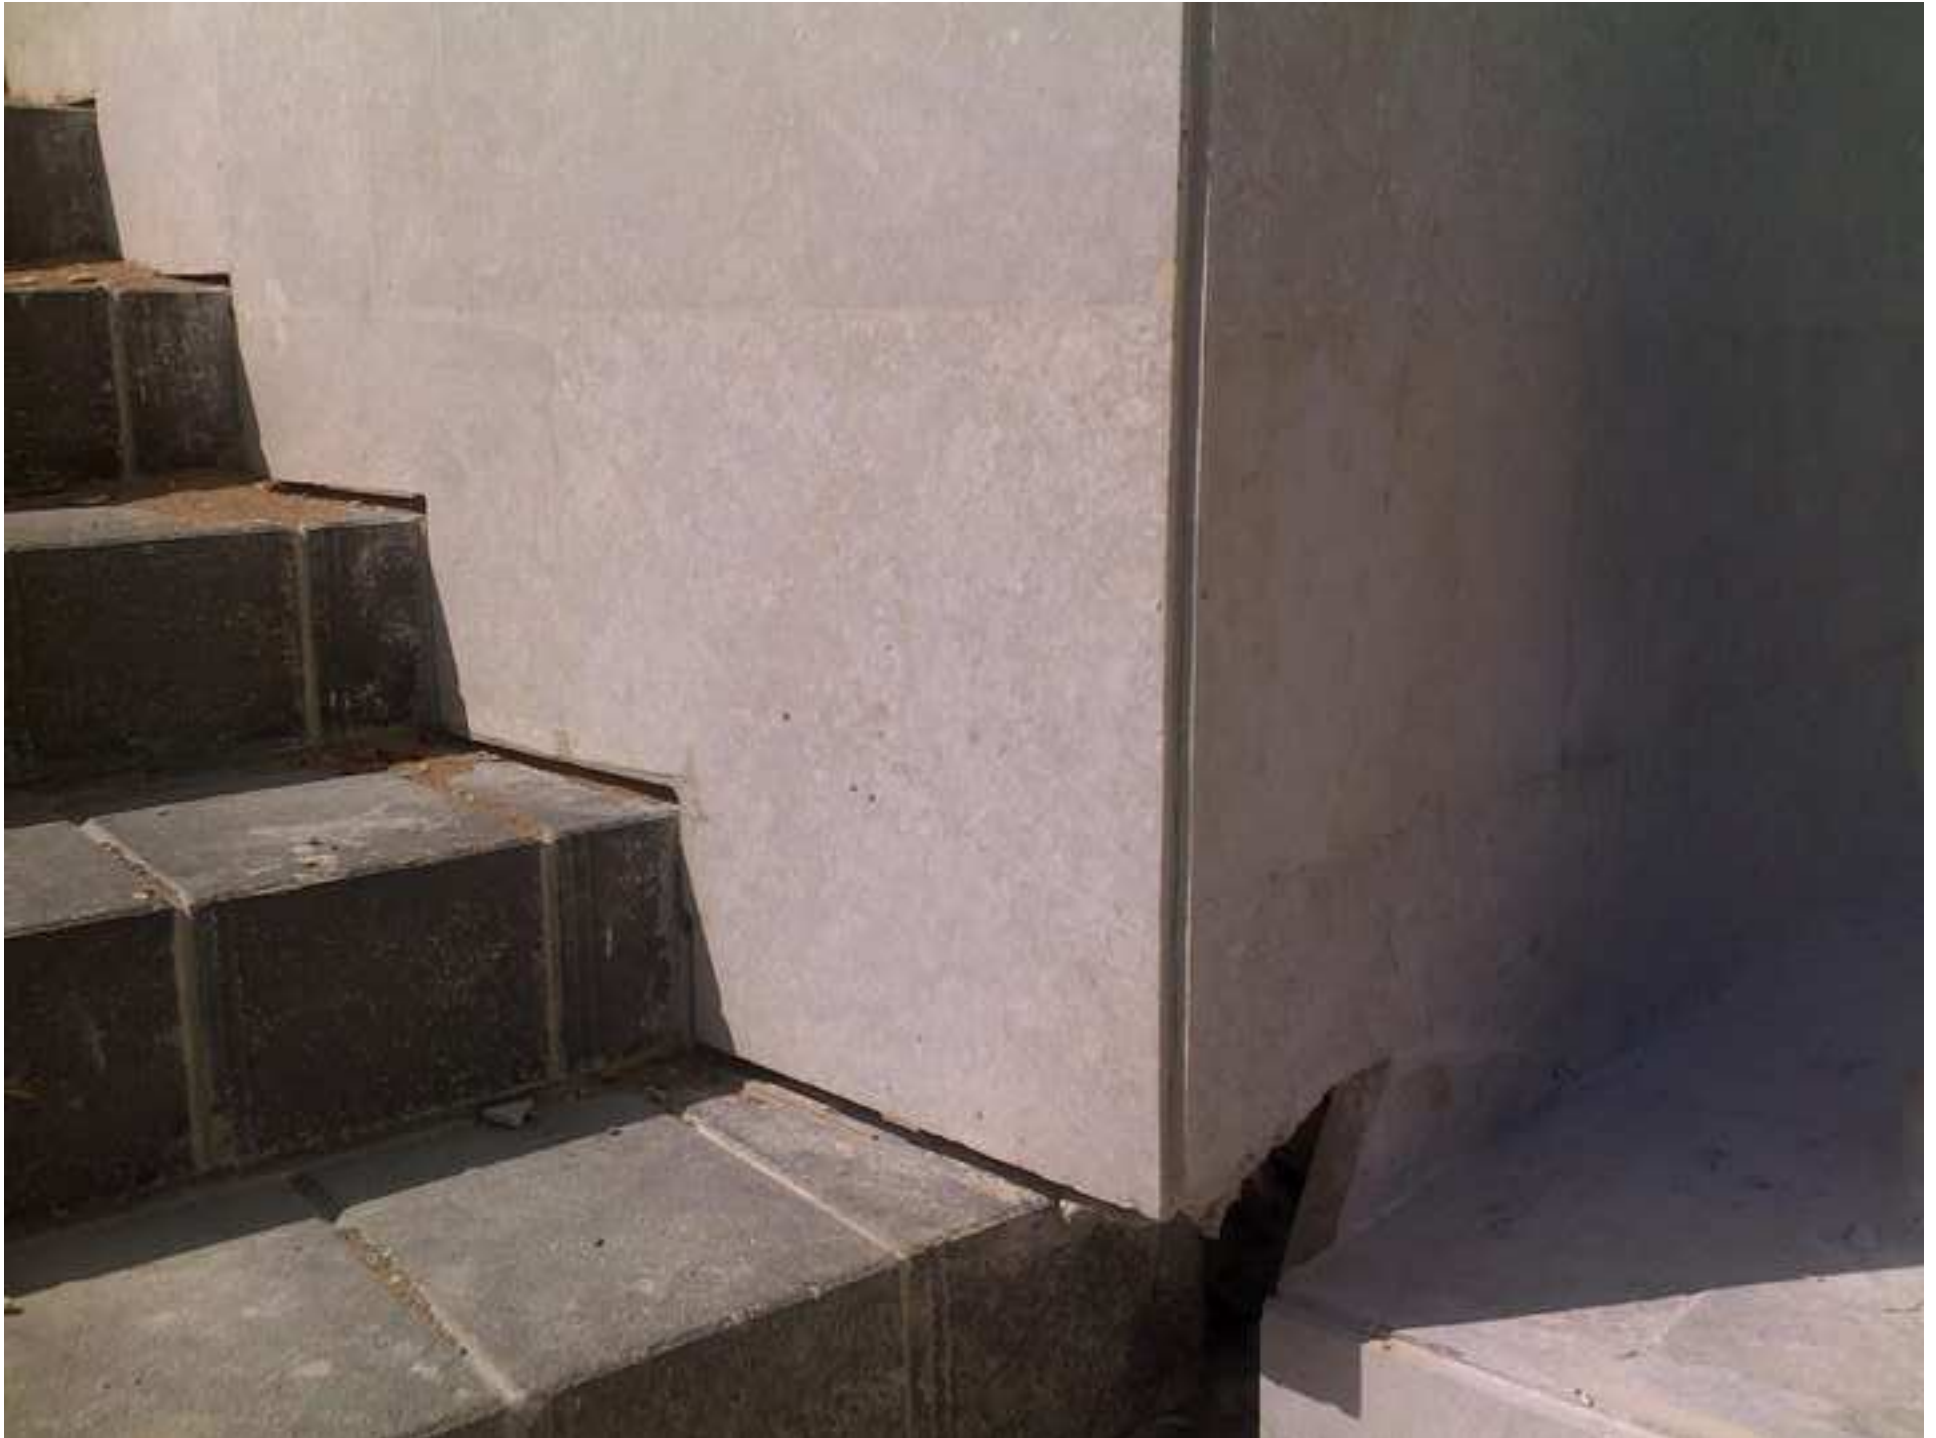
- 3 i. Kerbstones adjacent to landscaped areas were separated from the walkways by  
4 approximately 40mm.
- 5  
6 ii. The steps which are in close proximity to landscaped areas of the Guest house structure  
7 experienced subsidence, whereas the actual structure (founded on piles) did not (Figure 3).
- 8  
9 iii. Large settlements (approximately 80mm) were observed in areas paved with concrete slabs,  
10 which are in close proximity with landscaping areas.  
11  
12  
13

57 Figure 3. Separation of stairs from adjacent wall due to differential settlement

35 Considering the various structural distresses observed at the site and given the vast area of ground  
36 to be improved, it was thought that grouting would not be an economic option. Thus, hydro-  
37 compaction was recommended as a preferable and inexpensive option. To avoid further distresses  
38 due to settlement of soil while hydro-compaction was in progress, it was also recommended to use  
39 hydraulic jacks to lift up the existing gazebos and swimming pool structures existing at the site.  
40 Upon completion of hydro-compaction and cessation of ground settlements, cement grout would be  
41 injected along any resulting gaps, to ensure that the bases of the gazebos and swimming pool  
42 structures make complete contact with the ground.  
43  
44  
45  
46  
47  
48

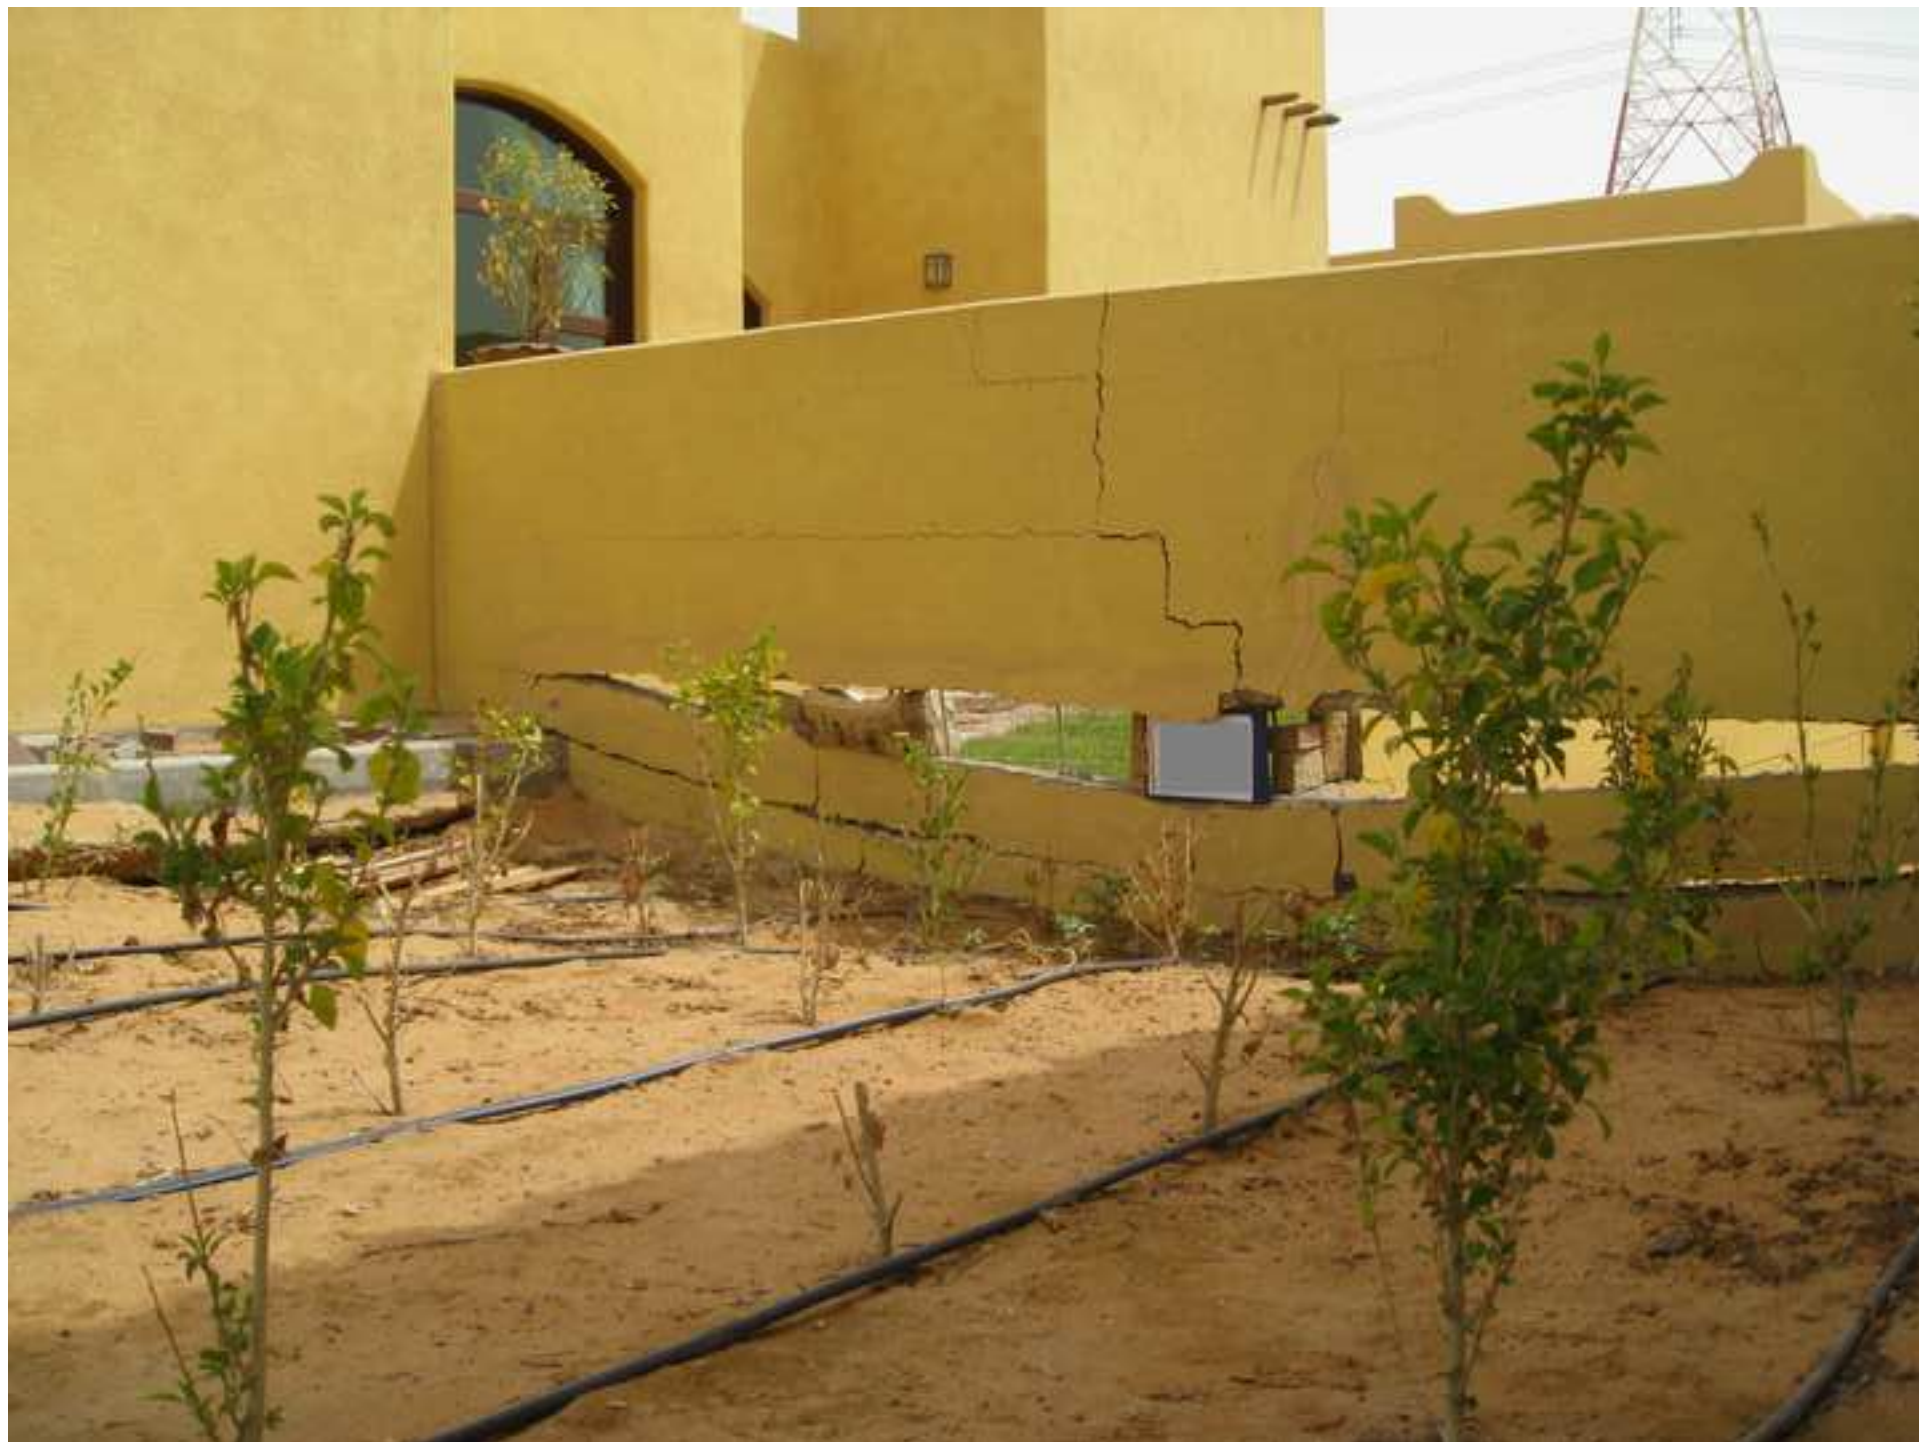
- 5  
6 ii. Though several boundary walls had distressed on site, those walls which are located with  
7 landscaping on either side had suffered the highest level of distress with settlements  
8 approximately 260mm (Figure-4).

58 Figure 4. Cracking and settlement of boundary wall  
59  
60  
61  
62  
63  
64  
65

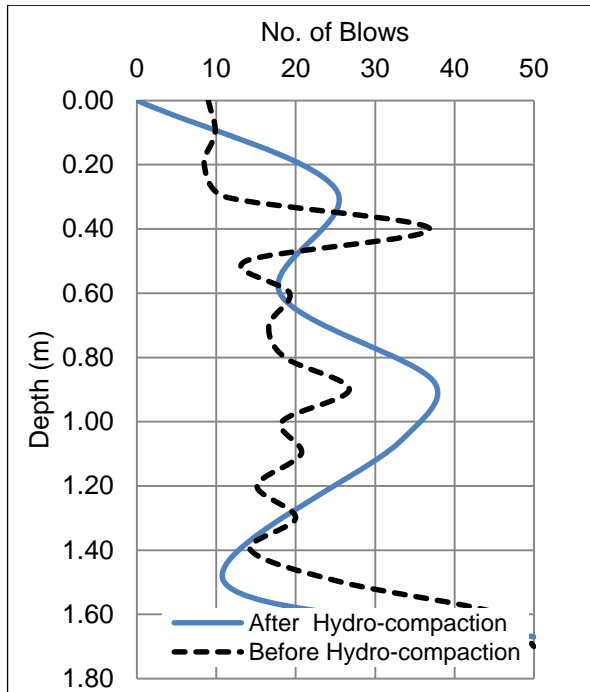
Figure 5 Mackintosh probe test results

45 and after the hydro-compaction process. As shown in Figure 5, it was found that the soils  
46 responded to water movement because the number of blows after hydro-compaction increased for  
47 all depths down to 1.4 m. However, the improvement in ground was not noticed locally at depth 0.4-  
48 0.6 m and this could be due to saturation of soil instead of responding to collapse of soil structure  
49  
50  
51  
52  
53  
54  
55  
56  
57  
58  
59  
60  
61  
62  
63  
64  
65

1 due to hydro-compaction, which otherwise might have responded to water movement. Similar  
2 behaviour was noticed at depth below 1.4m and this could be attributed to the nearness of  
3 groundwater table located at 1.5 m below ground. As stated by many researchers (Dudley, 1970;  
4 Reginatto and Ferrero, 1973; Petrukhin, 1989; Bell, 2000; Jotisankasa, 2005; Bolzon, 2010; Rezaei  
5 et al., 2012) collapsible soil do respond to moisture and their density increases with movement of  
6 water due to re-arrangement in soil structure into denser packing, presence of collapse soils in the  
7 area of concern was confirmed.  
8  
9  
10

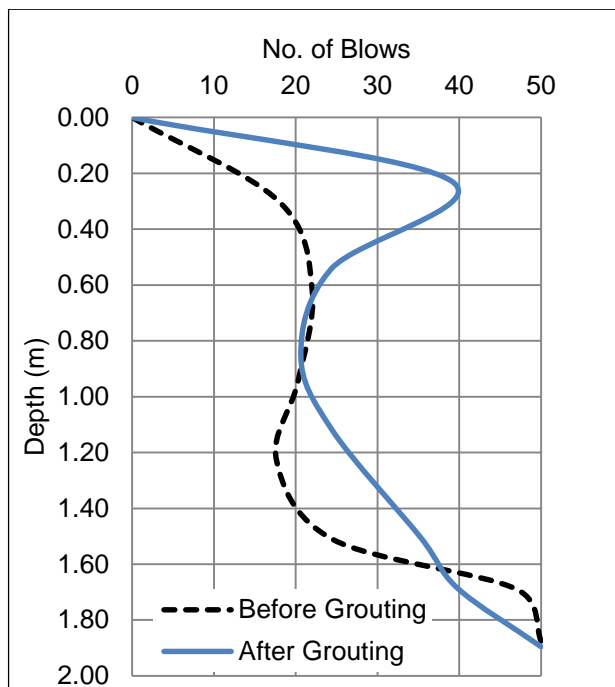
Figure 6 Mackintosh probe test results at boundary walls

21 grouting process to verify the effectiveness of the soil densification process. It can be seen (Figure  
22 6 and Figure 7) that the depth of improvement due to grouting was limited down to 0.6 m compared  
23 to hydro-compaction, where the improvement was noticed up to 1.4 m below ground. Such limited  
24 depth of improvement in ground due to chemical grouting could be due to non-uniform permeation  
25 of grout into soil beyond 0.6-0.8 m below ground. Hence, it was suggested to continue with the  
26 hydro-compaction in all areas where settlements were noticed, allowing the settlements to proceed  
27 to their maximum values before continuing with repair work to reinstate the distressed structures.  
28  
29  
30  
31  
32  
33  
34  
35  
36  
37
