## THERMAL SEGREGATION OF ASPHALT MATERIAL IN ROAD REPAIR

### ABSTRACT

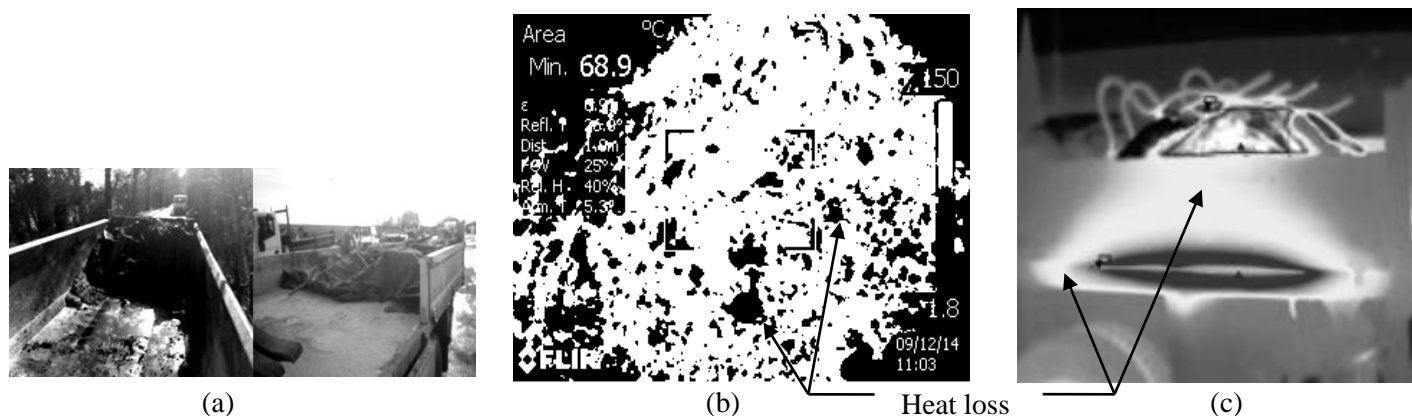
Figure 2: Asphalt transportation and initial temperature monitoring (a) Asphalt location onto the truck, (b) First thermal image 2 minutes after asphalt was loaded onto the truck and (c) Second thermal image where temperature is lost from the panels and the cover sheet

During transportation, asphalt was only covered with a thin sheet (Figure 2(a)). Figure 2(b) is the thermal image taken 2 minutes after the asphalt was loaded onto the truck. At this point thermal segregation had begun to develop, this is shown as black areas on Figure 2(b). The maximum temperature of asphalt at this stage was 150 °C. Figure 2(c) is a further thermal image taken few minutes after the image in Figure 2(b). This image indicates how heat was being lost through the panels of the truck and the cover sheet. Sections in white color in Figure 2(c) indicate this. Dark areas on the periphery of both images of Figure 2(b) and 2(c) are the surroundings of the asphalt and not the material itself.

The asphalt with Company A was transported to five different repair sites with a significant distance from the production facility. This led to significant temperature losses of the asphalt through the panel of the truck and the cover sheet (refer to Table 1 for temperature details on each repair site). The results shown on Figure 3 confirm these conditions. Table 2 presents the overall transport time of asphalt from the production plant to each repair site. All projects were completed during the same day.

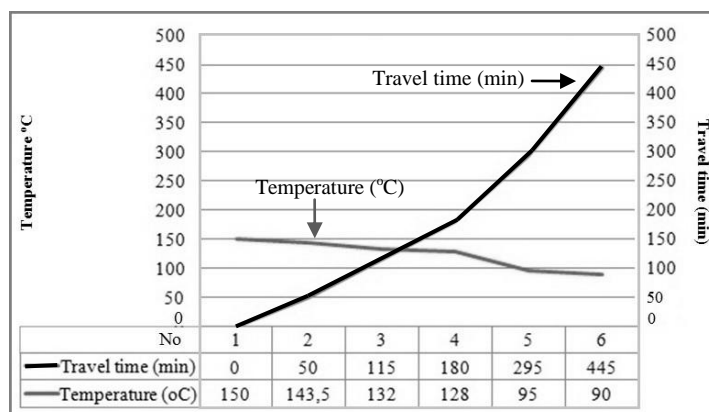
Figure 3: Asphalt temperature variation and transportation time between asphalt production facility and each repair site

There was an initial drop in temperature of 5 °C after 50min of transportation between the asphalt plant and the first repair site. The temperature reduced by up to 22 °C between the initial temperature of 150 °C and that of repair site 4.

There was a sudden drop in temperature between repair sites 3 and 4. The temperature dramatically decreased by 26% reaching 95 °C, a reduction of 37% from the initial temperature of 150 °C. In total the temperature decreased 40% between asphalt plant and repair site 5.

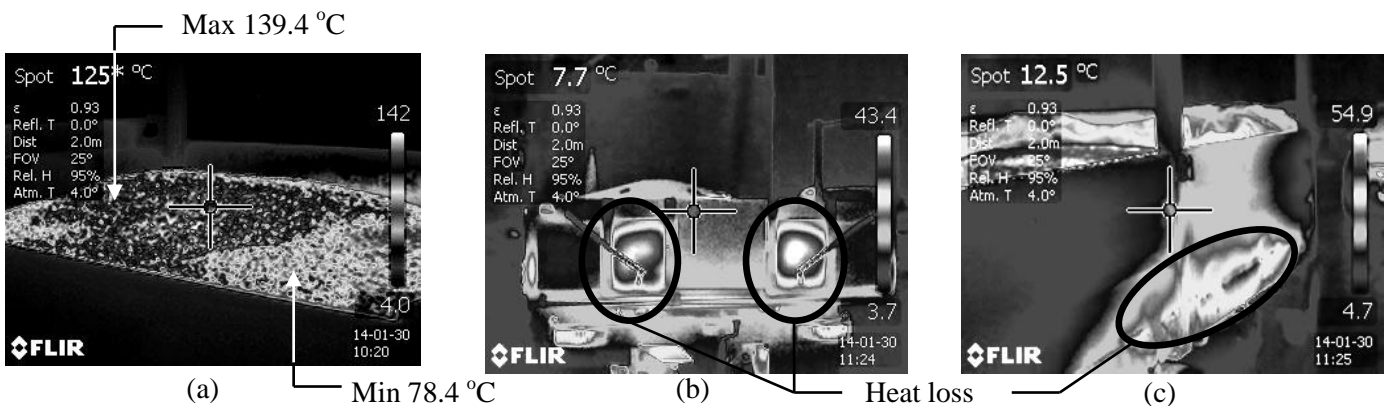
Figure 4: Thermal images indicating heat loss (a) Thermal image of asphalt on back of the truck five minutes after collection, (b) Thermal image on the back of the truck and (c) Thermal image alongside the vehicle

Company B was monitored during their patch repair activity on repair site 6, between the production facility and the single repair site. The process of transportation of Company B is very similar to that of Company A. A type of end dump truck was used to transport asphalt. When asphalt was loaded onto the track it was covered by a sheet. The prevailing weather temperature was around 0 °C (refer to Table 1). Thermal images of the asphalt were taken 5 minutes after it was loaded onto the truck, as shown in Figure 4(a).

Average, maximum and minimum temperatures were determined from the three thermal images with one of them shown in Figure 4(a), these being 138.8 °C and 79 °C respectively. Taking into consideration that the initial temperature of the asphalt was around 150 °C, the temperature had dropped dramatically and reached a difference of 11.2 °C between initial temperature and average maximum monitored, and a difference of 71 °C between initial temperature and average minimum. Therefore, it is apparent that the Company A transportation process results in notable heat loss and, thermal segregation. Further, Figures 4(b) and (c) demonstrate a heat loss from the joints at the back and alongside the vehicle respectively.

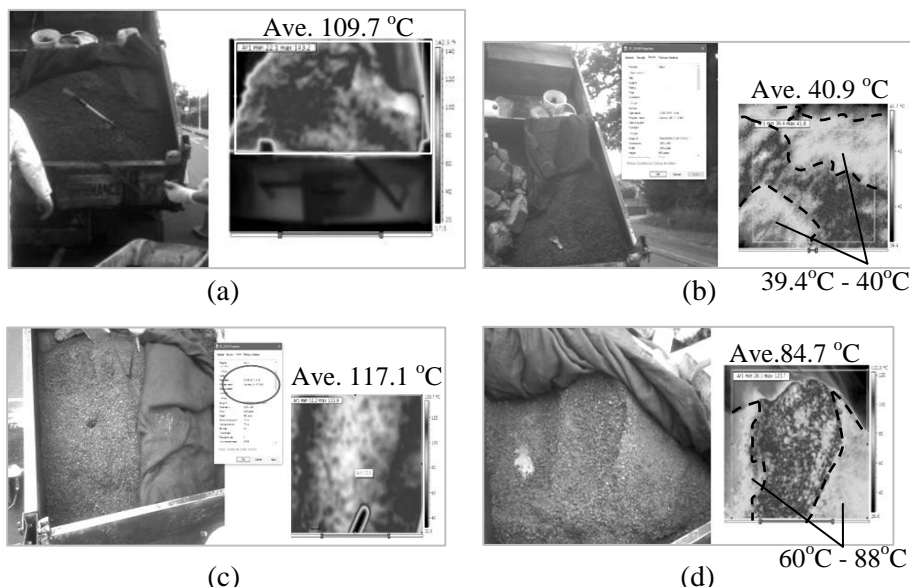
Figure 5: Thermal images of asphalt at (a) Repair site 7, (b) Repair site 8, (c) Repair site 9 and (d) Repair site 10

The maximum temperature of the asphalt when gathered from the production plant for both days of the repairs was around 150 °C with an average of 132.2 °C. On the day of the repairs at repair sites 7 and 8, the asphalt temperature decreased after loaded onto the truck and ranged between 62.9 °C and 131.9 °C with an average temperature of 118 °C. Therefore, a drop of around 11% had occurred before even the transportation start. The heat loss on this occasion was also measured with a thermometer. During the second day that repair sites 9 and 10 were completed, the average temperature of the asphalt onto the truck had decreased to a 124.7 °C from an initial 150 °C (a heat loss of 16.9%).

Figures 5 (a), (b), (c) and (d) present the asphalt and its thermal images when arrived at sites 7, 8, 9 and 10 respectively. Figures 6 (a) and (b) demonstrate the temperature variations when asphalt was loaded onto the truck, and when it was arrived on each repair site. As the results display, during asphalt transportation on day 1 there was an overall heat loss of 69% and on day 2 a temperature decrease of 35.9%.

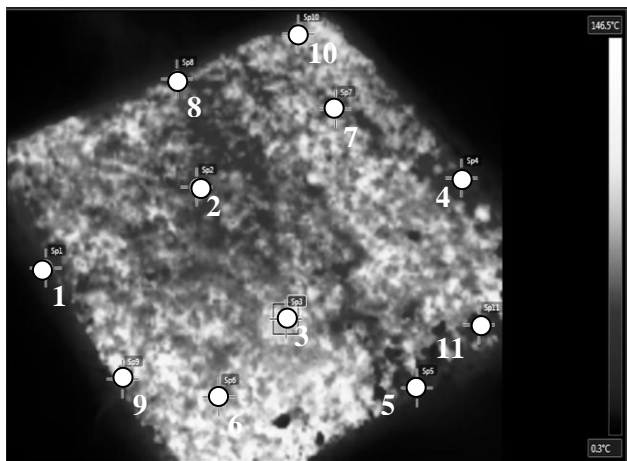
Figure 7: First thermal image of patch repair on paving site 1 immediately after compaction

For Company A, Figures 7 and 8 were taken after compaction of the repairs at site 1. Figure 7 presents eleven points taken randomly on the mat. The maximum temperature in the image is 146.5 °C. The temperatures of the eleven points shown on Figure 7 are presented on Table 4. The results indicate uneven temperature distribution. In other words, this means that areas with low temperatures are most likely to fail if these temperatures reach cessation temperature and continue to decrease below that. As revealed from the measurements, most of the points had reached and decreased below cessation temperature. Therefore, the compaction during this stage was ineffective.

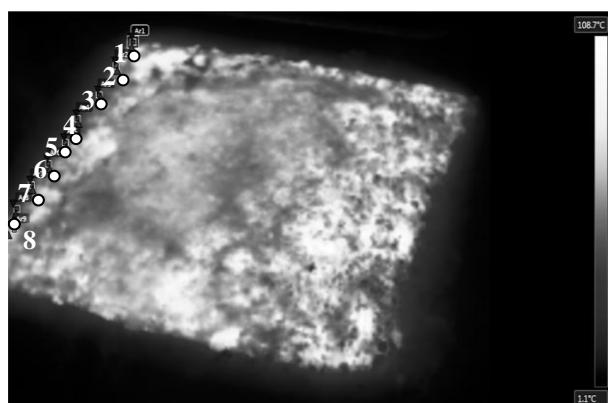
Figure 8: Second thermal image of patch repair on paving site 1 immediately after compaction

Figure 8 is the second thermal image taken after compaction at repair site 1. On this occasion eight points were chosen from the edge of the patch repair. The thermal image recorded a general maximum temperature of 108.7 °C in the mat which means that the compaction could be completed without major problems. However, the eight measurements on the edge of the patch repair revealed temperatures below the cessation temperature (refer to Table 5). Hence, although rollers can continue to improve smoothness and surface texture on the mat, compaction will generally not occur which would result on premature failure of the patch repair

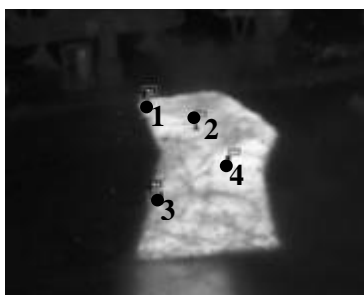
Figure 9: Thermal image of patch repair immediately after compaction on repair site 2

Figure 9 represents the third thermal image taken at repair site 2. After compaction four different points were selected to understand the variation in temperature. Further, for each point seven measurements were collected at different times. Points 1 and 3 were taken on the edges of the mat, and points 2 and 4 in the middle area of the mat. The measurements showed that different locations of the mat exhibit different repair quality. The points located on the edges (points 1 and 3) had lower temperatures than those located in the middle of the mat (points 2 and 4). The temperature reduced, reaching after 19 minutes from the first thermal image shot a temperature difference of 56.4 °C for point 1, 30.6 °C for point 2, 53.3 °C for point 3 and 32.9 °C for point 4 (refer to Table 6). This means that the average percentage of temperature reduction on the edges was 51% and in the middle 29%. Consequently, the edges of the repair appear to have a temperature difference with the middle of the mat of around 22%.

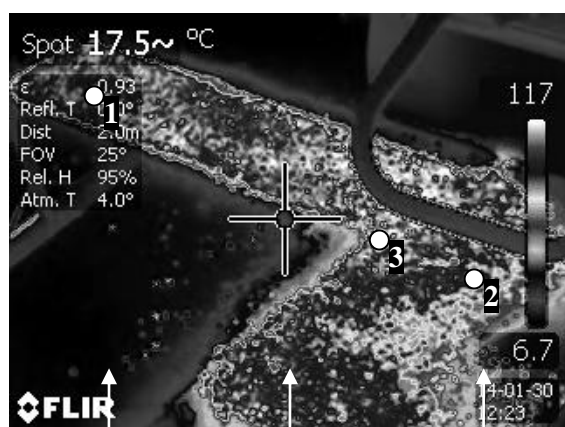
Figure 10: Thermal image of patch repair immediately after compaction on repair site 6

Figure 10 presents the patch repair area that Company B completed. In this figure there are shown three points where temperature was measured using the thermal imaging camera. Point 1 was situated away from the kerb line and drainage area. Point 2 was located near the kerb line and within the drainage area. Finally, Point 3 was at the edge between the new and old reinstatements. The temperature recordings for each point was as displayed in Table 7 where for each point eight temperature measurement were collected at different time. All points had an initial temperature of 100 °C. This is a 50 °C drop from 150 °C of asphalt temperature when it was collected from the production plant.

Further, the results presented on Table 7 indicate that in a period of 5 minutes temperature dropped for point 1 around 33%, for point 2 around 65% and for point 3 around 71%. As expected, having into consideration the results of temperature drop from Company A, points 2 and 3 displayed greater temperature reduction due to their position near the edge of the repair. As a result, the areas with less temperature of the cessation temperature tend to have lower density and cause failure of the patch repair around them.

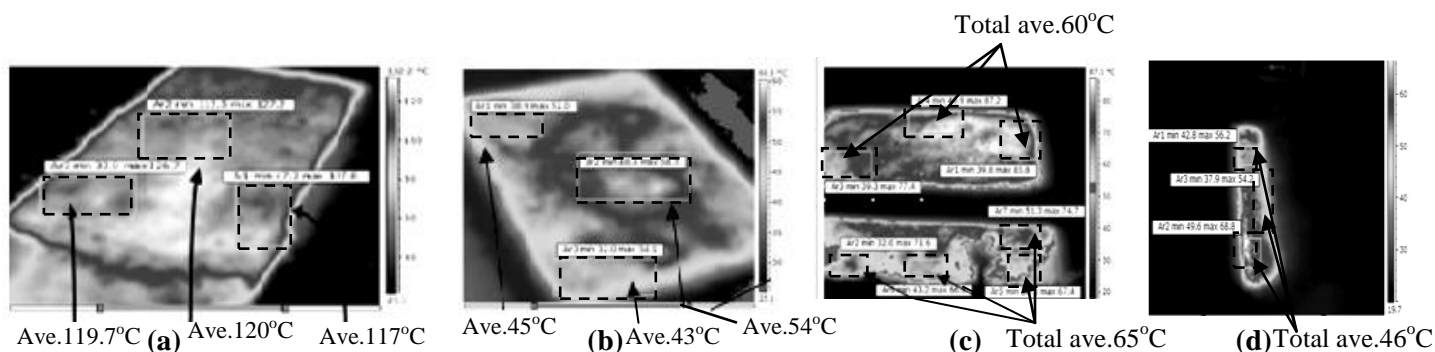
Figure 11: Thermal image of patch repairs immediately after compaction on (a) Repair site 7, (b) Repair site 8, (c) Repair site 9, and (d) Repair site 10

In contrast with the other two companies, temperatures during these repairs were measured on areas and not on specific points. Between sites 7 and 8, which were finalized at the same day with site 7 being completed first, thermal images showed quite acceptable levels of temperature for site 7 with an average temperature of 110.6 °C. However, on site 8 the average temperature was quite below cessation temperature (determined by pave-cool (Minnesota Department of Transportation, 2016)) and reached an average of 43 °C. Regarding sites 9 and 10 (completed the second day) the average temperatures were 60 °C and 65 °C for site 9, and 46 °C for site 10. On all repair sites the temperature on the edges was quite low (refer to Figure 11) as was seen on repairs of Company A and B.

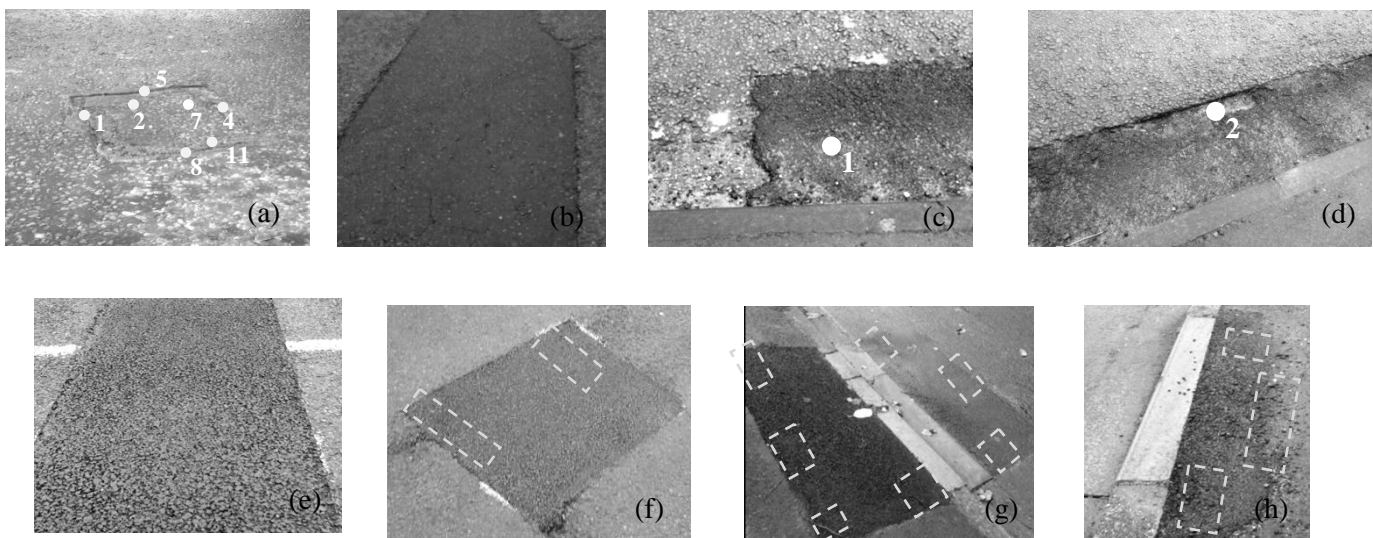
Figure 12: Patch repair sites after three months of completion (a) Repair site 1, (b) Repair site 2, (c) and (d) Repair site 6, (e) Repair site 7, (f) Repair site 8, (g) Repair site 9 and (h) Repair site 10

All the repaired sites were revisited three months after completion of the repair work. As is shown on the images of Figure 12, along the edges of the reinstatement, the new material had started to fall away. This is considered to be due to temperature differentials between the new and old surfaces, the temperatures in the material dropped below the cessation temperature when was laid and therefore inadequate compaction was occurred. On the other hand, on areas of the patch repair where the temperature was retained at levels over the cessation temperature there was no apparent deterioration.

Further, at all images of Figure 12 are included the points and areas respectively examined under the “Effect of compaction” section of this paper regarding their temperature levels after compaction. Those points and areas are the places with excessively low temperatures that correspond to failures shown on most of the images of Figure 12, excluding the images of 12(b) and (e) that continue to be in good condition. The points of Figure 12(a) and 12(b) are related to Figure 7 and 9 respectively, the points of Figure 12(c) and (d) are related to Figure 10, and the marked areas of Figure 12(e) – 12(h) are related to Figure 11.
