# Dynamic investigation on the Mirandola bell tower in post-earthquake scenarios

**Abstract** After the seismic events of the 20th and 29th of May 2012 in Emilia (Italy), most of the monumental and historic buildings of the area were severely damaged. In a few structures, partial collapse mechanisms were observed (e.g. façade tilting, out-of-plane overturning of panels...). This paper presents the case-study of the bell tower of the Santa Maria Maggiore cathedral, located in Mirandola (Italy). The dynamic response of the structure was evaluated through operational modal analysis using ambient vibrations, a consolidated non-destructive procedure that estimates the dynamic parameters of the bell-tower. The dynamic tests were carried out in pre-intervention and post-intervention conditions in order to understand the sensitivity of dynamic measurements to safety interventions. Furthermore, a comparative study is made with similar cases of undamaged masonry towers up to the 6th mode. Finally, an investigation on the state of connections and of the building itself is carried out via FE model updating.

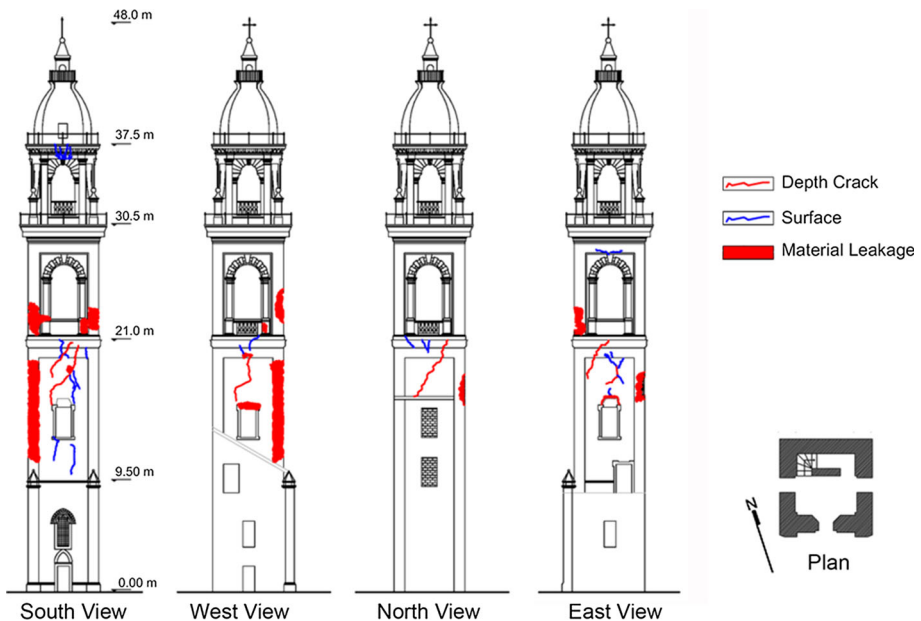
The May 2012 Emilia earthquake sequence severely damaged the cathedral, with two events on May 20th and 29th. The epicentre of the May 29th event was less than 1 km far from the site of the bell tower, which led to massive destruction to the historical city centre of Mirandola. It resulted in the collapse of the aisle, the side aisle, the roof and in several cracks on the bell-tower (Fig. 2).

**Fig. 2** Post-earthquake damage survey of the Mirandola bell-tower

The maximum displacements values are obtained for the CH-7 position, located in a higher, thus more flexible region of the tower, where the most severe damages were assessed (see Fig. 2). Observing the time-history responses in Fig. 16 and the results in Table 6 it is possible to notice how the amplitude of the response in the PR-I and PS-I configurations is quite similar with all the three aftershocks. As shown in Fig. 16, the response in the direction of the x and y reveals quite similar results between PR-I and PS-I differing only by the time of occurrence of the peak displacement. Only the responses to AS1 and AS3 aftershocks show an improvement of global behaviour when considering the maximum response in terms of displacement.

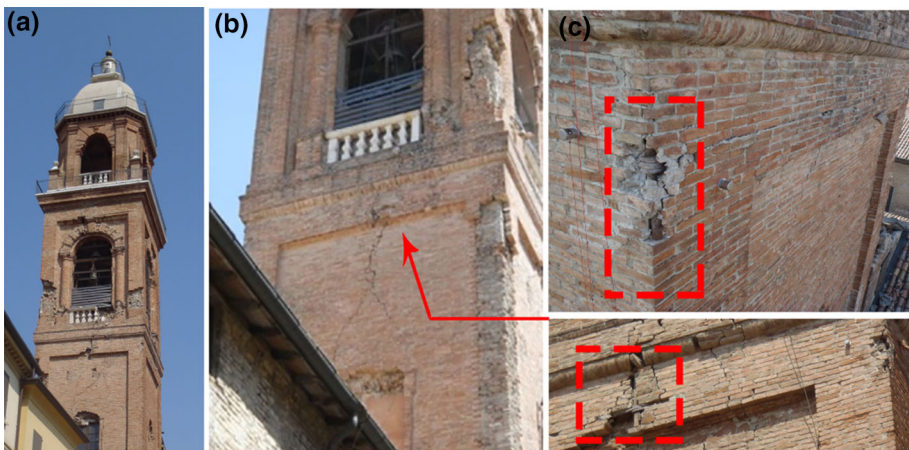
An exterior laser scanner survey of the cracking patterns, carried out by the INGV (Istituto Nazionale di Geofisica e Vulcanologia) within the ILRIS 3D project (Pesci et al. 2012), highlighted the activation of a twisting mechanism leading to a rotation of about 1 degree of the building portion located between 20 and 32 m. The structural damages are mainly concentrated in this section of the bell tower, where deep diagonal cracks right below the first order of openings on all four sides can be noted, extending down to the openings of the underlying level. Furthermore, various lintels failed on the South, West and East fronts. The twisting mechanism and the high local stresses caused the crushing of masonry near the area of the tower in contact with the adjacent building, especially at the

height of 21 m (Fig. 3a, b). Metal chains were revealed by the occurred damages inside the masonry layer around the perimeter at the base of this level of the structure, as shown in (Fig. 3c). The visual and laser scanner surveys did not confirm for the other levels.

**Fig. 3** Damage at the level of the belfry of the bell-tower (a, b) and the metal chains (c) at 20 m

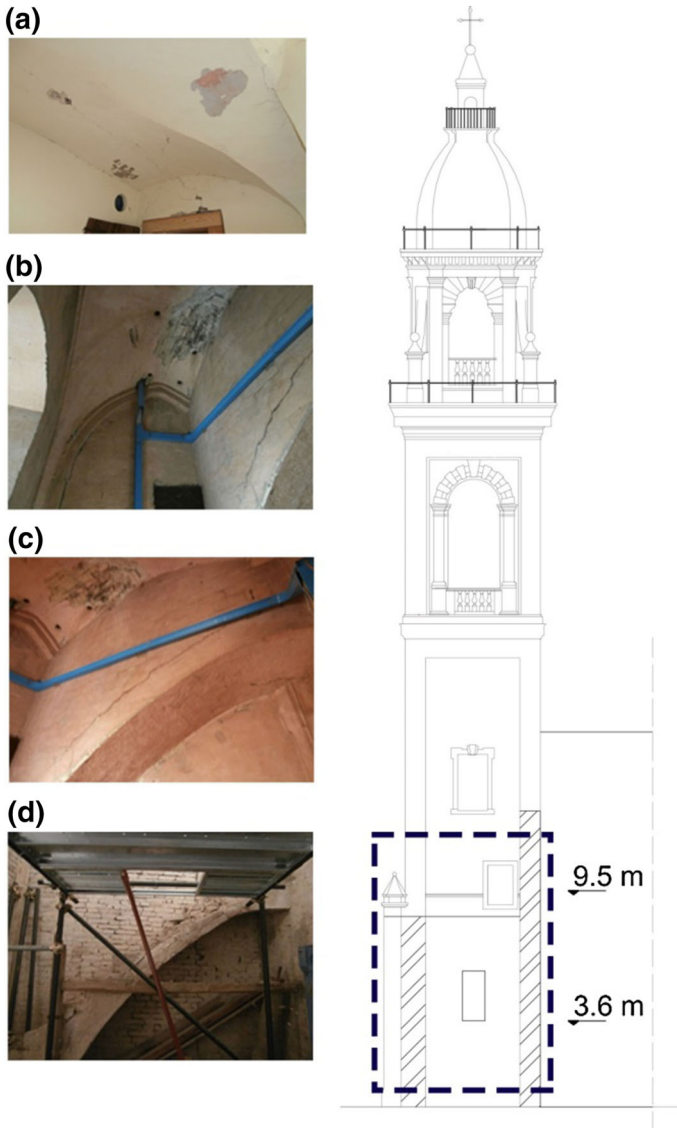
The internal state of the bell tower was assessed by visual inspection and this was compared to the laser scanner survey. Only two masonry vaults in the basement are still standing with clearly visible cracks (Fig. 4a, b). The internal staircases are partially collapsed and only the flight between 0 and 9.5 m (Fig. 4c) is still accessible. From this level up to the belfry all ceilings and stairs are collapsed as can be seen in Fig. 4d which depicts the remains of a flight of stairs at 9.5 m of height.

**Fig. 4** Damage on vaulted slabs at 3.6 m (a) and at 9.5 m (b) and internal staircase (c, d)

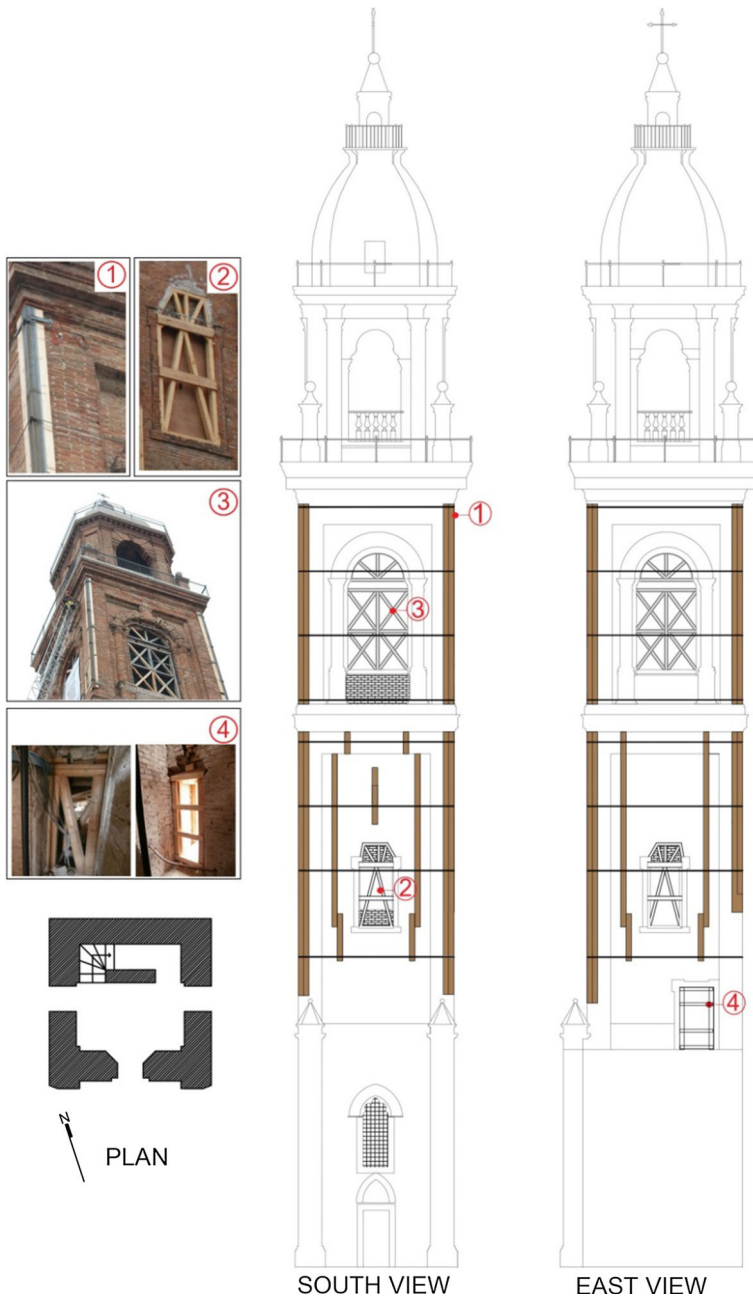
**Fig. 5** Post-earthquake provisional safety-interventions: metal tie rods (1), wooden falsework in the small opening of the first and second level (2, 4), wooden falsework in the large opening of the third level (3)

In order to guarantee the stability of the building and to avoid further damages, provisional post-earthquake safety interventions were put in place by the authorities between the 14th and the 18th August 2012. The bell-tower of S. Maria Maggiore was reinforced with eight metal tie-rods located at two levels of the structure (see Fig. 5-1). Moreover, the main and large openings were reinforced using wooden falseworks, as shown in Fig. 5-2, 3, together with wooden ribs in the smaller openings (Fig. 5-4).
