Assessment of Coating Performance on Waterwalls and Superheaters in a Pulverised Fuel-Fired Power Station

Nigel Simms¹ · Maud Seraffon² · Andy Pidcock¹ · Colin Davis²

Abstract Protective coatings offer one route to increase the lives of heat exchangers in pulverised fuel power plants. A range of candidate coatings have been exposed on the waterwall and superheaters of a 500 MWe UK power station unit for periods of up to ~ 4 years (24,880 operating hours), during which time this unit was fired on a mixture of UK and world-traded coals. Both nickel- and iron-based candidate coatings were included, applied using high velocity oxy-fuel or arc-wire process; a selection of these also had a surface sealant applied to investigate its effectiveness. Dimensional metrology was used to evaluate coating performances, with SEM/EDX examinations used to investigate the various degradation mechanisms found. Both the waterwall and superheater environments generated their characteristic corrosion damage morphologies which depended on the radial positions around the tube. Coating performances were found to depend on the initial coating quality rather than composition, and were not improved by the us

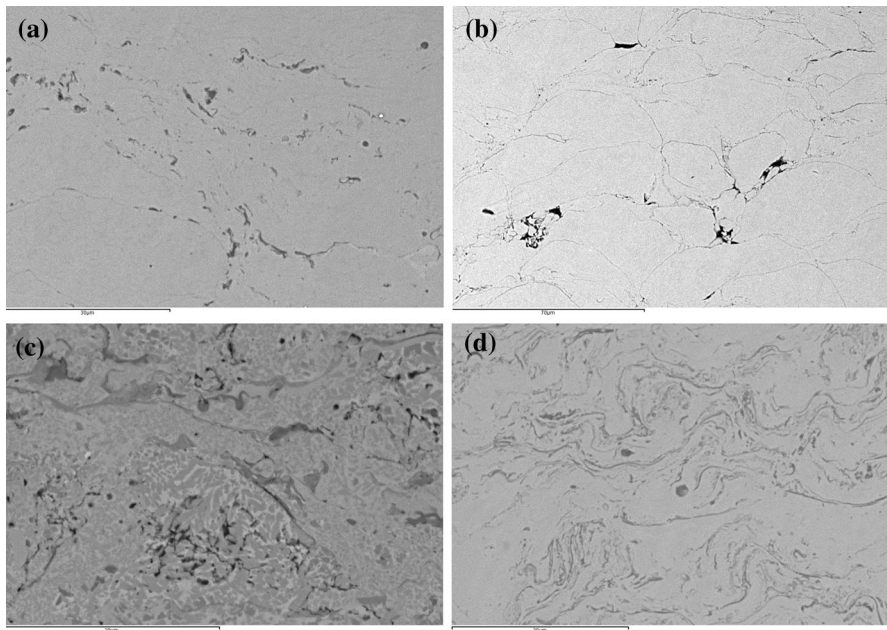
Fig. 4 Representative microstructures of different as-sprayed HVOF coatings. The images have been selected to illustrate the variations in coating microstructures observed. **a** Ni-50Cr, **b** FeCrAl, **c** Cr₃C₂-NiCr matrix, **d** alloy 625 NiCrMo(Nb+Ta)

1% voidage previously considered necessary to ensure good coating performance. One exception to this was for the alloy 625 coating which was observed to contain a unusually high oxide content (Fig. 4d). The Cr₃C₂-filled NiCr matrix coating contained a considerable amount of the hard, erosion-resistant carbide material as expected (Fig. 4c), although this prevented the assessment of its oxide and porosity content.

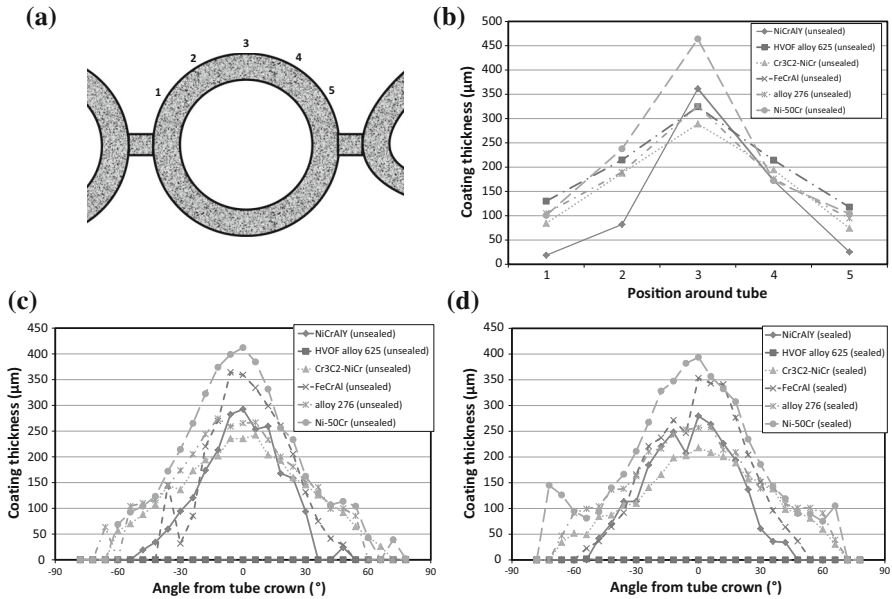
The cross-sections through the exposed samples showed that all of the coatings had experienced fireside corrosion on their surfaces at the crown (i.e. 12 o'clock positions), but only the HVOF alloy 625 coatings had disappeared completely (both unsealed and sealed variants, as shown in Figs. 5, 6). However, looking around the tube surfaces, it was clear that many of them had failed towards the 'sides' of the tubes (i.e. at angles greater than $\sim 60^\circ$ to tube 'crown'); this is shown in Fig. 7 for a sealed FeCrAl sample, with no coating left on the right 'side' of the tube. SEM/EDX analyses of samples were carried out to confirm the coating identities. These examinations also characterised the deposit compositions that had formed on the tube surfaces and that the corrosion damage morphologies were consistent with typical waterwall corrosion damage for a coal-fired boiler [7].

Fig. 5 Variation in unsealed HVOF coating thickness around waterwall tubes 3 and 8 before and after exposure. **a** pre-exposure measurement positions, **b** before exposure, **c** after exposure—unsealed coatings, **d** after exposure—sealed coatings

Dimensional metrology measurements were carried out on all the coated tubes before and after their exposures. Figure 5b shows the data generated by pre-exposure Elcometer measurements at the five radial locations for each of the unsealed coatings on tube 8. This illustrates the initial variation in the thickness of these coatings around the tubes. After exposures, measurements of coating thicknesses were carried out at 6° intervals around the tube cross-sections. The results of these are shown in Fig. 5c for the same tube 8 coatings and in Fig. 5d for an unsealed version of the same coatings (tube 3).

These data emphasise the much greater coating thicknesses in the ‘crown’ areas (or 12 o’clock positions) which are shown at zero degrees on the x -axis in Fig. 5c, d, and the tailing off of the coating thicknesses on either side of this peak position. These data should be compared to those generated by the pre-exposure metrology (e.g. Fig. 5b), which showed the coatings becoming thinner away from the ‘crown’ areas (i.e. either side of position 3 in Fig. 5a). It is clear that the areas of thinner coatings have failed during the course of exposures in the plant. Given the variation in coating thicknesses around the tubes that has resulted in areas of total coating loss, to obtain quantitative data on coating performances it is necessary to use the maximum coating thickness measurements (corresponding to the tube ‘crowns’) before and after exposure.

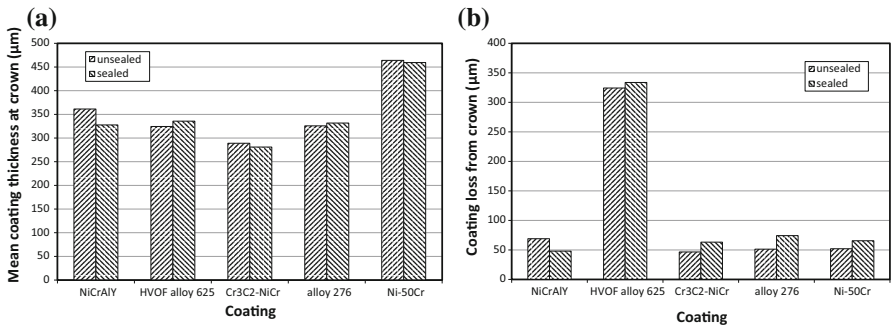
Fig. 6 Pre- and post-exposure HVOF coating thicknesses on waterwall tubes 3 and 8 (except FeCrAl as no pre-exposure data). **a** Mean coating thicknesses at waterwall tube ‘crowns’, **b** coating losses from waterwall tube ‘crowns’

Figure 6 shows the coating losses calculated for each of the coatings with and without sealant layers. As there is no HVOF IN625 coating left in either case, it has clearly performed the worse, with corrosion damage exceeding the 320–330 μm coating thicknesses. However, all the other coatings have performed similarly with damage levels of ~ 50 to $75 \mu\text{m}$ during their ~ 25 khour exposure (i.e. ~ 2 – $3 \mu\text{m}$ per 1000 h). There was no obvious benefit from the sealant—for the majority of the coatings the sealed version had apparently corroded a little more than the unsealed version (but this was within the standard deviation of the measurements).

On the waterwalls, it was found that the HVOF IN625 coatings were not present after their exposure. For the other coatings, similar damage levels of ~ 50 – $75\ \mu\text{m}$ were observed at the tube ‘crown’ (i.e. ~ 2 to $3\ \mu\text{m}$ per 1000 h). However, the wide range in initial coating thicknesses meant that some of the coatings had failed towards the sides of the tubes where they were all initially significantly thinner (due to the coating application methods used).

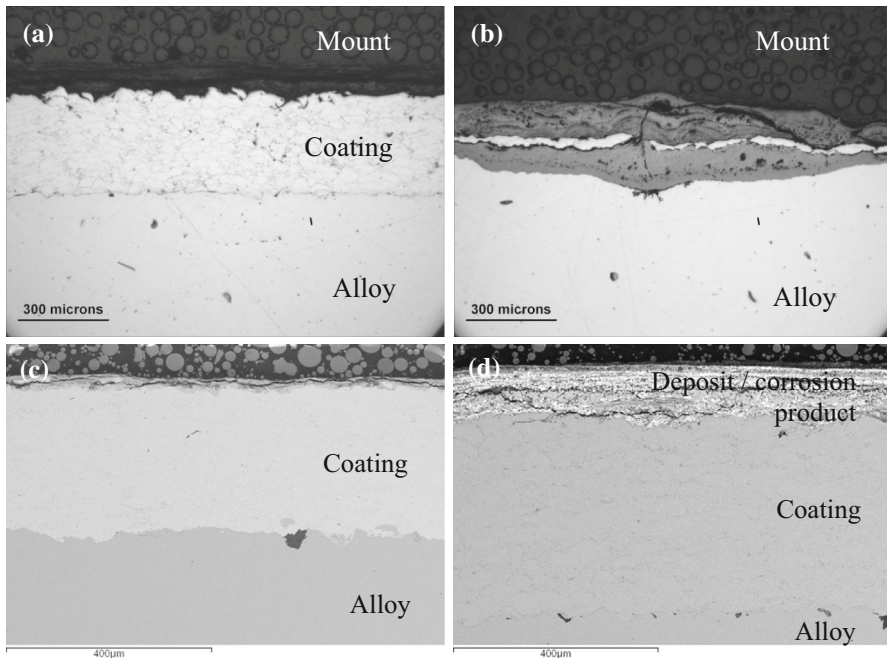
Fig. 7 Examples of variation in appearance of coated waterwall tubes after exposure (more detailed coating thickness information shown in Fig. 5). **a** ‘Crown’ of HVOF FeCrAl waterwall tube, **b** right side of HVOF FeCrAl waterwall tube, **c** ‘crown’ of HVOF alloy 276 waterwall tube, **d** ‘crown’ of Ni-50Cr waterwall tube

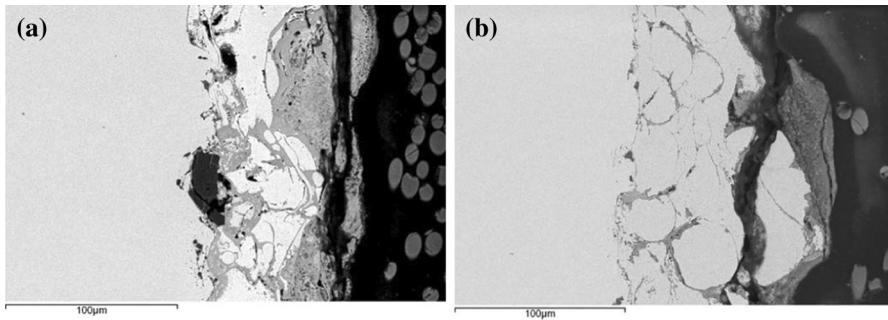
Similar examinations were carried out for the coatings exposed on the superheater tubing. SEM/EDX examinations of the cross-sections through the coatings confirmed the coating compositions. These examinations also characterised the deposit compositions that had formed on the tube surfaces and that the corrosion damage morphologies (e.g. Fig. 8) were consistent with typical superheater corrosion damage for a coal-fired boiler [7].

Fig. 8 Summary of coating performances on the superheater, **a** arc wire alloy 625 3 o'clock position, **b** HVOF NiCrAlY 3 o'clock position

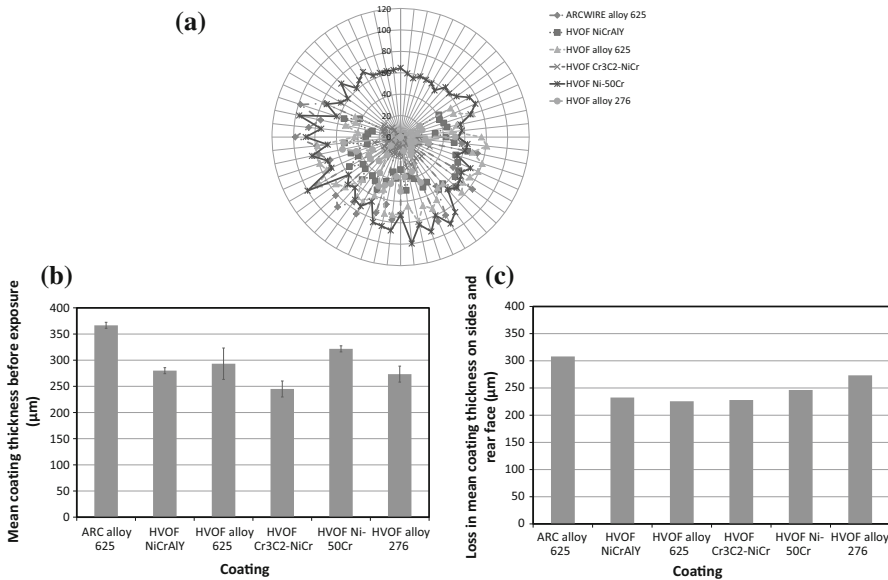
Figure 9a shows the thicknesses of the sealed coatings after their exposure. This shows that only HVOF Ni-50Cr had survived on the upstream surface of the tubes,

Fig. 9 Examples of coating performances on the superheater. **a** Coating thicknesses (µm) as a function of radial position around superheater (upstream tube face at top), **b** mean coating thicknesses before exposure on the superheater, **c** mean loss in coating thicknesses from the sides and downstream faces during exposure on the superheater

but all the coatings were present around the rest of the tube surfaces. Pre-exposure coating measurements were in the range ~ 250 to $350\ \mu\text{m}$ (Fig. 9b), with some coatings having initial thicknesses on average $100\ \mu\text{m}$ less than others (the bars in this figure show the standard deviations of the initial coating measurements). Figure 9c shows the differences between the average coating thicknesses before exposure for these samples and those measured on the sides/downstream surfaces of the samples after exposure. Given the spread in the measurement datasets, the results for the HVOF coatings, with thickness losses of ~ 220 to $260\ \mu\text{m}$, indicate similar levels of behaviour (i.e. ~ 9 to $10\ \mu\text{m}$ per 1000 h). However, the arc-wire alloy 625 coating performed worse with an average downstream coating thickness loss of $\sim 300\ \mu\text{m}$ (i.e. $\sim 12\ \mu\text{m}$ per 1000 h).

On the superheaters, it was found that the only coating that had survived on the upstream tube faces was Ni-50Cr. However, for the rest of the tube surfaces, on average all the coatings all had similar levels of damage at ~ 220 to $260\ \mu\text{m}$ (i.e. ~ 9 to $10\ \mu\text{m}$ per 1000 h), except for arc-wire IN625 which was higher at $\sim 300\ \mu\text{m}$ (i.e. $\sim 12\ \mu\text{m}$ per 1000 h).
