MONITORED ENVIRONMENTAL CONDITIONS IN NEW ENERGY EFFICIENT HOUSING IN SCOTLAND – EFFECTS BY AND ON OCCUPANTS

This paper presents findings emerging from a two-year Building Performance Evaluation (BPE) study, funded by Innovate UK, of 26 new build low energy houses in Scotland, UK. The programme aimed to develop capacity for undertaking BPE and this research undertook detailed monitoring of energy consumption and internal environmental conditions, as well as gathering information from users about how they use their houses. Although it is clear that housing standards are improving, the study has found evidence of performance gaps between design expectations and actual performance, both in terms of energy and also the quality of the internal environment. This paper presents data from four case study houses, which illustrates both the effects of occupancy on performance, but also how the building performance can affect the occupants' experience.

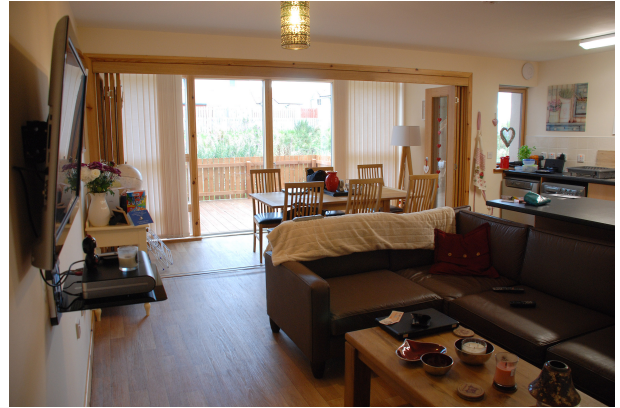
Figure 1: Open-plan living area, Case Study 2.

The residual sunspace was found to have negatively impacted thermal comfort in both the summer and winter months. In summer the internal temperature are high, partly due to reduced ventilation opportunities and solar gains through the large west facing glazed façade. The design phase compliance software warned of the 'HIGH' likelihood of high internal temperatures, yet the glazed façade was not optimised. Summer temperature peaks in the now occupied sunspace reached 36°C and the open-plan living room simultaneously reached 31°C. CIBSE guidance [5] suggests temperatures greater than 28°C for more than 1% of the year in a living room is termed overheating. The occupants found difficulty in cooling the space and used electric fans to create air movement. On cloudy days and at night in the winter, the surface temperatures of the double glazing provided a cooling effect through downdraughts which affected occupant thermal comfort, particularly for one household where their sofa is positioned in the sunspace. The sunspace operation was also compromised by advice from the police to use internal curtains or blinds on the external glazing to improve security during the day (although this is a low-crime area). This resulted fewer winter solar gains. To compensate for this the occupants increase the thermostat setting to 23°C on one dwelling and in the neighbouring property the occupants have placed their sofa against the only radiator in the open-plan space and consider their heating to be ineffective. The dwellings are served by a communal biomass system which also had technical difficulties and the occupants reported an inability of the heating system to simultaneously provide heat in the open-plan living room and the two bedrooms. To overcome this, bedroom radiators had been turned off. However, the (small) master bedroom maintained a comfortable temperature despite its north facing aspect and lack of solar gain. Thermography revealed the fridge/freezer and radiator in

Other building defects were identified using thermography and thermal bridges in large areas of external wall were identified, in particular surface temperatures in the sunspace were considerably cooler than the adjacent living room. There appeared to be insulation missing in the separating ceiling between vertical neighbours, which could be the route for the impact noise from the property above. It was noted occupants of both households did not frequently open bedroom windows to conserve heat, and condensation on windows and frames was observed. During feedback sessions the research team reported the recording of high CO₂ levels in bedrooms that during January 2014 peaked over 4550ppm correlating to an air flow rate of 1.42l/s (average 1595ppm (4.86l/s)) and advised that windows could be opened during the night to improve internal air quality. Following the feedback the occupants began opening their bedroom window during the night and during February 2014 the peaks were around 2525ppm (2.75l/s) with a February average of 1085ppm (8.37l/s). Although the peaks were above the recommended 1000ppm the occupants reported they had noticed an improvement in the quality of their sleep and the room was not as stuffy as before; they now routinely sleep with the window open.

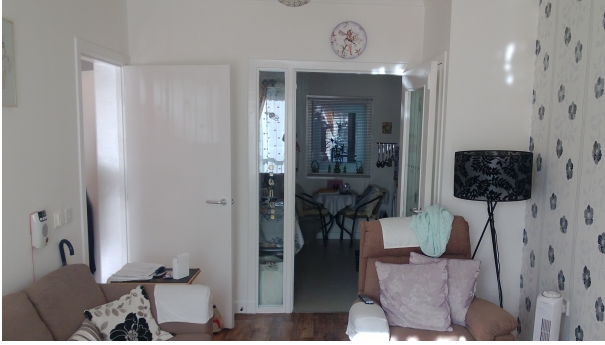
Figure 2: Living room with glazed partitions to kitchen for borrowed light, Case Study 3.

The kitchen is ventilated using a central mechanical extract unit which also serves the bathroom. This is light switch controlled and consequently activated when the bathroom and kitchen lights are on. The occupant had complained that the extract fan was not sufficient at removing smells from the property. The study identified poor quality of installation leading to the exhaust duct separating from the extract unit (located in the hall cupboard) which resulted in moisture, cooking smells and cigarette smoke extracted from the kitchen being dumped in to the hall cupboard and then distributed around the flat. This had implications on indoor air quality; stuffiness; smells and increased potential for microbial activity, which would have health implications for the occupant. Inadequacies in the extract system and increased use due to the lighting problem impacted on energy consumption, both through the ventilation system and the increased energy consumption from the kitchen lighting.
