Seismic behavior of an old masonry building in Vila Real de Santo António, Portugal

J. Ortega & G. Vasconcelos

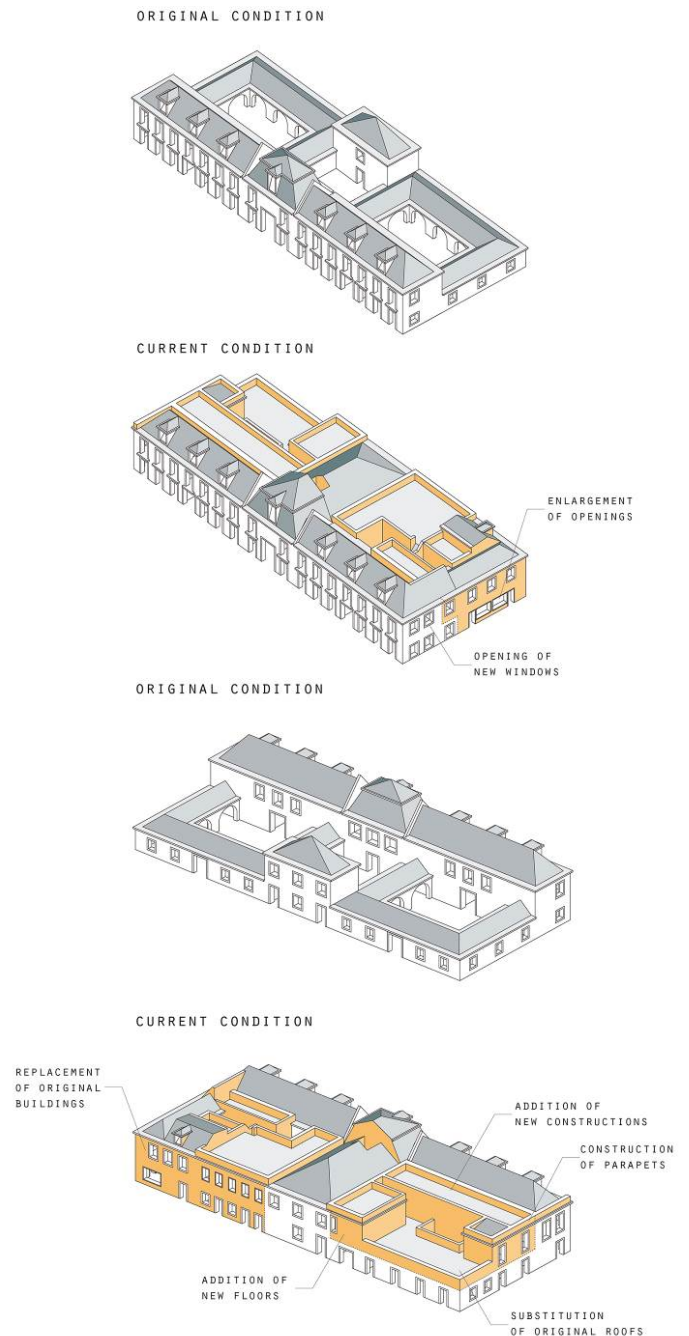
The *Alfândega* building overall preserves most of its original characteristics but the rest of the constructions within the block have suffered important alterations. The salting factories were either replaced with new buildings or highly altered (mainly by addition of new floors), while the original patios were occupied by additional constructions. There were also many alterations in the façade, such as the enlargement of the openings, the opening of new ones and the closing of others. Figure 4 shows an axonometric comparison between the original and current condition of the block.

All these changes may have increased the seismic vulnerability of the building. First of all, the original compact regular and rectangular plan configurations that typically behave better under seismic loading are completely modified. The accumulation of buildings within the patio has introduced setbacks and irregularities that may introduce torsional effects in the seismic response of the whole block. The addition of new floors to the original constructions has led to a significant increase in the height of the building and to the presence of adjacent buildings with different heights. This type of modifications can also entail the presence of staggered floors among the buildings within the block, which can be detrimental for the seismic response by introducing risk of hammering, particularly dangerous if the floors have been substituted for rigid reinforced concrete floors. This is important, since buildings within urban blocks do not behave independently and the actions of adjacent buildings should be taken into account.

Figure 4. Comparison between original and current state of the *Alfândega* block. The alterations are highlighted in orange.

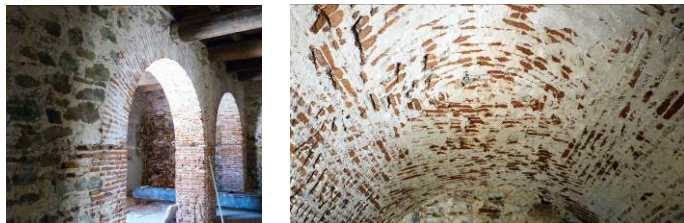
Figure 6. (left) Brick masonry arcades (right) brick masonry barrel vault.

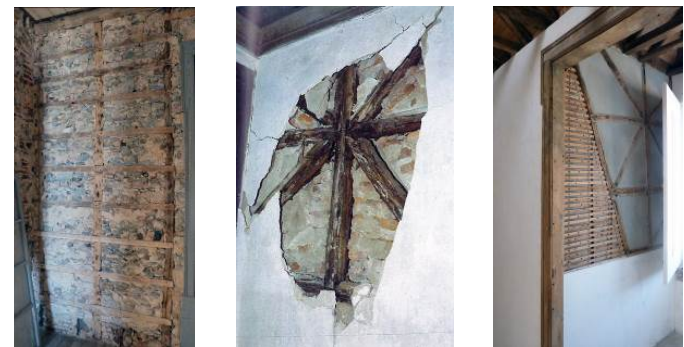
The first floor is more compartmentalized and the nonstructural light partition walls are made of different materials, some of them including timber frame structures showing different geometries (Figure 7). However, most of them do not seem to be original neither preserve their original structural bracing function. Another important alteration was the reconstruction of the mansard roof timber structure of the main building and the construction of a gable wall at the back part of the roof (Figure 8).

Figure 7. Different types of timber frame partition walls observed in the *Alfândega* building.

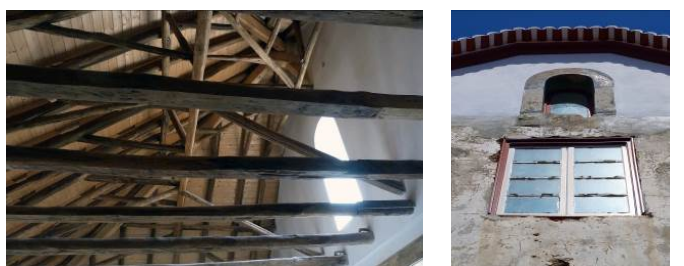
Figure 8. (left) Reconstructed timber mansard roof of the main building; (right) View from outside of the gable wall constructed at a later stage.

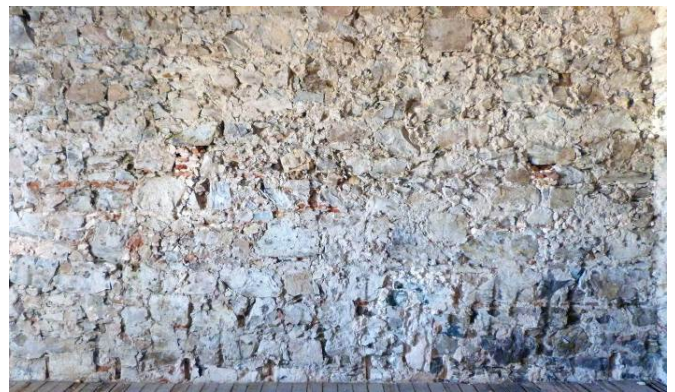
Load-bearing stone masonry walls are the main structural element. Since the walls masonry was exposed at the time of the visit, we could observe that it is composed of highly irregular units in size and shape with not respected horizontal courses, bonded with mortar and with pieces of brick and rubble inserted within (Figure 9). The morphology of the cross section could not be verified but after what could be observed in other buildings in the city, is most likely composed of two leaves with rubble in between. The walls thickness can vary between 0.60 and 0.70 m.

Figure 9. Stone masonry morphology.

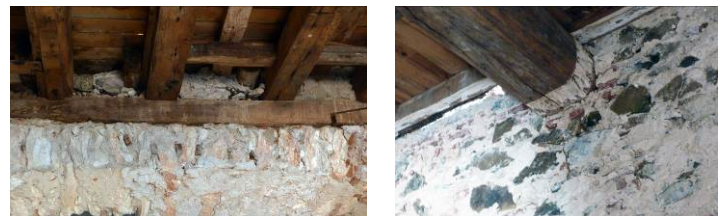
The timber beams composing the floor structure have a variable cross section that can be circular or rectangular, with dimensions significantly varying from around 0.15 up to around 0.30 m. diameter, and are in an overall good state of conservation. They are placed perpendicular to the façade and, in the main building, they rest on transverse timber plates, allowing a better distribution of stresses along the wall, while in the rest of the building, they pierce the stone masonry walls (Figure 10).

Figure 10. (left) Timber floor beams resting on transverse timber plate (right) Timber floor beams piercing the walls.

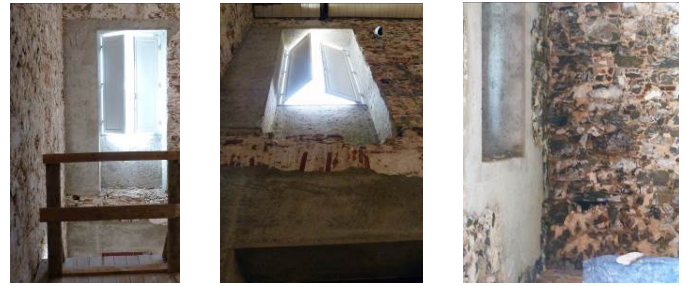
Figure 14. Different parts of the back wall partially reconstructed close to the connection with the longitudinal walls.

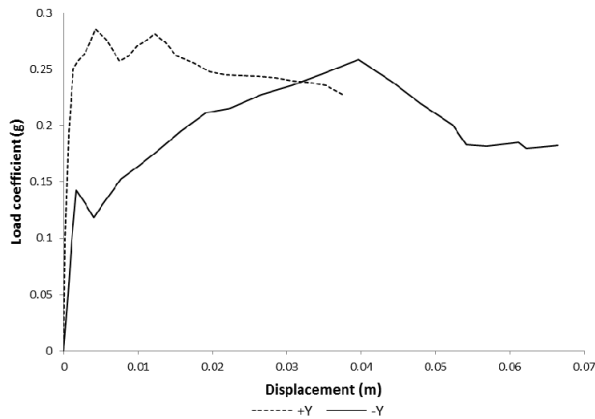
Figure 16. Capacity curves of the pushover analysis in + and - Y directions.

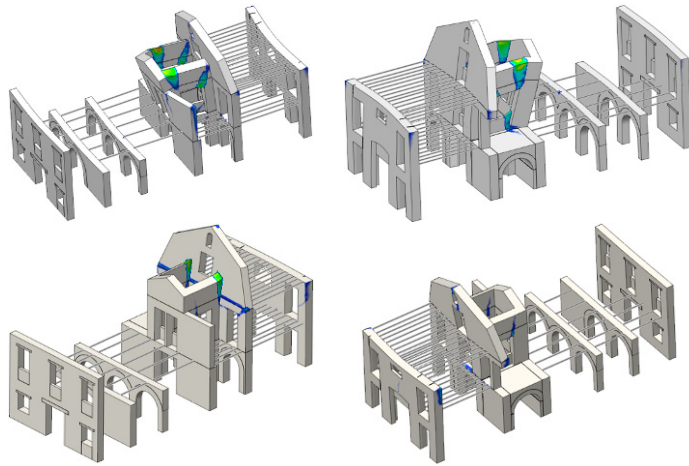
The maximum load coefficient obtained in the +Y direction is 0.28g and the failure mode consists of the out-of-plane rotation of one of the walls composing the courtyard. This failure is accelerated by the presence of big openings in the courtyard walls, which enhance their in-plane failure. As it could be expected, there is also important damage taken place at the connection of the transversal walls with the longitudinal one. Almost all the damage concentrates in the walls around the courtyard, except from some minor damage at the connections between the façade and the back wall with the longitudinal walls.

The pushover analysis in -Y direction reaches a maximum load coefficient of 0.25g. The lower capacity and higher deformation can be explained because the taller gable wall now rotates more freely, and the failure mode occurs because of out-of-plane rotation of this element. The horizontal crack that is also needed for the formation of this type of local mechanism can be clearly observed (Figure 17). This is a common failure mode of buildings that present gable walls, which are particularly vulnerable to seismic actions. Most of the damage concentrates at the connection with the perpendicular courtyard

walls, showing the separation between them. There is also damage at the connection of the gable wall with the longitudinal wall.

Figure 17. Maximum principal strains (a cracking measure) at peak load: (top) in +Y direction; (bottom) in -Y direction.

Again, the courtyard walls present widespread damage, revealing their in-plane failure, where cracks always arise from the opening edges. The cracks that occur at the top window of the tympanum and another crack developing at the middle part of the façade wall show also flexural bending failure taking place in both walls. This time, the façade wall shows more extended damage at the connection with the longitudinal wall.
