Lessons from the Great House: Condition and treatment history as prologue to site conservation and management at Casa Grande Ruins National Monument

Frank G. Matero

CONSERVATION AND MANAGEMENT OF ARCHAEOLOGICAL SITES

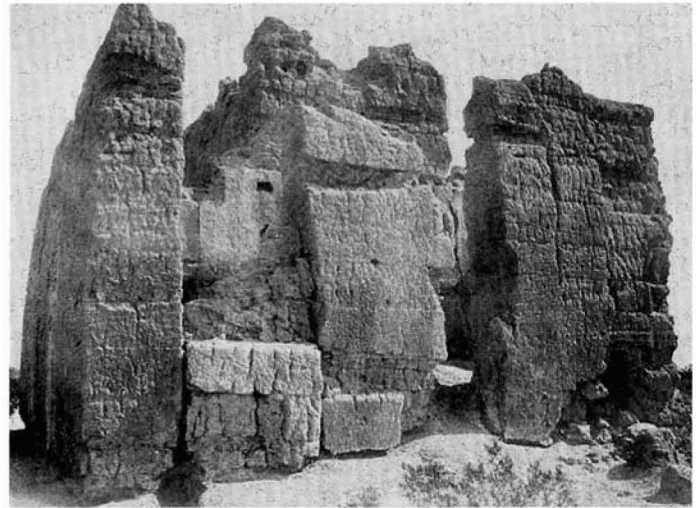
Figure 3. South elevation of the Casa Grande, c. 1888, published by Fewkes (1892). Note partial wall segment that collapsed by 1891–2.

Also visible in these photographs are the three wall segments that subsequently collapsed on the north, east and south elevations around 1891–2. Although Rizer in his completion report documents the loss of the south end of the exterior east wall and a separate section of the south wall during stabilization [10:321–42], it is clear from photographs during and after stabilization that the east end of the north wall also collapsed or was removed at that time. The instability of all these wall sections is clearly evident given the combination of unsupported wall ends on the northeast and southeast corners and their associated vertical construction seams and through-wall cracks, especially defining the fallen section of the south wall (compare Figs 3 and 4). Additional damage to the structure also may have occurred from the Sonoran Earthquake of 3 May 1887 but clearly most of the collapses occurred earlier.

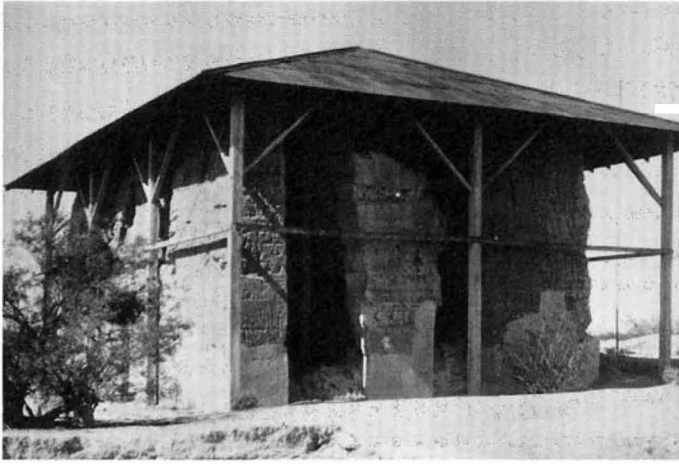
Figure 4. South and west elevations of the Casa Grande with its first 1903 shelter and Mindeleff repairs, c. 1910 (NPS/CAGR).

As recommended, a reassessment of the ruin was made by W. J. McGee in 1895 after field visits and comparison with photographs taken in 1892 before preservation work began. While comparison showed no perceptible change over most of the walls, conditions on the south and east walls were found to have worsened in just three years. He reported: 'the profiles are more extensively modified ... some of the old crevices are widened and deepened, and some new crevices appear; and in some parts it can be seen that the walls are lowered several inches ... destruction is proceeding at a not inconsiderable rate' [10:348]. If accurate, this supports earlier and current observations regarding the severe condition and exposure of the south and east elevations due to the prevailing winds and storms. Eventually, in 1903, with another \$2000 of funding secured by Congress, a redwood and corrugated iron roof shelter was constructed over the Casa Grande closely following the design published earlier by Mindeleff [10: Plate CXXIV] (Fig. 4).

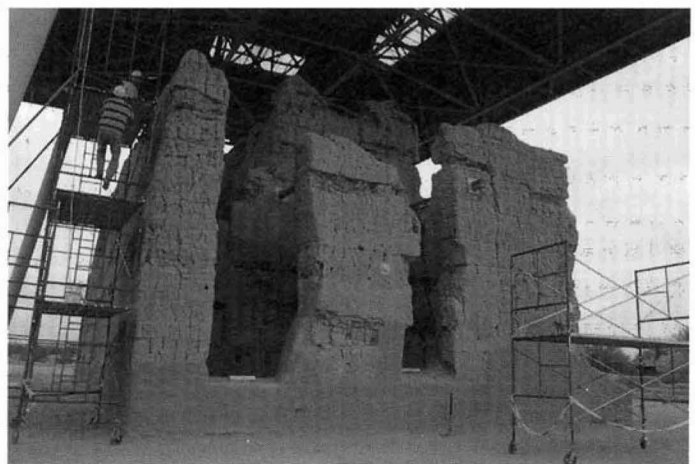
Figure 5. South elevation of the Casa Grande, 1997. Compare with Figs 3 and 4 (ACL (UPENN)).

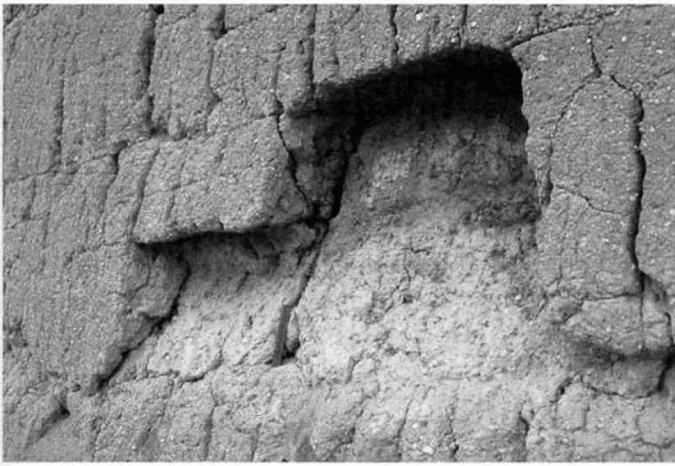
Figure 6. Lower west wall of the Casa Grande, north end showing area of detachment and loss in 1975 (left) and 1995 (right), 1998 (ACL).

Differential deterioration is not only due to physico-chemical changes in the caliche. Other intrinsic causes of deterioration are construction-related combined with subsequent damage from timber removal. Extrinsic factors have been responsible for aggravating existing intrinsic problems resulting in the various detachment of fragments and cracking of the Great House. Site observations based on patterns of deterioration, along with results obtained from the wall conditions survey and the present characterization of the caliche have provided additional information on wall construction and construction sequencing of the Great House, thus extending recent investigations of the original construction [13,14]. The integration of such findings has allowed new interpretations of the differential weathering of the structure, especially in relation to the large fragment detachments that have been occurring at various locations (Figs 6 and 7).

Detachment cracking, on the other hand, represents a very different problem. Although insignificant in appearance, its association with detachment indicates the potential for large losses of lens-shaped fragments. These have occurred in both isolated and associated areas of the exterior and interior as indicated by several recorded events over the past fifty years and probably even earlier, judging from the presence of tell-tale lens-shaped losses on the surface. This peculiar condition appears to be clue to inherent planes of weakness within the walls caused by the mounding or puddling of large and small units of prepared caliche, especially along the lower courses, often above now unsupported areas (Figs 6–7). Given the blind nature of these failures, incipient detachment can occur for a long period of time undetected, allowing additional damage from animal activity and salt formation such as was observed in association with the most recent spall on the west exterior in 1995, and earlier in 1975.

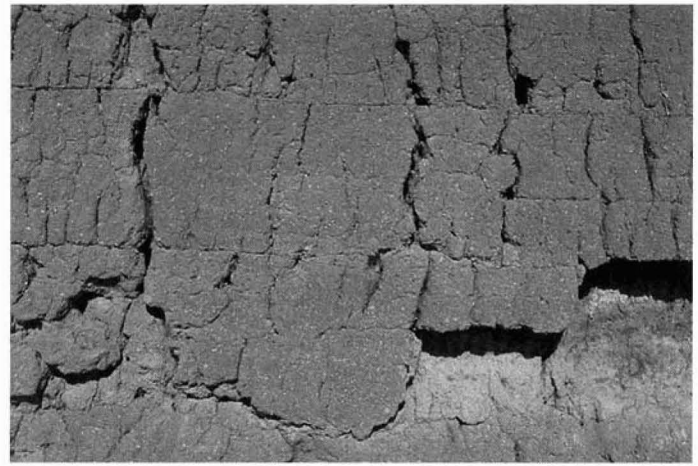
Figure 7. Lower west wall of the Casa Grande, north end adjacent to Fig. 6. Note cracking and detachment cracking indicative of potential future loss (ACL).

similar to 'English cob' was employed. Research conducted during the present study also suggests that more than one system may have been employed to construct the walls in which larger 'dumps' of the puddled caliche may have been used in combination with the smaller hand-moulded units to create the horizontal wall courses. This aspect of construction is important as it may explain the characteristic detachments or spalls of both large and small fragments that have occurred over time as the result of the weathering of the puddled earth of various but prescribed sizes making up the wall cross-section (Figs 6 and 7).

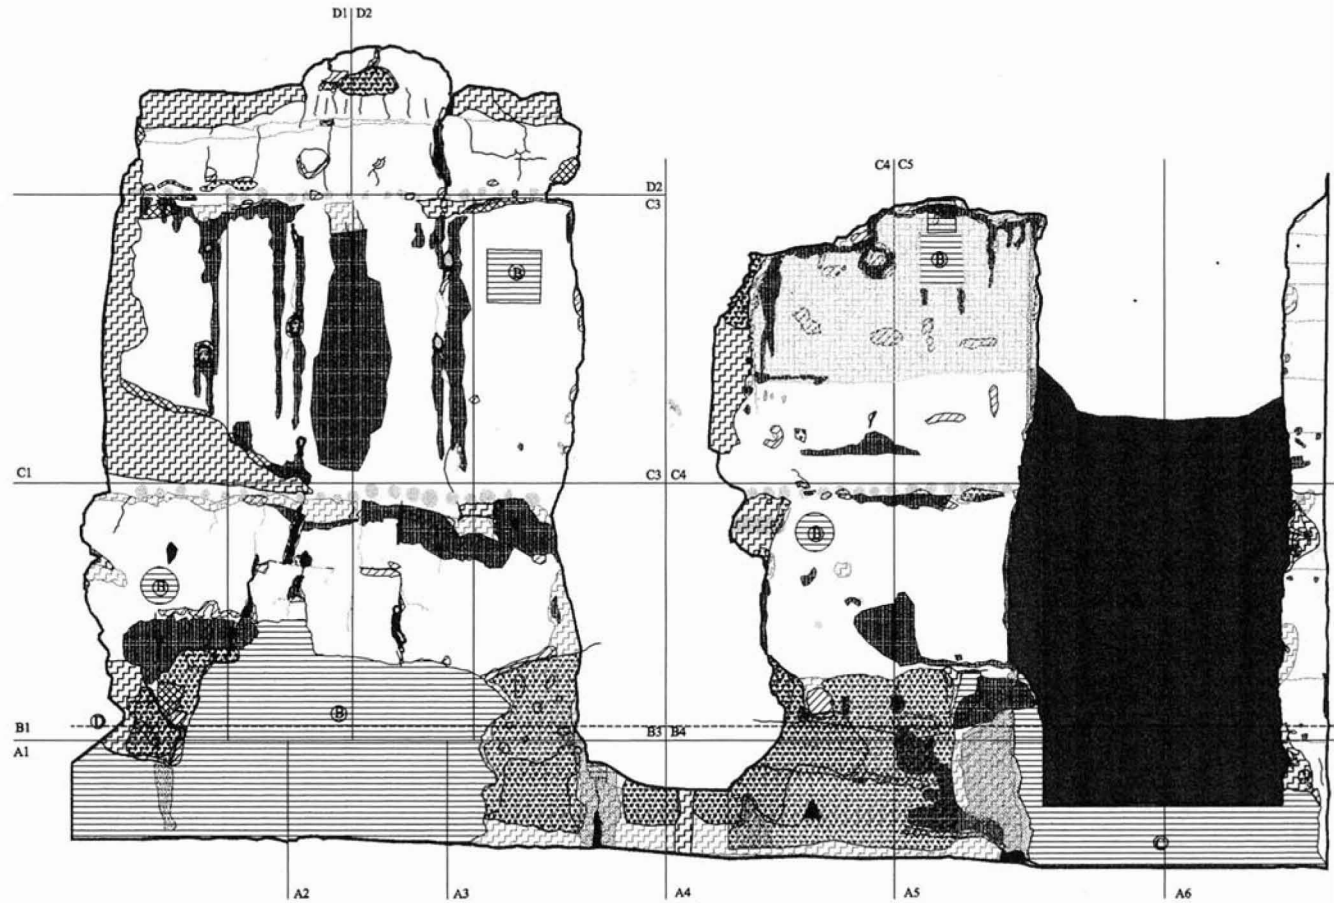
TIER E SOUTH

Figure 8. Representative elevation of wall conditions survey, Tier E, south interior wall, 1997-8 (ACL).
