Quantitative Analysis and Treatment of Pennsylvania Blue Marble at the Philadelphia Merchants' Exchange

Presented to the Faculties of the University of Pennsylvania in Partial Fulfillment of the Requirements for the Degree of Master of Science in Historic Preservation.

Felicia Lyles McBratney

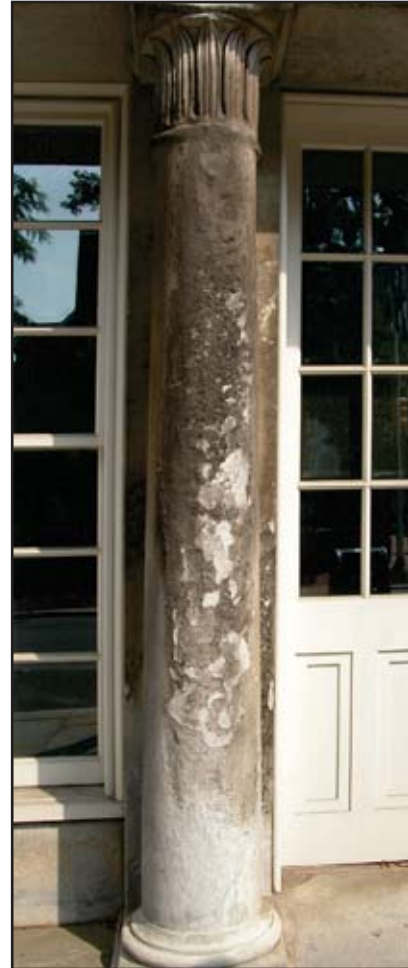
Figure 1.2: West Elevation, column 3, summer 2004

As a result of the condition survey, two major deterioration factors were identified. These are the presence of acid air pollutants and freeze-thaw cycles. The presence of air pollutants, originating from vehicular traffic and nearby local industry, result in the formation of black crusts, characteristic of marble decay in urban areas. The reaction of the pollutant gases, primarily sulfur oxides, with the marble leads to the formation of gypsum, a slightly soluble salt. The surface blackening is due to the deposition of dirt, fly ash, and carbon particles that are trapped on the surface and incorporated into the gypsum crust, as seen in Figure 1.2.

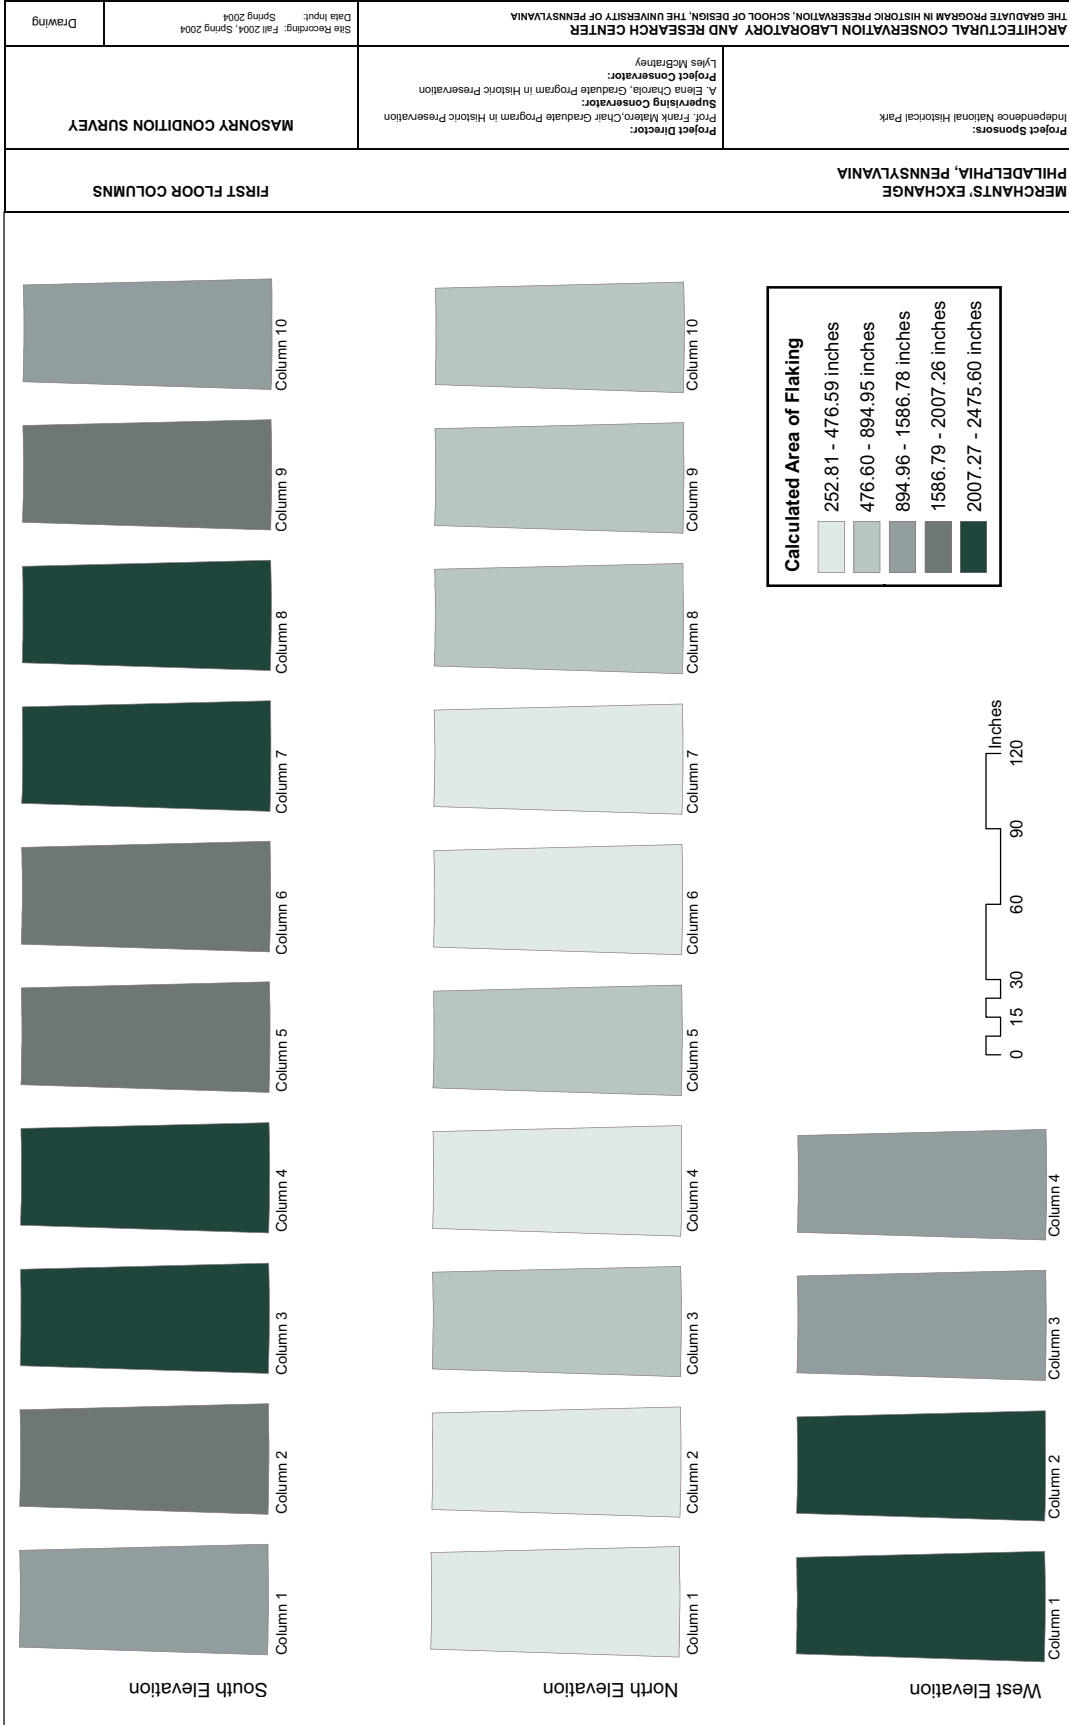
Figure 4-9: GIS Masonry Condition Survey Drawing, Type II. Calculated surface area of flaking on all columns, indicating larger areas of flaking on the south and west elevation columns.

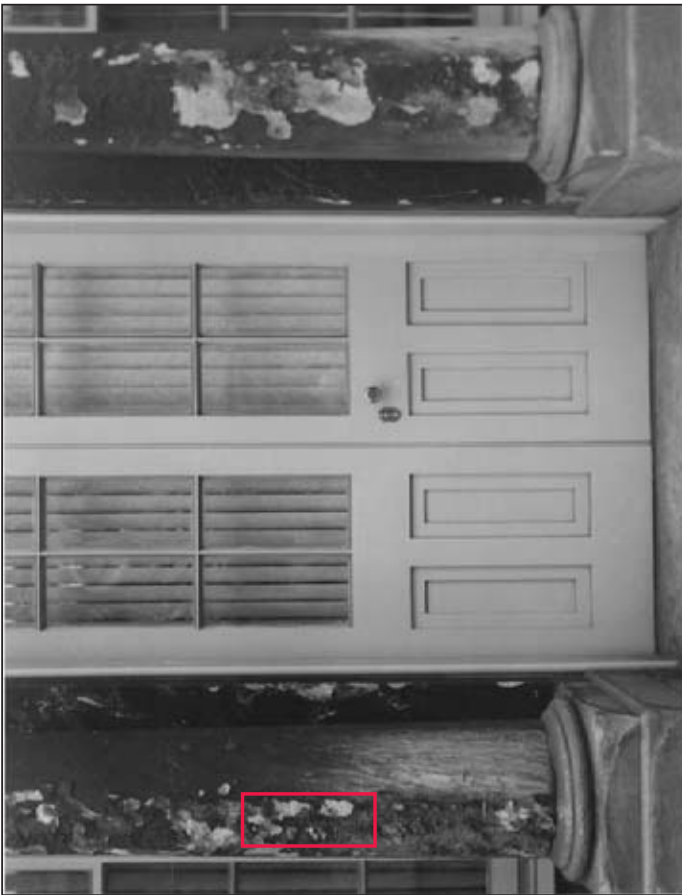
Figure 4.18:
South Elevation, columns 9 and 10
Source: INHP Archives
Caption: Merchants' Exchange marble
deterioration
Creator: W. A. McCullough
Date: April 5, 1961

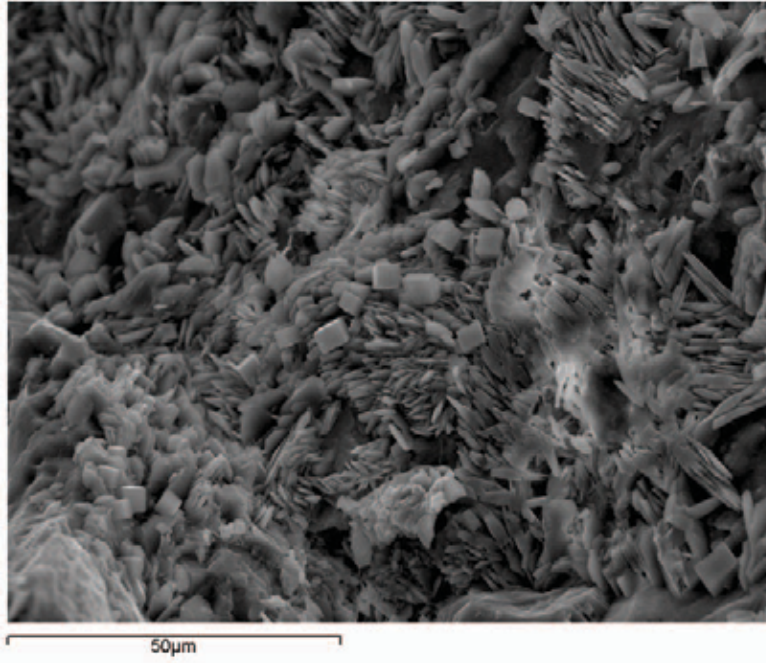
Figure 4.34:
Sample ID: W-4 Before Sample Location: West elevation, column 4
SEM Photomicrograph, 1000x, showing platy gypsum crystals and cubic halite crystals

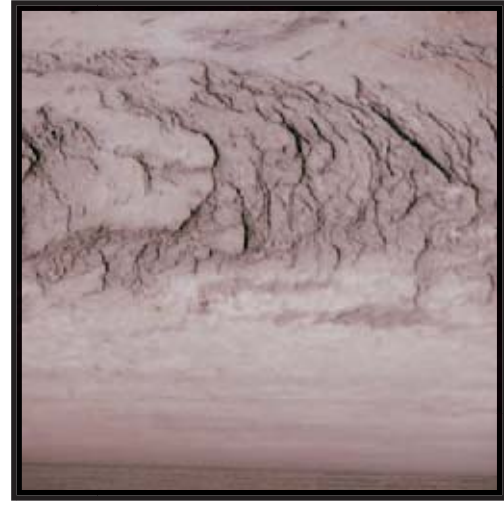
(c) flaking associated with mineral inclusions

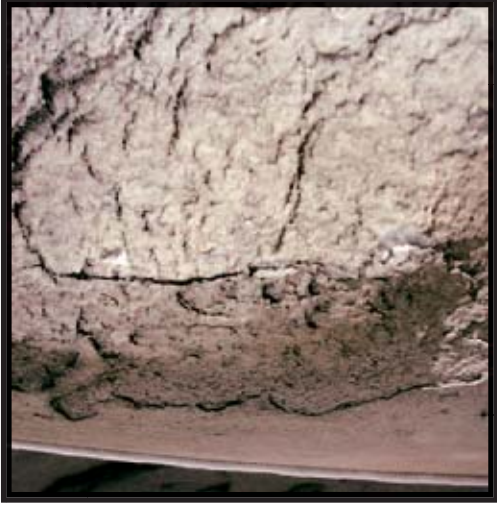
large blister detaching from stone surface

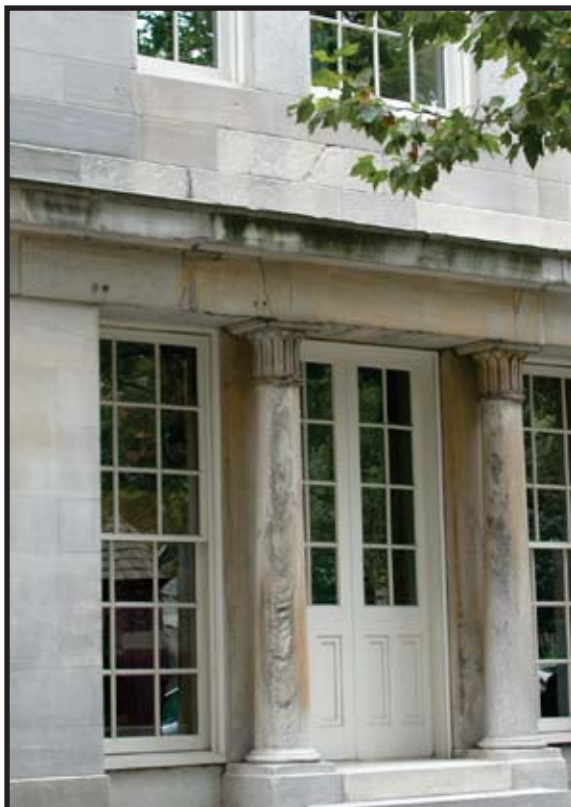
Figure C.10:
North elevation, Summer 2004
Columns 9 and 10
Source: University of Pennsylvan-
ia

Comments: Column 9 still exhib-
its contour scaling. The deteriora-
tion that has occurred since 1975
is only slightly advanced.

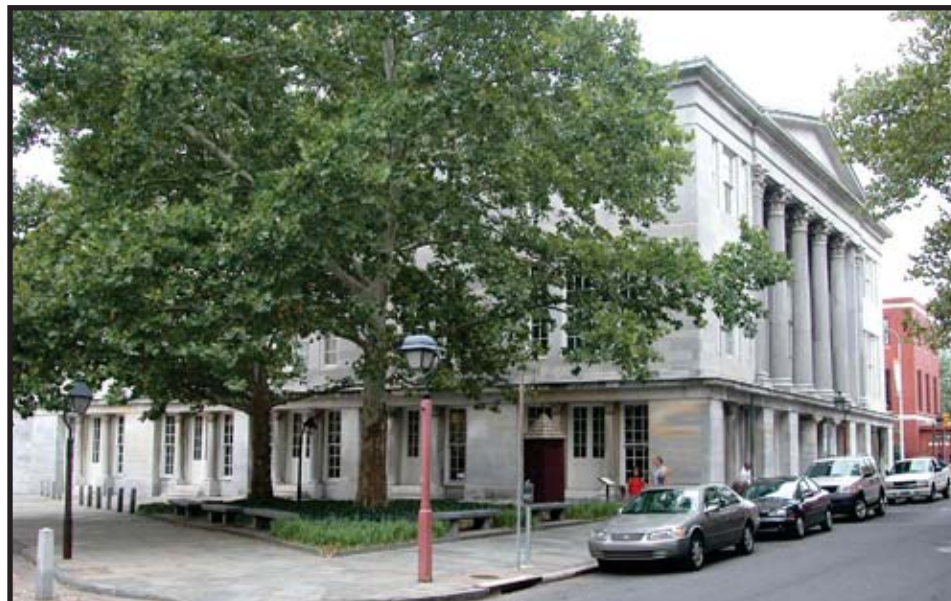
Figure C.14:
North elevation, Summer 2004
Source: University of Pennsylvania

Comments: The surrounding conditions on the north façade of the Merchants' Exchange have drastically changed. The historic photograph shows a darkened soiled façade behind a gas station with parking next to the building. The current photograph shows that these surrounding conditions have been removed, Dock Street was blocked off in 1962 and the location of the gas station and parking has been filled with sidewalks and plantings.

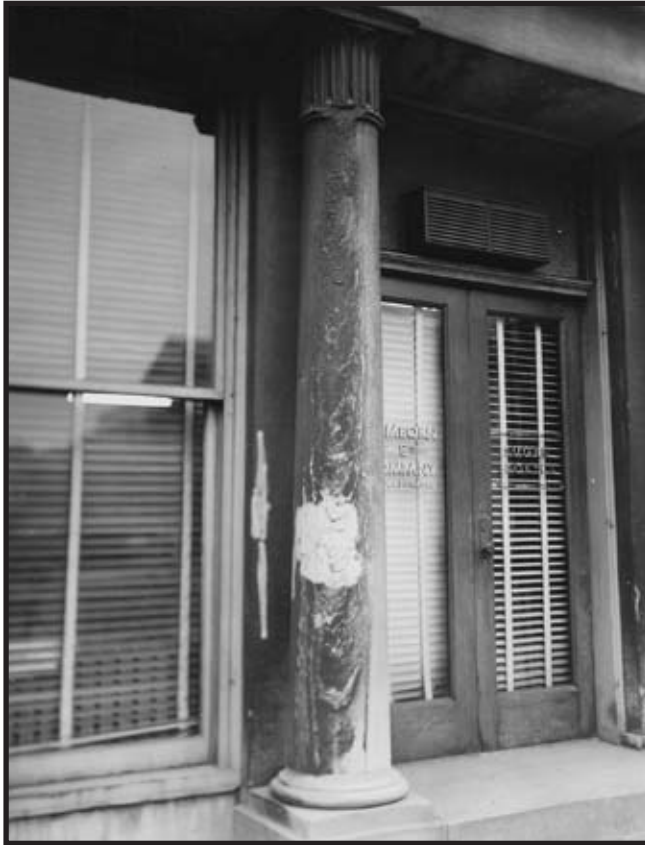
Figure C.19:
North elevation, column 9
Source: INHP Archives,
Historical Society of
Philadelphia
Caption: Merchants'
Exchange: north elevation,
note: deterioration of
stonework on column
Creator: PH
Date: February 19, 1957

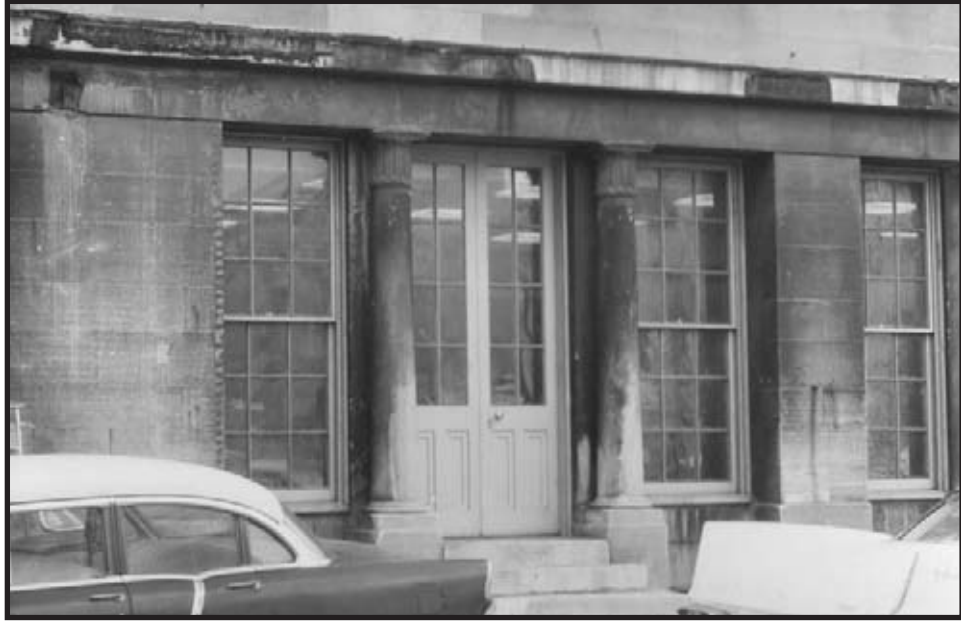
Figure C.21:
North elevation, columns 3 and 4 (second bay from the east)
Source: INHP Archives
Caption: Merchants' Exchange – bay deterioration
Creator: W. A. McCullough
Date: March 16, 1961

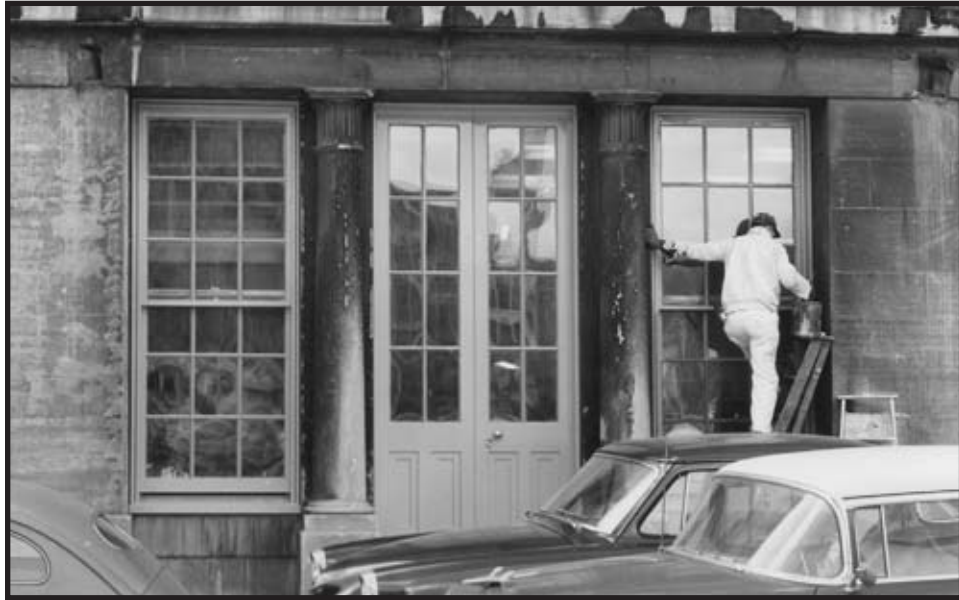
Figure C.23:
North elevation, columns 1 and 2 (first bay from the east)
Source: INHP Archives
Caption: Merchants' Exchange – bay deterioration
Creator: W. A. McCullough
Date: March 16, 1961

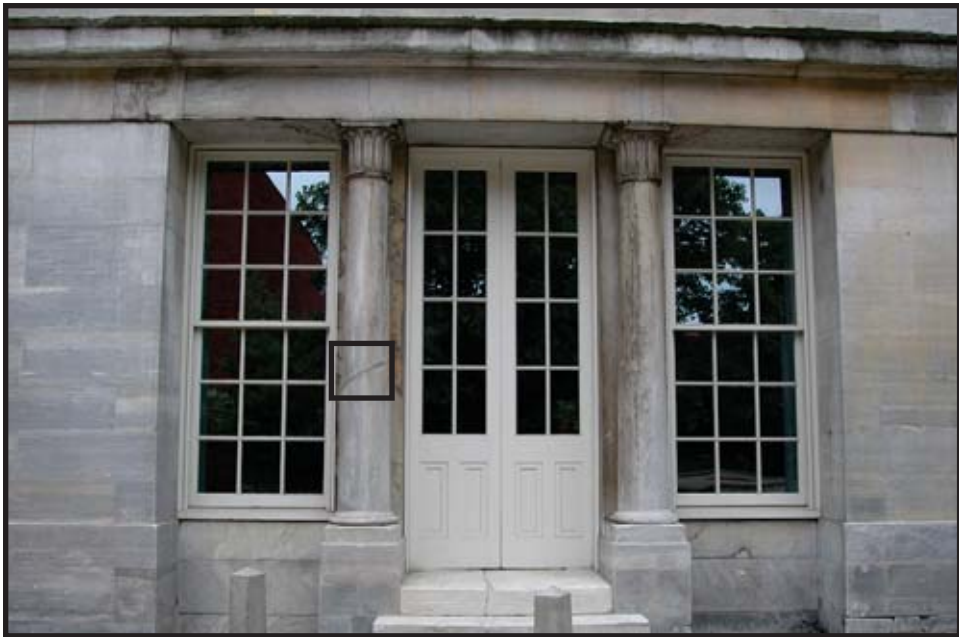
Figure C.24:
North elevation, columns 1 and 2
Summer 2004
Source: University of Pennsylvania
Note on column 1, a composite repair that runs diagonally across the the column that was not present in the historic photograph.

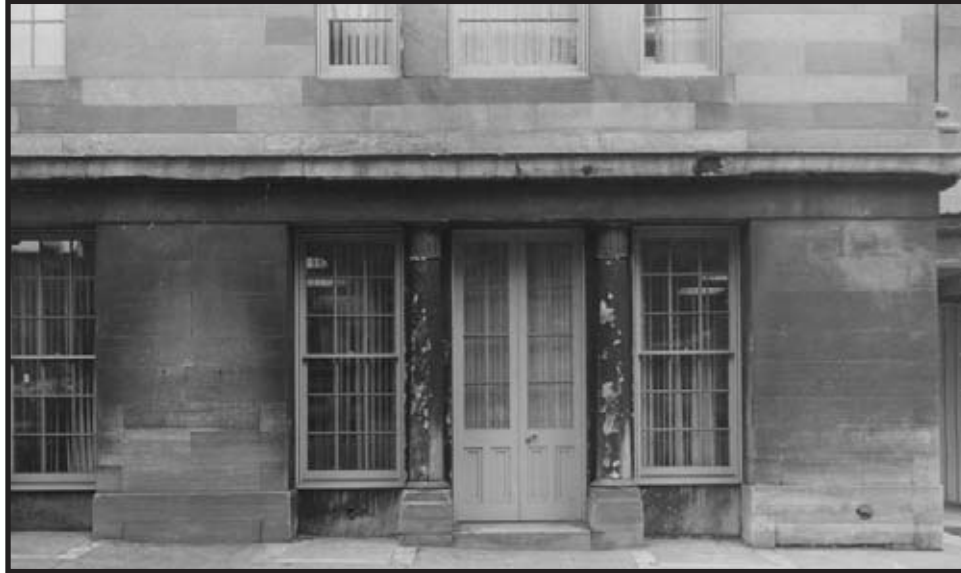
Figure C.37:
South elevation, columns 9 and 10
Source: INHP Archives
Caption: Merchants' Exchange marble deterioration detail
Creator: W. A. McCullough
Date: April 5, 1961

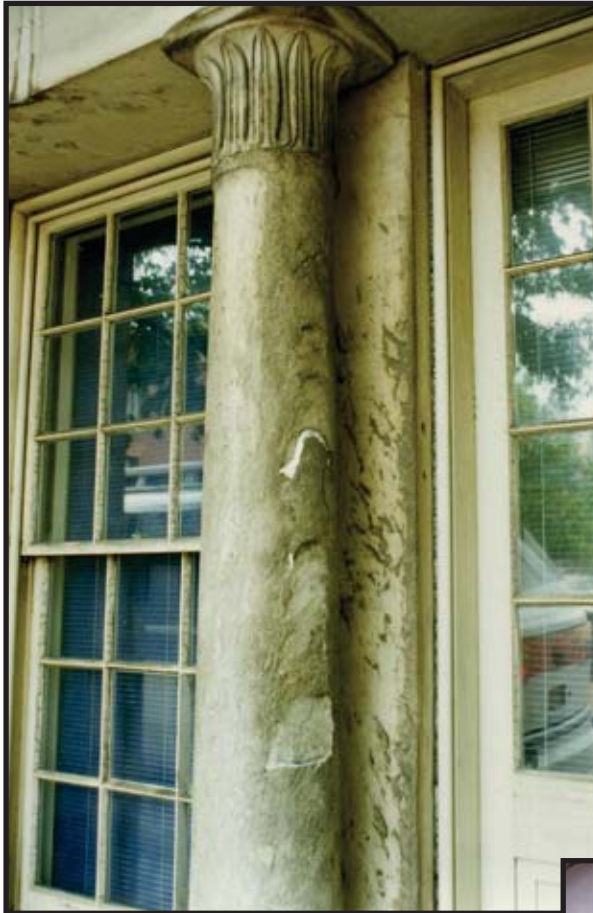
Figure C.46:
 South elevation, column 2
 Source: INHP Architects' office
 Caption: Merchants' Exchange: south elevation column with marble decay and fill
 Date: September 1993

Comments: The most evident deterioration mechanisms shown in the historic photograph are contour scaling and dimensional loss. The caption of the photographs mentions a "fill", which is no longer present. There is a clear up-side-down u-shaped pattern of contour scaling which follows the stone's orientation and correlates to the location of mica mineral inclusions. The action of contour scaling is compounded by the presence of salts and freeze-thaw action. This deterioration pattern is evident in both the historic and current photographs.
