Managing Change: The Role of Documentation and Condition Survey at Mesa Verde National Park

Frank G. Matero

Journal of the American Institute for Conservation, Vol. 42, No. 1, Architecture Issue. (Spring, 2003), pp. 39-58.

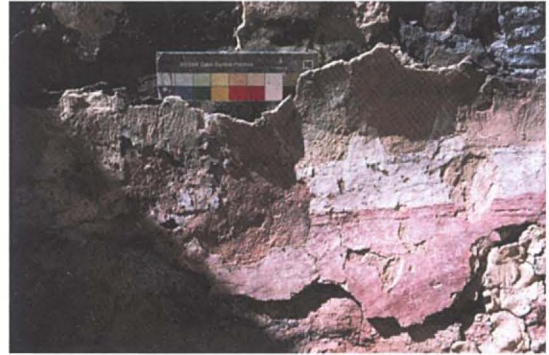
Fig. 4. Mug House, Kiva C, 1995, showing detail of detachment, delamination, and flaking before treatment. Courtesy Architectural Conservation Laboratory, University of Pennsylvania

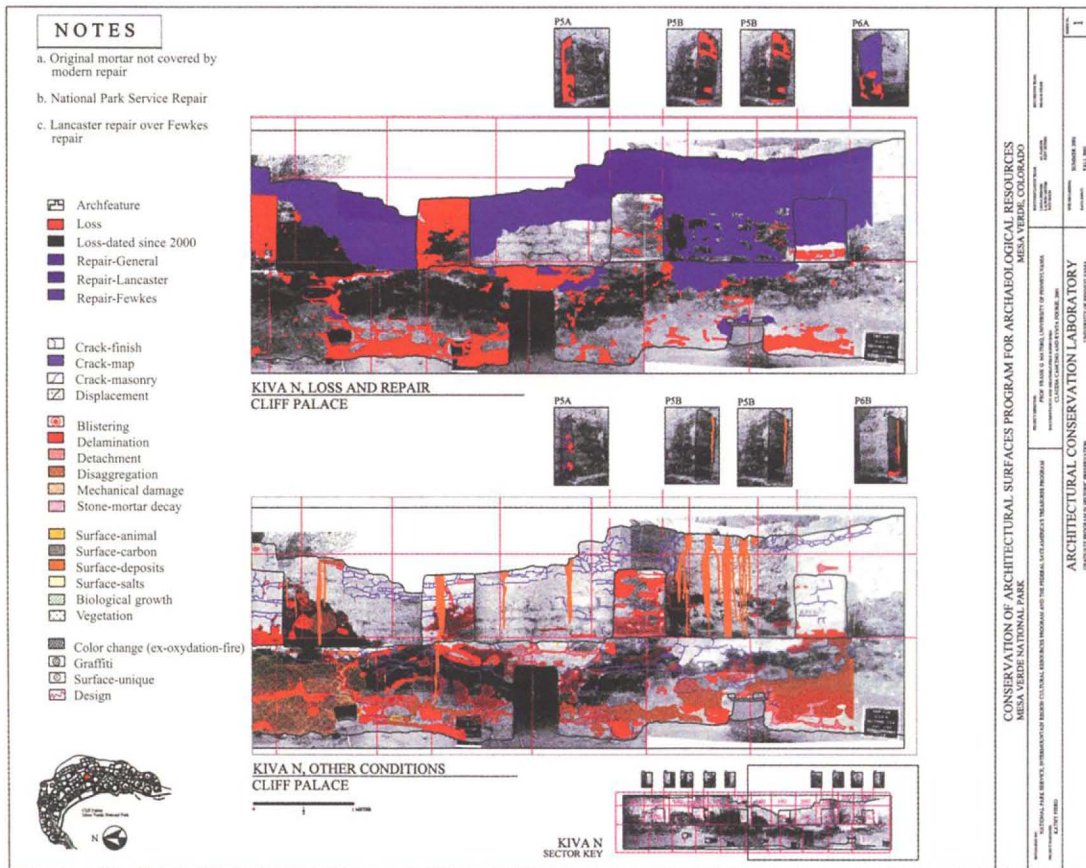
Fig. 5. Elevation montage of Kiva N, Cliff Palace, conditions. Courtesy Architectural Conservation Laboratory, University of Pennsylvania

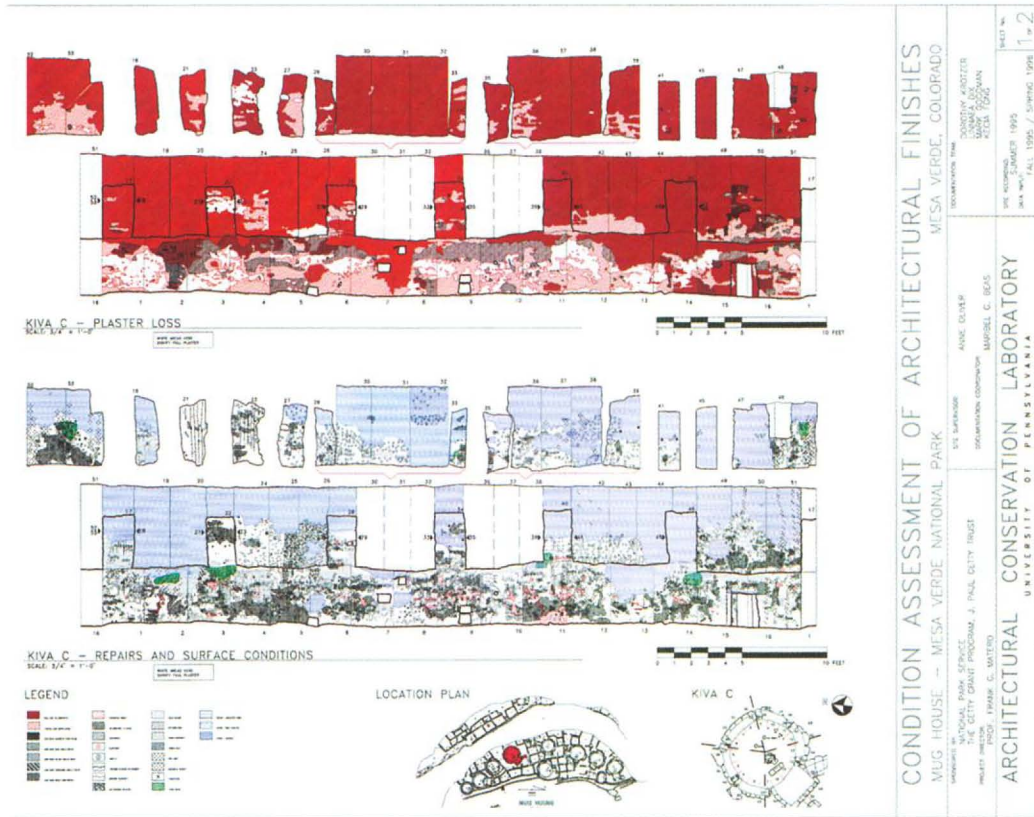
Fig. 6. AutoCAD elevation of Kiva C, Mug House, showing all recorded conditions, past and present. Courtesy Architectural Conservation Laboratory, University of Pennsylvania

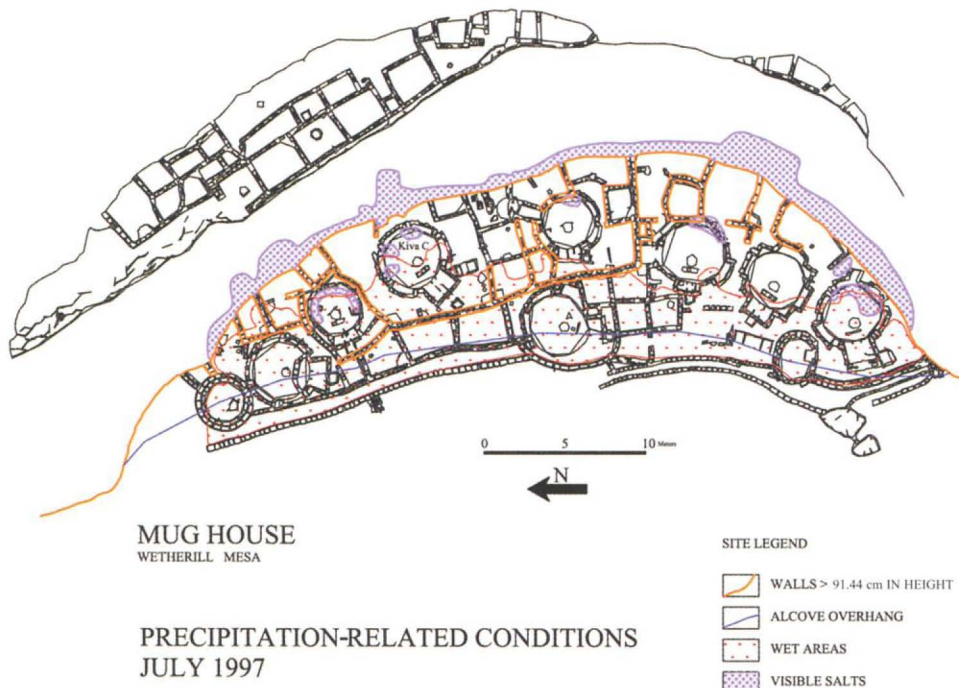
- Room/space location and orientation, in terms of exposure and grade, are significant factors in determining the overall condition of the stone, mortar, and architectural finishes of alcove sites, all other factors being equal. This relationship is due predominantly to the deleterious effects of water on the earthen materials either as direct precipitation (melting snow and rain) or as groundwater from percolation and rising damp through the sandstone (fig. 7, see page 60).

Overall patterns of groundwater emergence for the entire alcove are further complicated by the orientation of the north-south dip of the alcove's shaley layers, which affects the location and quantity of water emerging from the rock. For example, those kivas and rooms located along the rear of the northern half of Mug House, upslope of the shaley seam, exhibit far more salts, presumably due to the initial discharge of water at this end. Conversely, rooms along the rear of the southern half, downslope of the shaley seam, display less efflorescence and water damage where protected from wind-driven rain and snow.

Fig. 7. Plan of Mug House showing field-observed patterns of precipitation and active efflorescence. Courtesy Architectural Conservation Laboratory, University of Pennsylvania

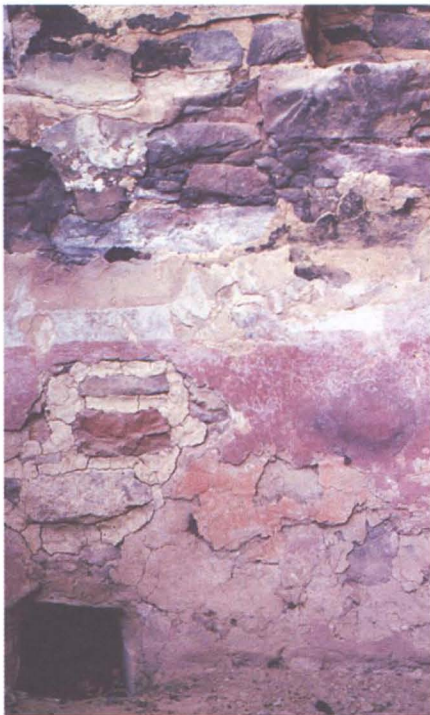
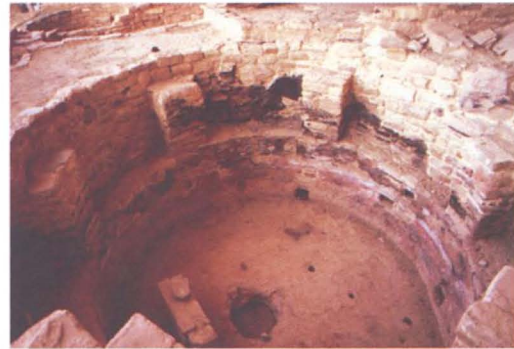
In Kiva C (and most other kivas), nearly all loss has occurred across the upper walls and along the upper quarter of the lower banquette walls (fig. 8, see page 61). This loss pattern is due to the overall vulnerability of these areas to weather exposure during occupation from roof leaks (prehistoric repairs are often found in the upper walls), after abandonment from associated roof collapse, and after excavation and rebuilding during stabilization. Early prestabilization photographs of Kiva C (1935) show masonry and roof collapse, exposed upper walls, and total plaster loss (fig. 9). The lower banquette walls—being concealed and possibly protected by fallen roof and debris—were observed in 1935 to be generally intact, a situation common for many kivas in cliff sites. A comparison of the extent of surviving plaster evident immediately after excavation and stabilization in 1959–60 to today overwhelmingly illustrates the loss of plaster that often results after excavation. At Kiva C more than 25% (surface area) of the existing plaster finishes recorded in 1960 was subsequently lost over the next 40 years of exposure, most of the loss occurring along the upper banquette.

The finishes on the walls directly under the flat banquette ledges between the pilasters succumb to the wind-driven rain and melting snow that accumulate on these flat, horizontal upper surfaces along the outer west and northwest sections. This pattern of precipitation has been observed in action and can be deduced from the succession of related conditions along the upper banquette wall, beginning at the top with total loss and detachment and deformation of the remaining plaster edges, to partial loss and delamination lower down the wall. The telltale evidence of new and old soil wash patterns in these locations down the upper and lower walls (monitored over two years) clearly points to active water flow channeling. This activity leads to the probable sequence of plaster decay including saturation, swelling, and shrinking of the clay fraction of the finishes, salt formation, deformation, blistering and detachment of the layers, debris accumulation in the detachment, and eventual mechanical failure and loss. These conditions have been recently induced in sequence through laboratory simulation in preparation for treatment testing and evaluation. Changes in partial loss over time clearly indicate the active nature of this condition in exposed areas (Carr 2002).

Fig. 8. Kiva C, Mug House, north end, 1994, before treatment. Courtesy Architectural Conservation Laboratory, University of Pennsylvania

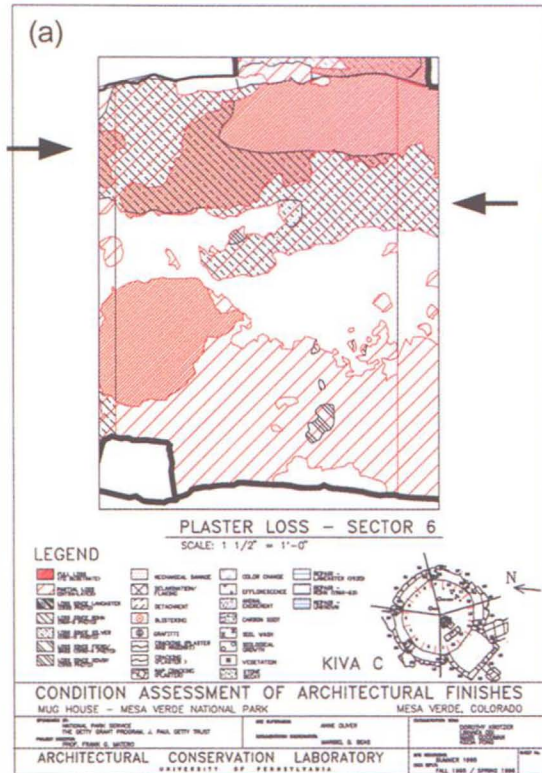
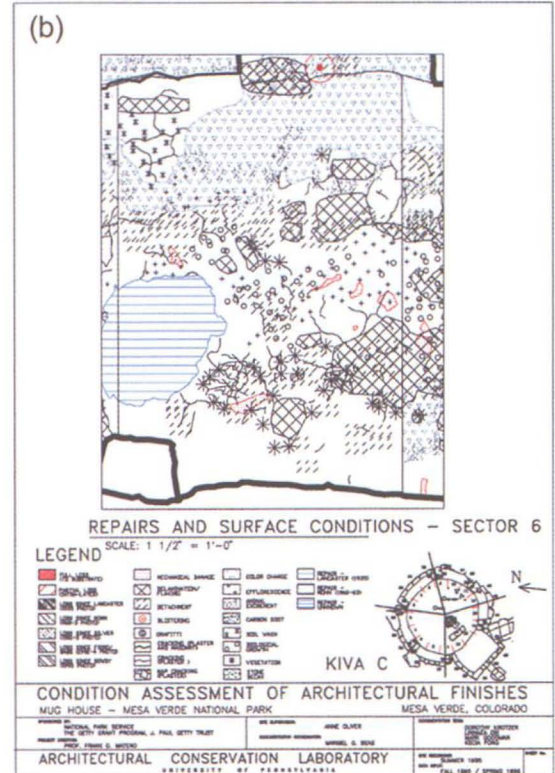
Note areas of loss since excavation (1959–60).

Fig. 10. Kiva C, Mug House, Sector 6-conditions. Arrows indicate areas of loss since excavation (1959–60) in a. Sector 6 photo elevation and condition drawing. Courtesy Architectural Conservation Laboratory, University of Pennsylvania

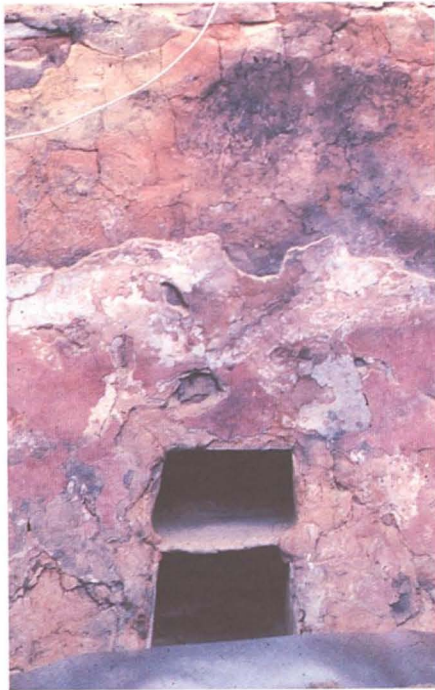
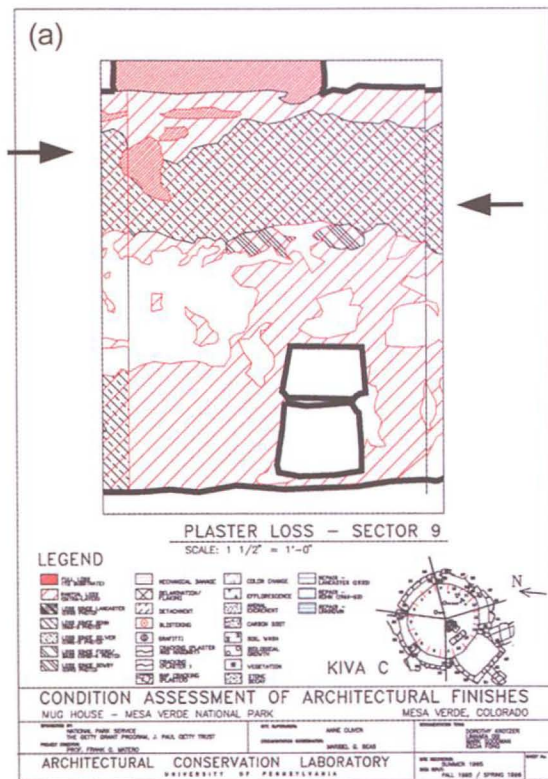
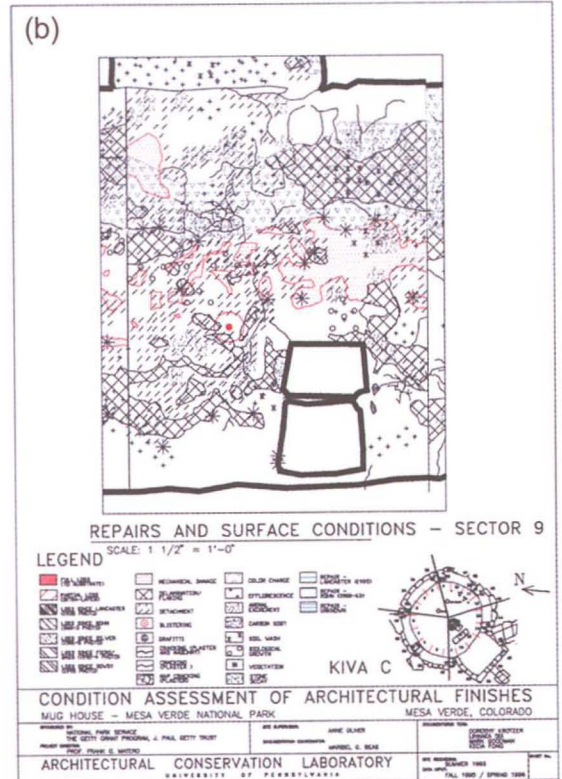
Fig. 11. Kiva C, Mug House, Sector 9—conditions. Arrows indicate areas of loss since excavation (1959–60) (a) and salts and flaking in lower wall (b). Sector 9 photo elevation and condition drawing. Courtesy Architectural Conservation Laboratory, University of Pennsylvania

Note areas of loss since excavation (1959–60).

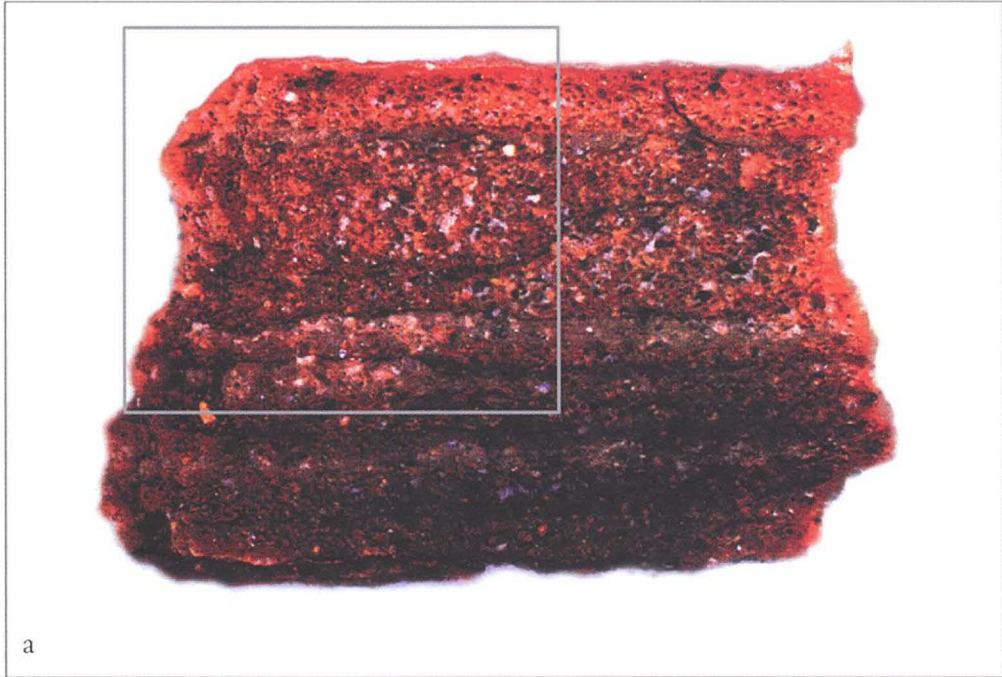
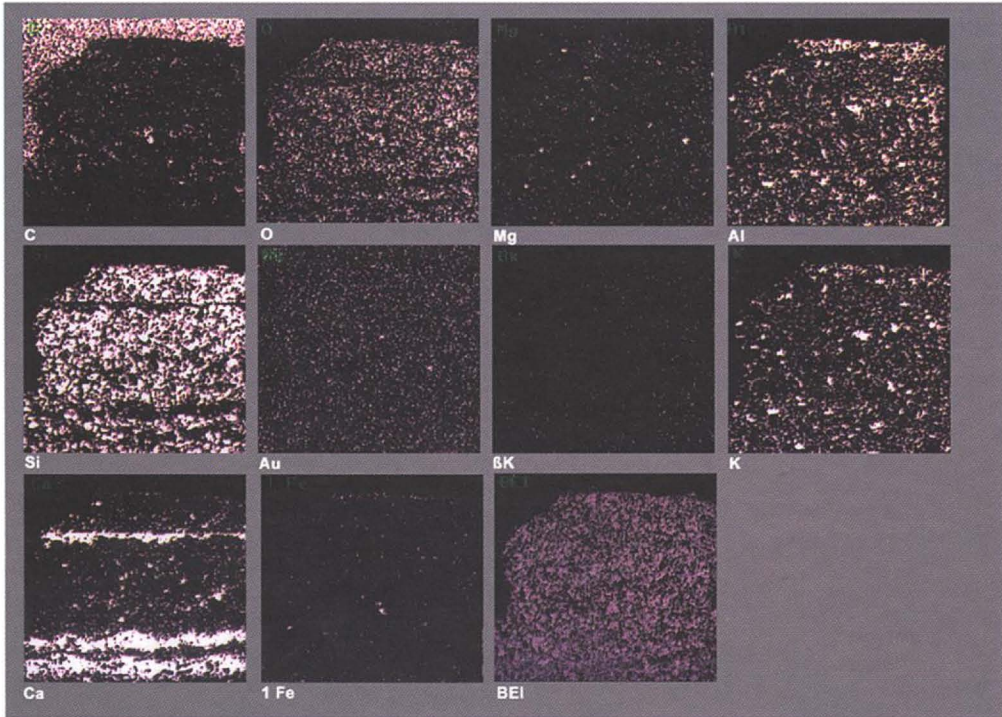
tion, is without doubt a significant factor in finish condition. With very few exceptions, each plaster layer applied probably represents a single campaign, evidenced by heavy carbon soot buildup and separation fractures that often occur between layers over time. Of all the building and room types, kivas, without exception, contain the greatest number and most complex application of surface finish layers and intralayer soot deposits (fig. 12, see page 63). This condition may well be due to the largely ceremonial

Fig. 12. Kiva C, Mug House, cross section, 25x in reflected light (a) and SEM electron dot map of sample 06 from lower dado wall identifying elemental composition of layers (b) (Dix 1996). Courtesy Architectural Conservation Laboratory, University of Pennsylvania
