# A Diagnostic Study and Treatment Evaluation for the Cleaning of Perry's Victory and International Peace Memorial

Frank G. Matero

Reprinted from *Bulletin of the Association for Preservation Technology*, Volume 16, Issue 3/4, National Park Service, 1984, pages 39-51.

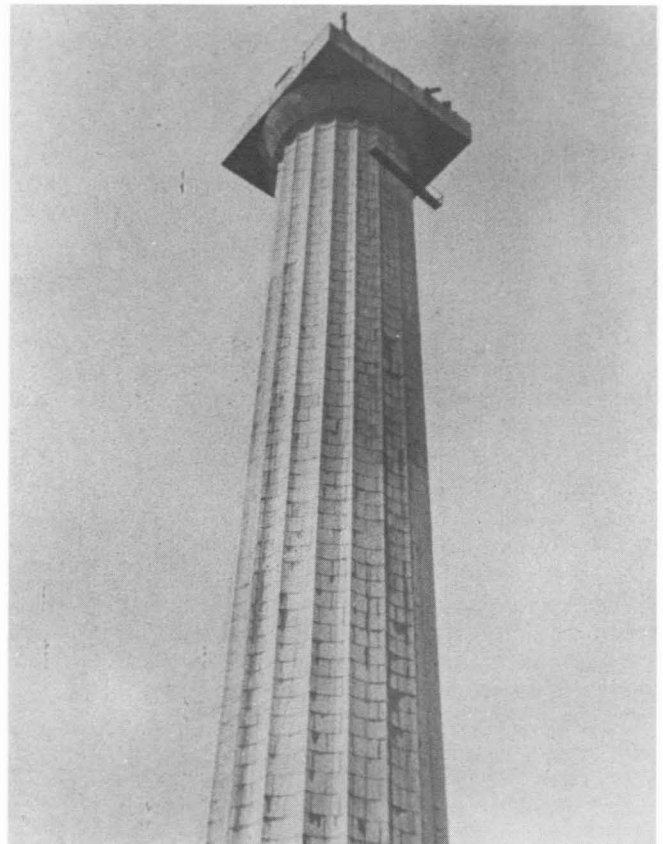
2. Perry Memorial: Construction photograph (1914).

Nonetheless, staining of some sort can be seen in several construction photographs taken prior to sand-blasting and repointing (Fig. 2), as well as in early photographs of the completed monument in ca. 1920 (Fig. 3). While it would be reasonable to assume the entrapment of water within the *open* joints of the column *prior* to final pointing and hence the formation of continually wet areas (possibly the dark staining in the 1914 photograph), a similar staining phenomenon observed in the later photographs (after cleaning and pointing) cannot be attributed to these same conditions (i.e., water in open joints). Viewed collectively, the photographs spanning the years between 1920 and the present indicate that surface staining has been and continues to be an active process and one of serious concern due to its apparent acceleration in recent years (Figs. 3-13).

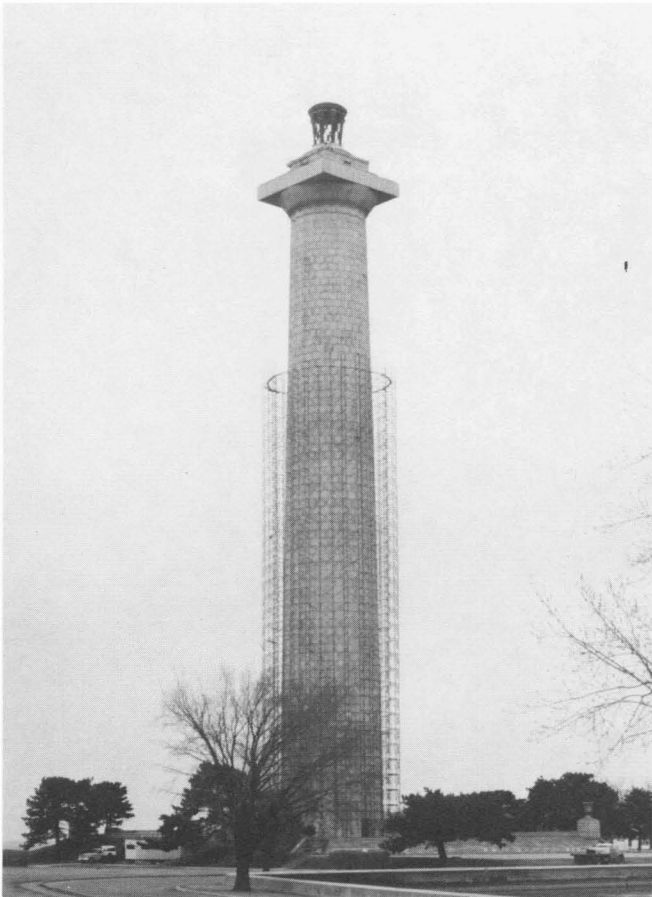
13. Perry Memorial Column (1981).

Despite repeated attempts in 1952 (Figs. 7-9) and 1964 (Figs. 10-12) to remove the surface staining using low pressure abrasive cleaning, the dark discoloration was not effectively removed and white deposits were removed only temporarily. Both conditions still prevailed in 1981 (Figs. 13 & 14).

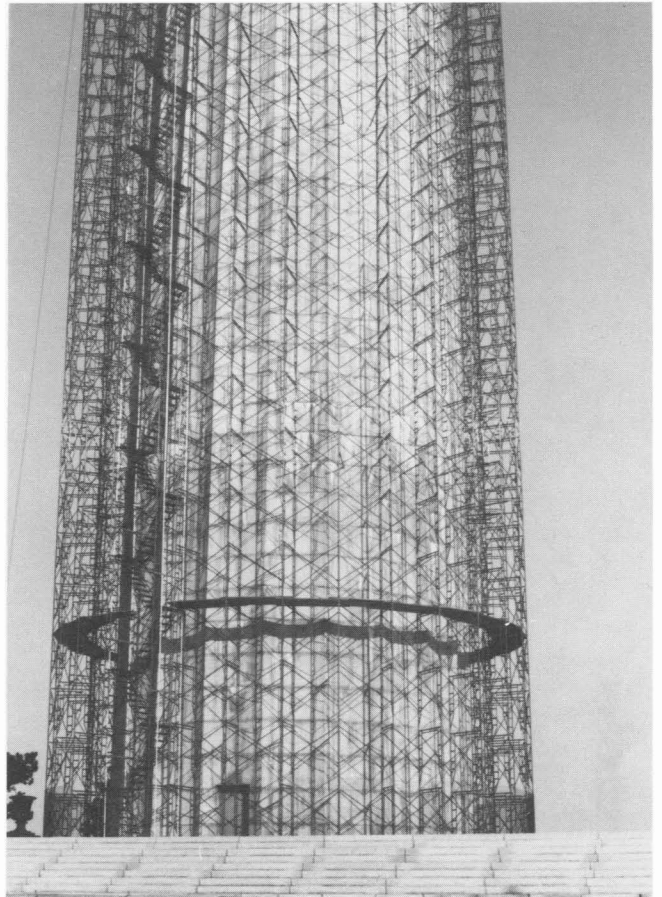
14. Base of Perry Memorial Column (1981).

perimeter was a hard, thin glassy deposit, clear to milky-white in color (Figs. 15-17). The heaviest concentration of these staining deposits existed around the lower fifth of the shaft, particularly between courses 10-15 (Fig. 14).

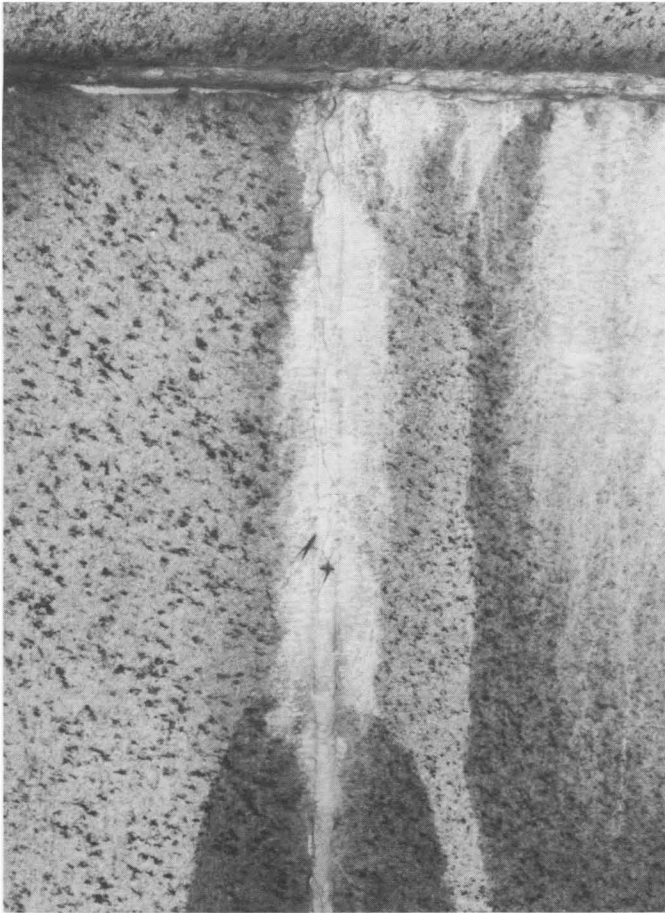
The exterior face of the column shaft exhibited damp white crumbly deposits of an accretive nature up to 2.5 cm thick (maximum) (Fig. 15). These deposits were only found *below* the head and bed joints and sometimes across the entire face of a stone. Associated with these white deposits and occurring along their outer

15. Characteristic carbonate/silicate deposit around defective joint.

Prior to cleaning, it was strongly recommended that all joints be raked, thus allowing the column to dry out as much as possible. This was critical since during cleaning tests, it was observed that freshly cleaned areas around joints and open cracks immediately began to leak, thus beginning the entire process of redeposition all over again (Fig. 17). Once the column was allowed to dry out, an alkali-resistant primer sealant and closed cell backer rod was installed to prevent the discharge of any further water. Abrasive cleaning was then executed and the finish sealant installed and tooled. This system also accommodated the decision to wash the entire monument with a low pressure water rinse to remove any carbonate dust residue and overall surface particulates after deposit removal.

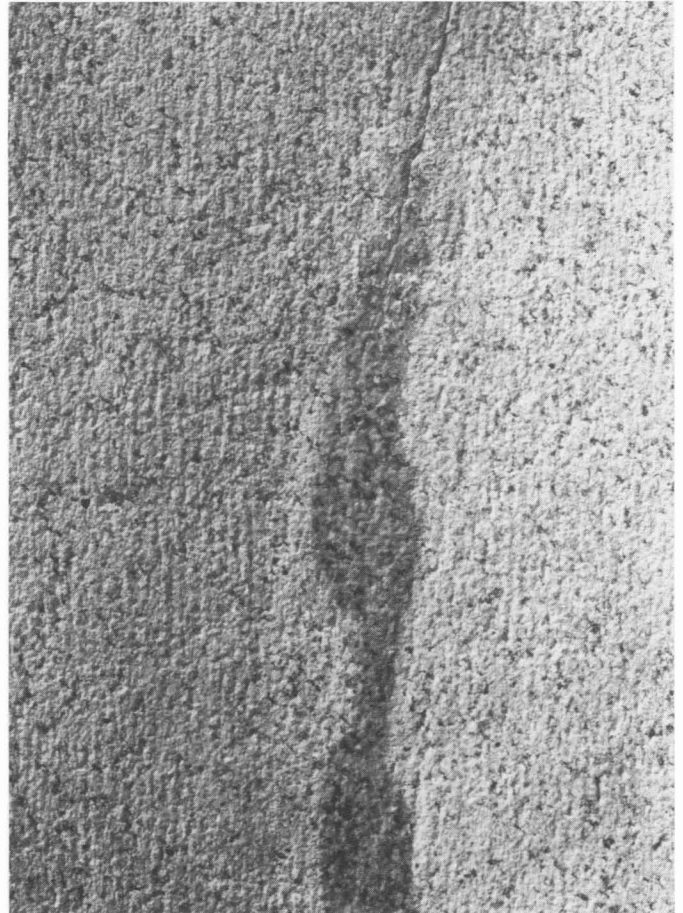
17. Crack oozing water.

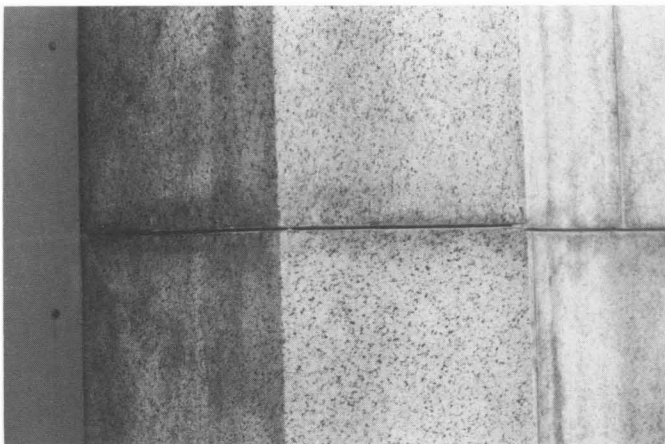
A second form of staining or discoloration was also found along the border edges of the stone joints (Fig. 16). This condition can best be described as dark narrow banding following both edges of the bed and head joints and in some cases extending over the entire face of a stone. Unlike the accretive staining, this discoloration exists within the first few millimeters below the granite surface. While these two forms of staining often occurred together (Fig. 15), the latter condition was far more prevalent over the entire exterior surfaces of the monument's stonework.

16. Characteristic discoloration around open joint.

these calcium silicate compounds carried in solution and absorbed into the granite which appear to be the cause of the discoloration generally found around the joint edges and sometimes on the ashlar faces (Fig. 15). This discoloration, like the carbonate deposits, also includes air-borne particulates, but it is not predominantly a surface stain. This can be verified by the unsuccessful cleaning tests previously executed using low abrasive blasting on these areas.

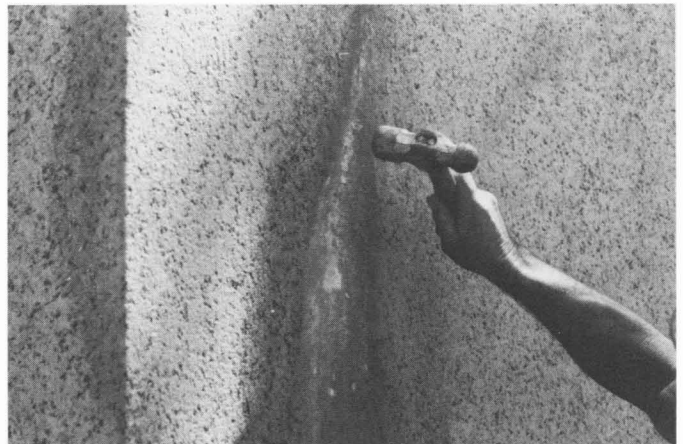
18. Ineffective hand removal of deposits.

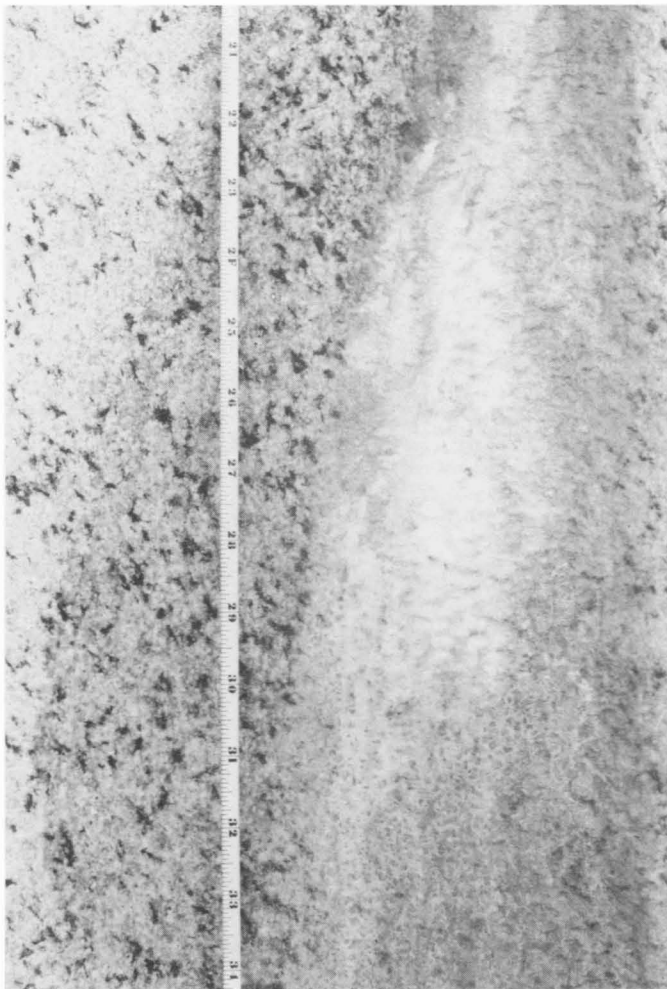
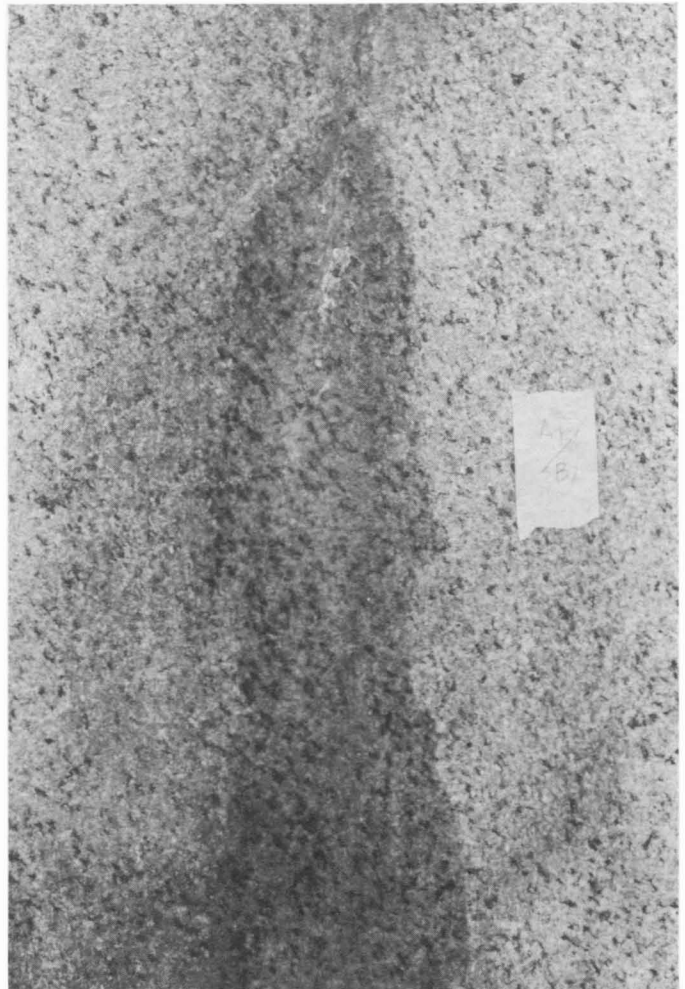
19. Area prior to 50-psi cleaning with flint shot sand (A1) and slag (B1).

20. Area after 50-psi cleaning with flint shot sand (A1) and slag (B1).

At all pressures of 50, 100 and 150 psi, all four aggregates were successful in removing even the heaviest

surface deposits. Of the aggregates, only the walnut shells exhibited reduced efficiency (increase in time and volume of material) at lower pressures. Slight surface abrasion resulted with all four aggregates at 150 psi only when the application distance was decreased to less than 4 inches from the surface of the stone. Due to the consistent results obtained in the removal of the surface deposits with all aggregates at 100 psi and at a distance

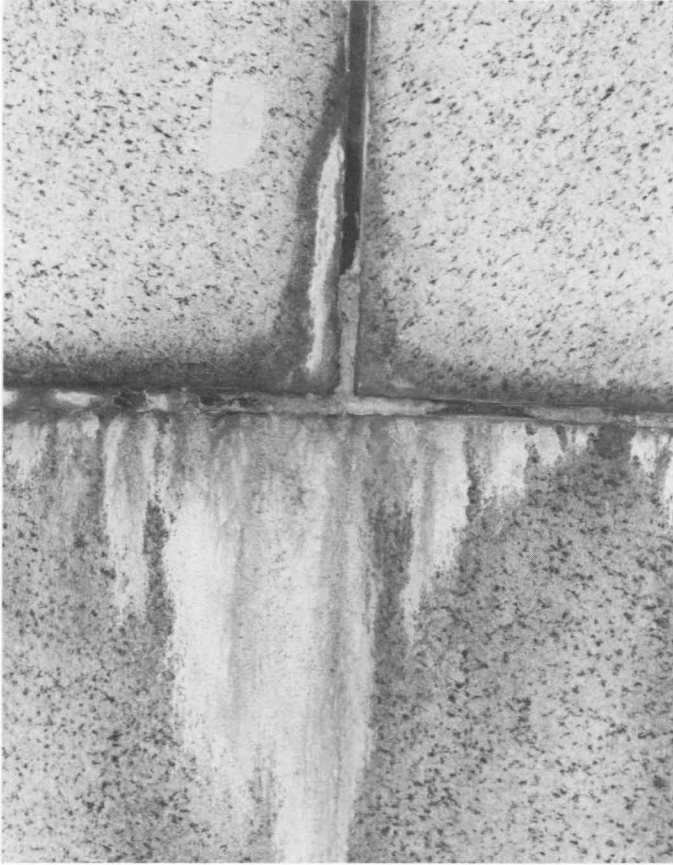
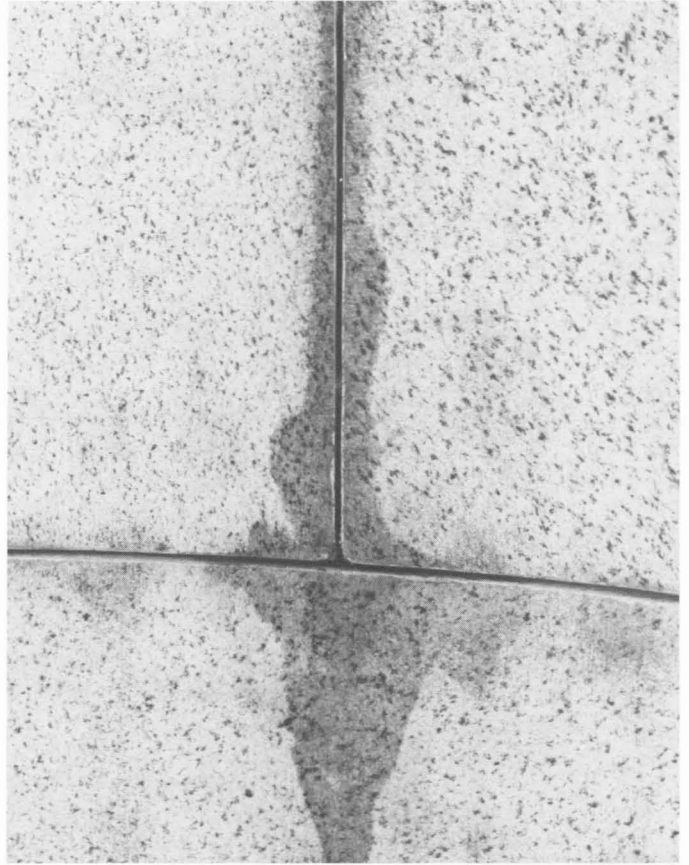
23. Area prior to 100-psi cleaning with flint shot sand (A2) and slag (B2).

24. Area after 100-psi cleaning with flint shot sand (A2) and slag (B2).

Based on the results of the method tested, it was concluded that dry abrasive cleaning with slag aggregate at 100 psi was the most suitable technique for the effective removal of the calcium carbonate/silicate deposits, without causing physical or chemical damage to the granite substrate.

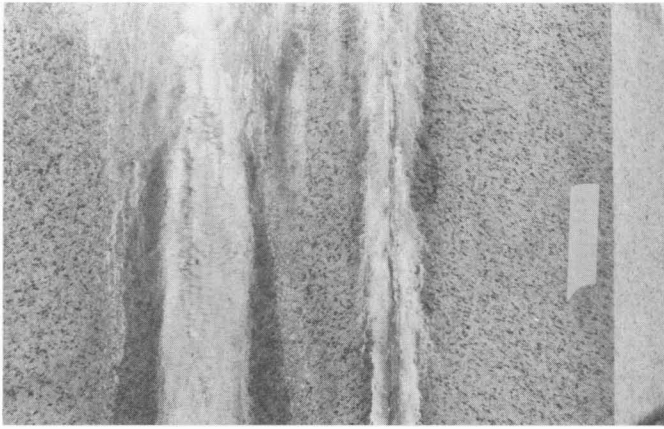
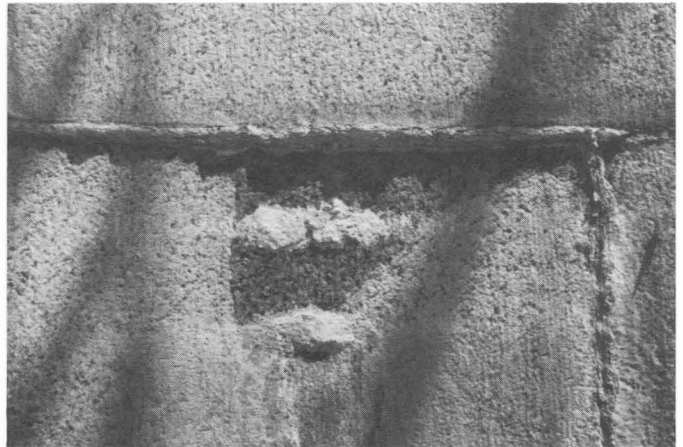
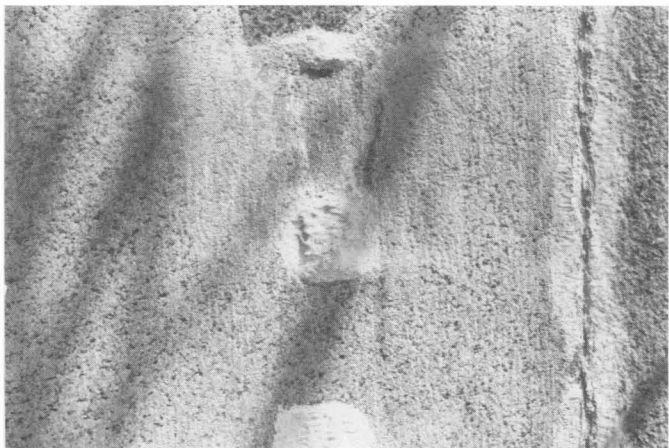
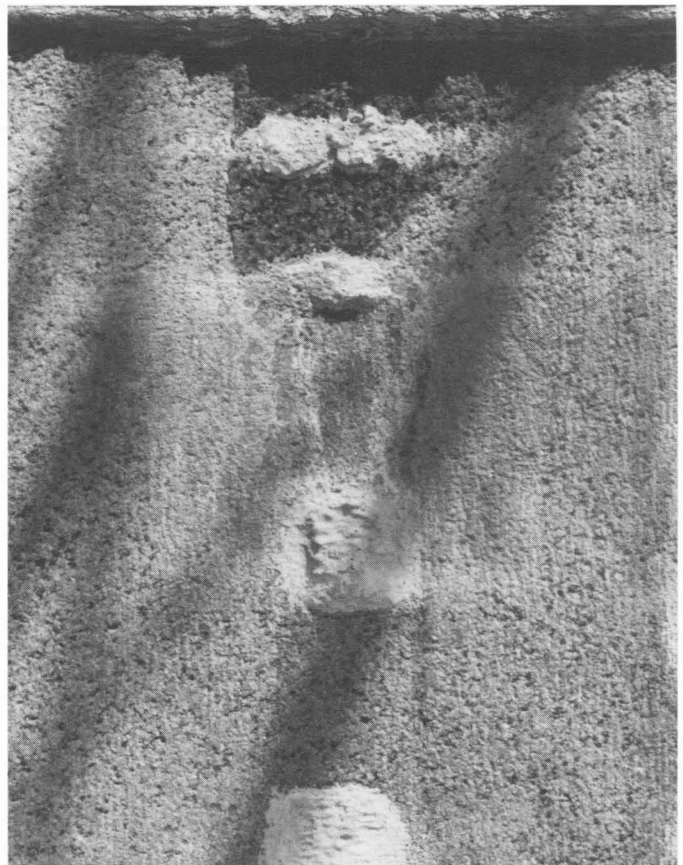
27. Area prior to 150-psi cleaning with flint shot sand (A3), slag (B3), walnut shells (C3), and sharp-edged sand (D3).

28. Area after 150-psi cleaning with flint shot sand (A3) and slag (B3).

29. Area after 150-psi cleaning with walnut shells (C3) and sharp-edged sand (D3).

30. Comparative results of 150-psi cleaning with all four aggregates.

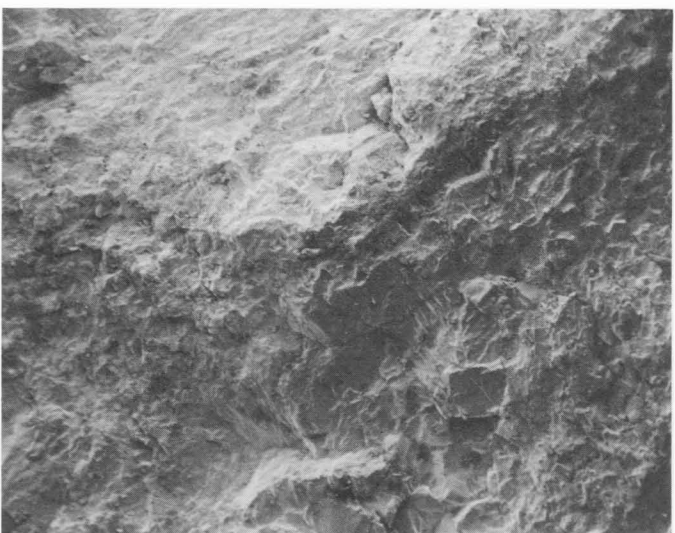
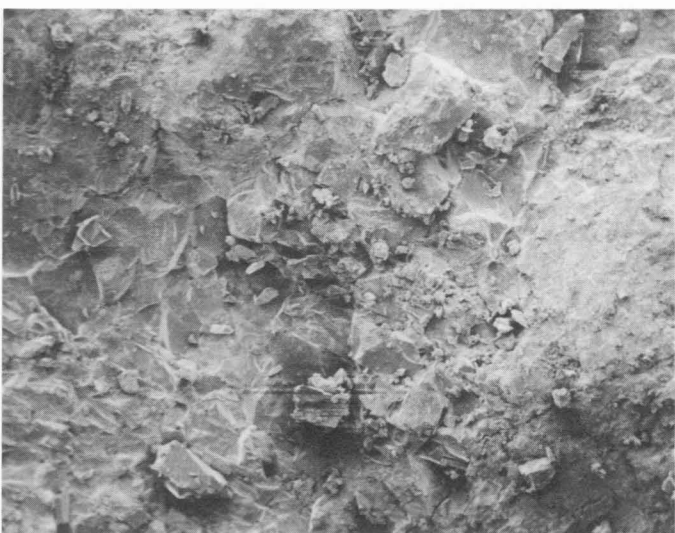
35. Scanning electron photomicrograph of granite control surface (mag.: 50x).

36. Scanning electron photomicrograph of granite control surface after 150-psi cleaning with slag (mag.: 50x).

Results from the above experiment indicate that a change in average surface depth of 0.16mm or 0.027% surface loss was recorded from an area approximately 16.32 cm.<sup>3</sup> This difference was not observable in the field at 30x magnification and could only be seen under the Scanning Electron Microscope (Figs. 35 & 36).
