Conservation Plan for the Suddards-Manuel-Clark Funerary Monument, The Woodlands Cemetery, Philadelphia, PA

A thesis in Historic Preservation Presented to the Faculties of the University of Pennsylvania in Partial Fulfillment of the Requirements for the Degree of MASTER OF SCIENCE IN HISTORIC PRESERVATION, 2009.

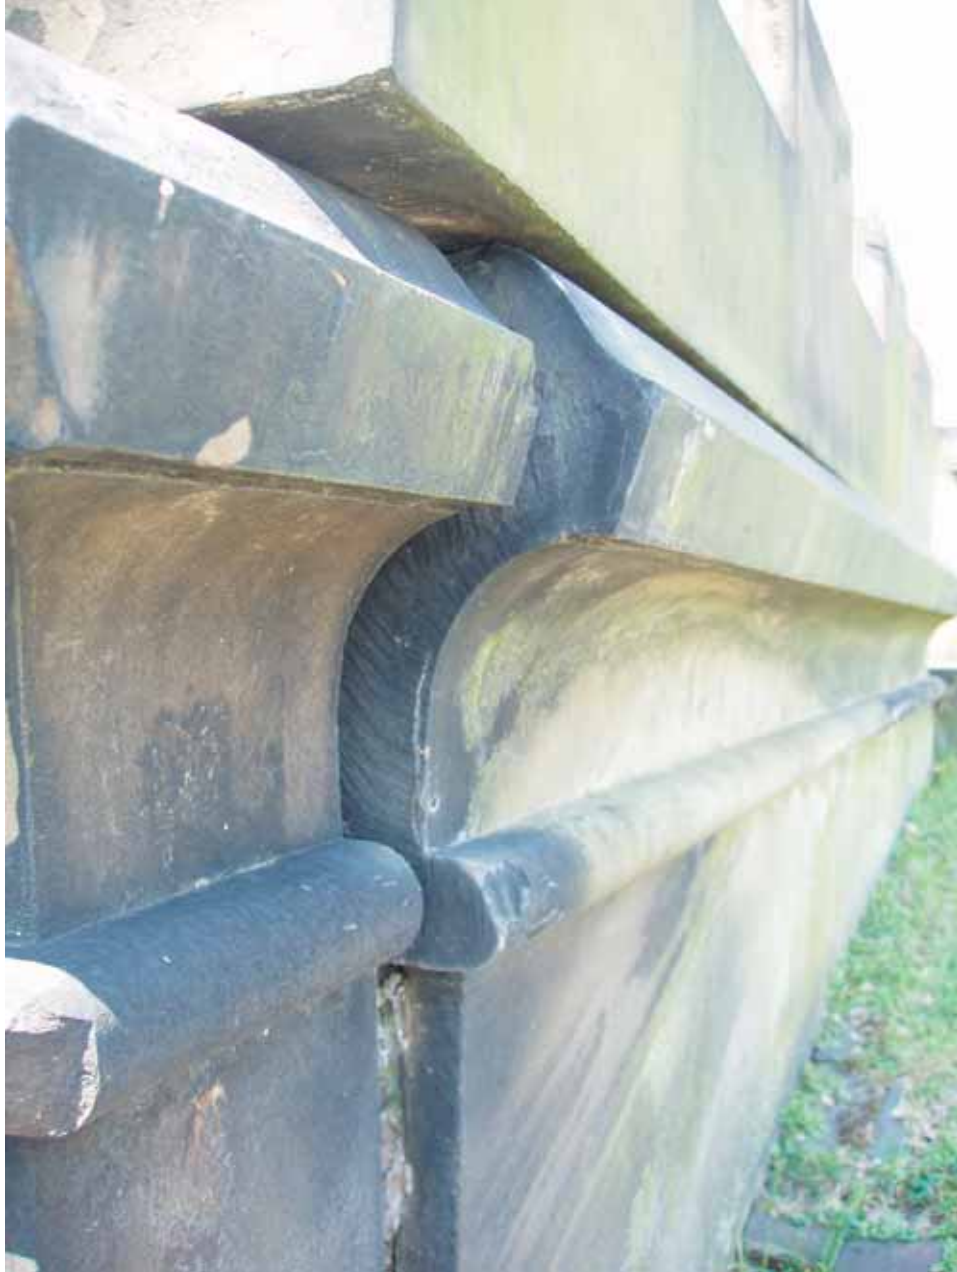
Figure 2.11 Toolmarks visible on east wall open joint (Source: E. Kemery, 2009)

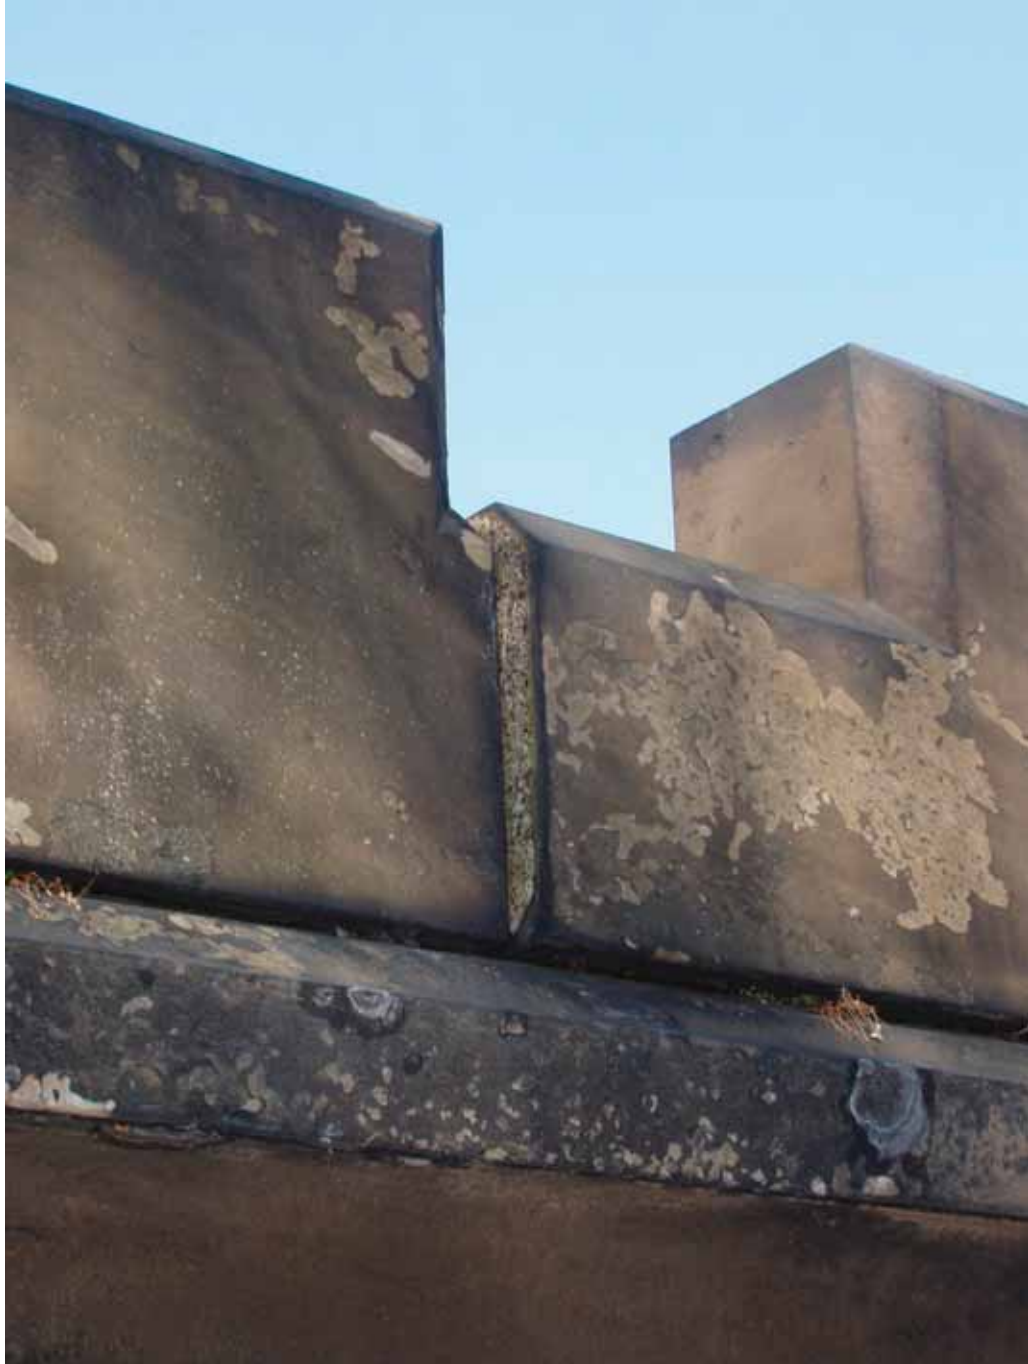
Figure 2.12 Recessed mortar joint on displaced crenellation (Source: E. Kemery, 2009)

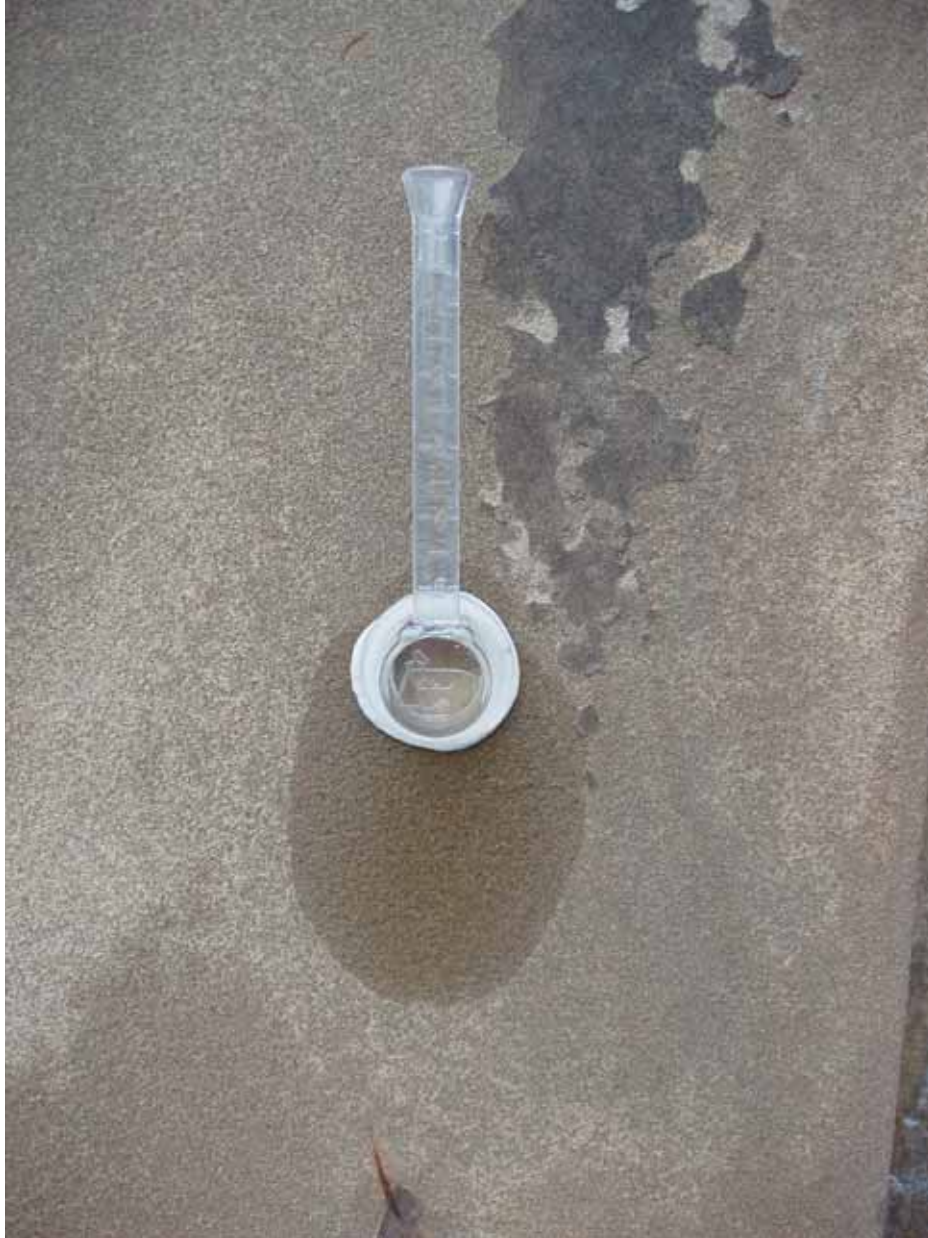
Figure 4.13 Failed RILEM tube testing in situ on a differentially eroded surface
(Source: E. Kemery, 2009)

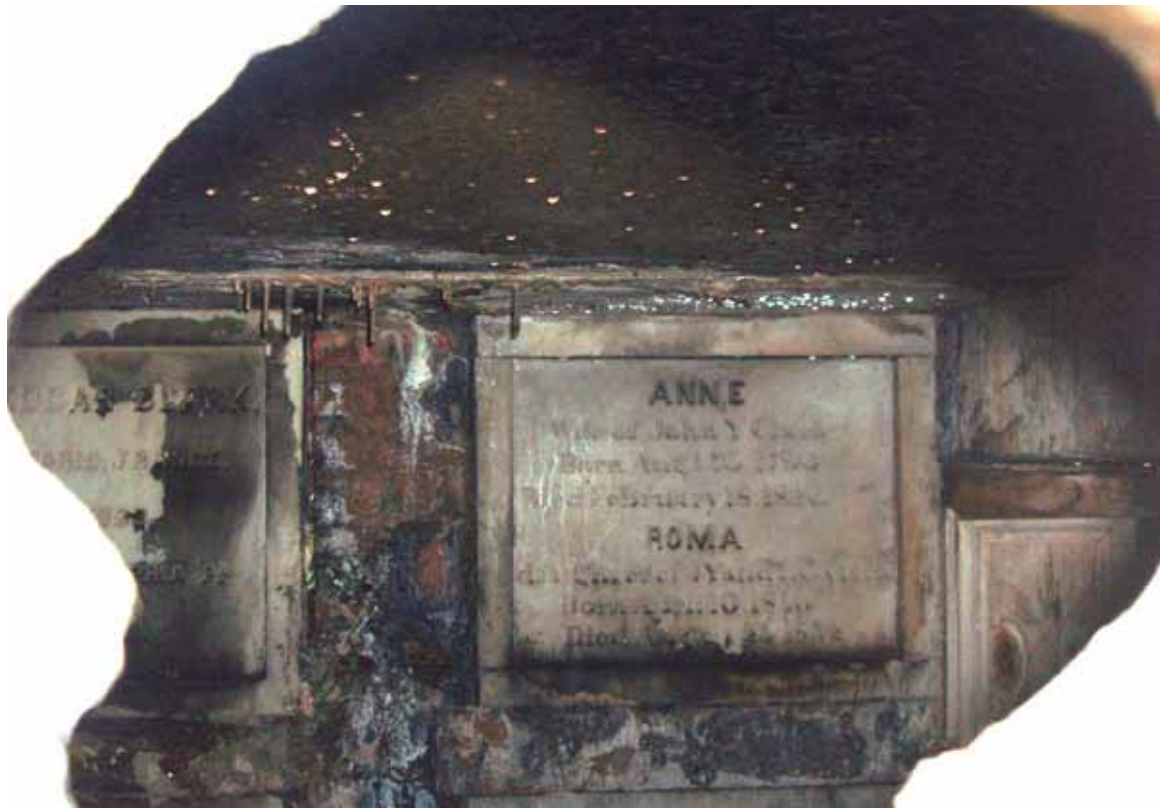
Figure 6.9 Interior of Suddards-Manuel-Clark vault under wet conditions (Source: E. Kemery, 2008)

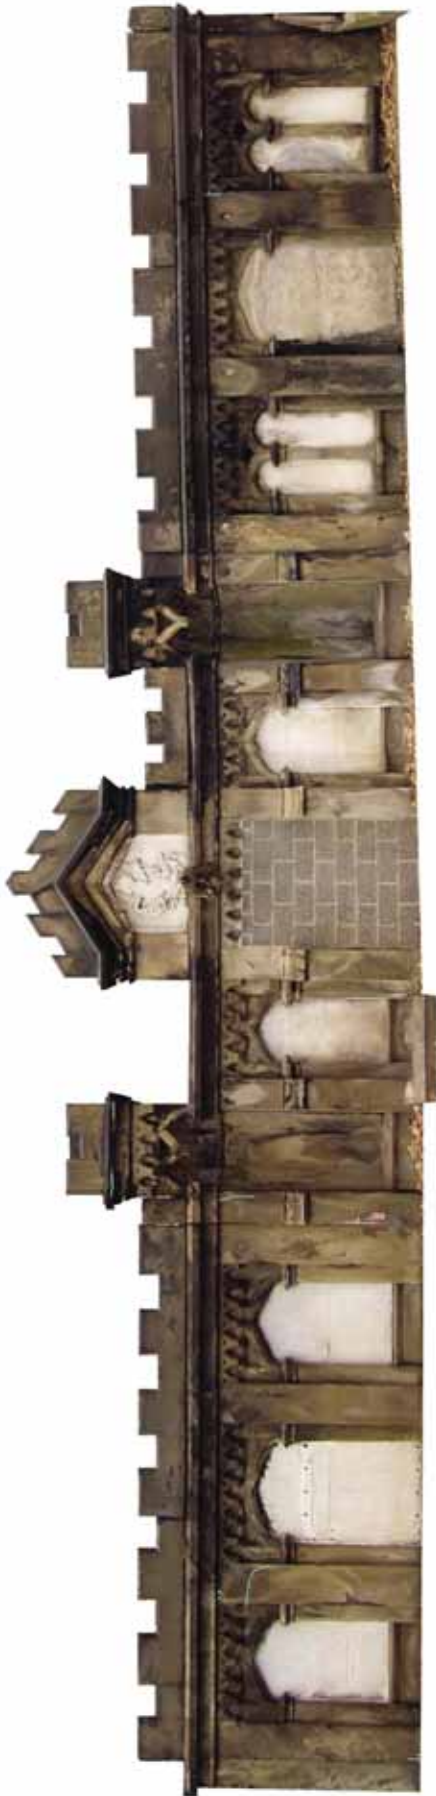
0 1 5 ft
CRACK

a large dimensional spall or structural problem should the crack fracture the entire face of the pier.

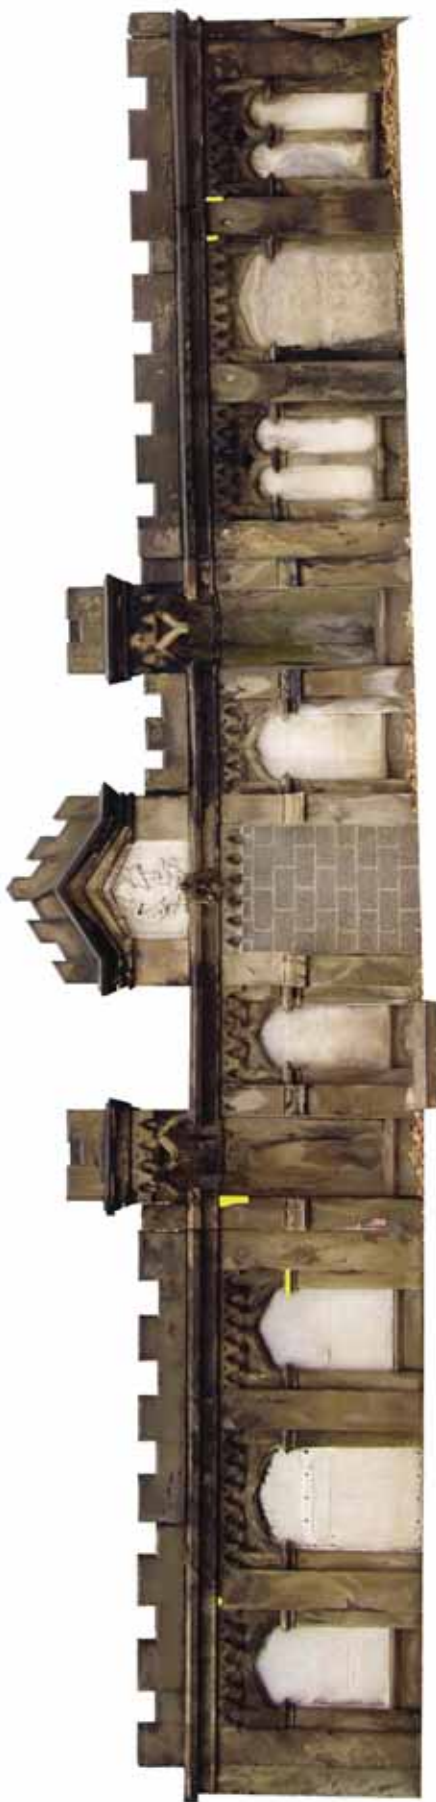
■ INCIPIENT SPALL

and ensuing shearing is the cause of the cracking and spall. Spalls also eventually lead to dimensional loss.

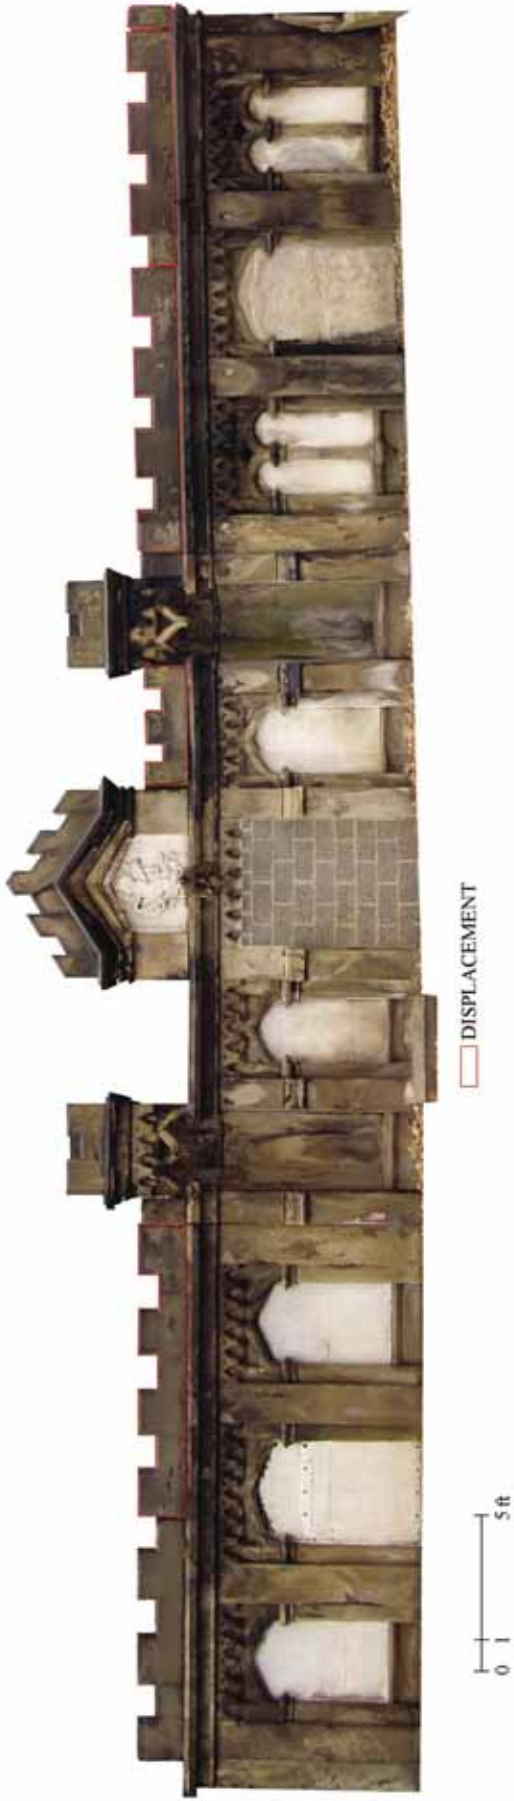
Figure 6.14 Displacement

The smaller easternmost crenellation is a single block that has been displaced. This displacement is likely the result of settlement. This block has moved both laterally east-west and north-south, having shifted outward away from the rest of the façade to the east (right) and north, backward from the plane of the façade. There is also evidence that a thick, wide strap, most likely metal, once tied this block to the adjacent long crenellation. Loss of mortar can be seen in the widening of the joint between the two stone units. In all cases of displacement here, the condition of displacement is obviously accompanied by the condition of open joint as displacement widens spaces between masonry units in at least one direction

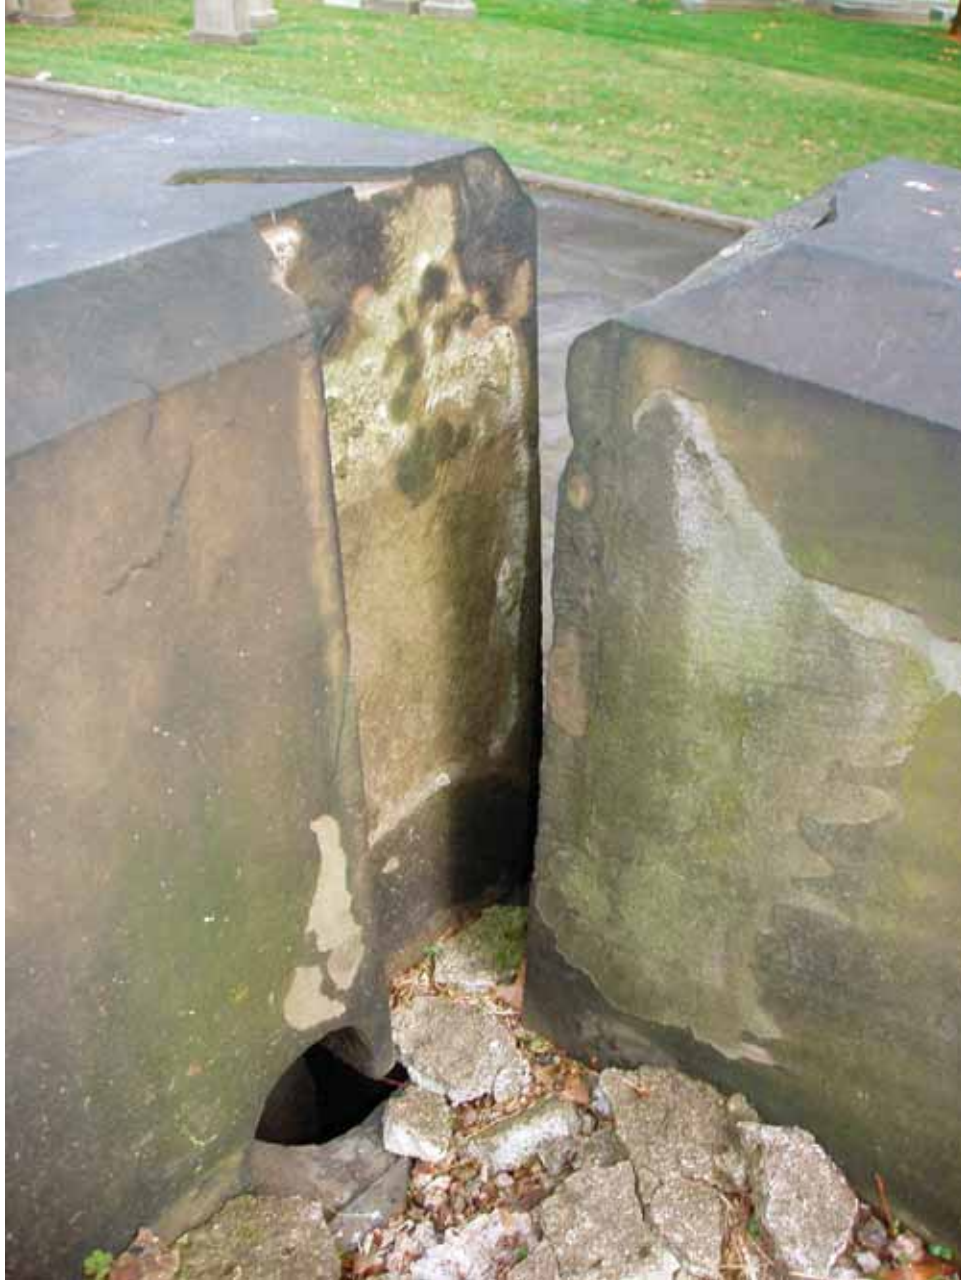
Figure 6.15 East corner of the Suddards-Manuel-Clark monument, gutter drain hole and evidence of a strap that held these two blocks together (Source: E. Kemery, 2008)

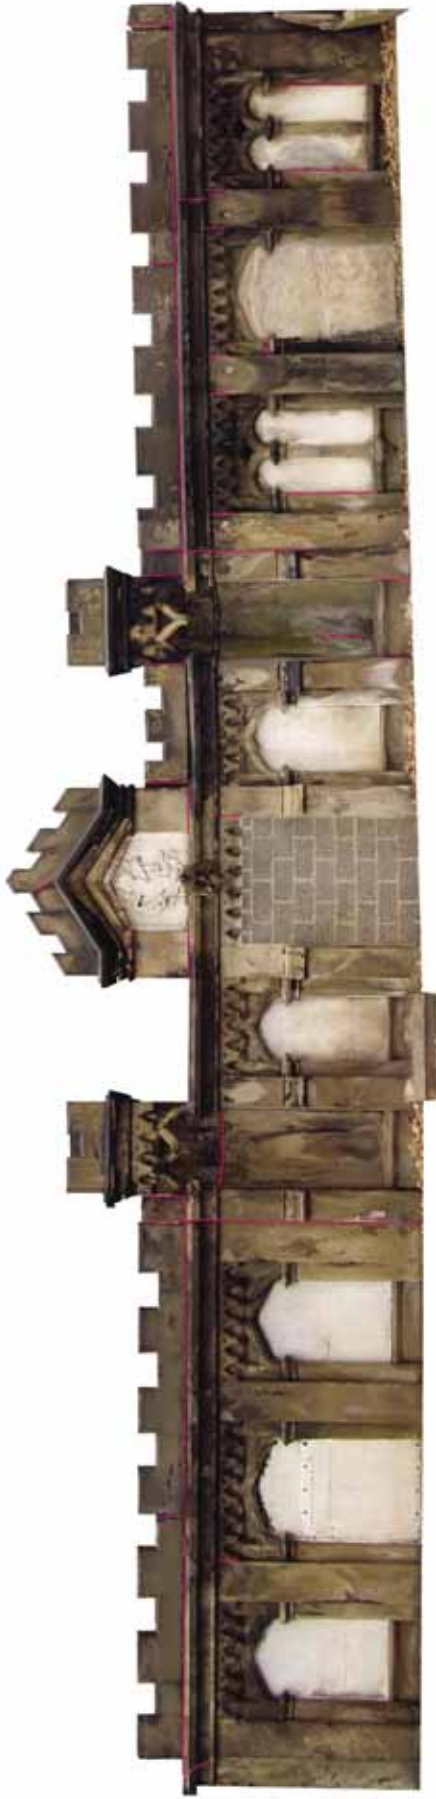
0 1 5 ft — OPEN JOINT

been created by thick growth of mosses, woody stems and roots and correspond with the condition of macrobiological growth.

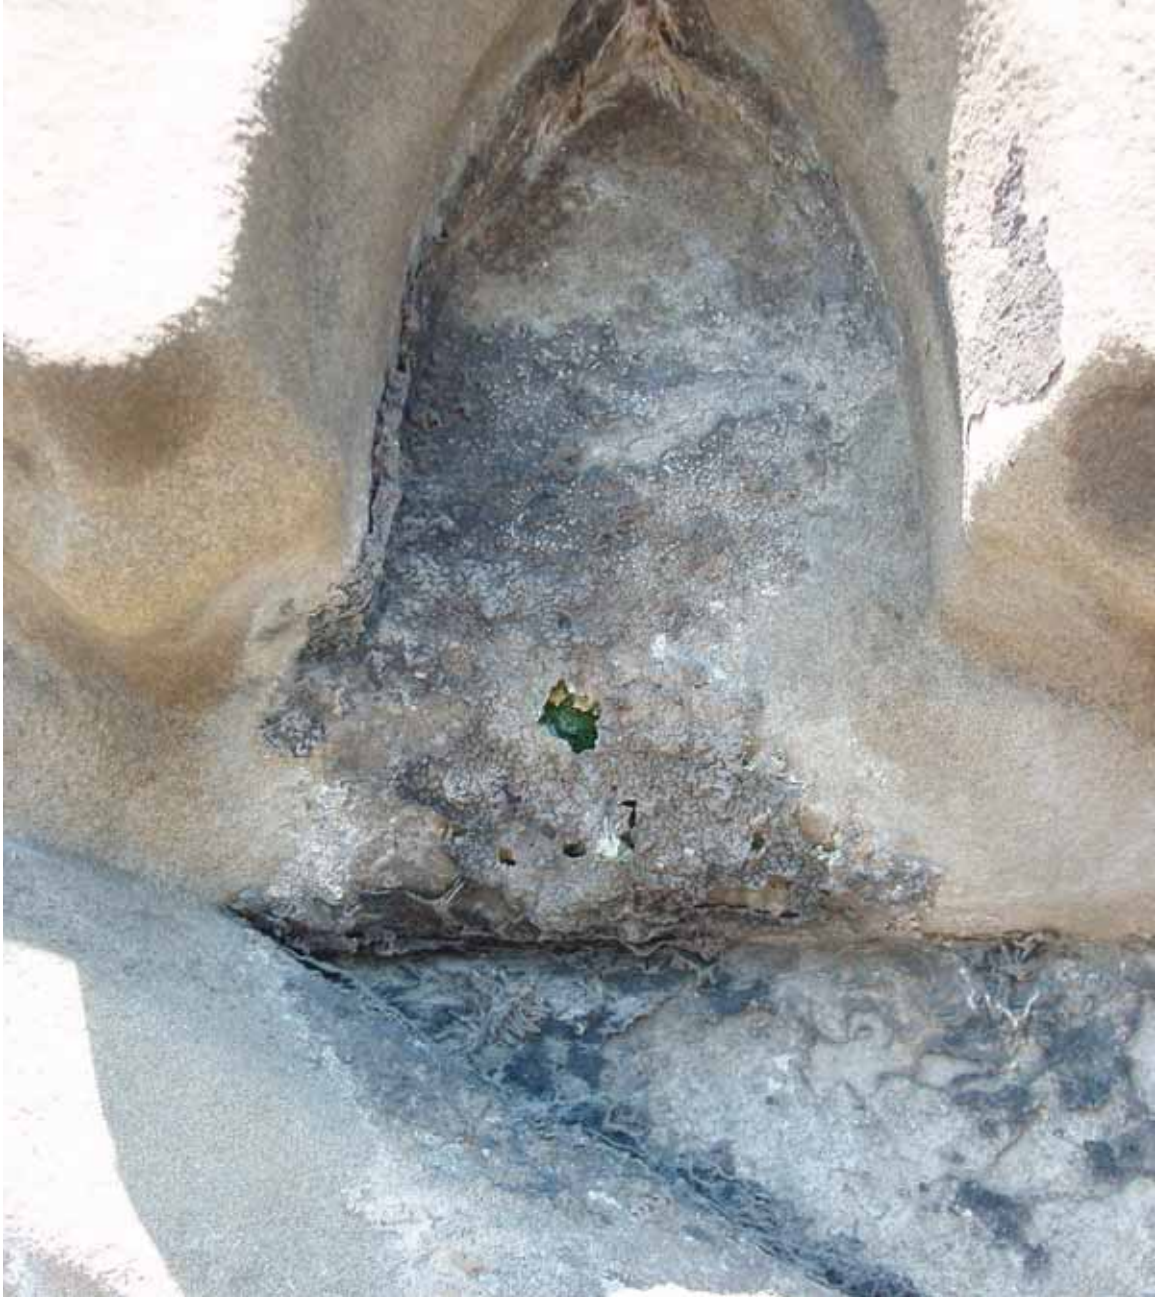
Figure 6.21 Microbiological colonization beneath blisters (Source: E. Kemery, 2009)

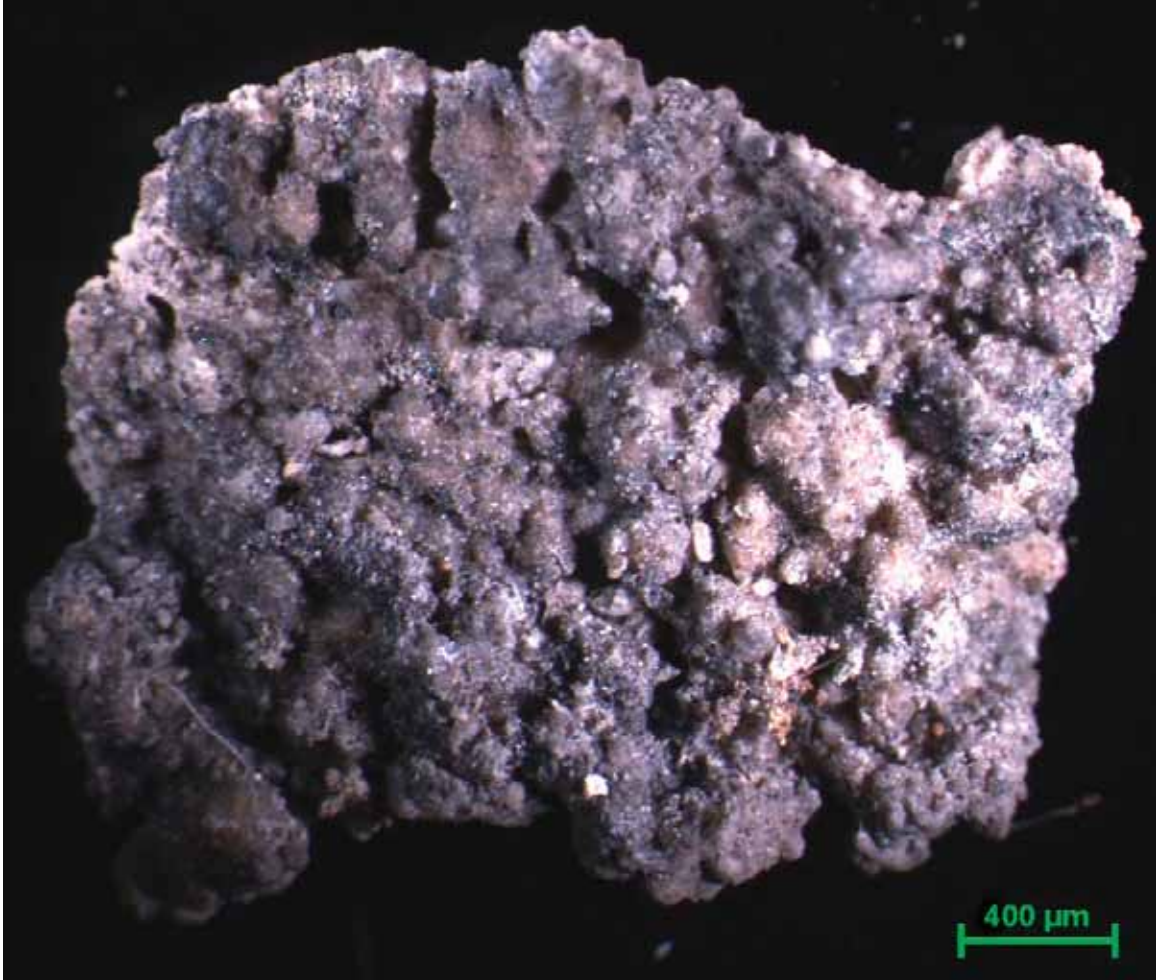
Figure 6.29 Sample of blistering, 20x, Leica MZ16 stereomicroscope, reflected light (Source: E. Kemery, 2009)

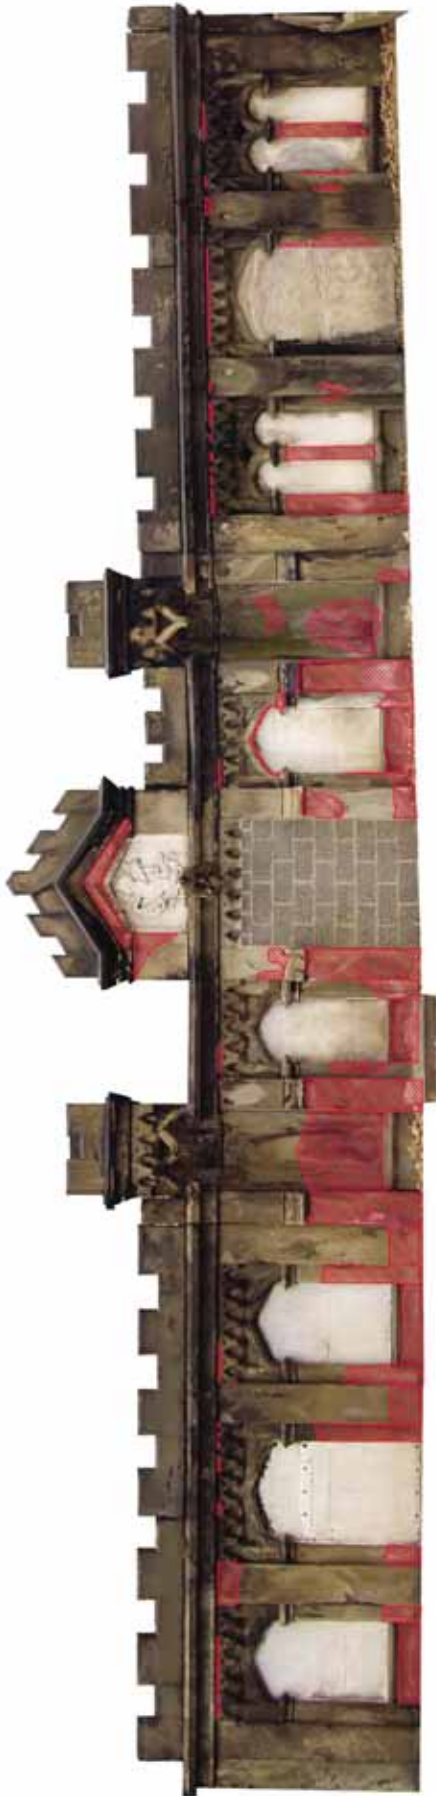
base of the monument and can extend up to the height of the capillary fringe. In some areas, differential erosion from salt cycling has been so severe that it has caused loss of sharp corners and even partial loss of carved detail.

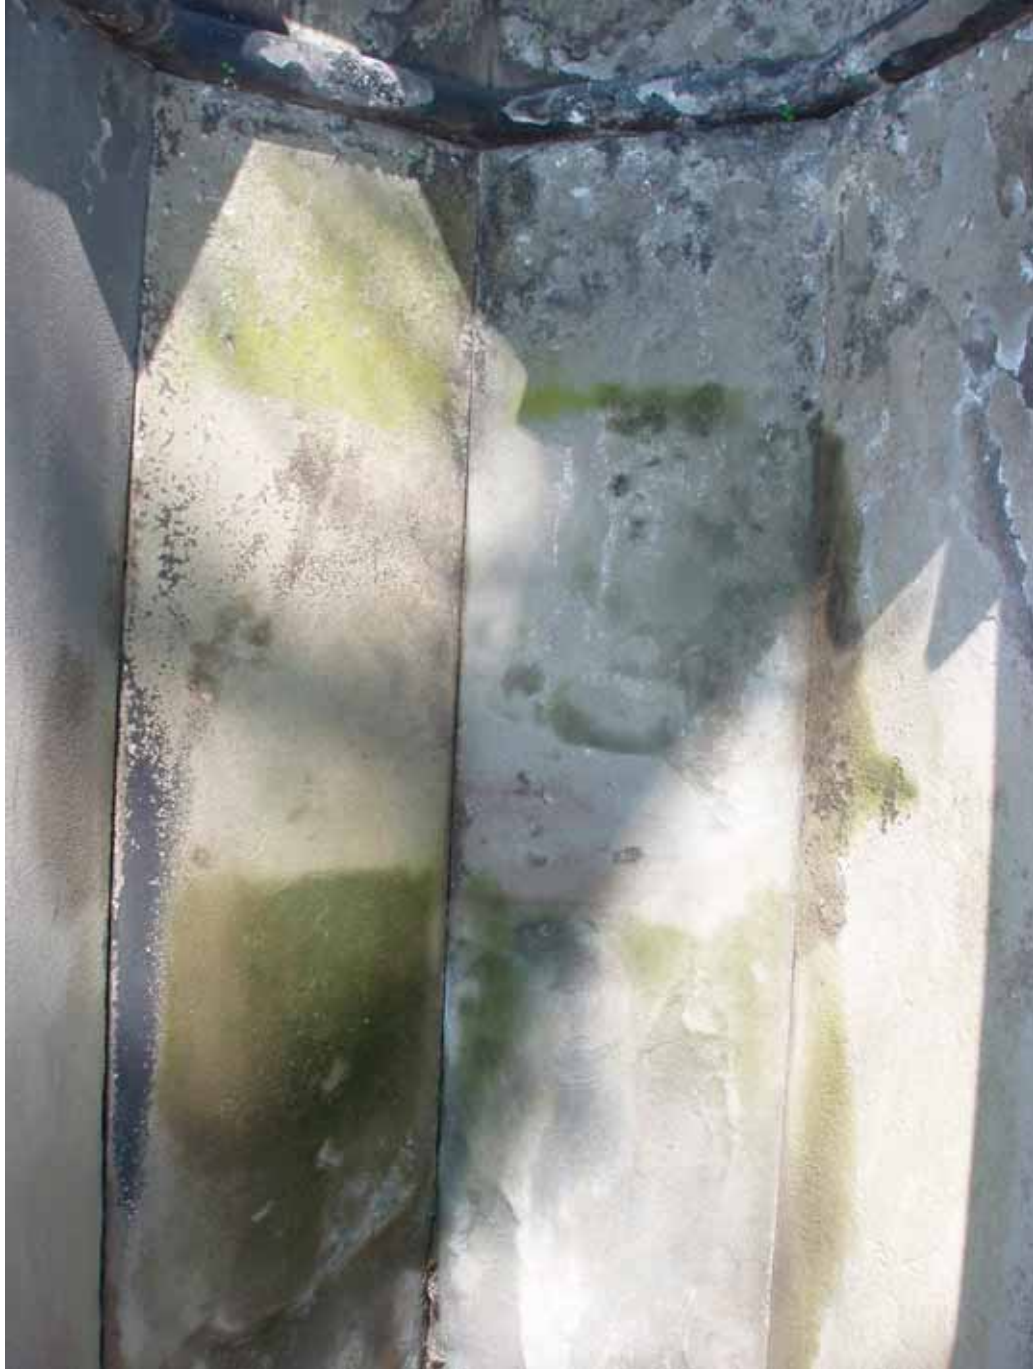
Figure 7.4 Cove after first cycle of Cathedral Stone® Products D/2 Biological Solution application (Source: E. Kemery, 2009)

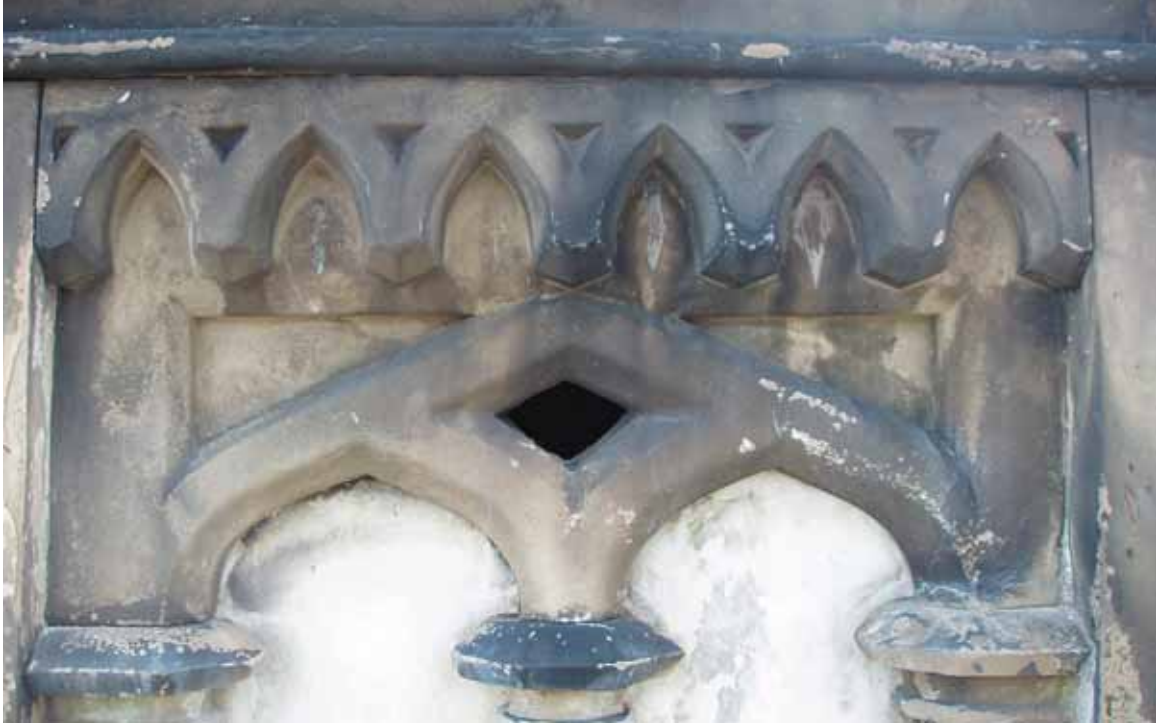
Figure 7.8 D/2 Solution removed biological growth in this area but did not remove other soiling (Source: E. Kemery, 2009)
