A Technical Study and Conservation Proposal for the Glass Mosaic Decoration of Villa Caparra in Guaynabo, Puerto Rico

Yaritza Hernández
University of Pennsylvania

A THESIS

Historic Preservation

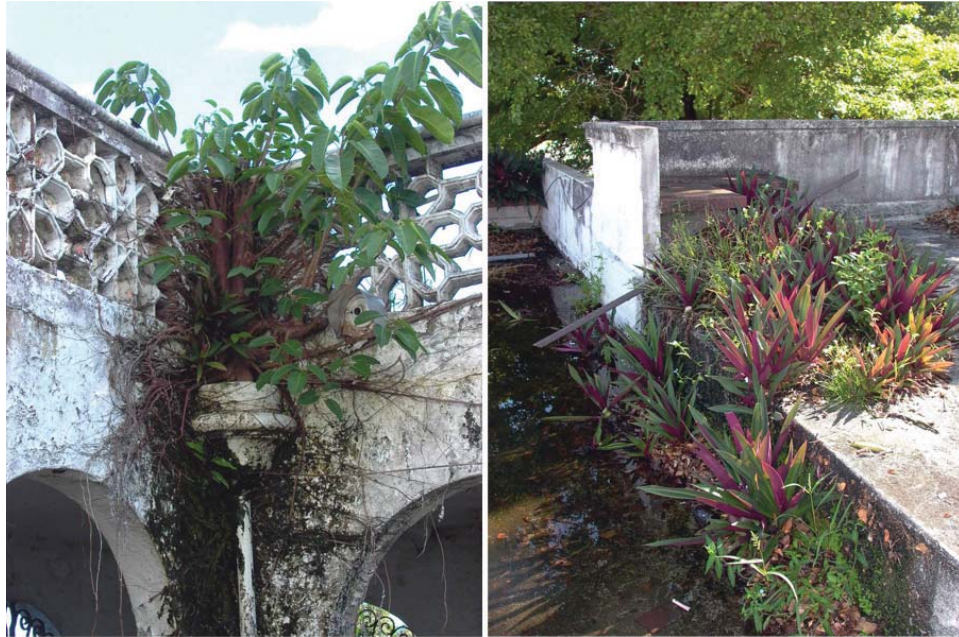
Figure 14: Villa Caparra clogged drains and plant growth on roof surfaces. (source: by Beatriz del Cueto, FAIA, 2010.)

done soon, the damage could be beyond repair. (*see figure 14*)

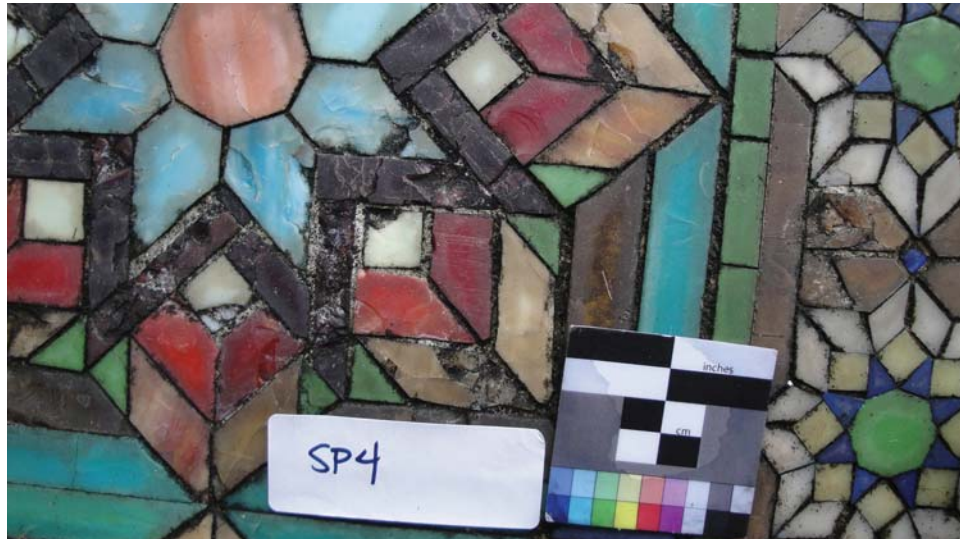
Figure 15: Sample ME_4 Main Entrance door. (source: by author, January,2010.)

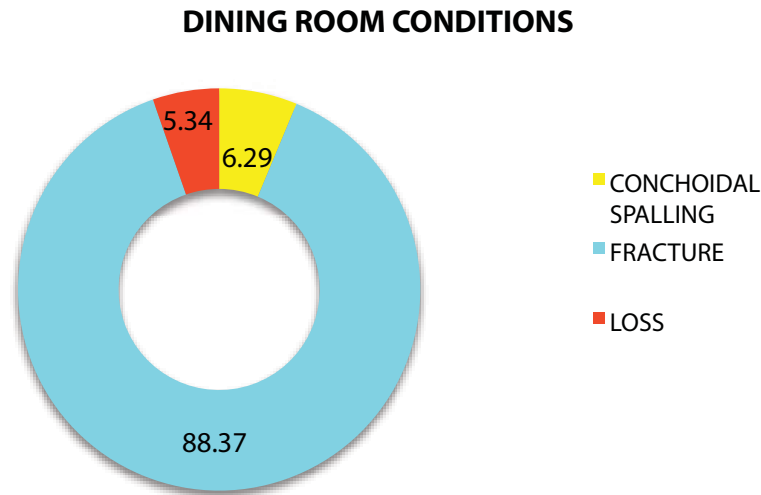
Figure 16: Dining Room Conditions - ESRI GIS

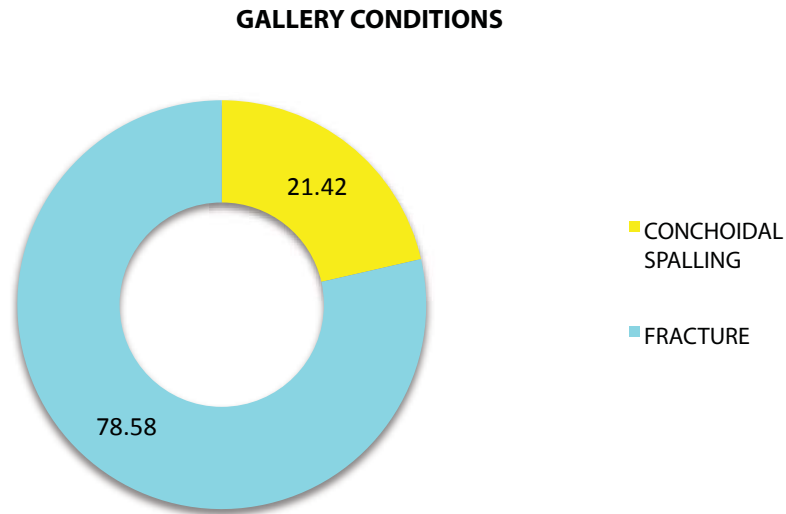
Figure 17: Gallery Conditions - ESRI GIS

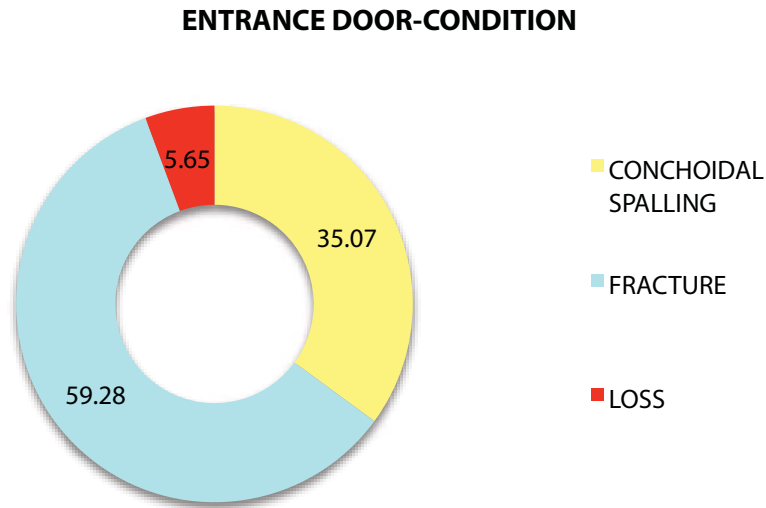
Figure 18: Entrance Door Conditions - ESRI GIS

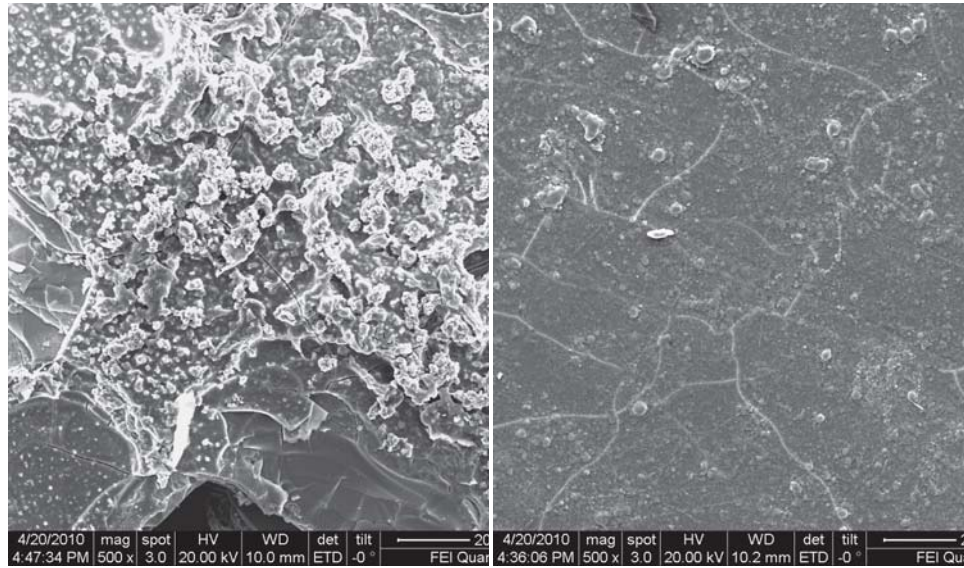
Figure 20: SEM image of Sample ME_04 Main Entrance door, to the left S4(B) and to the right S4(T) (source: by author, January, 2010.)

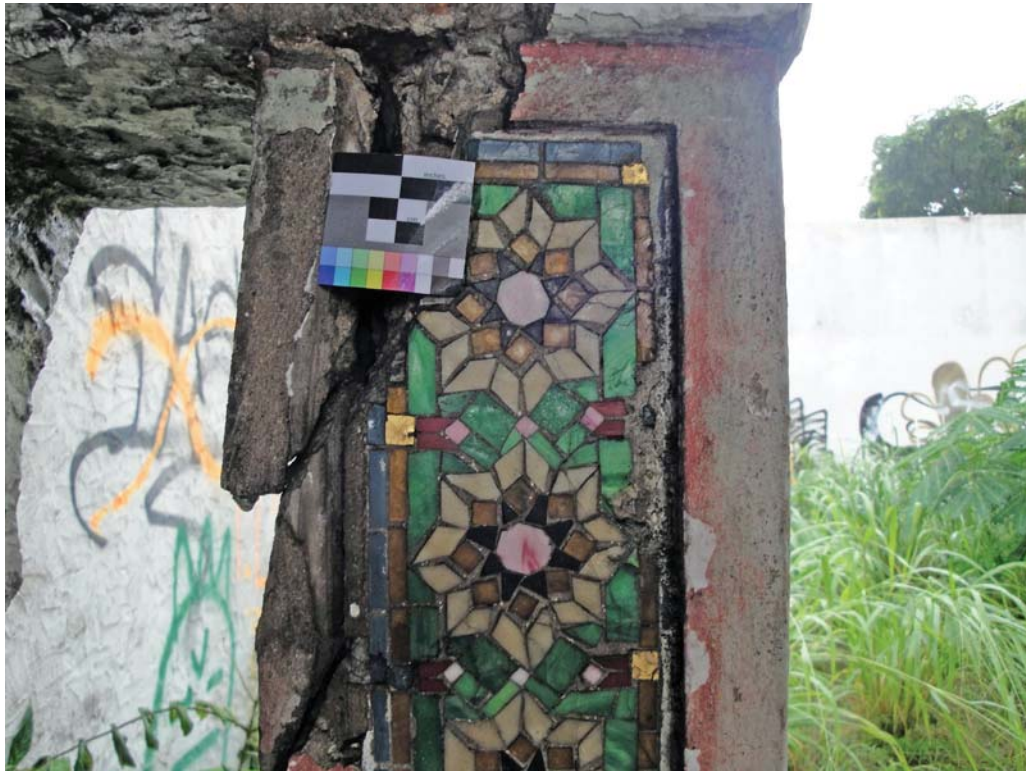
Figure 23: Rebar damage to porta-cochere column (source: by author, January,2010.)

to the surface. This study discovered that the reinforcement bars in some areas of the residence had been exposed after removing the original formwork.⁵⁸ This was due to their installation too close to the bottom of the wooden forms and the concrete mix. Pedro De Castro's solution at the time was to cover the areas with a thin layer of cement to cover the rebar and correct the problem which created a weak bond. In addition, the building's vacancy and its lack of maintenance has allowed plants to grow through the drains causing multiple cracks to the substrate and complete failure to the drainage system of the house. The water infiltration, cracks and high temperatures of the tropical climate have combined to reduce the high alkalinity protecting the rebar and allowed the corrosion(rust) to begin.

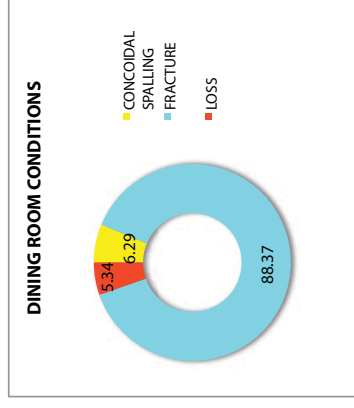
DINING ROOM - CONDITIONS		
CONDITION	TOTAL AREA	%
CONCOIDAL SPALLING	57.75	6.29
FRACTURE	811.38	88.37
LOSS	49.04	5.34
TOTAL	918.16	100.00

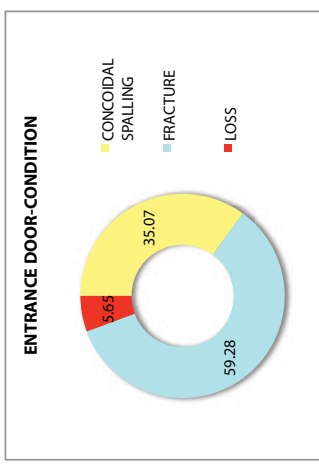
ENTRANCE DOOR CONDITIONS		
CONDITION	TOTAL AREA	%
CONCOIDAL SPALLING	580.28	35.07
FRACTURE	980.93	59.28
LOSS	93.57	5.65
TOTAL	1654.78	100.00
