A Thesis in Historic Preservation Presented to the Faculties of the University of Pennsylvania in Partial Fulfillment of the Requirements for the Degree of Master of Science in Historic Preservation 2007.

GRANDMA PRISBREY'S BOTTLE VILLAGE:
A VALUES BASED CONDITIONS ASSESSMENT OF AN
AMERICAN FOLK ART ENVIRONMENT

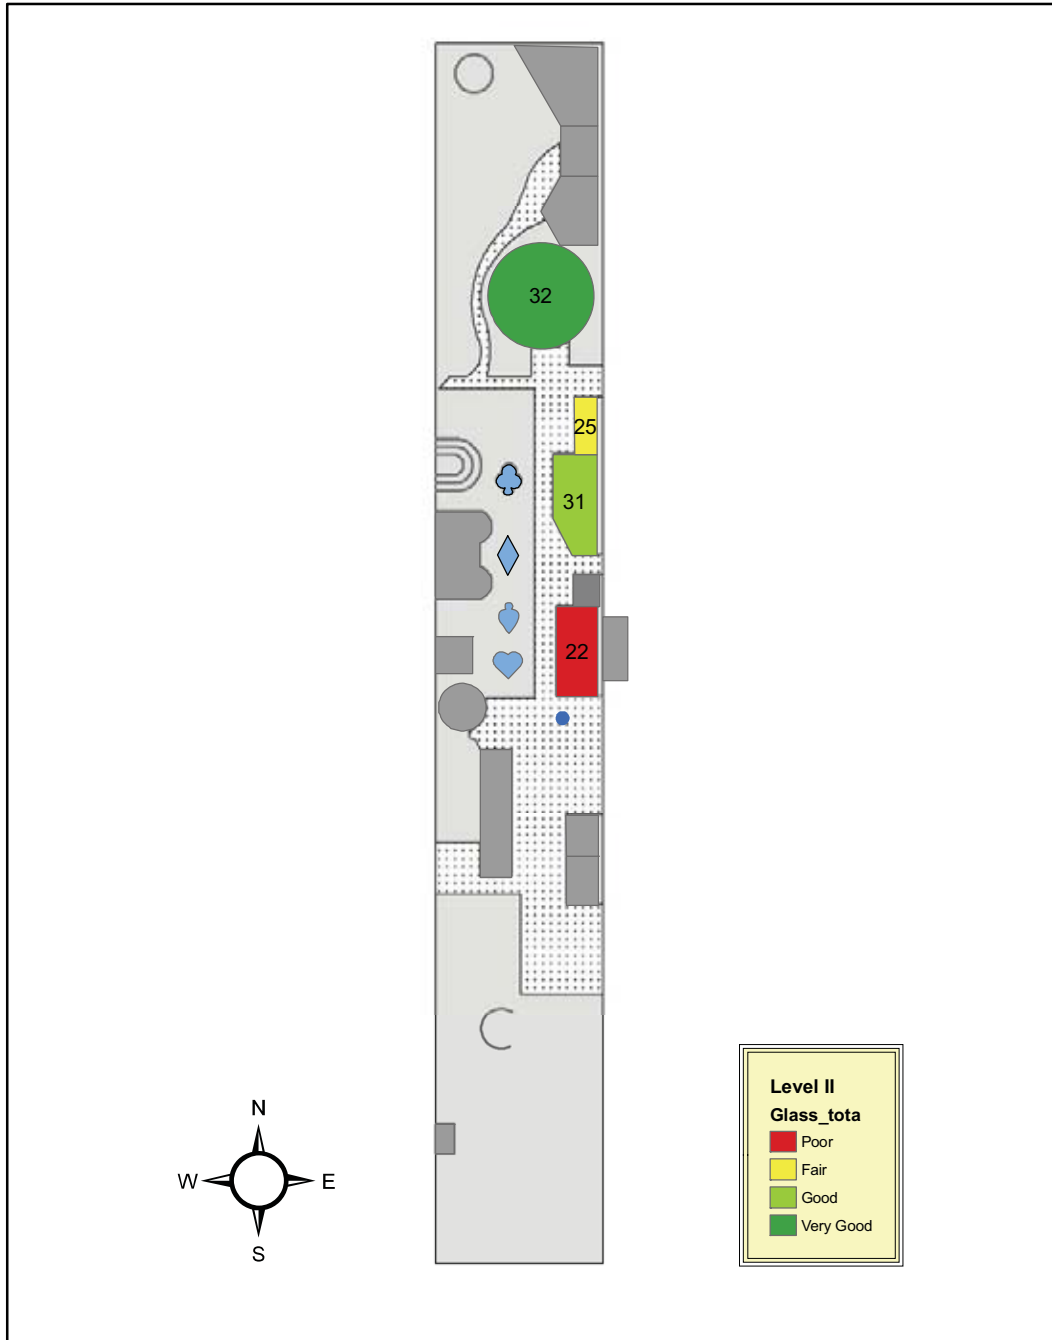
Fig. 6.5: ArcView Conditions Map
129

BottleVillage: Level II Glass

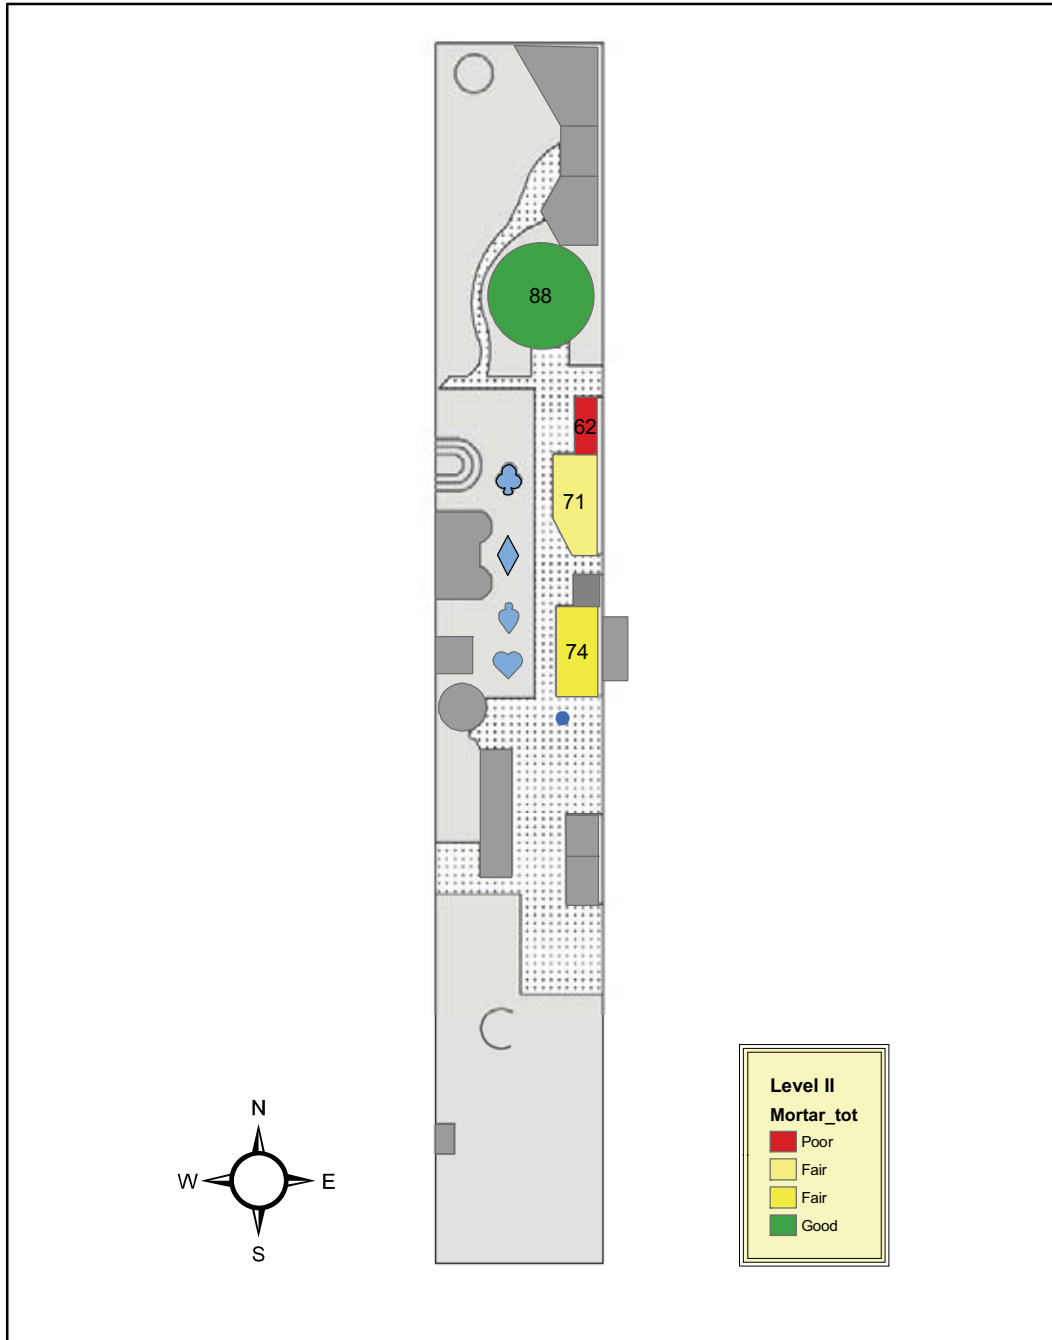
Fig. 6.6: ArcView Conditions Map

BottleVillage: Level II Mortar

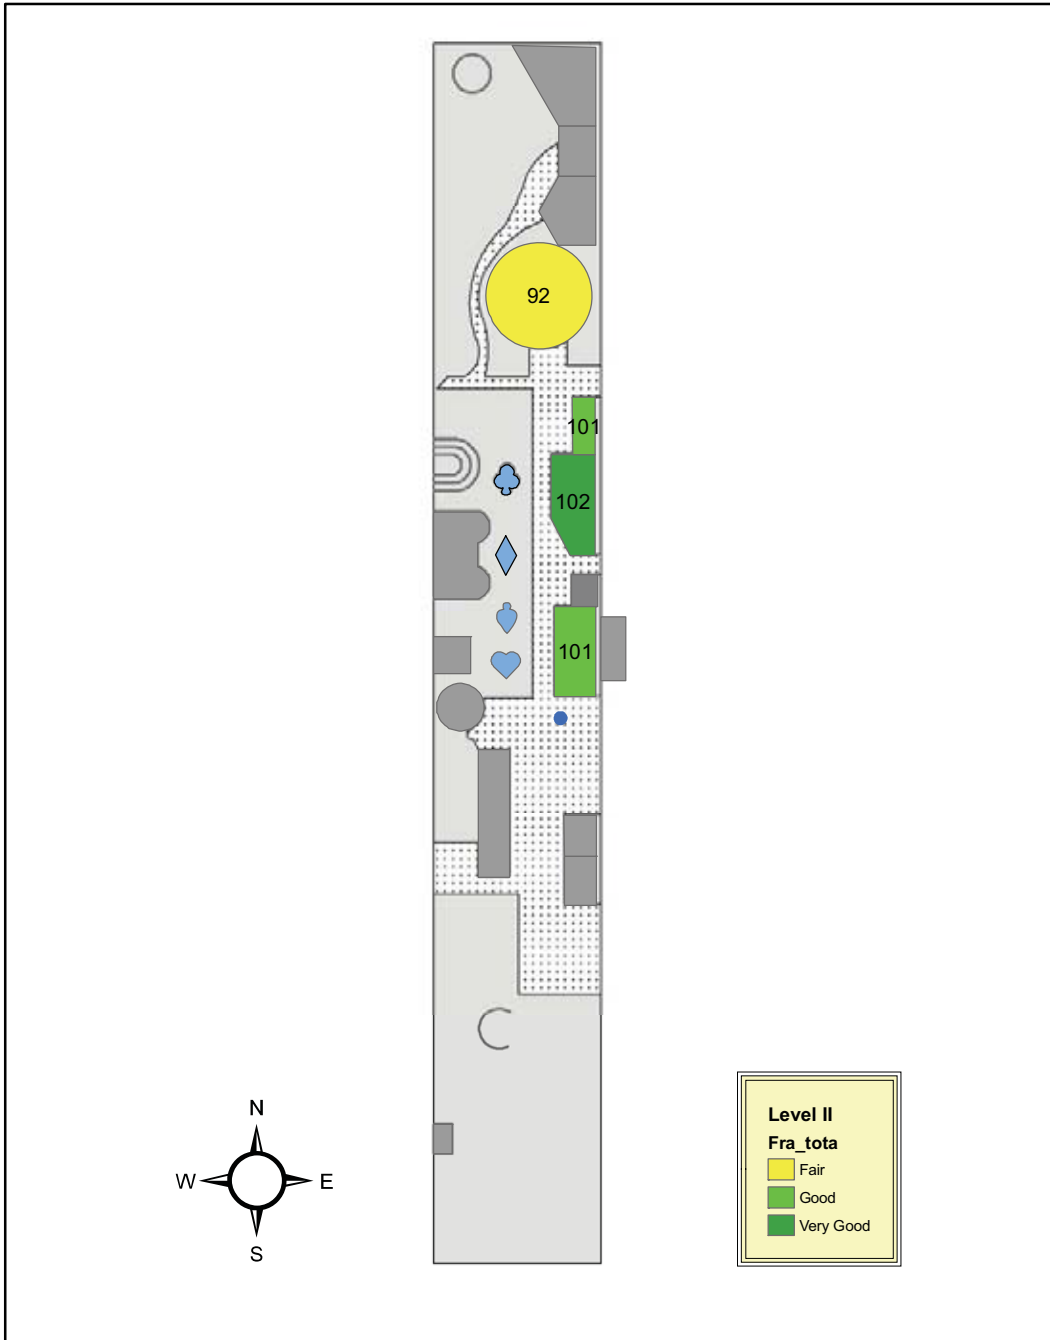
Fig. 6.7: ArcView Conditions Map

BottleVillage: Level II Framing

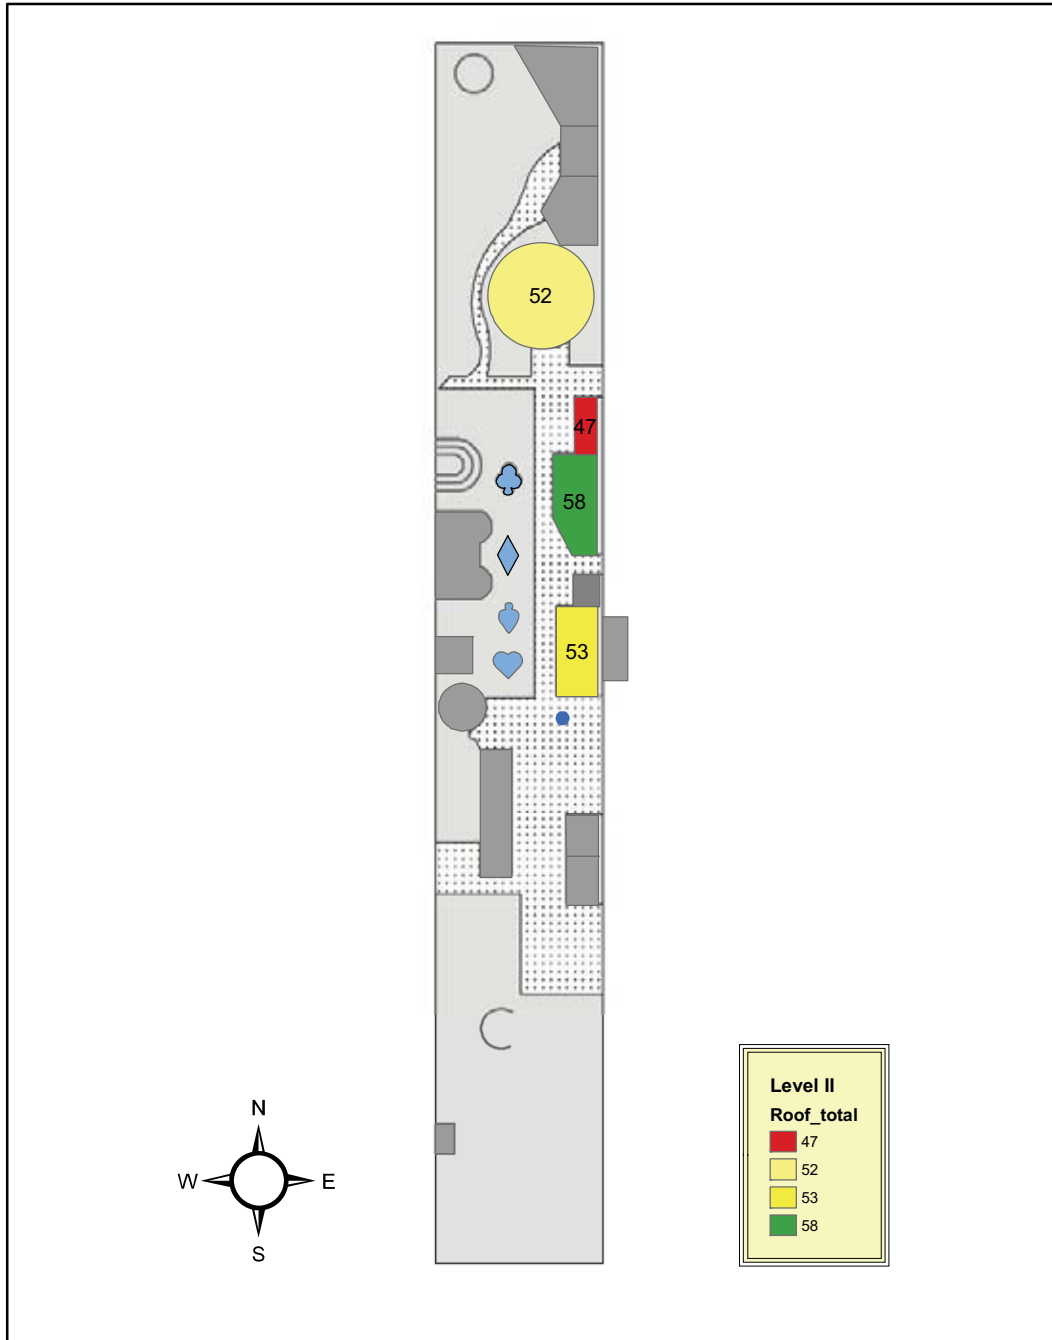
Fig. 6.8: ArcView Conditions Map
132

BottleVillage: Level II Roof

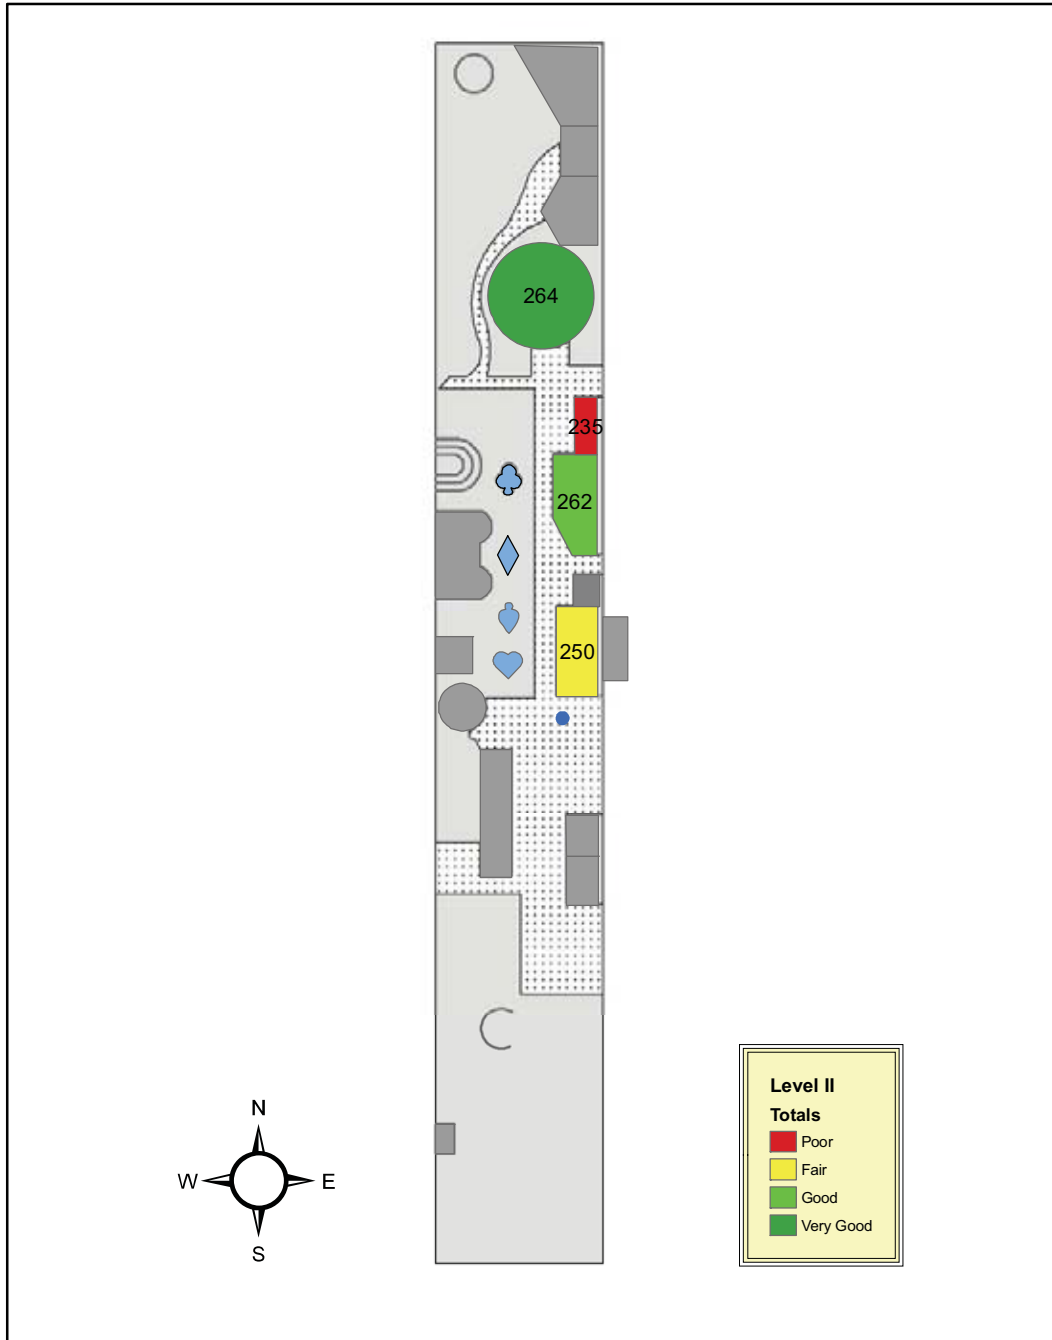
Fig. 6.9: ArcView Conditions Map

BottleVillage: Level II Condition Totals

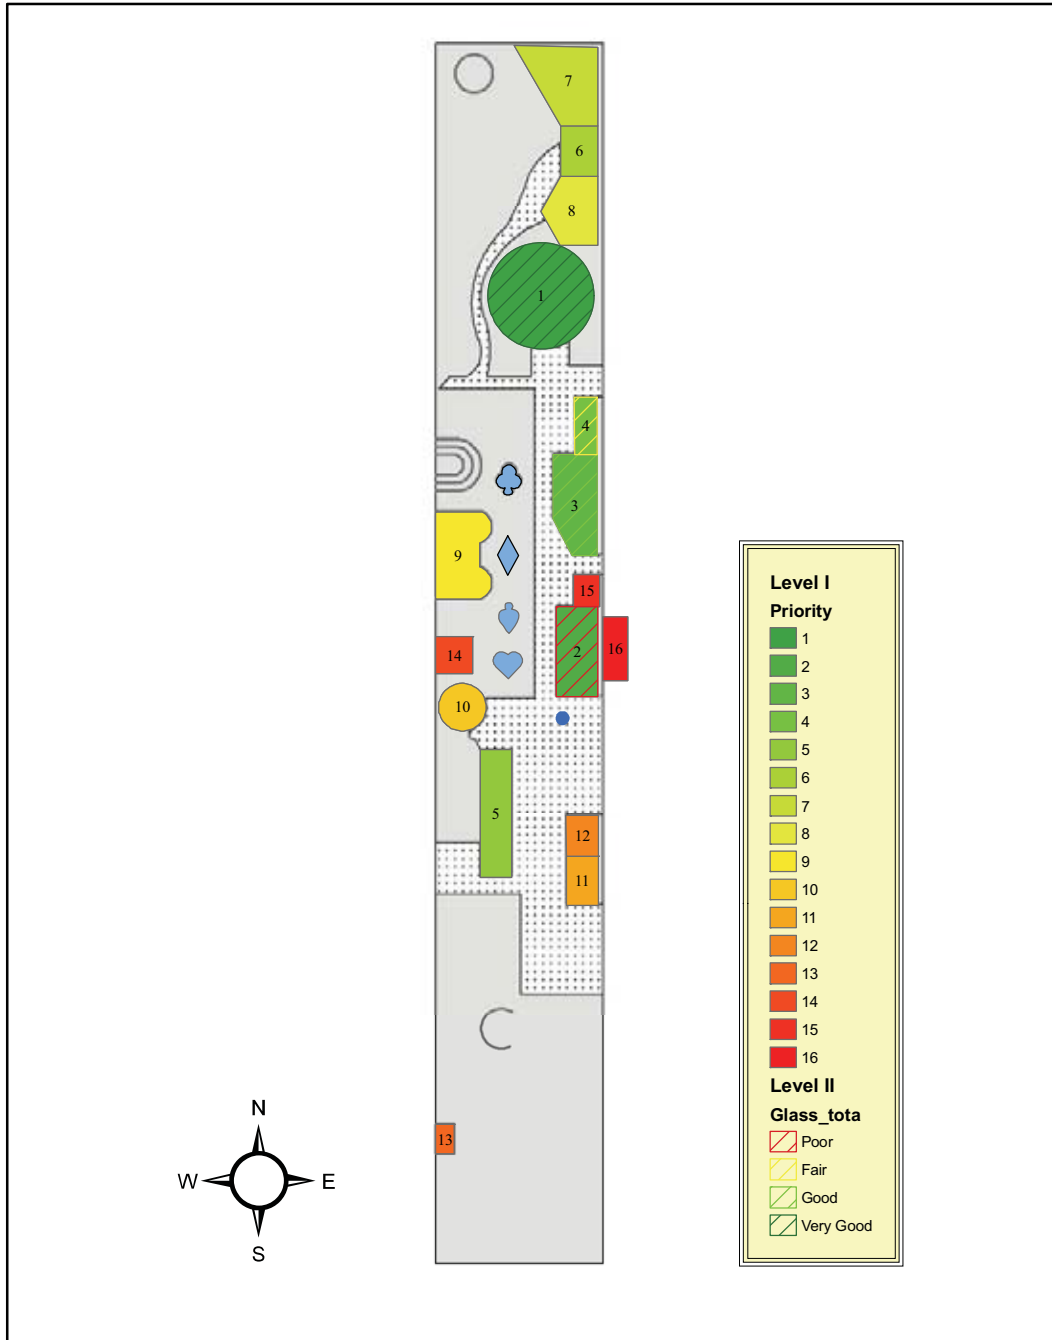
Fig. 7.1: ArcView Conditions Map
135

BottleVillage: Level III Priority & Glass

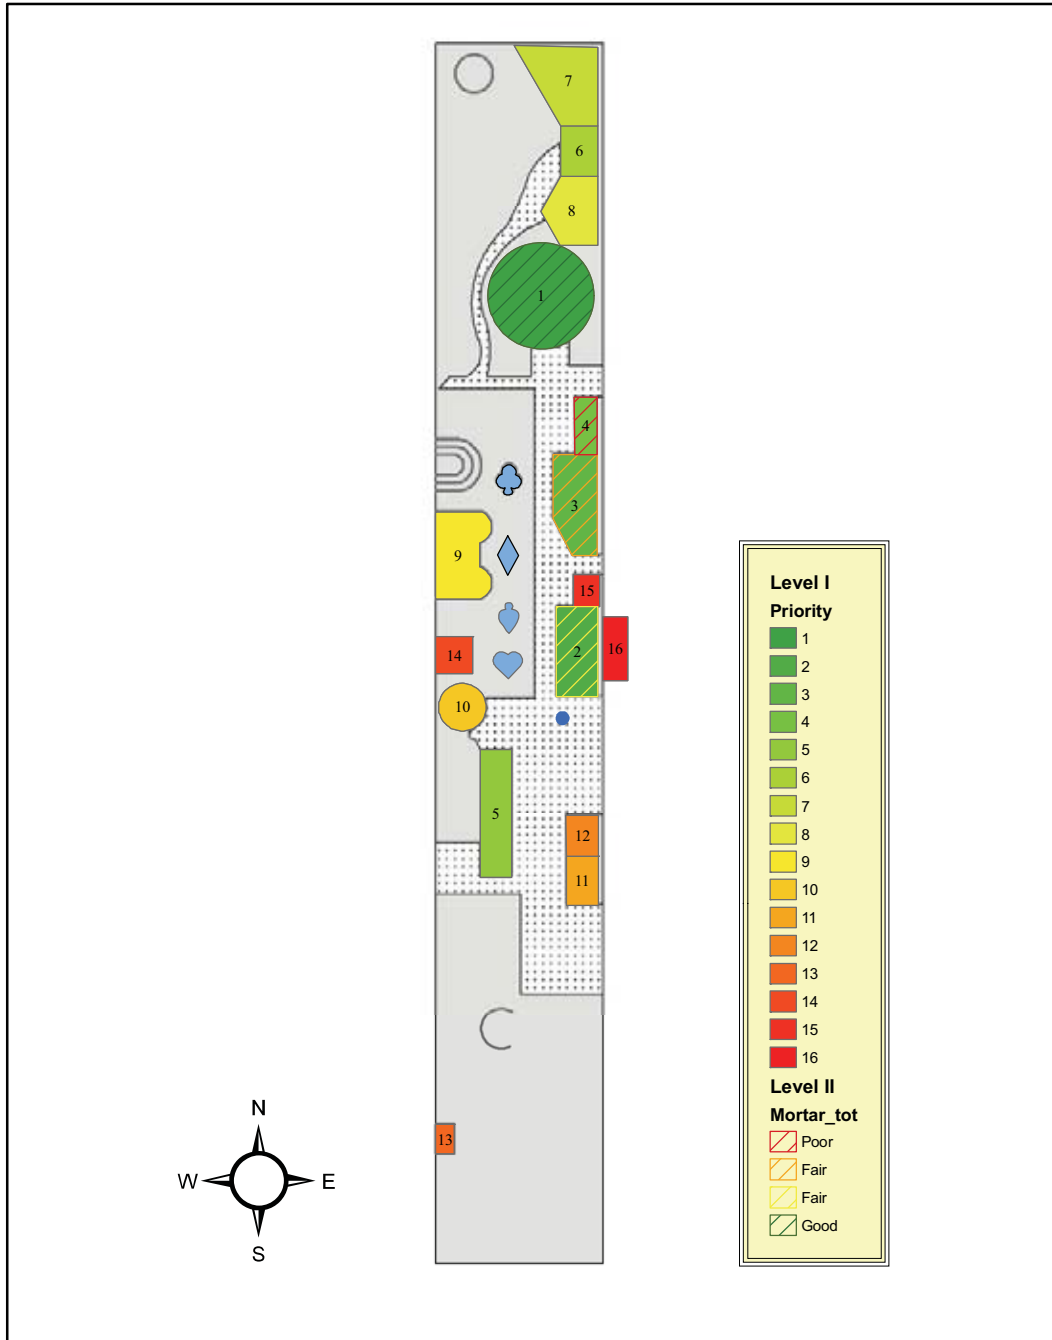
Fig. 7.2: ArcView Conditions Map

BottleVillage: Level III Priority & Mortar

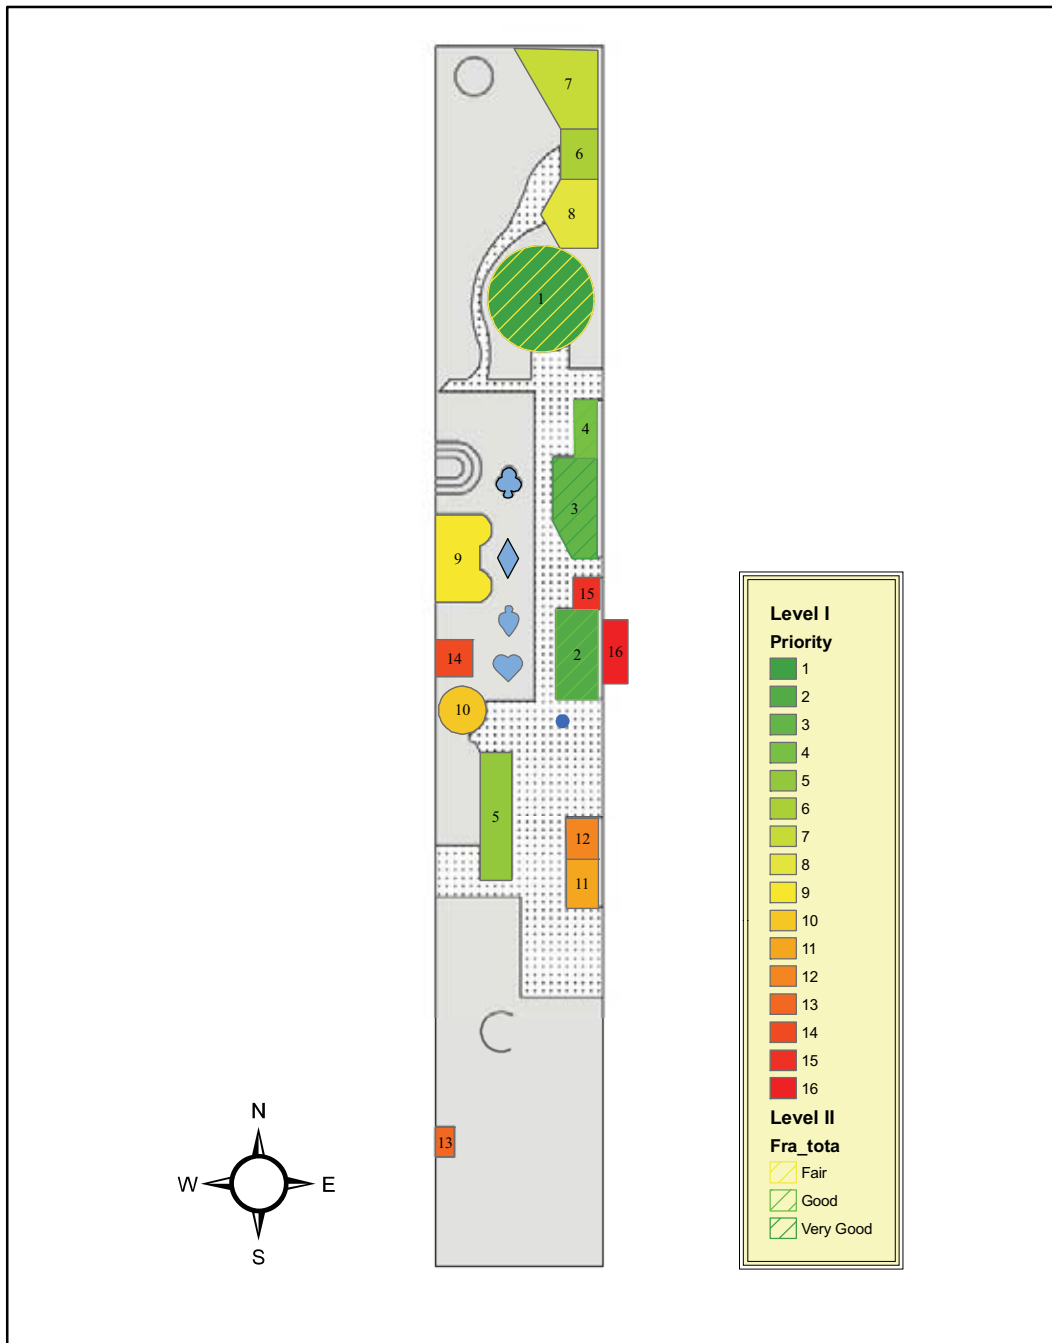
Fig. 7.3: ArcView Conditions Map

BottleVillage: Level III Priority & Framing

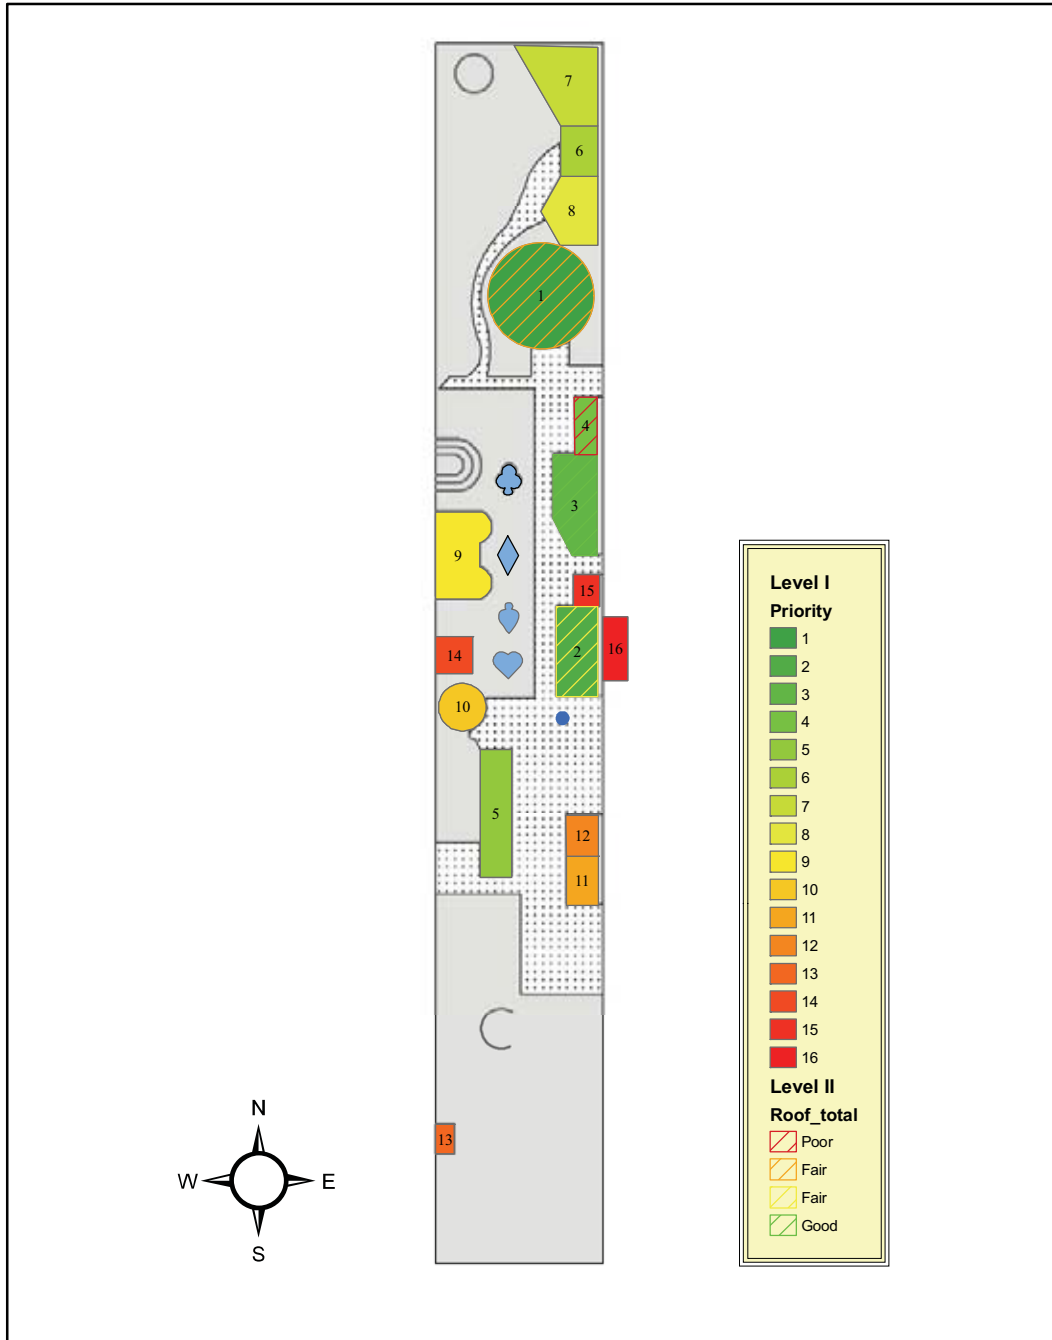
Fig. 7.4: ArcView Conditions Map
138

BottleVillage: Level III Priority & Roof

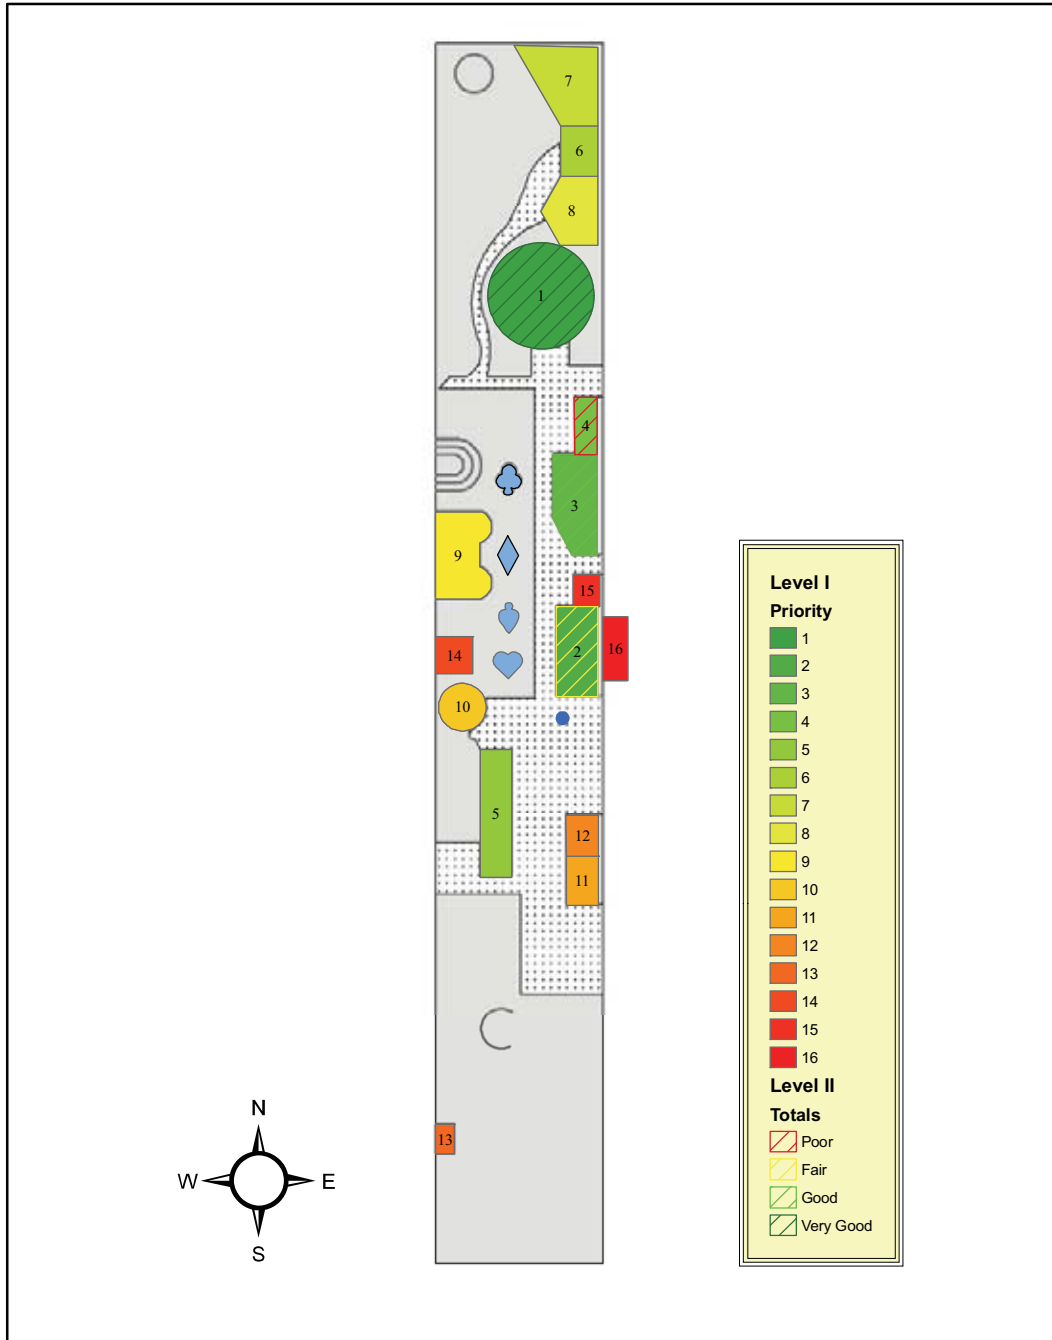
Fig. 7.5: ArcView Conditions Map
139

BottleVillage: Level III Priority & Condition Totals

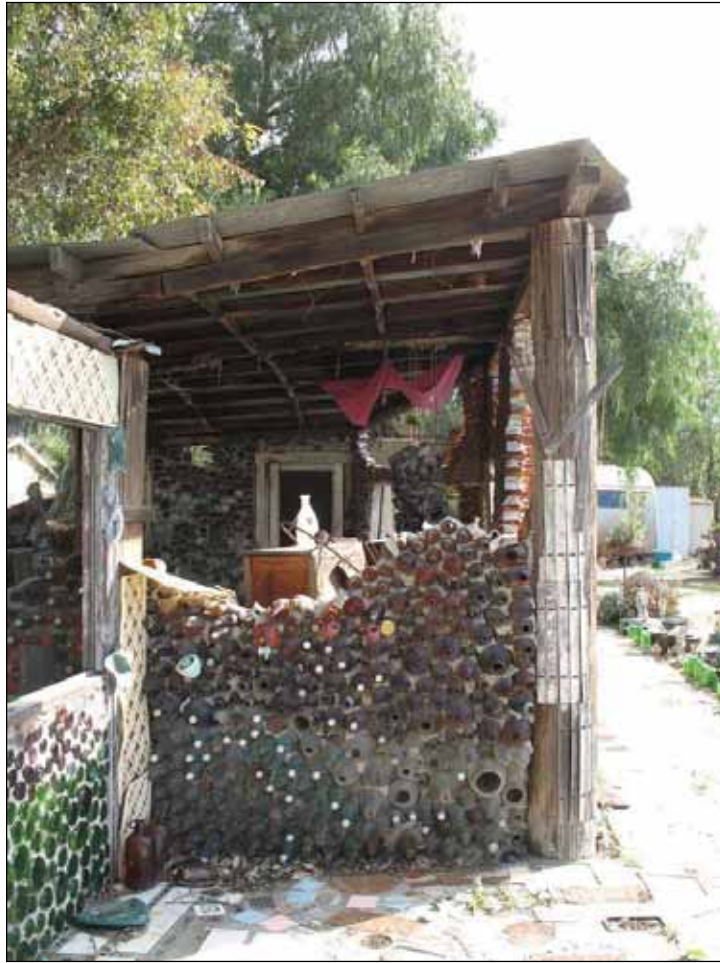
Figure 7.12: Cleopatra's Bedroom framing system. Recycled telephone poles constitute three vertical load bearing members of this structure (only one pole is pictured above). These poles are in direct contact with the cement ground (TSD 2007).

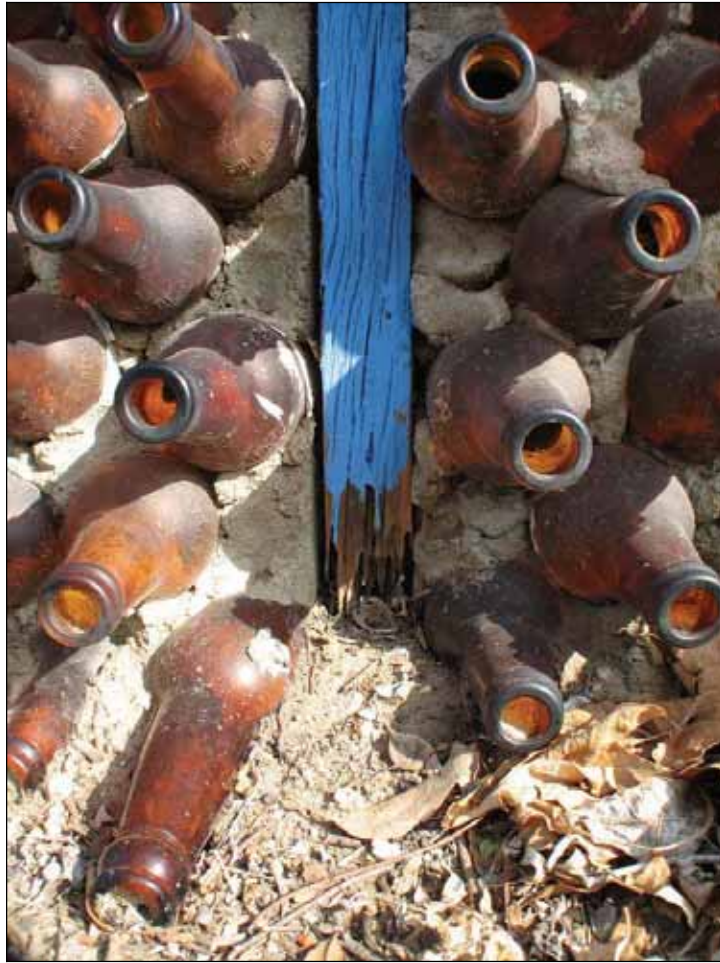
Figure 7.14: Round House wood framing, rot and termite damage due to direct contact with damp ground. (TSD 2007)

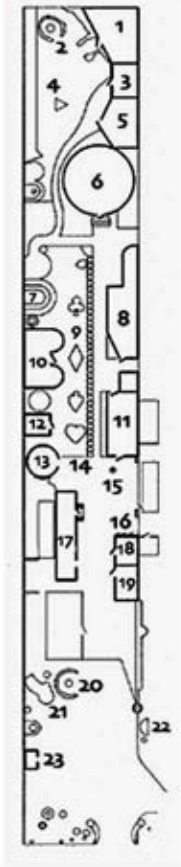
- Very good condition - Structurally stable - Minor loss of bottles - Rot and termite damage in wood studs, some areas exhibit complete loss - Moderate roof deformation
