Frank Lloyd Wright's Hanna House: Recommendations for a Seismic Strengthening Program

Carolyn Ruddell Samuels
University of Pennsylvania

A THESIS

Historic Preservation

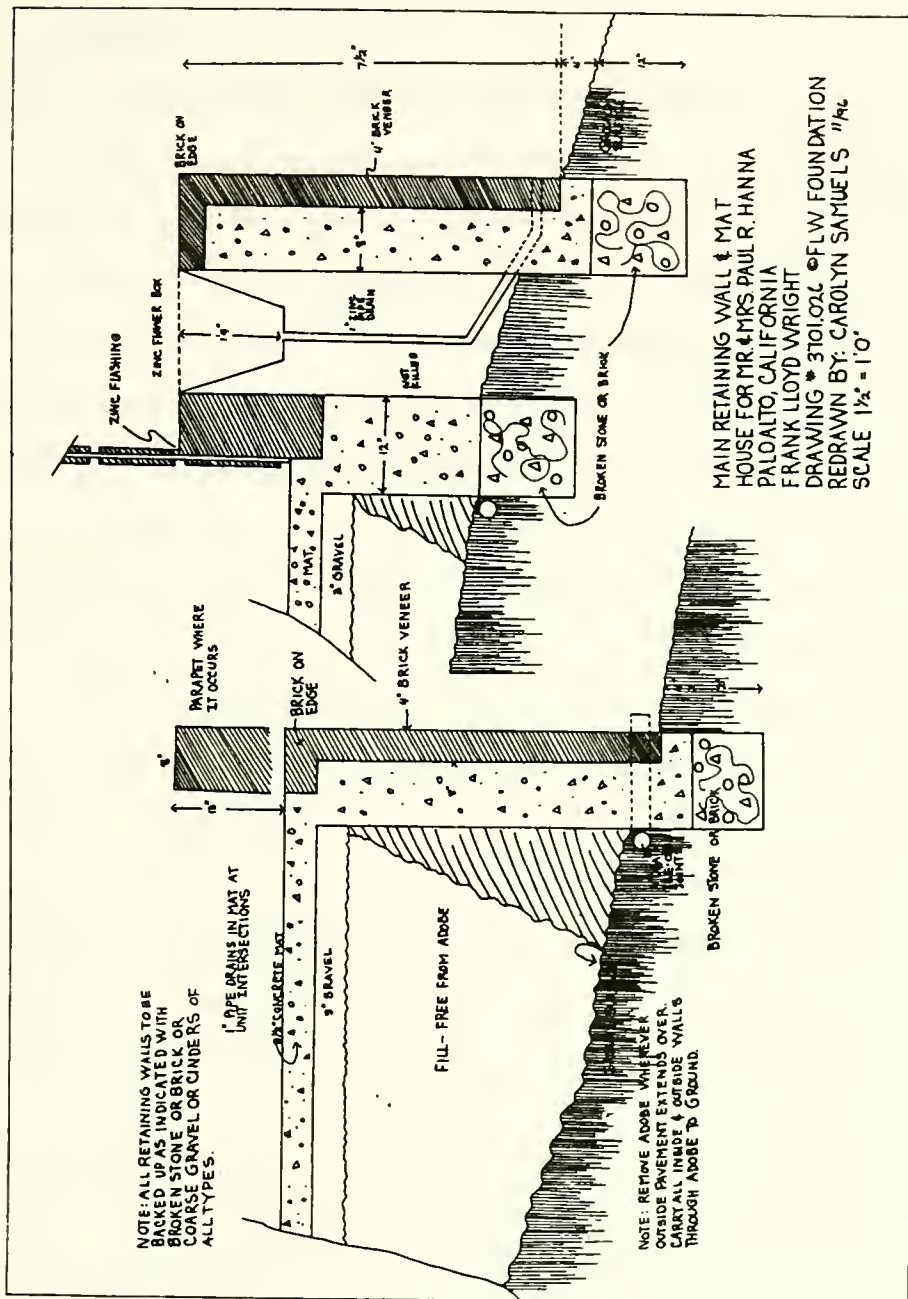
ILLUSTRATION 3

Working drawing #37 in the Stanford University Archives and working drawing #3701-026 in the Getty Foundation Frank Lloyd Wright Archives, detail construction of a 12-inch wide perimeter wall foundation and an 8-inch wide foundation for a retaining wall⁴⁸ (Illustration 3). Notes on the blueprint held

at Stanford indicate "Carry all inside and outside walls through adobe to ground". Wright also specified that the foundation for the living room fireplace should be constructed as the others and extend as the others, to "...solid ground"⁴⁹.
