Bethesda Terrace: Conditions Assessment and Evaluation of Previous Stone Conservation Treatments

Christopher John Gembinski
University of Pennsylvania

Historic Preservation

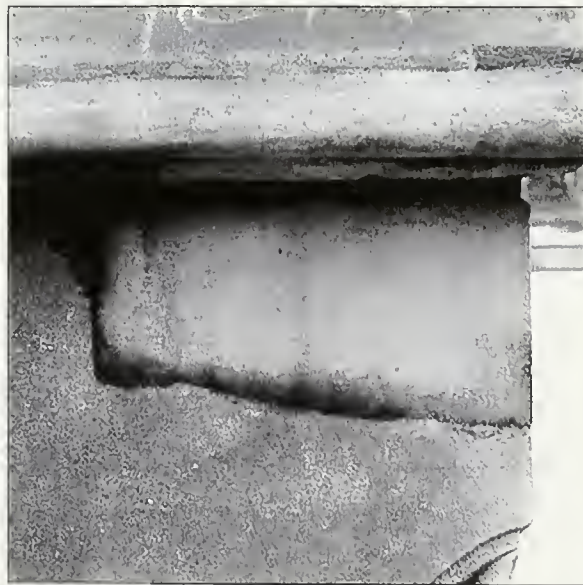
Fig. 1 - Composite repair showing signs of visual alterations.

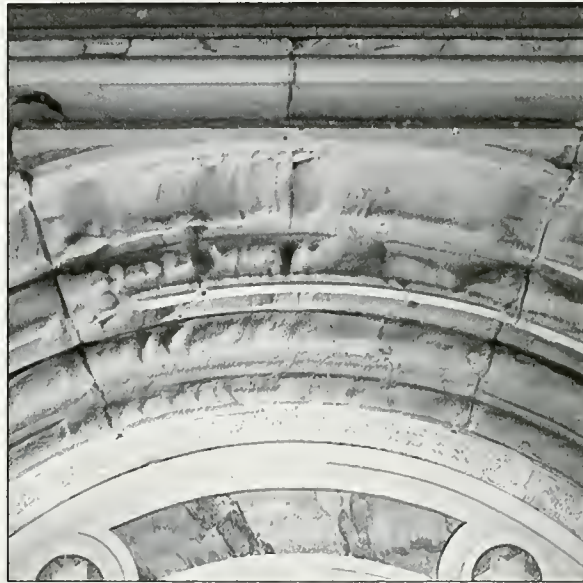
Fig. 5 - Retroweathering - uniform back loss parallel to the original stone surface due to various weathering determined at individual occurrences.

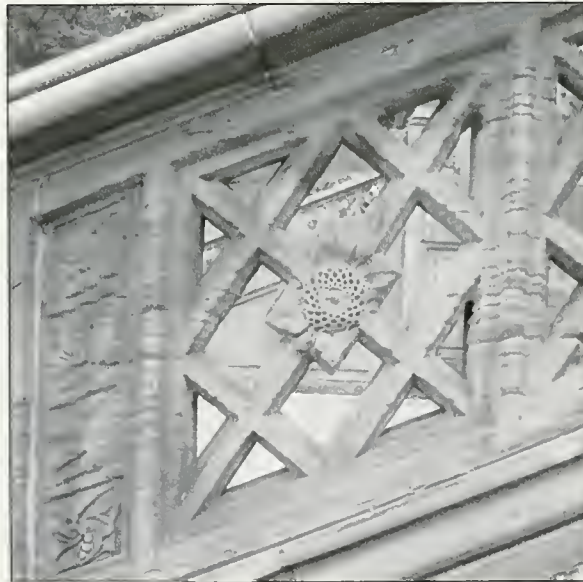
Fig. 8 - (1b.c) Weathering pattern dependent on stone structure - relief of stone surface caused by weathering dependent on structural features such as bedding.

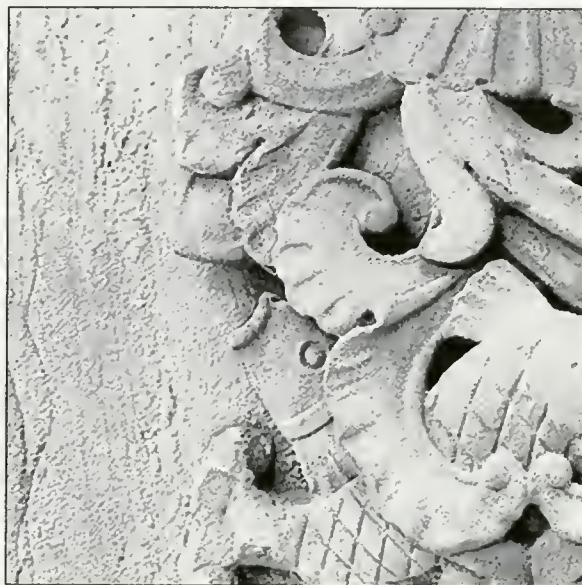
Fig. 9 - (1b.d) Exposure of stone components - raised exposure of stone aggregate through loss of less stable stone components.

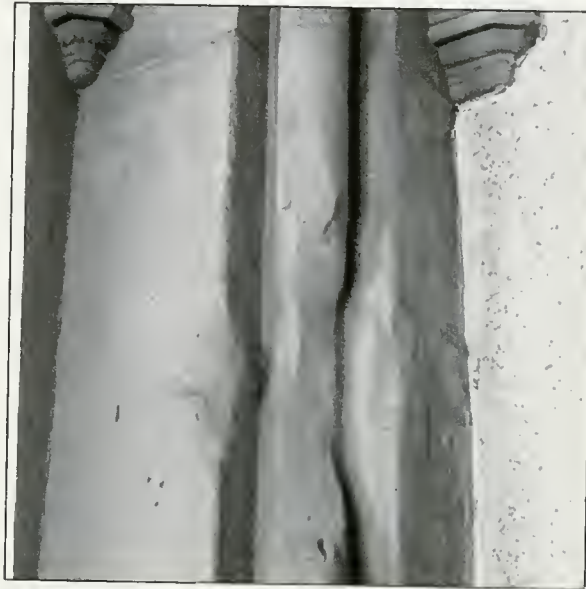
Fig. 13 - (1c.d) Breakage resulting from unrecognizable causes.

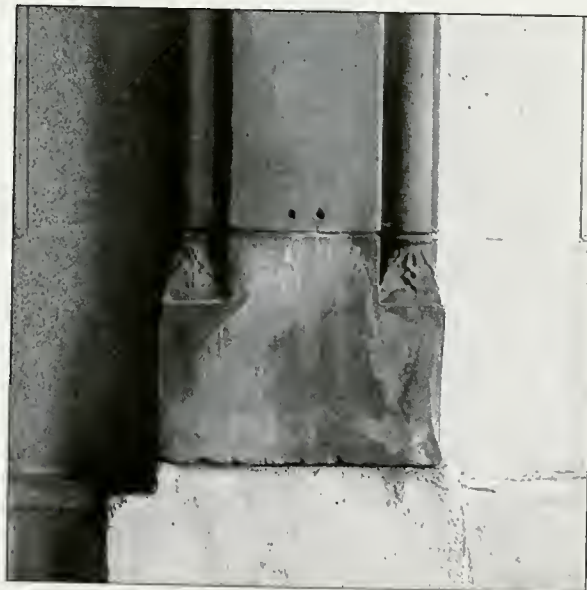
Fig. 14 - (2a.a) Coloration - chromatic alteration of original stone surface resulting from accumulation of coloring matter through natural weathering or chemical treatments.

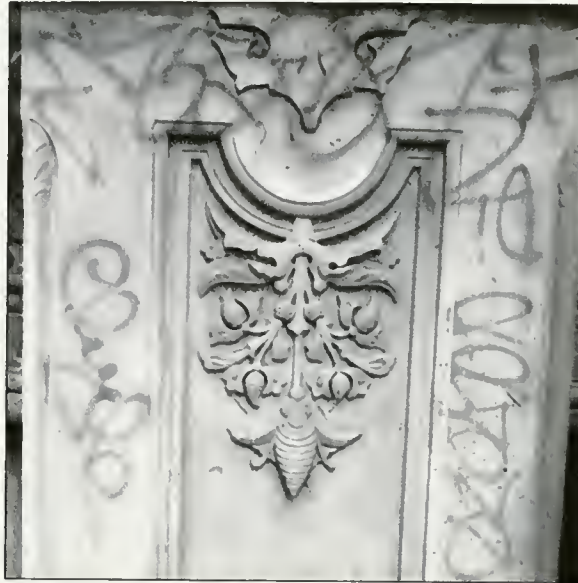
Fig. 17 - (2b.d) Soiling from direct anthropogenic causes - graffiti, paint, stickers, etc.

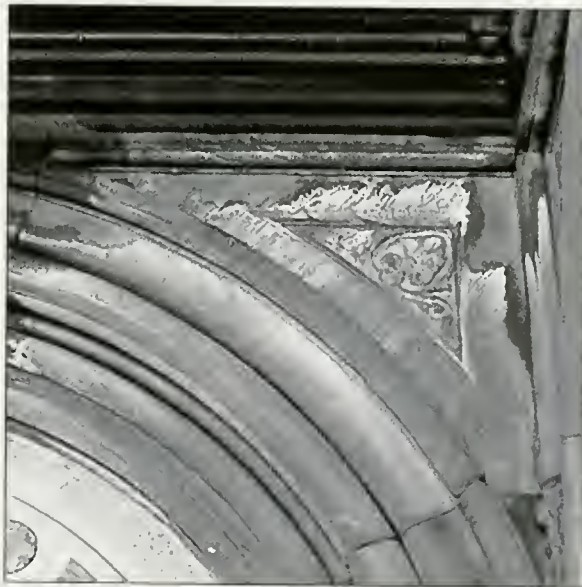
Fig. 18 - (2c.a) Efflorescence - loose salt deposits on stone surface.

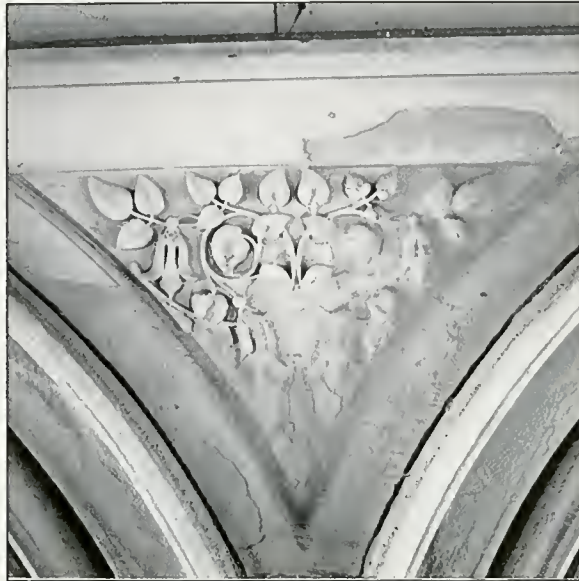
Fig. 19 - (2d.a) Dark/light or colored crust tracing the surface - crust tracing the morphology of the stone surface usually due to moisture related processes.

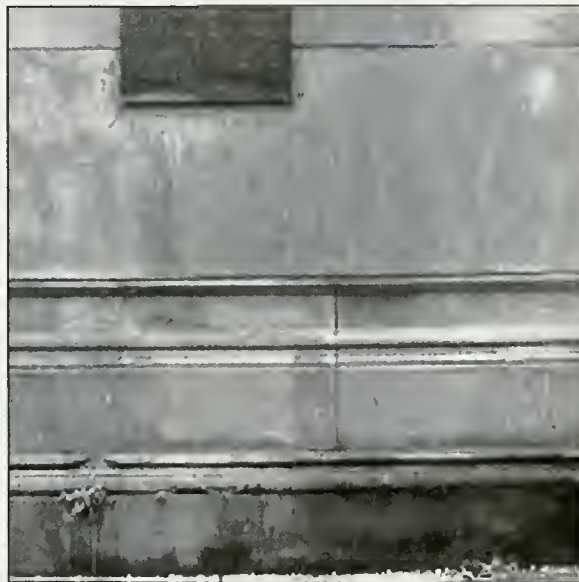
**Fig. 20 - (2e.a) Microbiological colonization - algae, fungi, lichen and bacteria.
Fig. 20 (2e.b) Colonization by higher plants.**

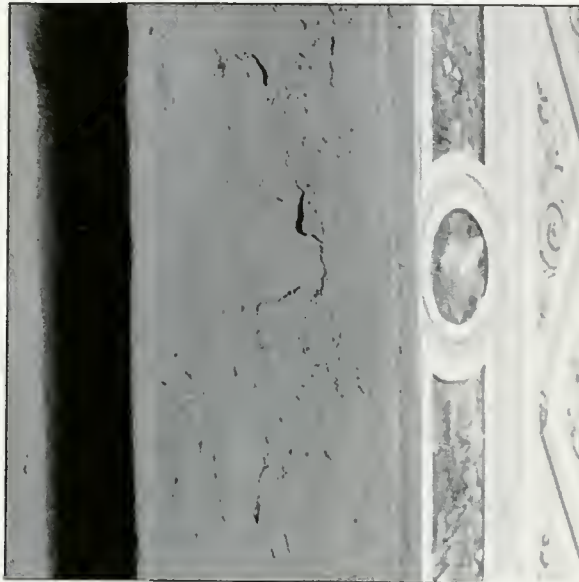
Fig. 21 - (3a.b) Granular disintegration resulting in sanding - detachment of granular stone components of sand aggregate size specific to Bethesda Terrace.

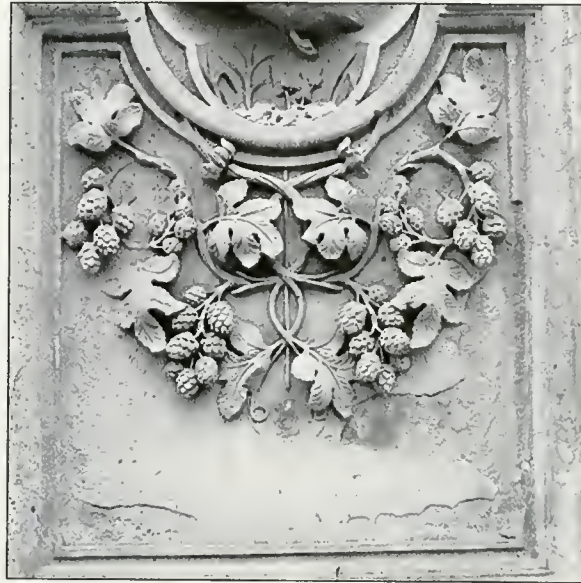
Fig. 23 - (3f.b) Delamination - detachment of larger stone elements parallel to stone structure, but not necessarily to stone surface.

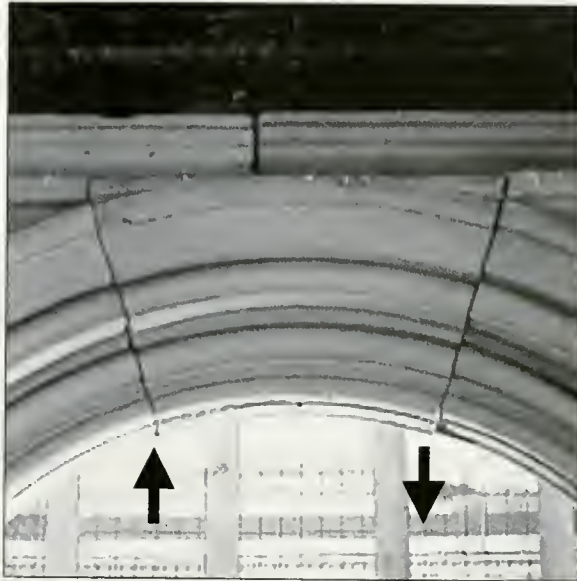
Fig. 24 - (4b) Displacement - stone elements from moved from original location due to natural or anthropogenic causes.

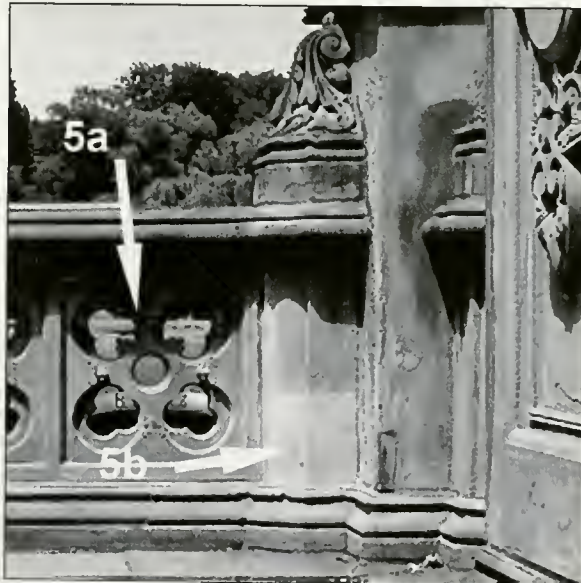
Fig. 25 - (5a) Stone replacement - replacement of stone with new stone. (5b) Artificial stone replacement/mortar patch - replacement of stone elements with artificial stone or mortars.

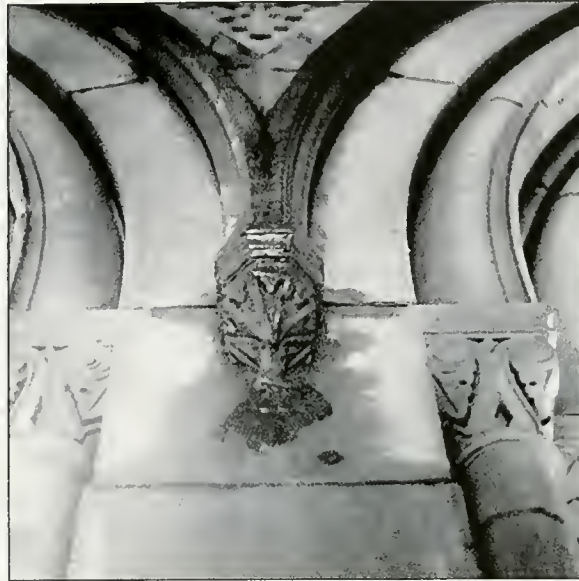
Fig. 26 - Water penetration on north arcade column.

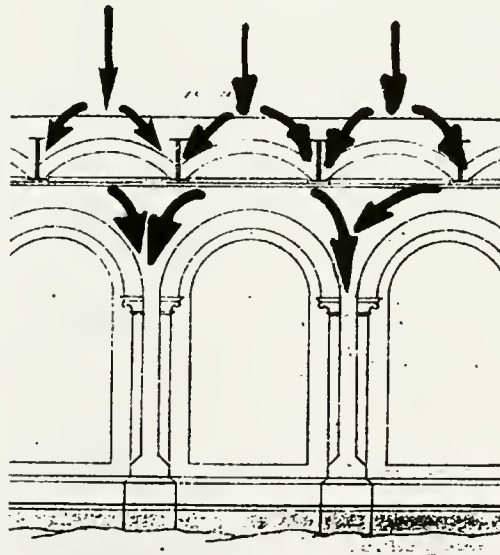
The construction of the shallow barrel vaulting of the arcade ceiling may also create a potential for surface water transport to the sandstone. The iron girders lead water directly from the vaults to the voussiors of the perimeter wall pilasters where it collects at the impost blocks and runs down the pilasters. This mechanism may have been even more pronounced before the removal of the Minton tile ceiling because water was pooling on the backsides of the panels and probably running directly to the stone. The dismantling of the ceiling probably diminished moisture collection and enhanced salt efflorescence as the stone dried.

Fig. 27 - Path of water penetration through ceiling to voussiors.

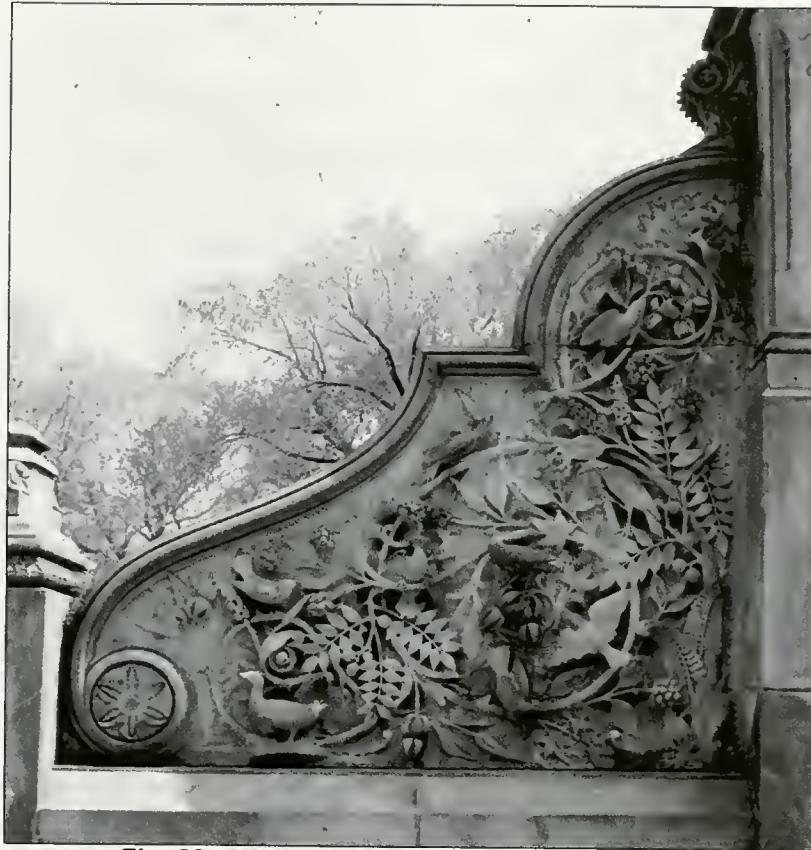
**Fig. 28 - Northwest bird panel, western exposure.
Note erosion under drip molding along the top.**

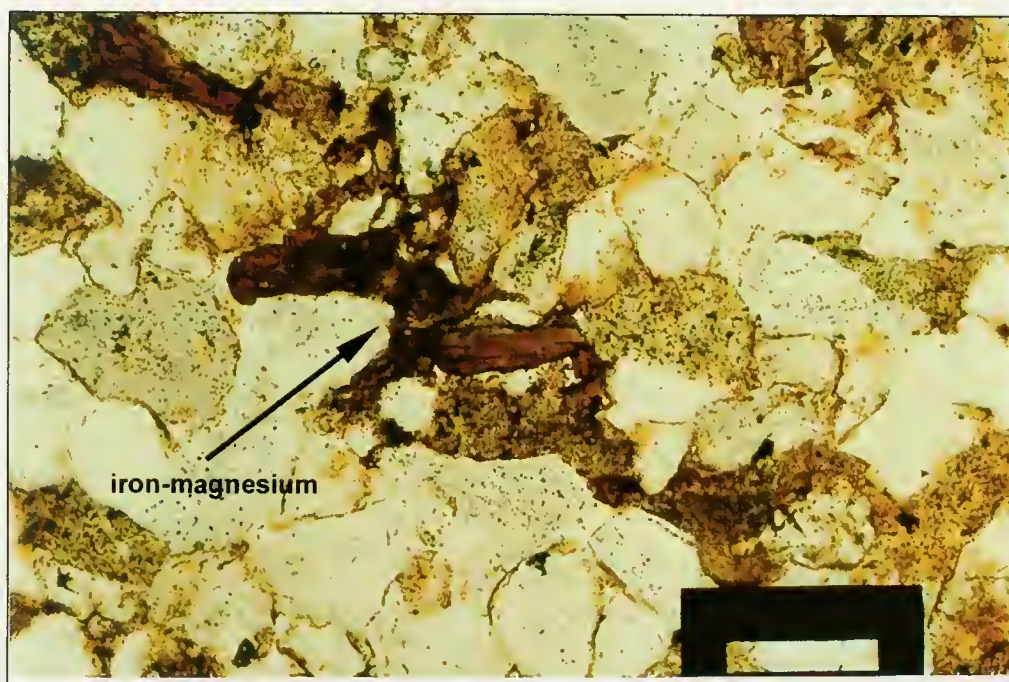
**Fig. 33 - Bethesda Terrace sandstone (100X – plane-polarized light).
Large inclusion of iron-magnesium in highly altered state.**

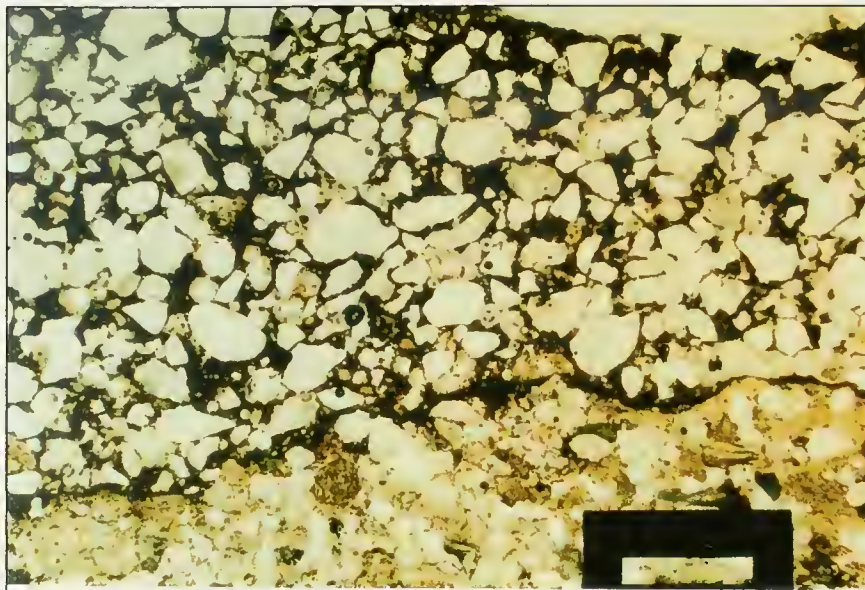
Fig. 46 - Composite repair – thin section (50X - plane-polarized light). Black coloration is throughout the patching material (top layer) and no calcite crystals are visible in the matrix. No alteration to the sound stone beneath the patch is evident.

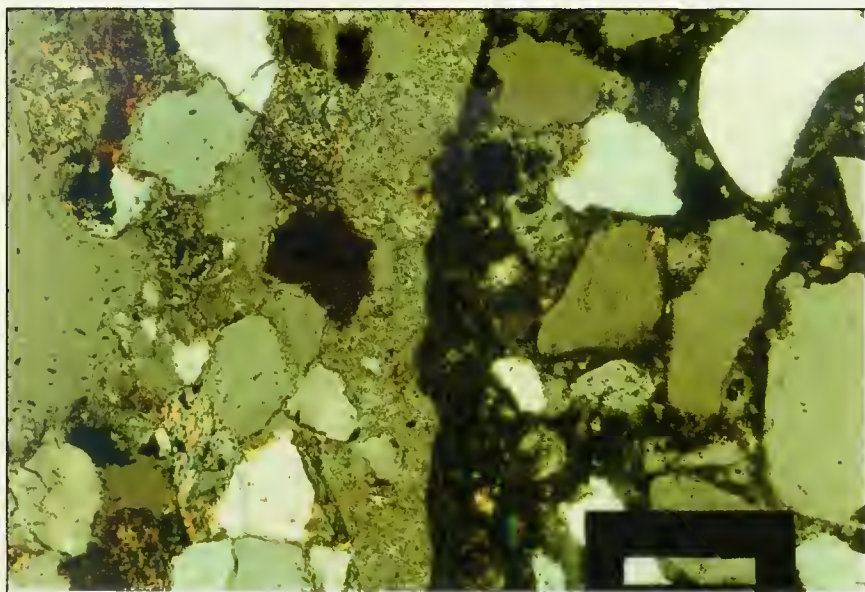
Fig. 47 - Patching material – thin section (100X - plane-polarized light). Black layer at interface between sound stone (left) and mortar patch (right).

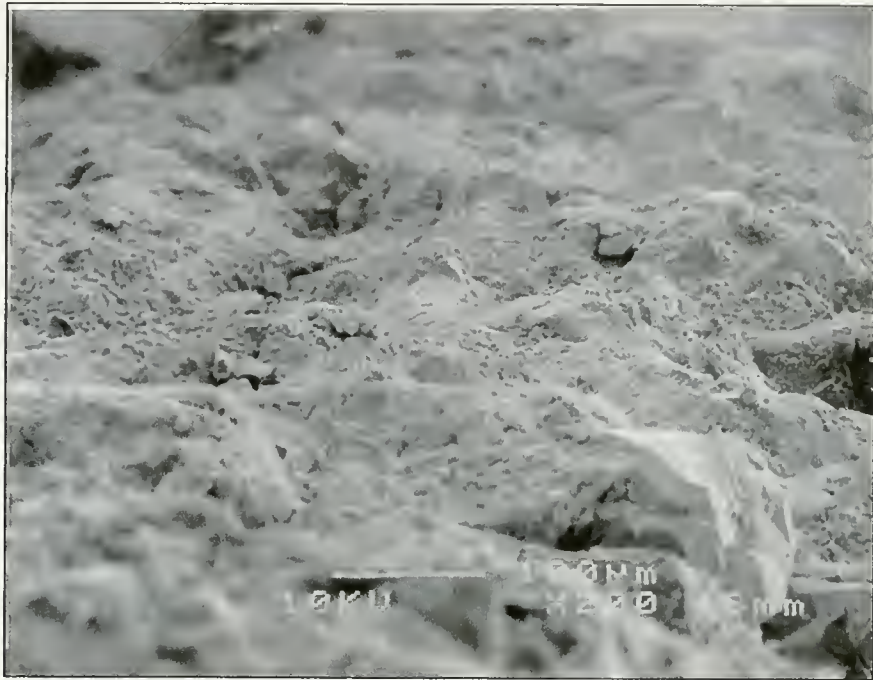
Fig. 58 - Honed Bethesda Terrace sandstone (200X – JEOL SEM).
Honed surface covered by 100µm layer of dust.

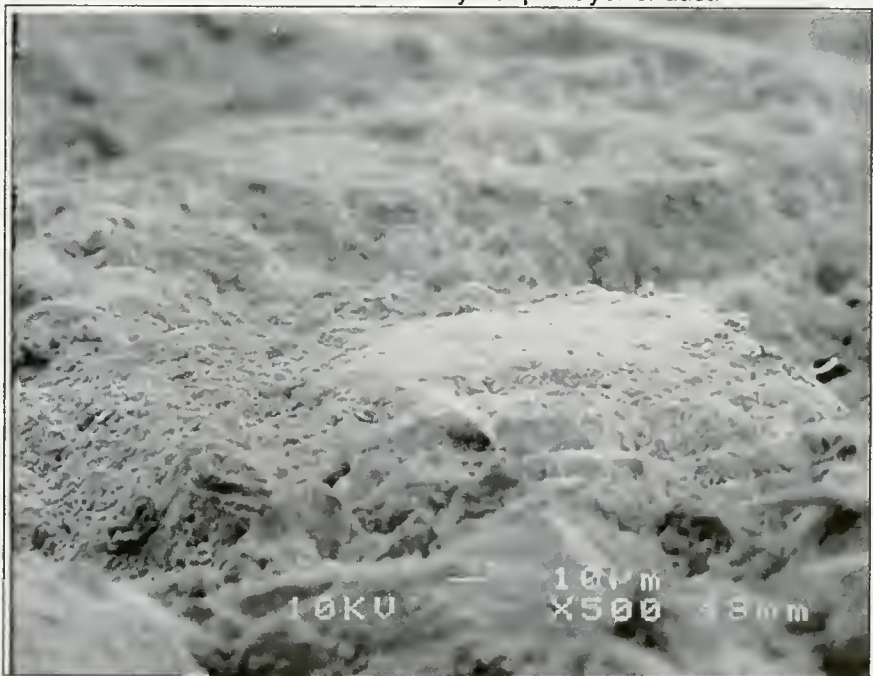
Fig. 59 - Honed Bethesda Terrace sandstone (500X – JEOL SEM).
Dust layer completely covers sandstone grains.

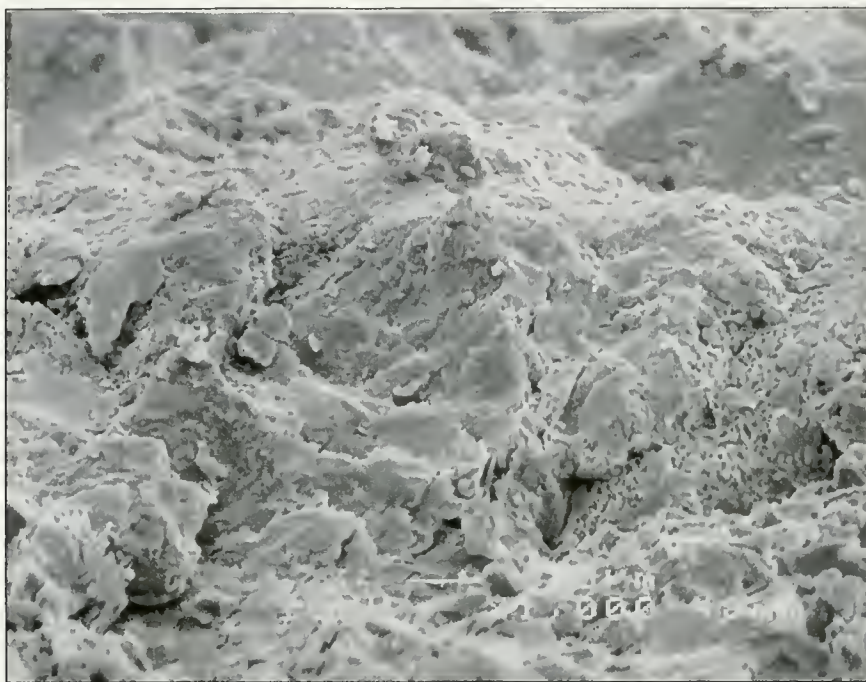
Fig. 60 - Honed Bethesda Terrace sandstone (1,000X – JEOL SEM).
Higher magnification shows smooth flaking surfaces in the 100 μ m layer on the surface
