Congress Hall Hotel: An Historic Structure Report

Michael Calafati
University of Pennsylvania

CONGRESS HALL HOTEL:

AN HISTORIC STRUCTURE REPORT

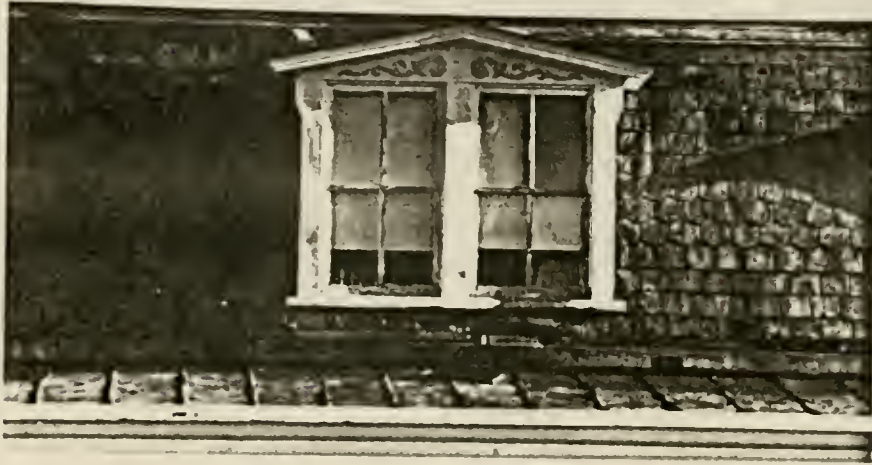
The vertical face of the mansard constitutes the second area. It is covered by both slate shingles and asphalt shingles. In general terms, the mansard roof areas which face the water no longer retain their cut slate tile. At these locations asphalt shingles appear to have replaced or been placed over the slate (fig. 26). The way in which the asphalt shingles cover the mansard have obscured the edge ridge conditions which were originally white (or a light color) painted wood and the pleasant accentuation of the outline has been lost (compare figures 11 and 18). The mansard roof areas which face Congress Place and Perry Street, however, still retain their slate tiles (fig. 27). Slope at this area is 1 in 1/4.

Fig. 27: (Top) Double dormer facing Congress Place. Notice slate shingles to the right and asphalt shingles to the left.

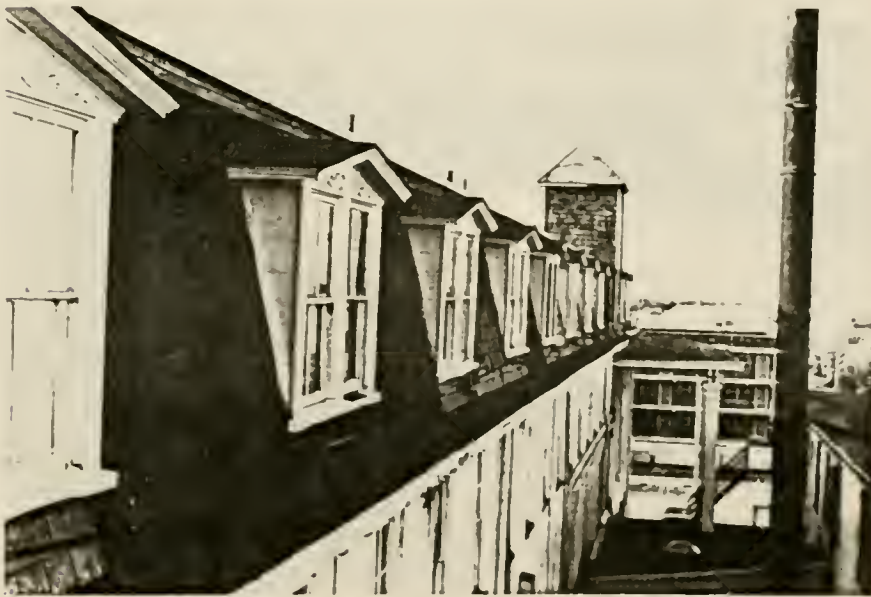
roof is in good overall condition. The condition of the mansard's vertical faces varies greatly. Substantial areas of the slate are largely intact and appear to be functioning well. Where repairs have been necessary pitch or tar has been used to smear failing areas (fig. 28). This unfortunate approach is fairly limited but unsightly where evident, especially on the northeast elevation of the Perry Street wing closest to the ocean. Slate predominates at areas facing away from the ocean.

Fig. 28: (Bottom) Pitch applied over slate shingles as a hasty remedy at the mansard roof facing the annex. View looking west.

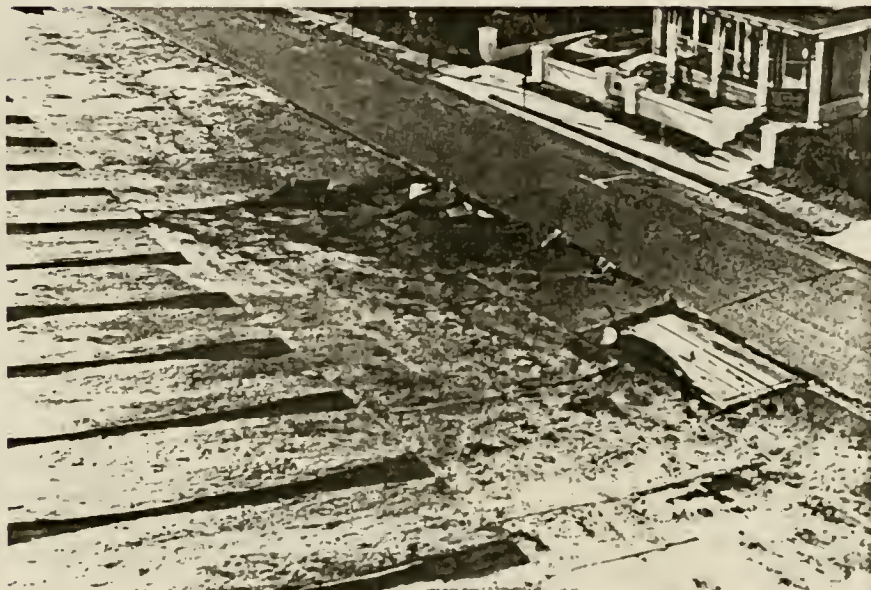
The veranda's roof, as the nearly vertical face of the mansard, appears to be in covered by original materials at areas where it does not face the ocean. The metal roofs at these locations are beyond their useful life although they still continues to function. Surface rust and crimping of the standing seams caused by foot traffic. There are few areas of total failure, however (fig. 29).

Fig. 29: (Top) Metal roofing failure at the Congress Place veranda roof.

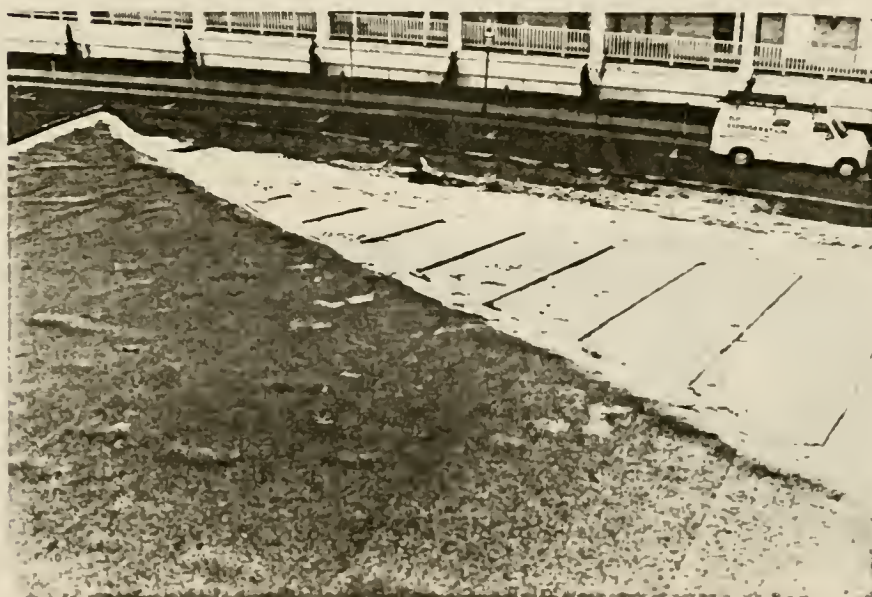
The roll roofing applied to the balance of the veranda is in good overall condition and appears to be in the middle of its service life (fig. 30). There is one significant failure, however, at the southernmost tip of the Perry Street wing (fig. 31). Area and shape of the failure together with this end's proximity to the ocean, indicates that beachfront winds

Fig. 30: (Bottom) Roll roofing to metal transition at the south end of the Congress Place wing.

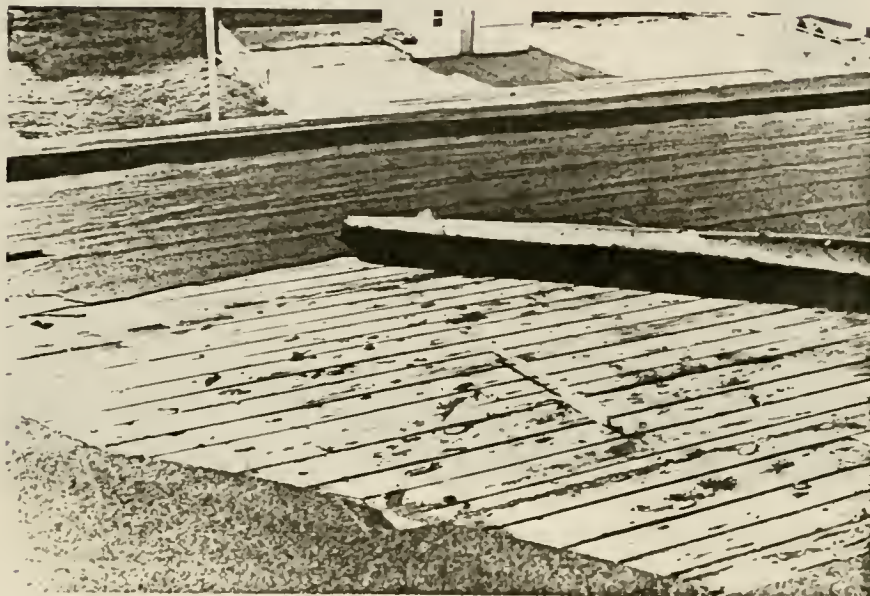
contributed to this failure. The failure is so complete that the sheathing boards are exposed. Fortunately these types of failure are not found over occupied interior spaces.

Fig. 31: (Top) Major failure at roll roofing south end of Perry Street wing.

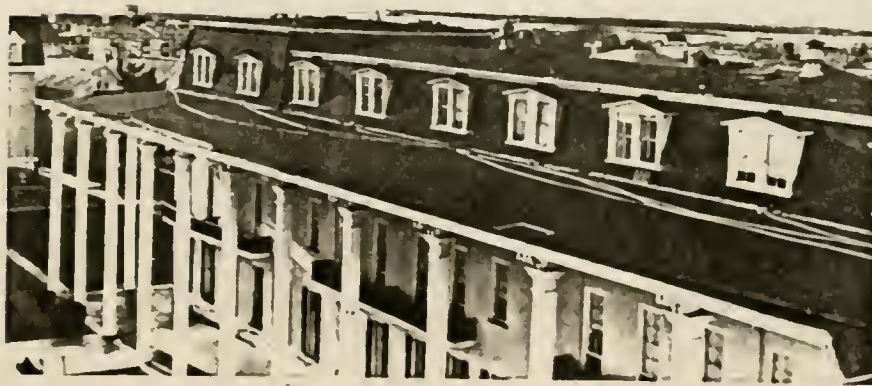
Fig. 32 (Bottom) Dams along veranda roof.

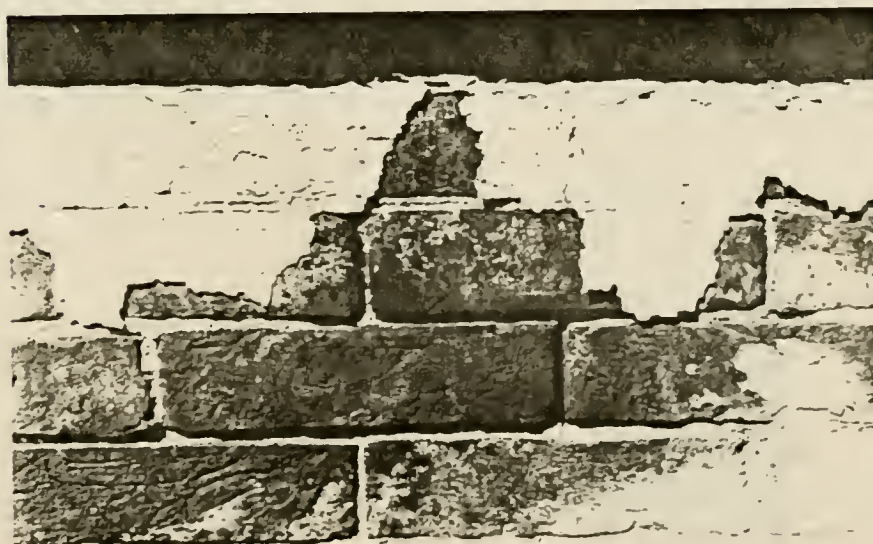
Fig. 36: (Top) Peeling paint due to rising damp at south end of Congress Place wing facing the ocean.

Fig. 37: (Bottom) Detail of flaking paint and delaminating brick face caused by rising damp.

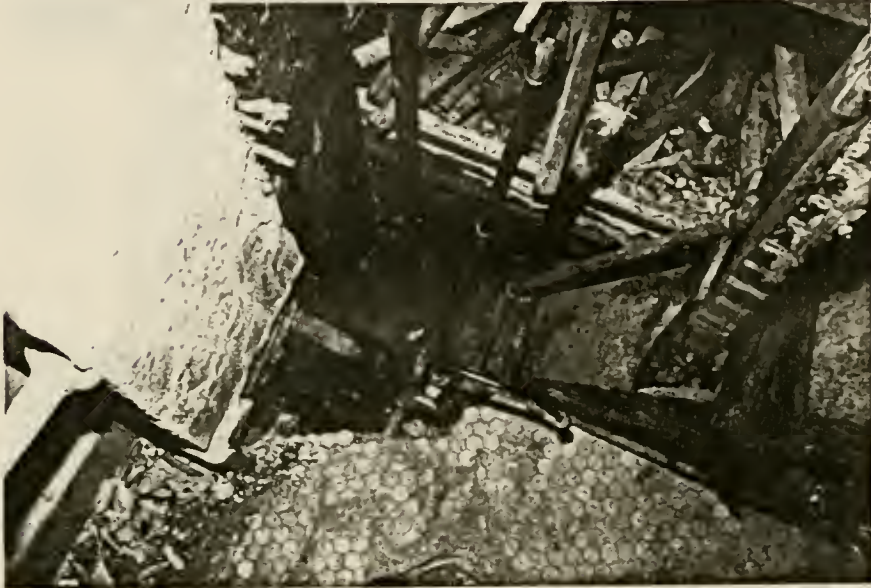
Fig. 41: (Top) Detail view looking down on bearing end of truss T4 at east end. Note proximity and number of plumbing lines.

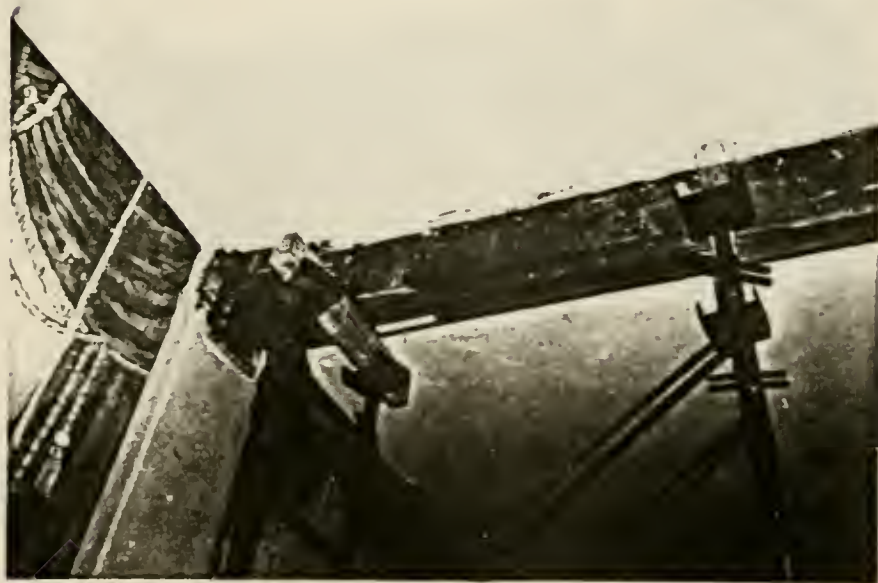
Fig. 42: (Bottom) Shoring at dining room of truss T6, east end.

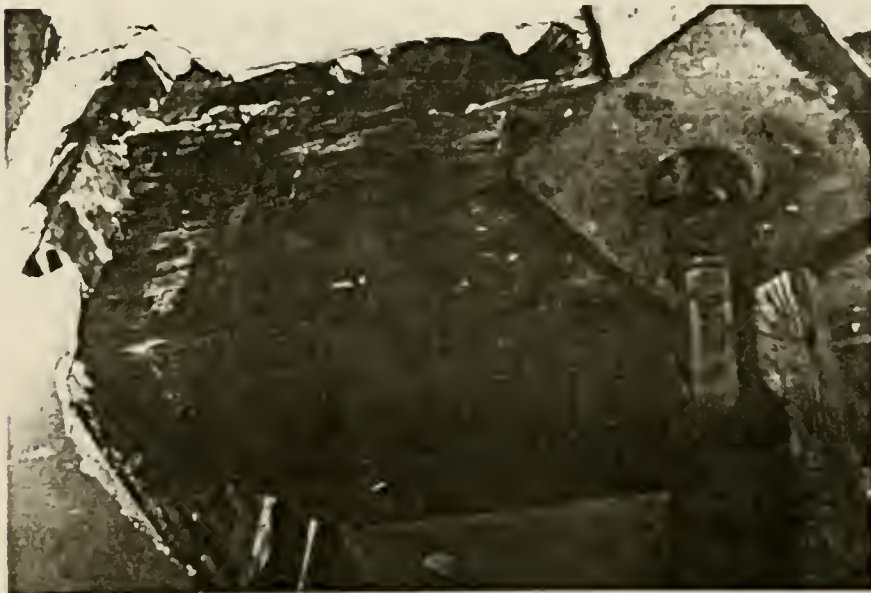
Fig. 44: (Bottom) Detail of failure at bearing end as viewed from the dining room.

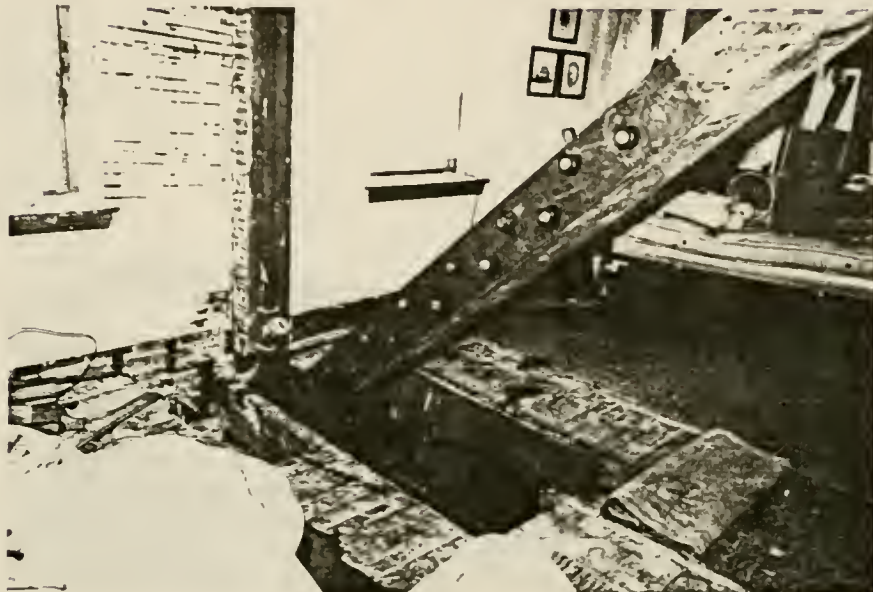
Fig. 45: (Top) View of new steel plates bolted to reinforce the truss.

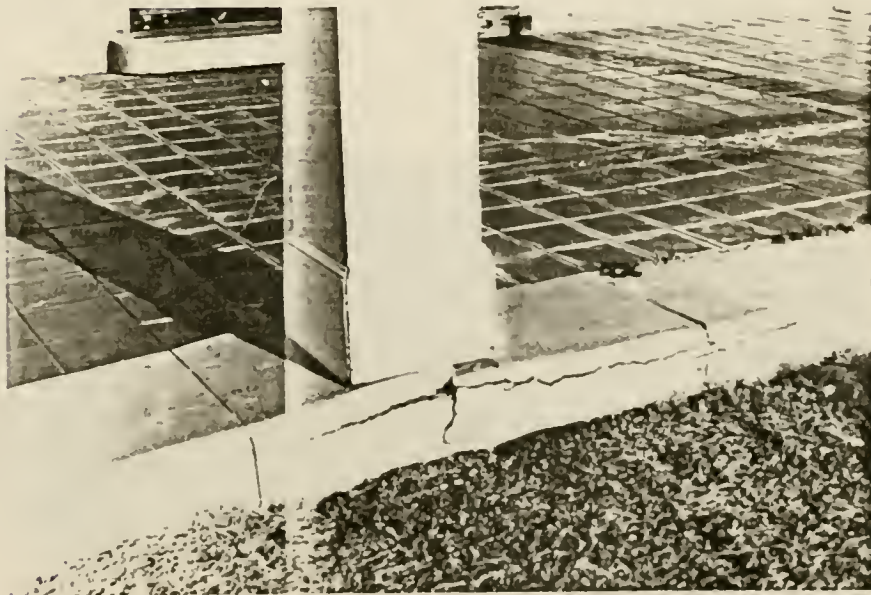
Fig. 50: (Bottom) Concrete breakage.

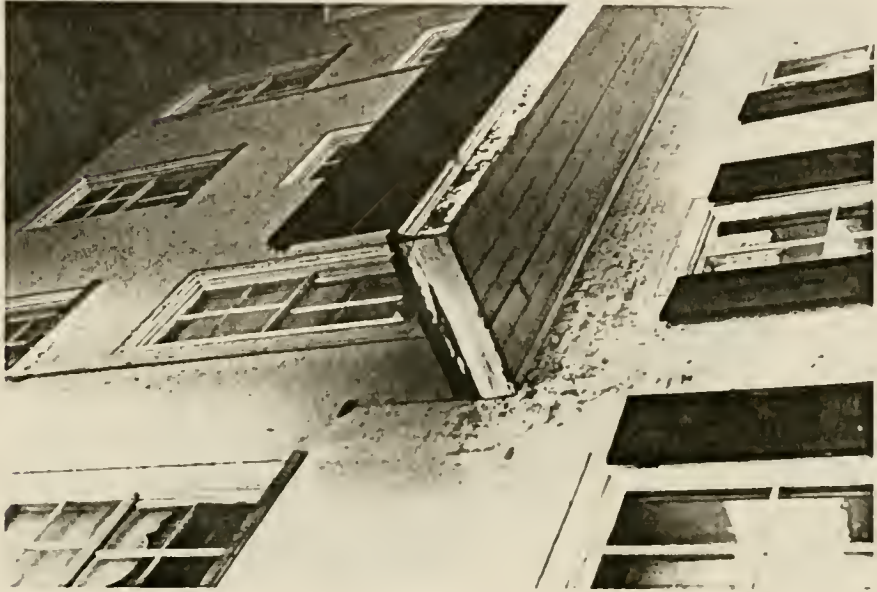
Fig. 53: (Top) Deteriorated second floor balcony at Congress Place wing closest to main entrance.

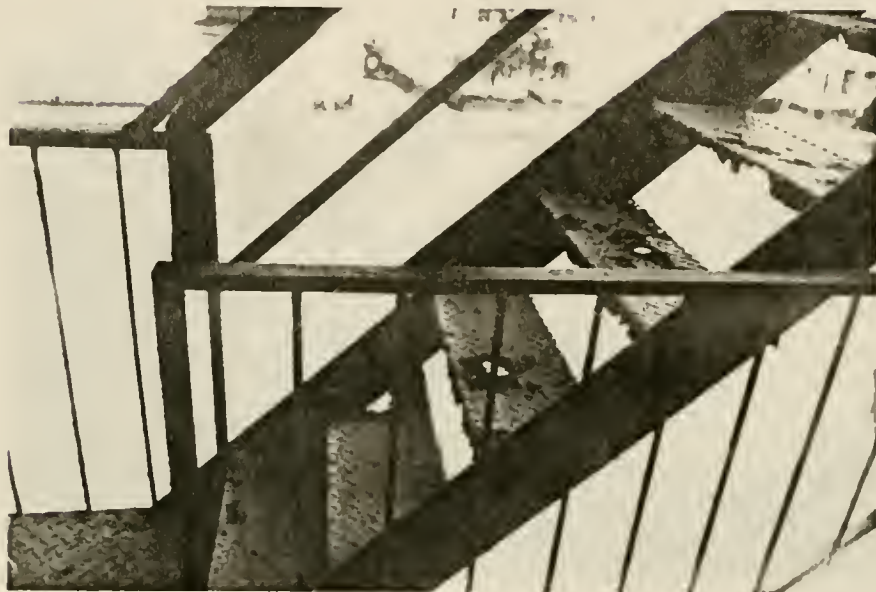
Fig. 55: (Top) Corroded fire escape at the end of the Congress Place wing.

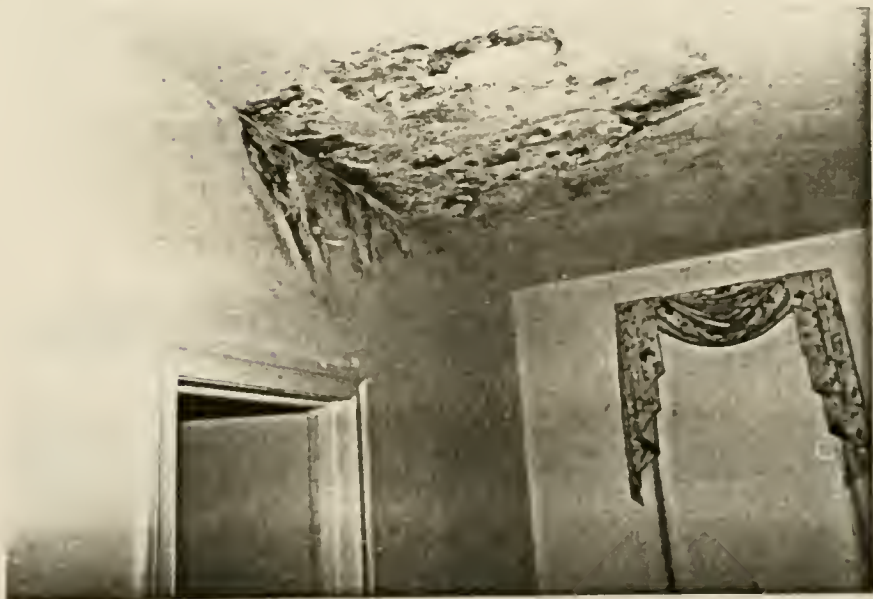
Fig. 57: (Top) Mildew bloom in the bathroom of room 306.
Fig. 58: (Bottom) Mildew bloom in guestroom 316.

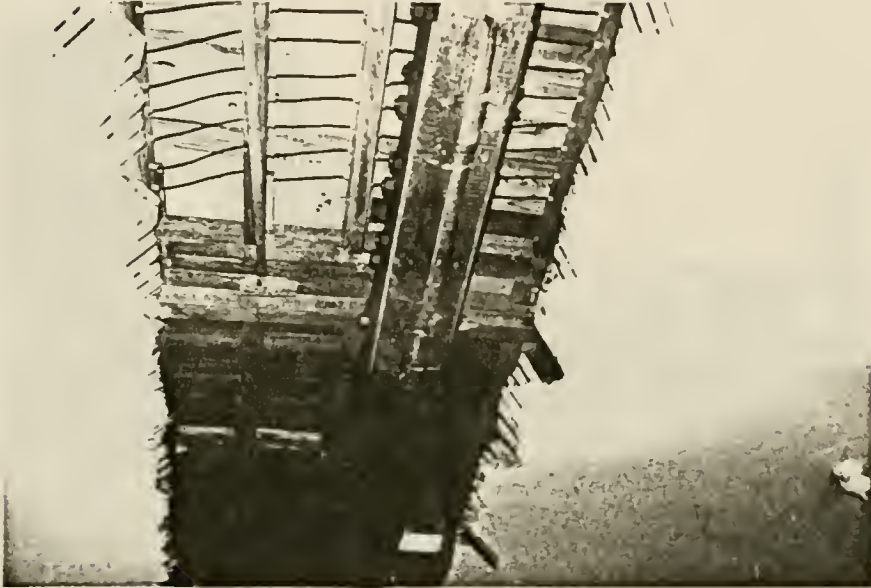
Fig. 63: (Top) Knob and tube wiring running in void between truss and floor framing.

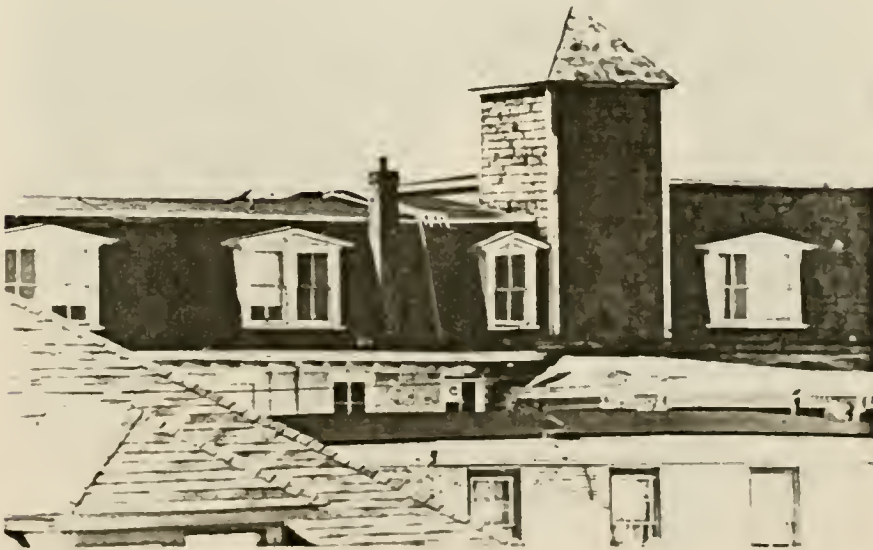
Fig. 64: (Bottom) Electrical conduits as they cross over the mansard roof. The elevator penthouse is to the right.

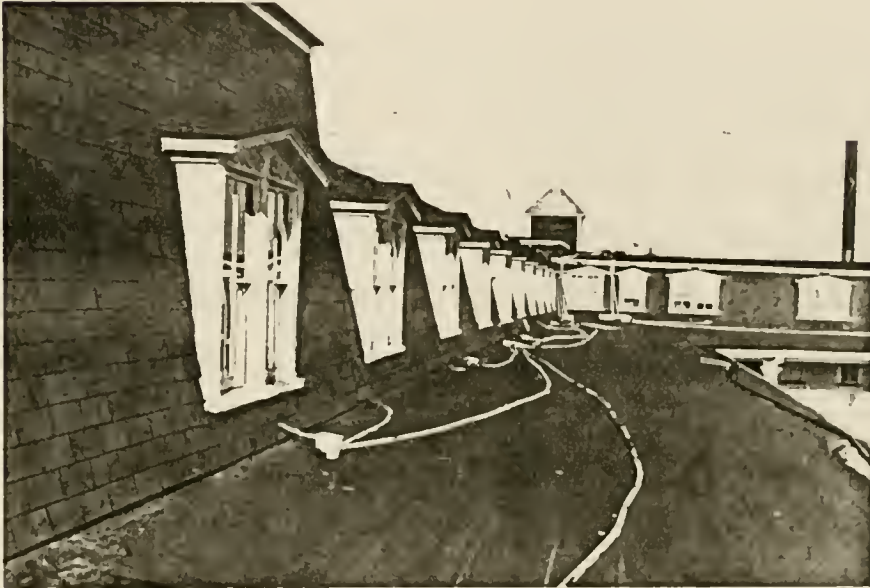
Fig. 65: (Top) Plastic electric conduits as they lie on the veranda . View looking northeast.

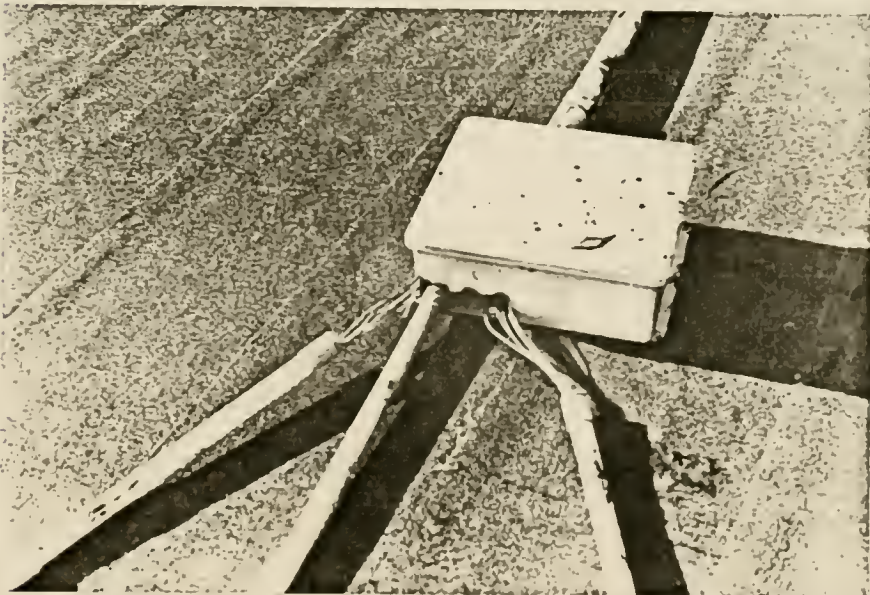
Fig. 66: (Bottom) Broken plastic electric conduits and junction box on the veranda roof.
