Documentation and Architectural Analysis of Little Manor Plantation House

William Luby Ferguson
University of Pennsylvania

A THESIS

Historic Preservation

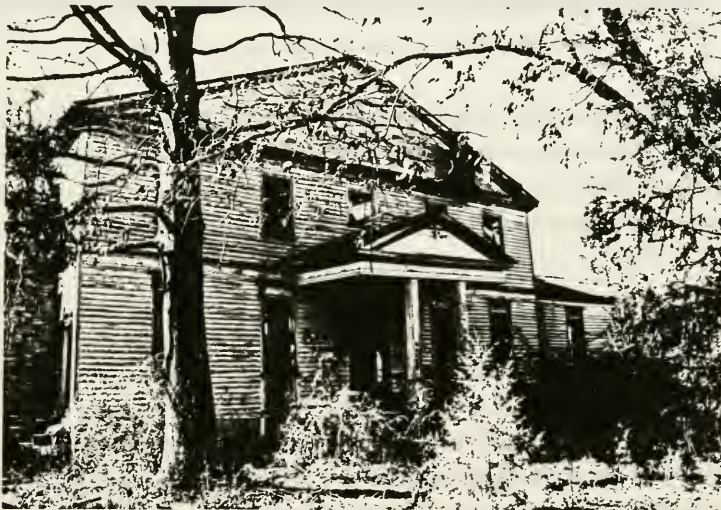
Figure 2: North Elevation

Little Manor is isolated, being in woods where there is no viable access road or functioning utility services. It has been in a steady state of physical decline for the last fifty years and has been deteriorating at an accelerated rate since last occupied in the 1960s. It has been vandalized and now is totally neglected. In the 1940s, the building was documented by noted photographer Frances Benjamin Johnson and studied by architectural historian Thomas Weston Waterman. In 1964, architecture student L. Scott Garner of North Carolina State College (now University), assisted by other students, documented the building with measured drawings. The timing of the latter survey was fortunate, for since that time major sections of the Federal main massing have deteriorated, the east wing chamber has collapsed, all the porches except the main portico are gone, and all doors and window sashes and most of the interior ornamental details have been vandalized or removed. The photograph below shows a view of the north elevation in its current condition. The chimney on the left is the only surviving component of the east wing chamber, the structural integrity of the main massing is tenuous at best, and the main portico is supported by only its two inside square columns.

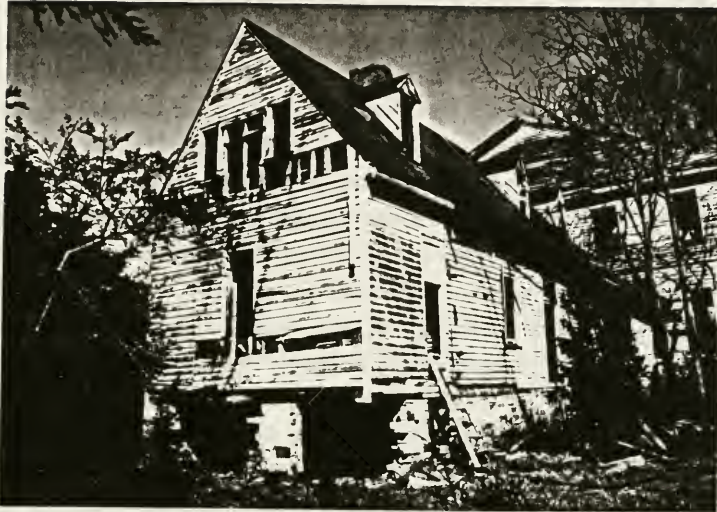
Figure 3: South and East Elevation of the Georgian Section

The Georgian section, at the south or rear elevation, has fared better, but as seen in Figure 1 at the top of the next page, it has lost its foundation at the southeast corner and weatherboard has peeled off the south gable and below the eaves of the east elevation.

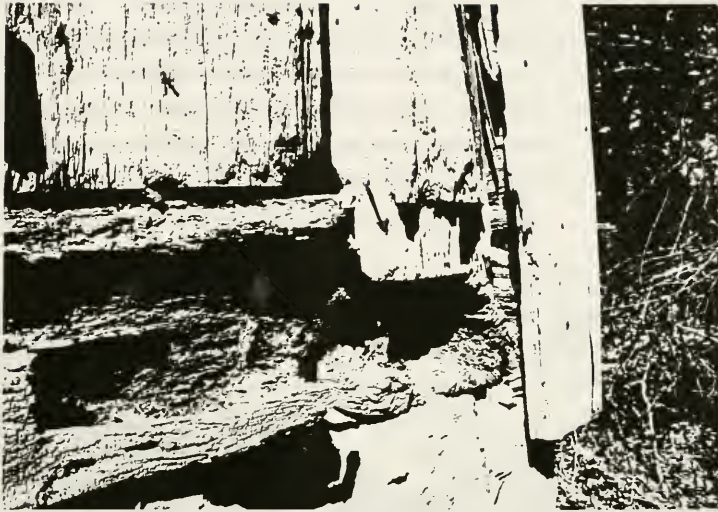
Figure 15: Federal Section Northeast Corner Connection

The complexity of the corner post and sill connections are shown in Figure 15. The photograph is taken at the northeast corner of the Federal section. The rotted sill (center left) is a twelve-by-twelve which receives the tenon of the corner post. A second mortise and tenon joint is located at the intersection of the east sill and the north sill, but this is not visible. In addition to having hidden joints, these connections were also difficult to analyze because the sills and plates differ in size and in the planes of their connections. This is illustrated in the oval shown at the northwest corner of the north elevation drawing. The vertical cross section member (center left in oval) is the west second floor top plate, a four-by-twelve. It is mortised and tenoned into the massive north plate and rises three inches above it, to the same level as the top of the joists.

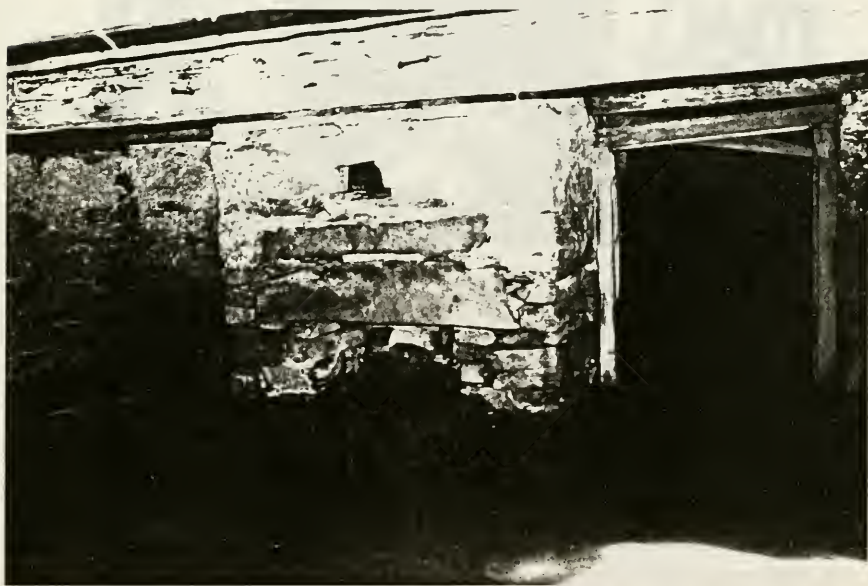
The English basement fireplace is of moderate height, with slightly diagonal cheeks and a deep back. Shown below, its examination was hampered by its being in a foot of water, but the massive lintel is clearly visible.

Figure 39: Georgian English Basement Fireplace (Below Georgian Parlor).

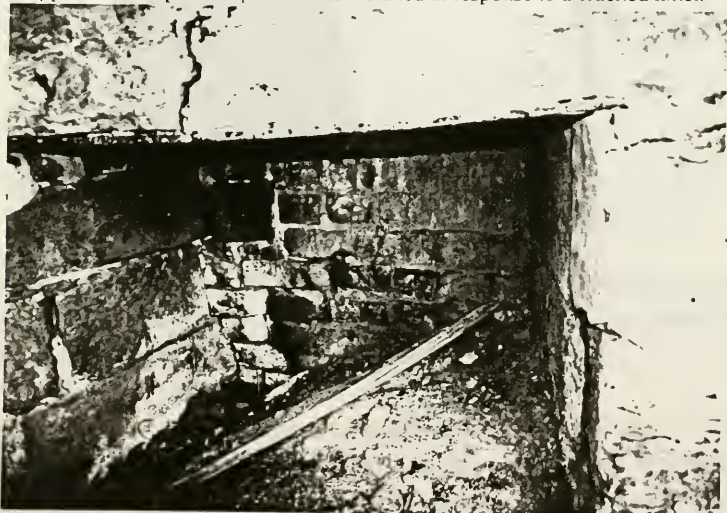
The only other fireplace in the Federal section accessible for examination was the that of the Federal west chamber. Shown below, it has a brick fireback and a relatively low opening. The iron support at the top of the picture was installed in response to a cracked lintel.

Figure 42: Federal West Chamber Firebox

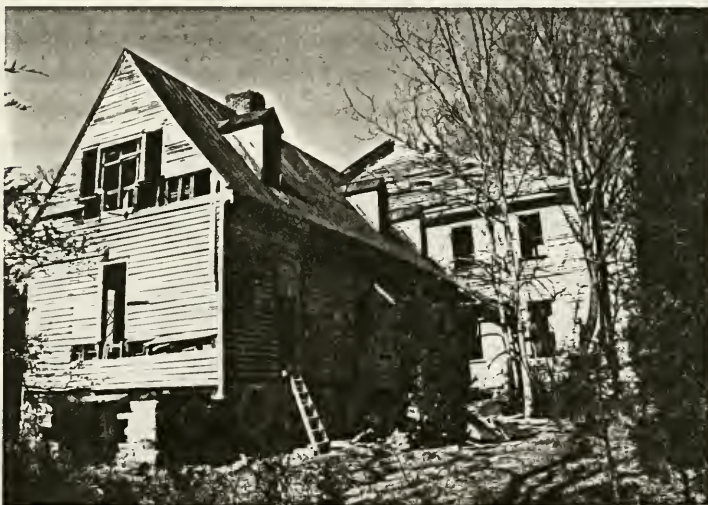
Figure 85: Loss of Fabric at Southeast Corner of Georgian/cross hall Section

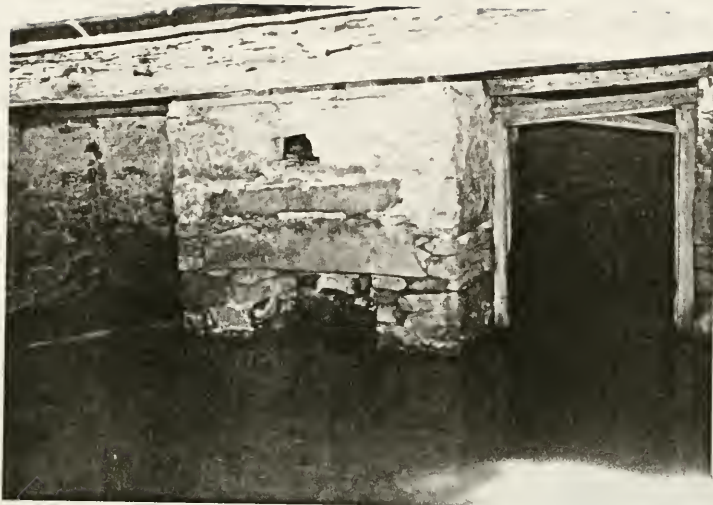
Figure 86: Flooded Basement under Georgian Parlor

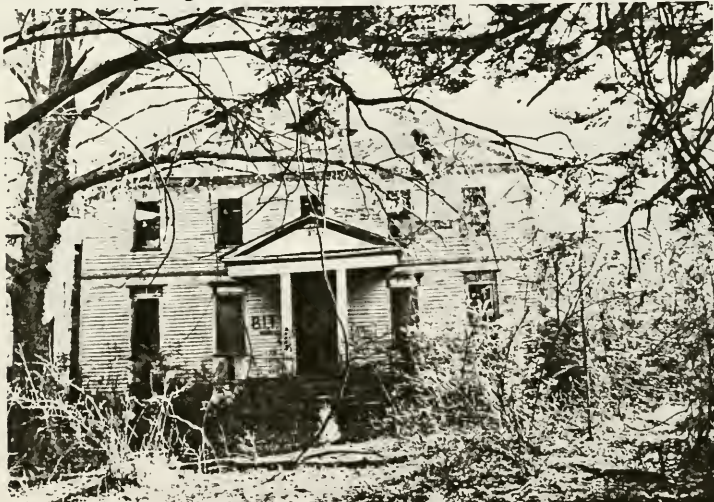
Figure 87: North Elevation Damage

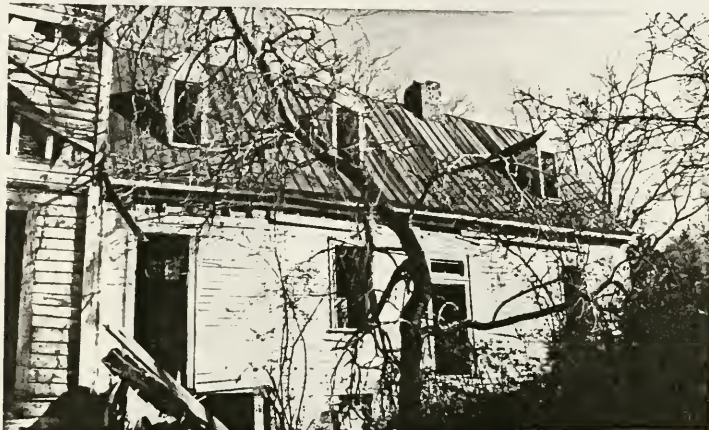
Figure 88: Damage to West Elevation of Georgian/cross hall section

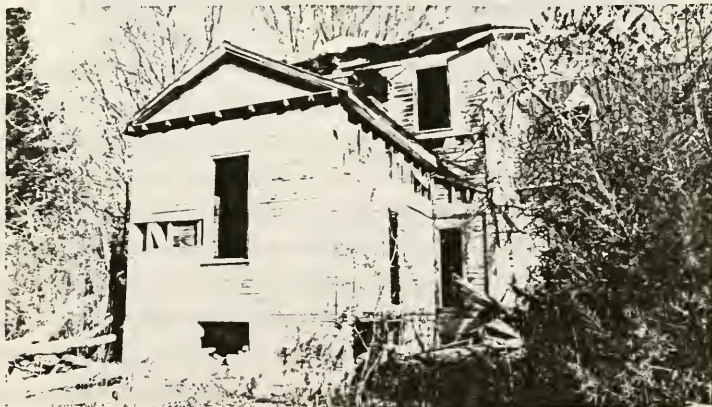
Figure 89: Damage to Federal West Elevation

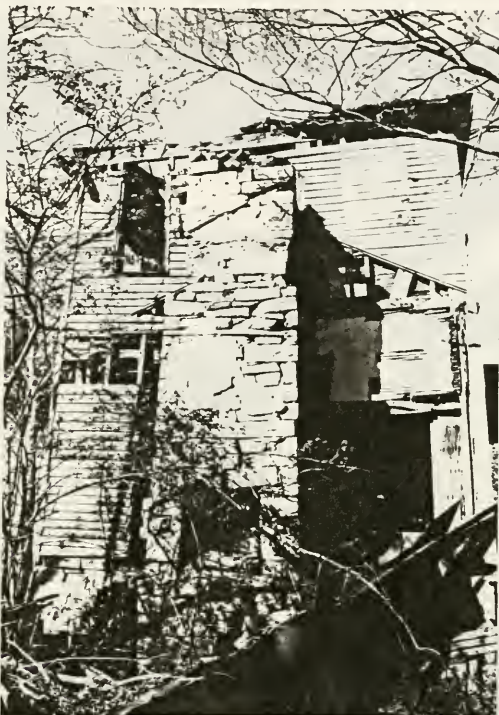
Figure 90: Damage to East Elevation of Federal Main Massing

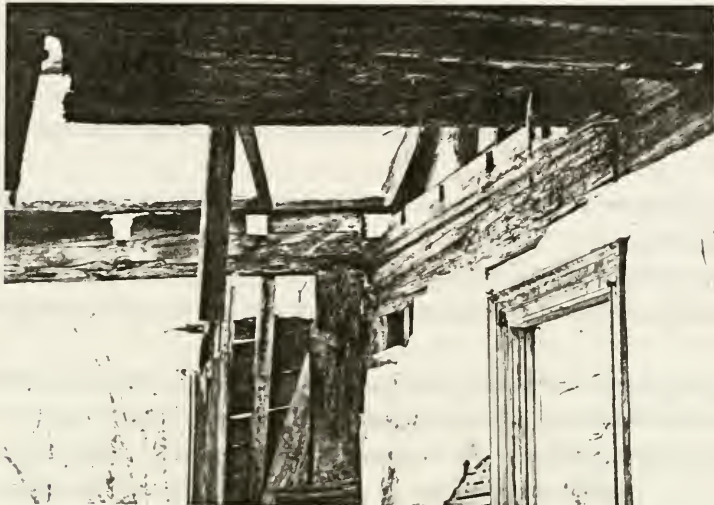
Figure 91: Damaged Roof Near East Elevation of Federal Main Massing

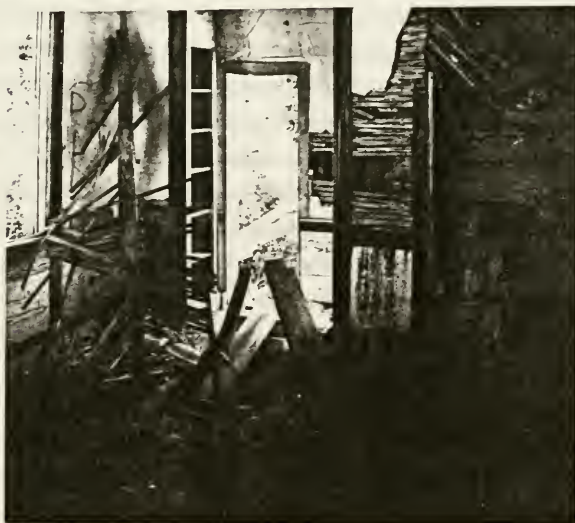
Figure 92: Collapsed Floor of Federal East Parlor (Foreground)
