Structural Failures of Single Wall Construction in a Western Mining Town: Bodie, California

Andrea Sue Morrison
University of Pennsylvania

A THESIS

Historic Preservation

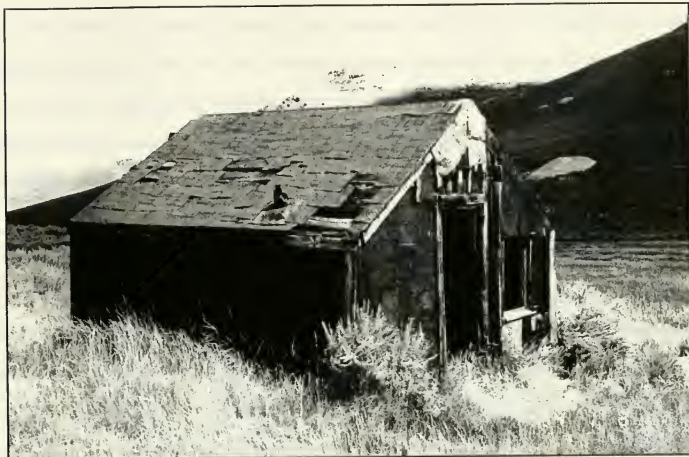
Figure 3.3a. Photo illustrating vertical sinking. South-West elevation of Chinese House. Taken 3 Sept., 1998 by A.S. Morrison.

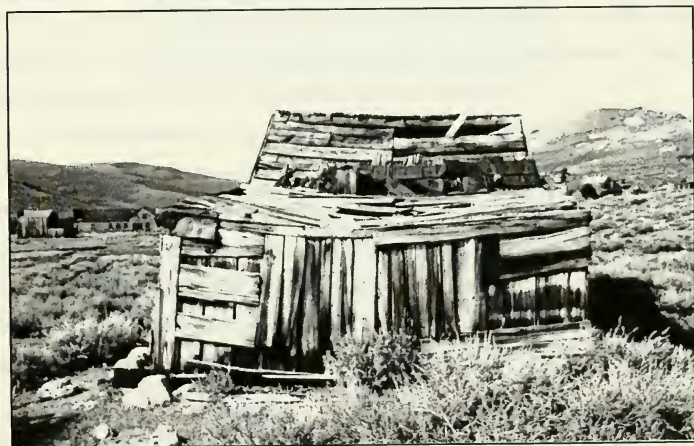
Figure 3.3b. Photo illustrating slumping. South elevation of Campana. Taken 20 June, 1996 by P.D. Schulz.

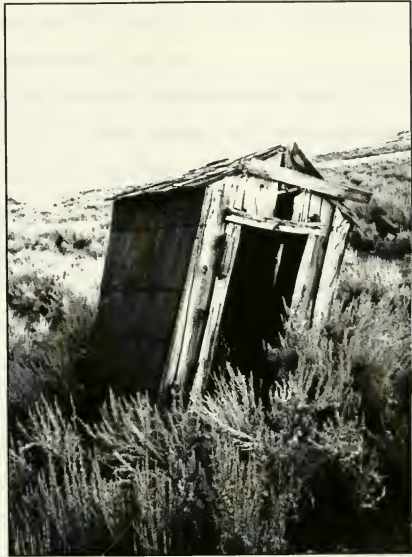
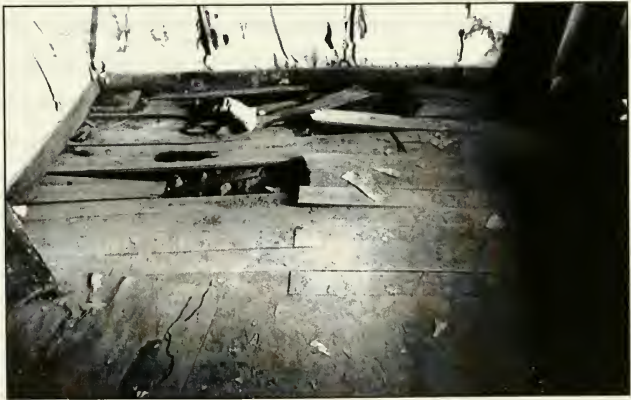
Figure 3.4a. Photo illustrating Tilt. Building O Privy taken 22 Sept., 1995 by P.D. Schulz.
Figure 3.4b. Photo illustrating Heaving. Murphy, Rm. 4 taken 30 April, 1997 by author.

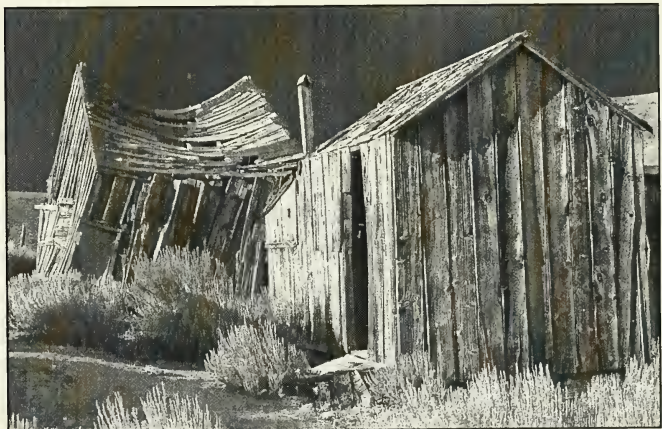
Figure 3.7a. Diagram of failures due to loads in gable roof. Rafters act as an arch.
Figure 3.7b. Photograph illustrating deformation of structure into trapezoid. Members buckle due to lack of ridge member and collar ties. Lester Bell House Barn, looking North. Photo taken 3 Sept., 1998 by A.S. Morrison.

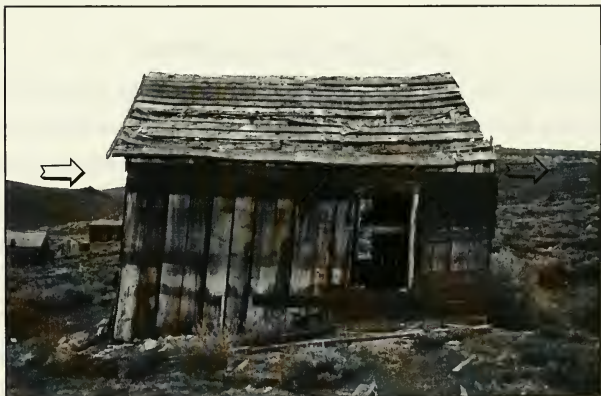
Figures 3.8a & 3.8b. Diagram of load induced by wind. Photograph of result of shear stresses on Owen. South Elevation taken 21 May, 1997 by P.D. Schulz.

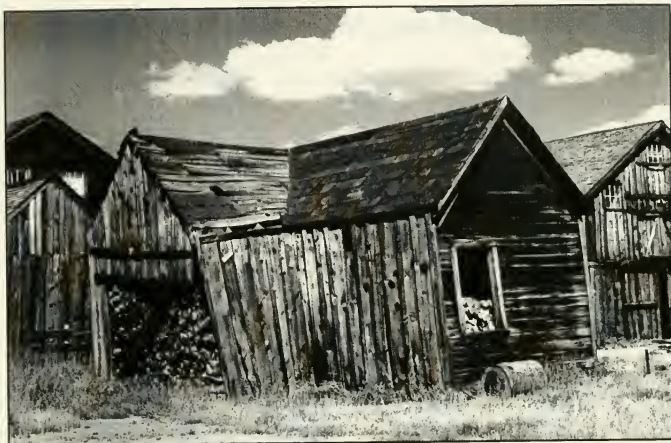
Figure 3.9a. Photograph illustrating deformation of "L" additions due to lateral loads. South-West Elevation, Building "D" taken 2 Sept., 1998 by A.S. Morrison.

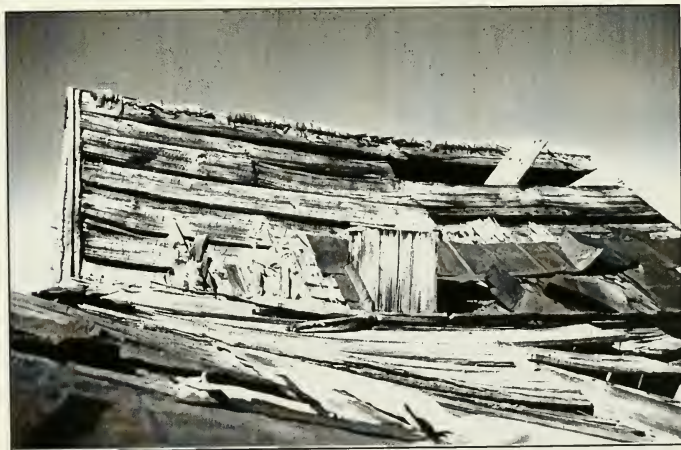
the shingles into levers causing nails to uplift from the roofs, the shingles to blow off, or in some instances, the sheathing itself to blow [Figure 3.9b]. The absence of these critical elements to the closure system then allows snow and water to penetrate the buildings, creating additional damage internally.

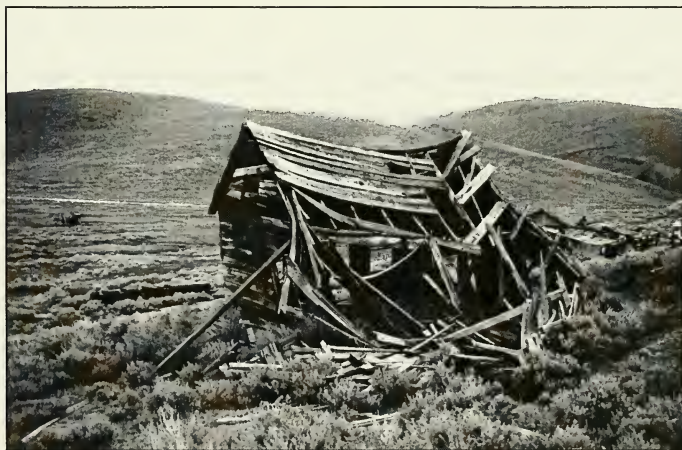
Figure 3.10a. Diagram of buckling and wall collapse (combination of loads)
Figure 3.10b. Photograph of wall collapse. South-East elevation Building "N" taken 13 June, 1996 by Lee Motz.

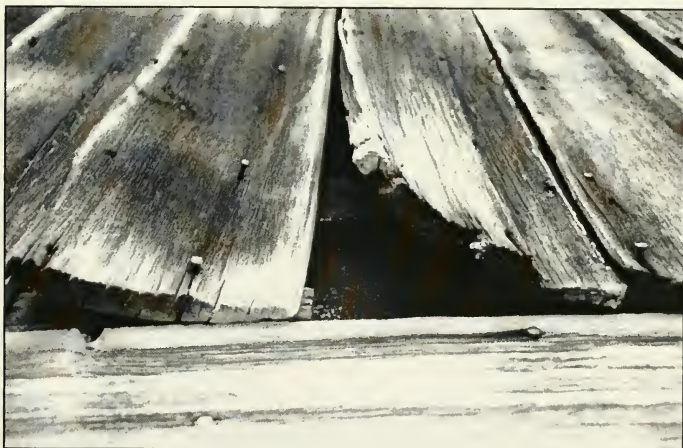
Figures 3.11a & 3.11b. Diagram and Photograph of types of material failure (physical). Photograph of South Elevation siding west of Win. 3, Building "N." Taken 14 June, 1996 by P. D. Schulz.

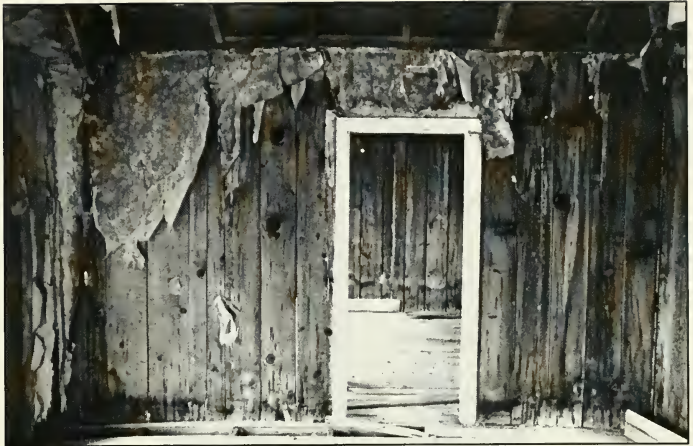
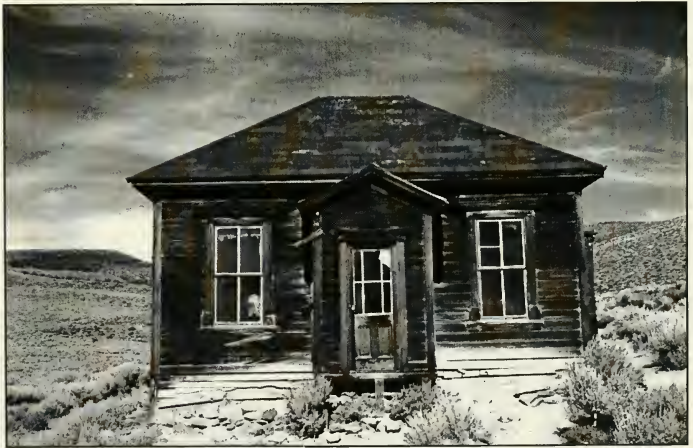
Figure 3.12a. Photo showing chemical failure of wood. Discoloration along bottom of wall due to black rot. Rm. 2, West wall, Selhorn taken 29, July, 1997 by P.D. Schulz.
Figure 3.12b. Photograph of “weathering” of wood. East Elevation of McDonald taken 3 Sept., 1998 by A.S. Morrison.

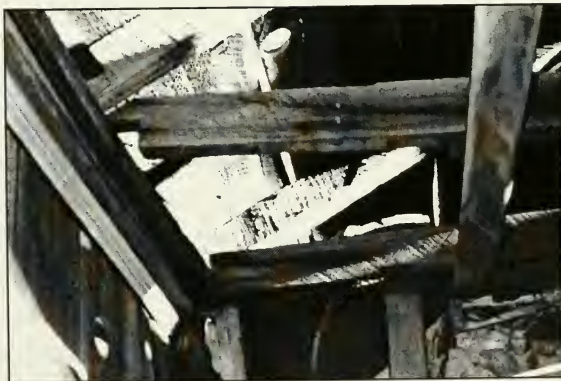
Figure 4.3a. Diagrams of intervention strategies for broken joints.
Figure 4.3b. Photograph showing failure of connection. Bldg. "P" Rm. 1, NW corner taken
6 Aug., 1996 by P.D. Schulz.

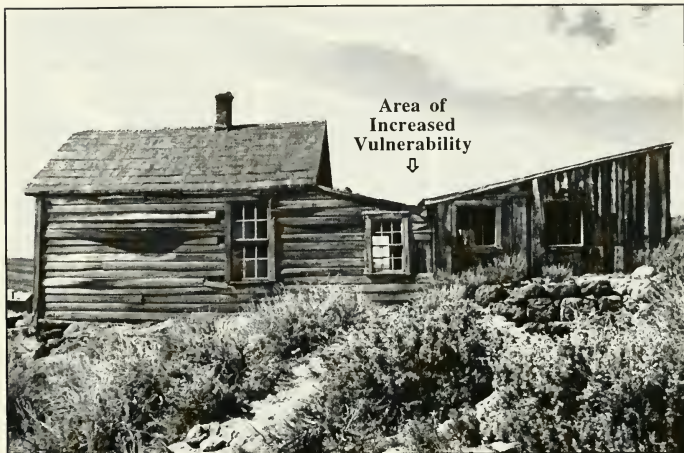
Figure 4.4a. Photograph illustrating incompatible additions and area of increased vulnerability to vertical loads. North Elevation of Metzger taken 23 May, 1996 by P.D. Schulz.

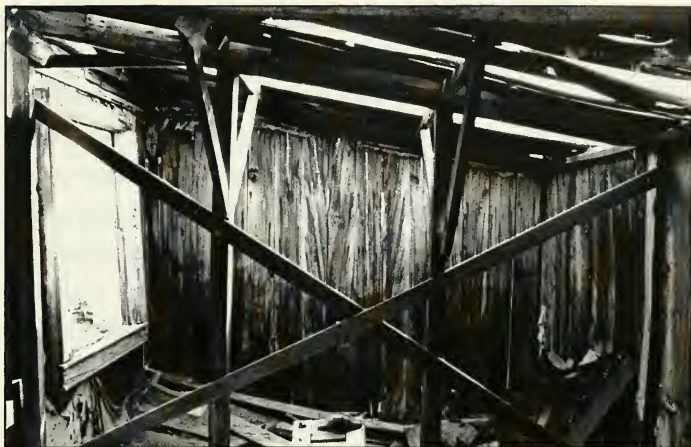
Figure 4.5a. Photograph showing shoring technique for deflected roof members (Cross bracing in photo for lateral movement) Andrews, Rm. 4- South wall taken 22 May, 1997 by P.D. Schulz.

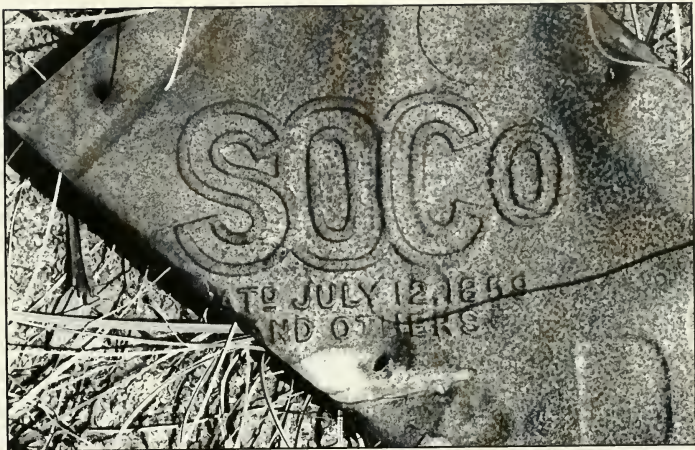
Figure 4.6a. Recycled tin can shingle w/ trademark blown off sheathing above Door 4, exterior, Building "C" taken 15, Aug., 1997 by P.D. Schulz.

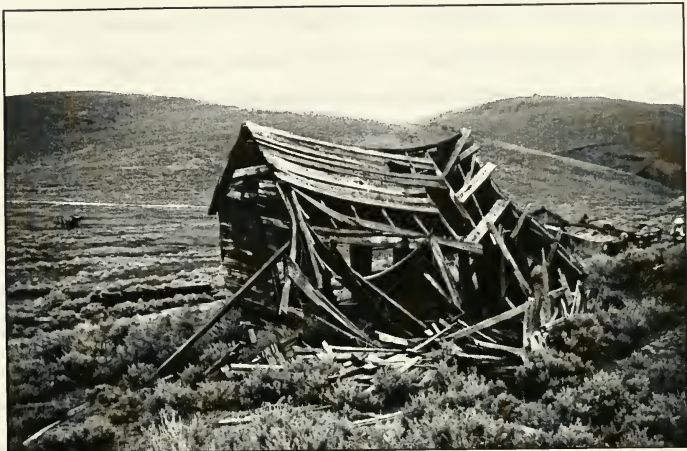
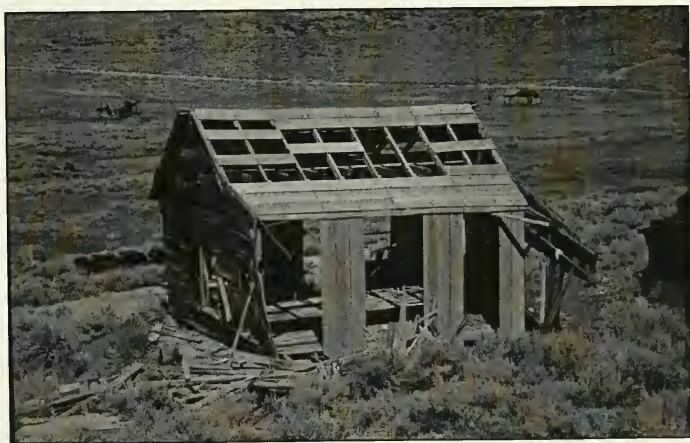
Figures 4.7a & 4.7b. Building "N" before and during reconstruction of collapsed wall.
