Pressing Forward: A Technical Study of the Mancos Times-Tribune Building With Recommendations for Conservation

Samuel Loos
University of Pennsylvania

PRESSING FORWARD: A TECHNICAL STUDY OF THE MANCOS TIMES-
TRIBUNE BUILDING WITH RECOMMENDATIONS FOR CONSERVATION

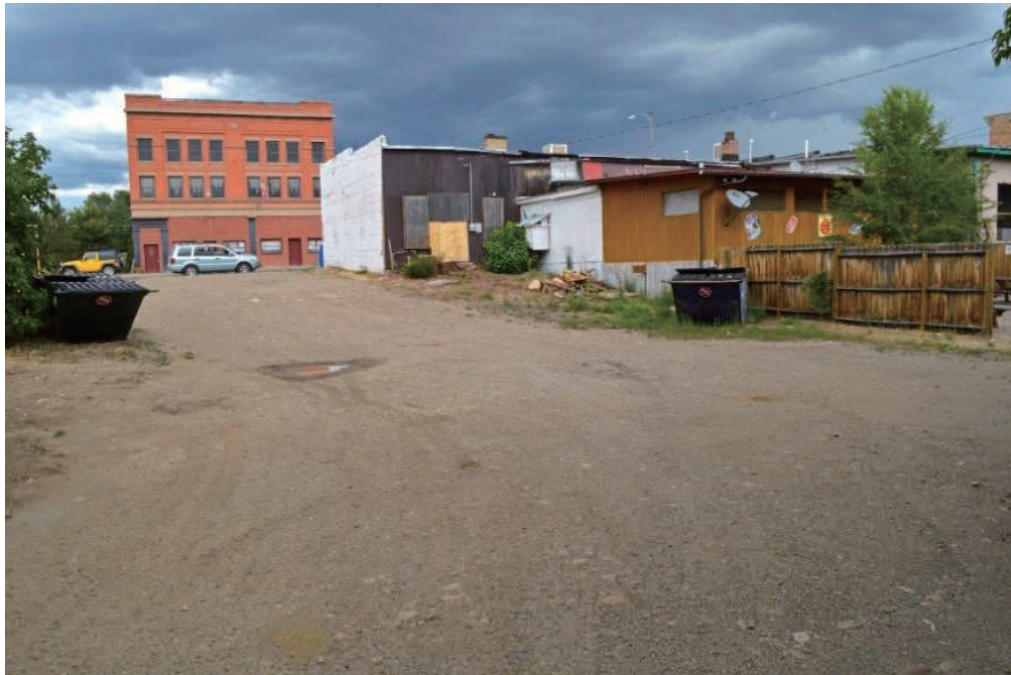
Figure 3.2 Sloping grade of the site and adjacent lot (Author 2014).

The site is in overall good condition. Its slope allows for adequate drainage, and being covered in gravel, deters erosion.

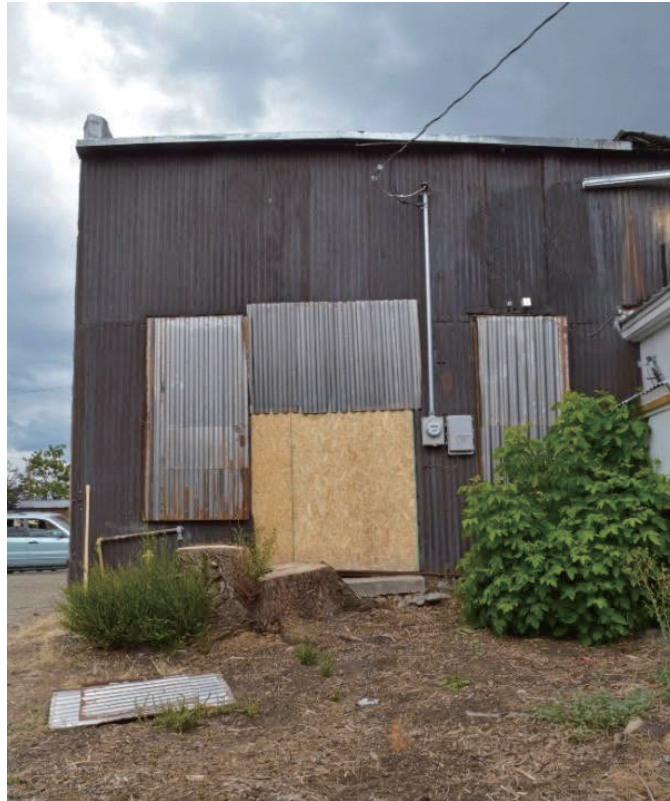
A very large, mature cottonwood tree was allowed to grow at the rear of the building, closely abutting the corner of the south and west walls (Figure 3.3). Its growth undermined the rear wall, causing cracking and uplifting of rear concrete floor of the interior and south foundation. The tree was recently cut down, but its root mass and the displacement it caused still remain.

Figure 3.3 Stump of tree compromising the foundation and floor (Author 2014).

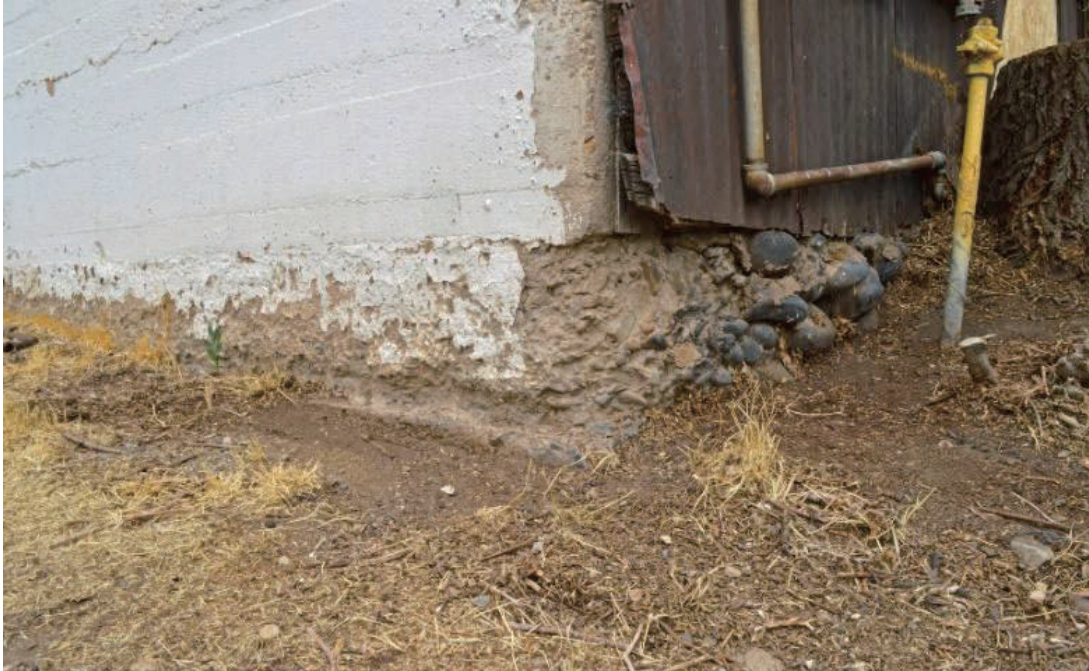
The east and west supporting walls and interior concrete flooring sit on a distinct concrete footing which in turns rests on a larger subsurface foundation of unknown depth (Figure 3.4). The footing contains very large aggregate, possible river rock from the nearby Mancos River, some of which are cobble size. It is exposed at the southern half of the building, but covered by the site's grade at its northern half. The foundation has a flat, even top upon which the footing was poured. It is almost entirely below grade, but its topmost edge is exposed at the southern end of the building. It appears to have the same size aggregate as the footing, without the cobbles, but it was not excavated for complete assessment.

The exposed and excavated portions of the foundation appears to be in good condition and are performing well. The surface of the footing has weathered to a degree, removing mostly cement binder along with some aggregate, creating a rough appearance. This weathering is occurring at a slow rate and has not compromised the foundation's structural integrity. The visible footing is solid with no apparent cracks or major loss of material. No damage from rising damp is visible.

Figure 3.4 Two-part foundation with west supporting wall above (Author 2014).¹

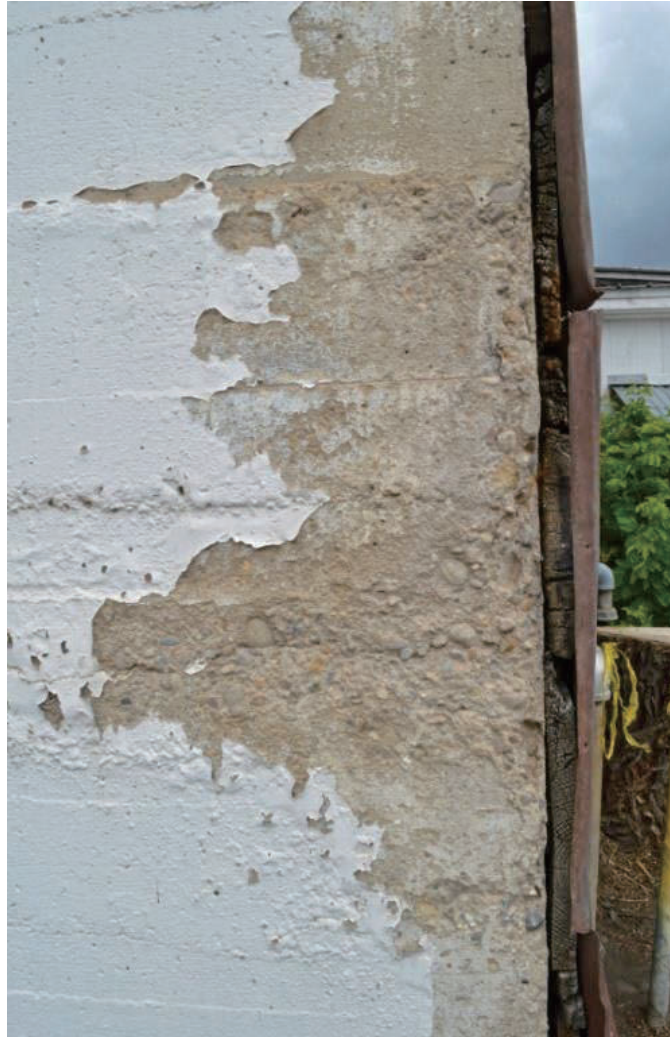
Figure 3.6 Weathering on southern edge of exposed west wall (Author 2014).

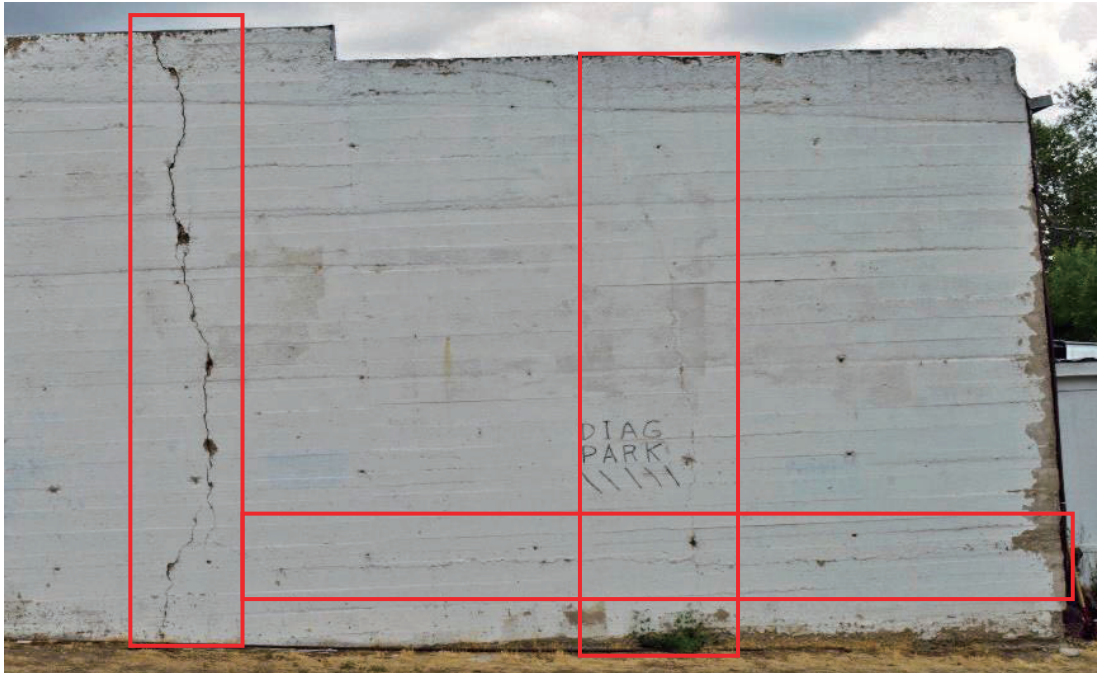
Two vertical and one horizontal cracks are visible on the west exterior (Figure 3.7) and another vertical crack on the east party wall (Figure 3.10), raising concerns about the structural integrity of the walls. All cracks have a linear path with no other cracks branching off from them. The three vertical cracks cut across the entire and widths of their walls and are visible on the building's interior (Figures 3.8, 3.9 and 3.10). The more northern (primary) crack on the west wall also cuts along its entire height and the vertical crack on the east wall likely does as well (Figures 3.7 and 3.8). This crack is also wider and more severe than the other two on that wall. The horizontal crack is along the lower portion of the west wall, beginning at the primary crack

and terminating at the southern edge of the wall. The vertical crack locations on either wall do not correspond to each other, with the east wall crack located between the two on the west. All adjacent crack faces are in plane.

construction and appears stable. Crack gauges are currently installed on the two primary vertical cracks and will be monitored for any movement to determine if the cracks are active.

Figure 3.7 Southern portion of exposed west wall with cracks highlighted (Author 2014).

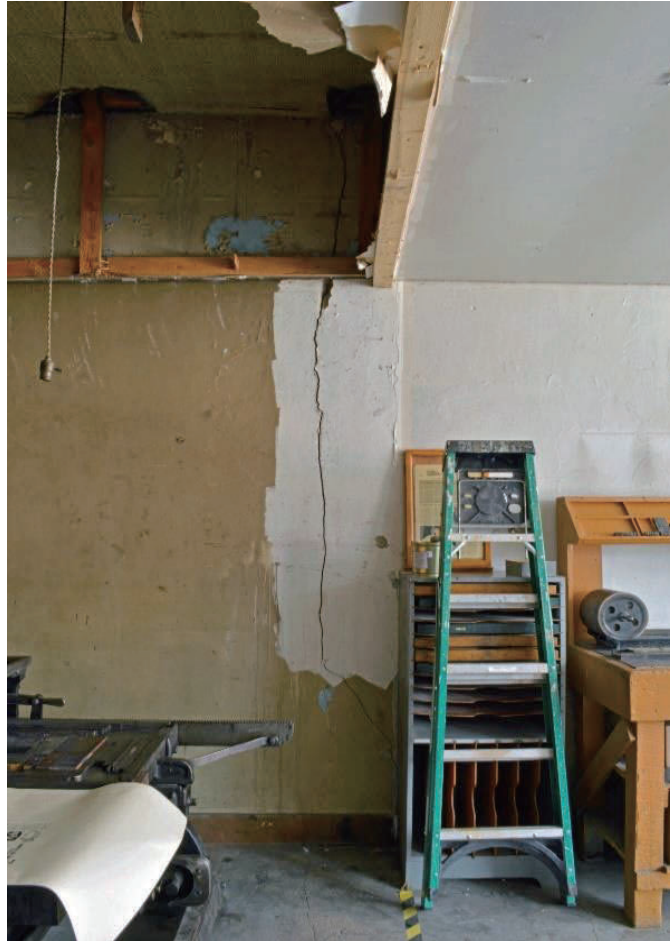
Figure 3.8 Primary crack on west wall seen from the interior (Author 2014).

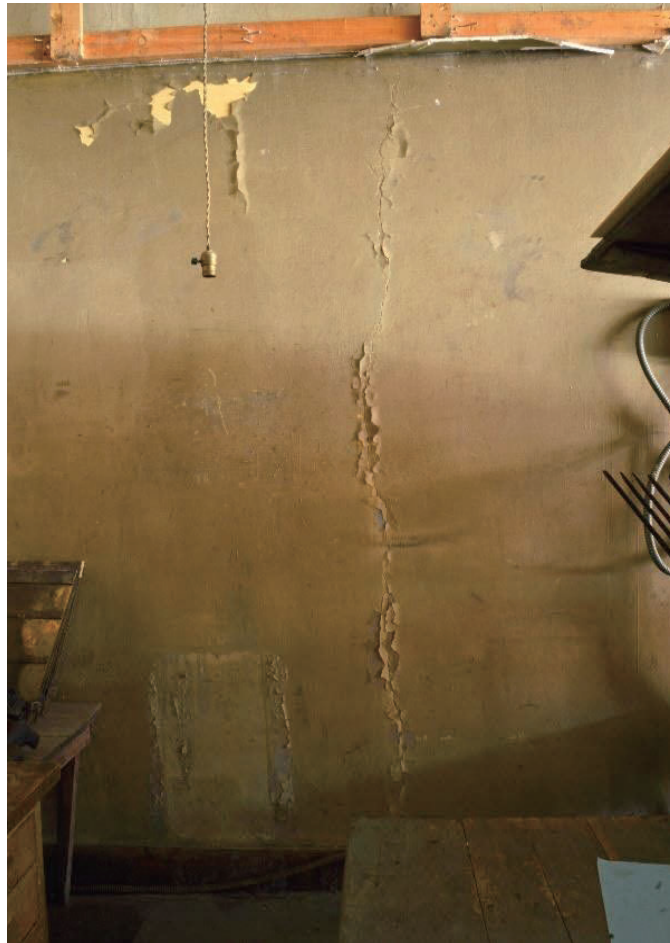
Figure 3.9 Secondary crack on west wall seen from the interior (Author 2014).

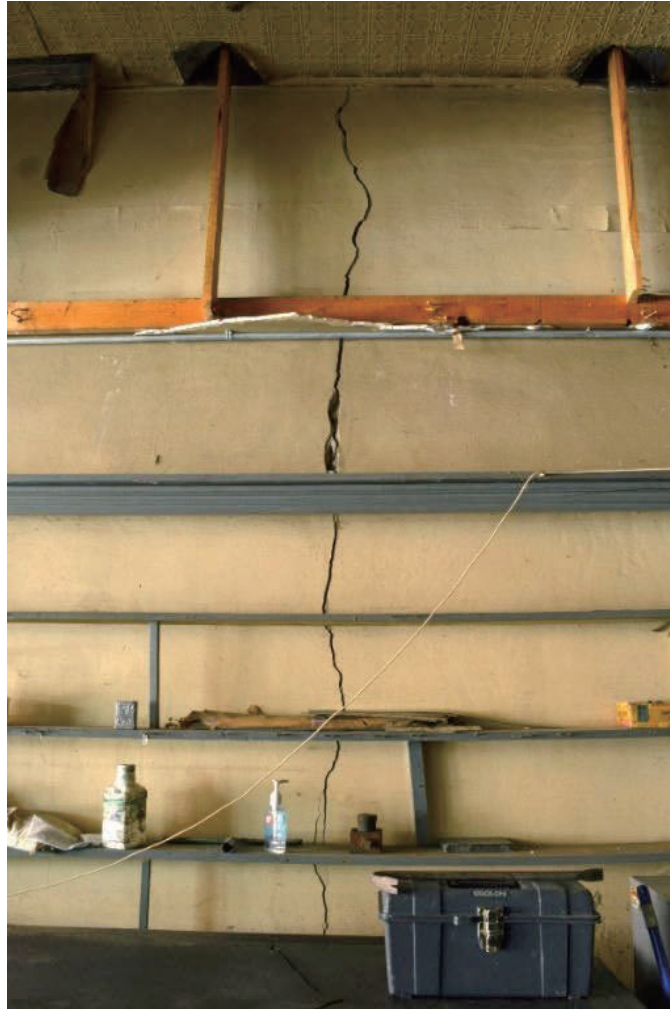
Figure 3.10 Crack on east wall seen from the interior (Author 2014).

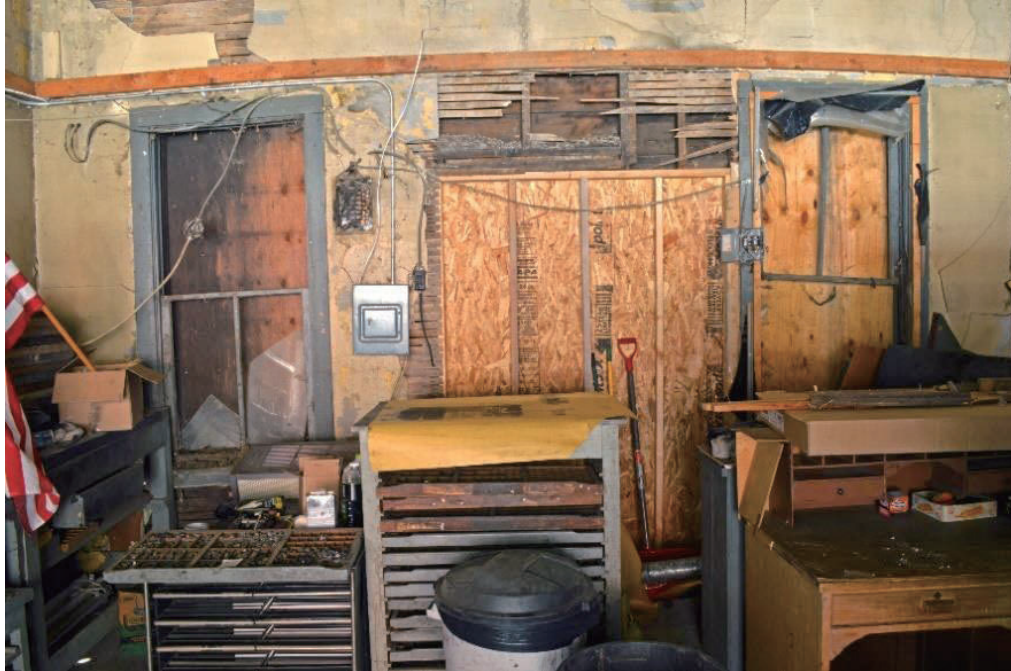
The rear wall is in poor condition in terms of performance, and its historic integrity has been degraded due to the loss of the original door and two original window sashes. The original doorway was enlarged at some point with all traces of the door and its surround being removed. Two inch by four inch wooden framers have been recently installed within the opening created by this expansion, to provide increased support for the wall. The upper sash of the east window and the lower sash of the west window have also been lost (Figure 3.12). The remaining sashes have lost their panes and their glazing is deteriorated, but the wooden stiles, rails and muntins are structurally sound. The window surrounds have been retained and are in good condition. The unprotected corrugated iron has uniformly oxidized, forming a corrosion product of iron oxide, or rust, but appears structurally sound. The boards beneath are in good condition and have held up extremely well given their age and exposure. Wood checks are present, but those are a natural occurrence from the boards shrinking and expanding due to moisture content (Figure 3.6). Most importantly, no rot is visible on the wood.

Figure 3.12 Interior view of rear wall showing entryway and windows (Author 2014).

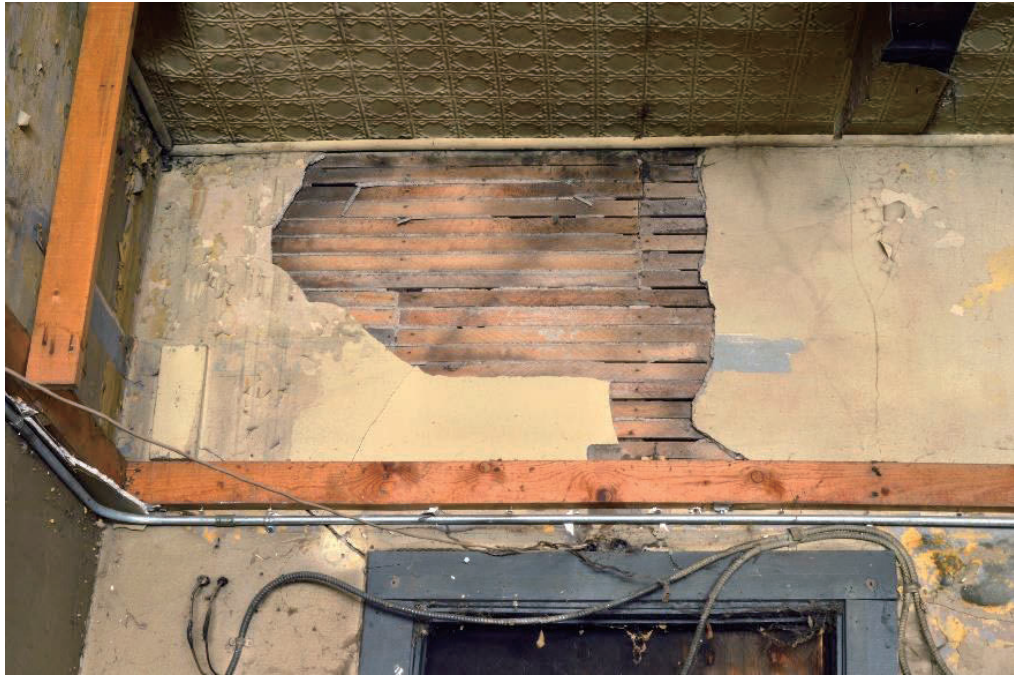
Figure 3.28 Plaster loss above east window on south wall (Author 2014).
