THE GEOLOGY, HYDROLOGY AND
STABILITY OF THE LANDSLIPS BETWEEN
OTLEY AND OLD POOL BANK, WEST YORKSHIRE

A. H. COOPER

WN/EG/84/21C

January 1984

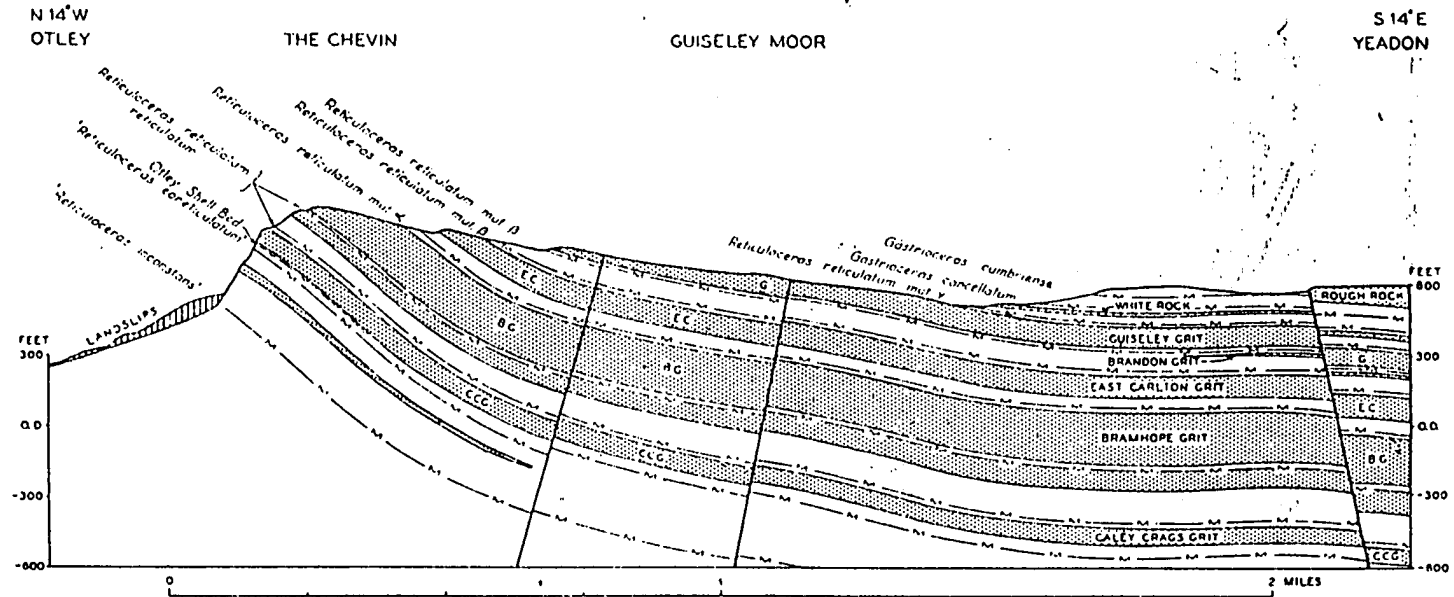
Fig. 1. Section from Otley to Yeadon showing the higher beds (R_1 and R_2 stages) of the Millstone Grit

Crags Grit, however, has caused beds on the crest of the escarpment to dip gently northwards. The structure (Fig. 1) is similar to, but less steeply dipping than, that of Otley Chevin (Stephens and others, 1953). The area is partly covered by glacial till (boulder clay), which is thick low on the valley slopes, but thins to a feather edge against the escarpment, not extending much above 122m (400 ft) A.O.D.

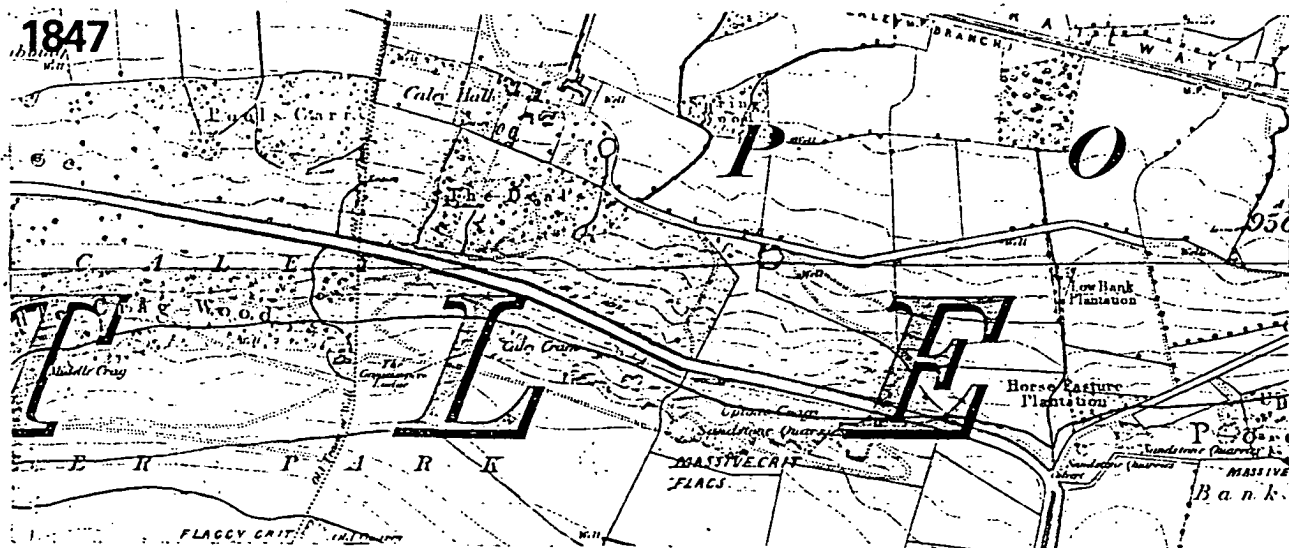
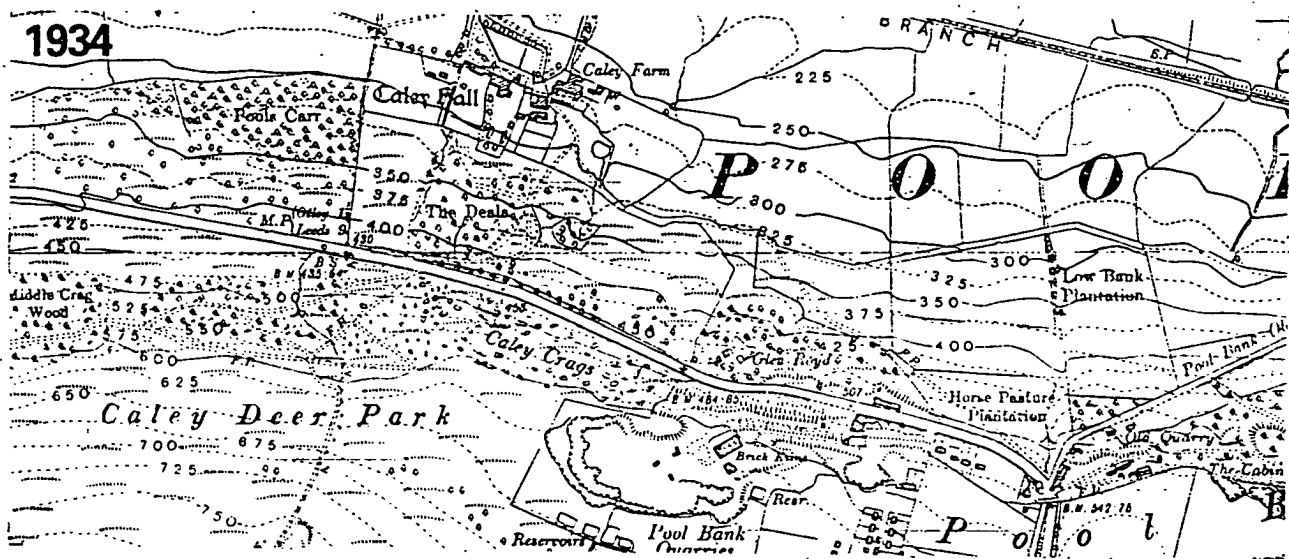
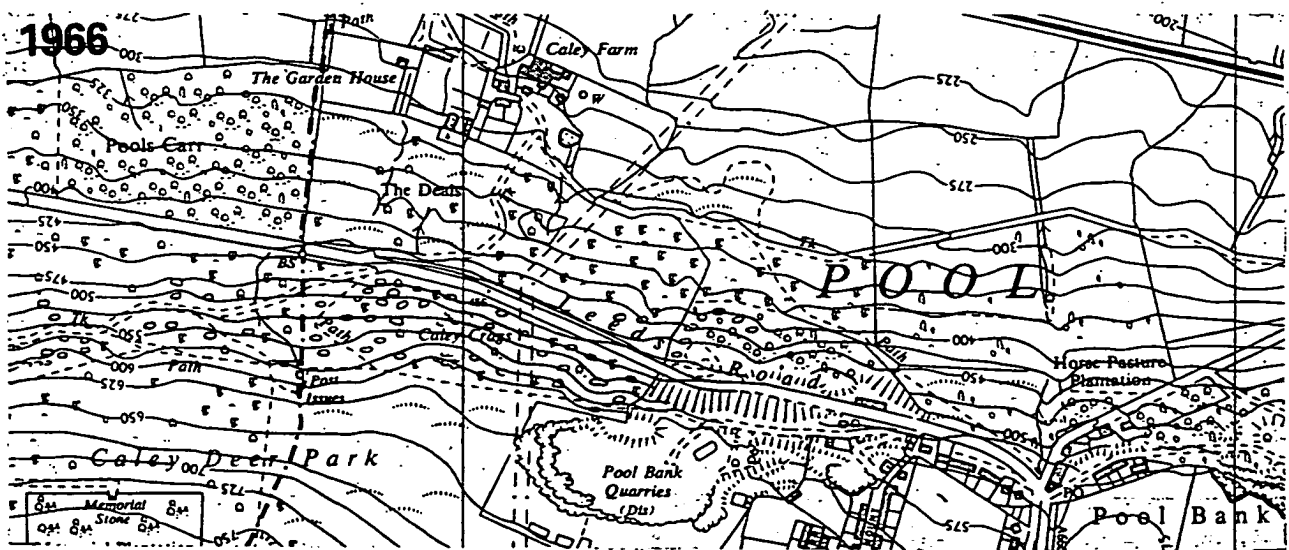
Fig. 2. 1:10,560 and 1:10,000 scale O.S. maps showing the changes in the walls and tracks over the Pool Bank Quarry landslip between 1847 & 1966.

of the wall abutting the track at the toe of the slip. Comparison of the maps (Fig. 2) indicates a northward surface movement of up to 20m at the track. The northern edges of the mud-flow form a bank 3-4m high; to produce these features whilst retaining the track and the wall appears to require the movement of sub-soil material in a semi-fluid waterlogged state.

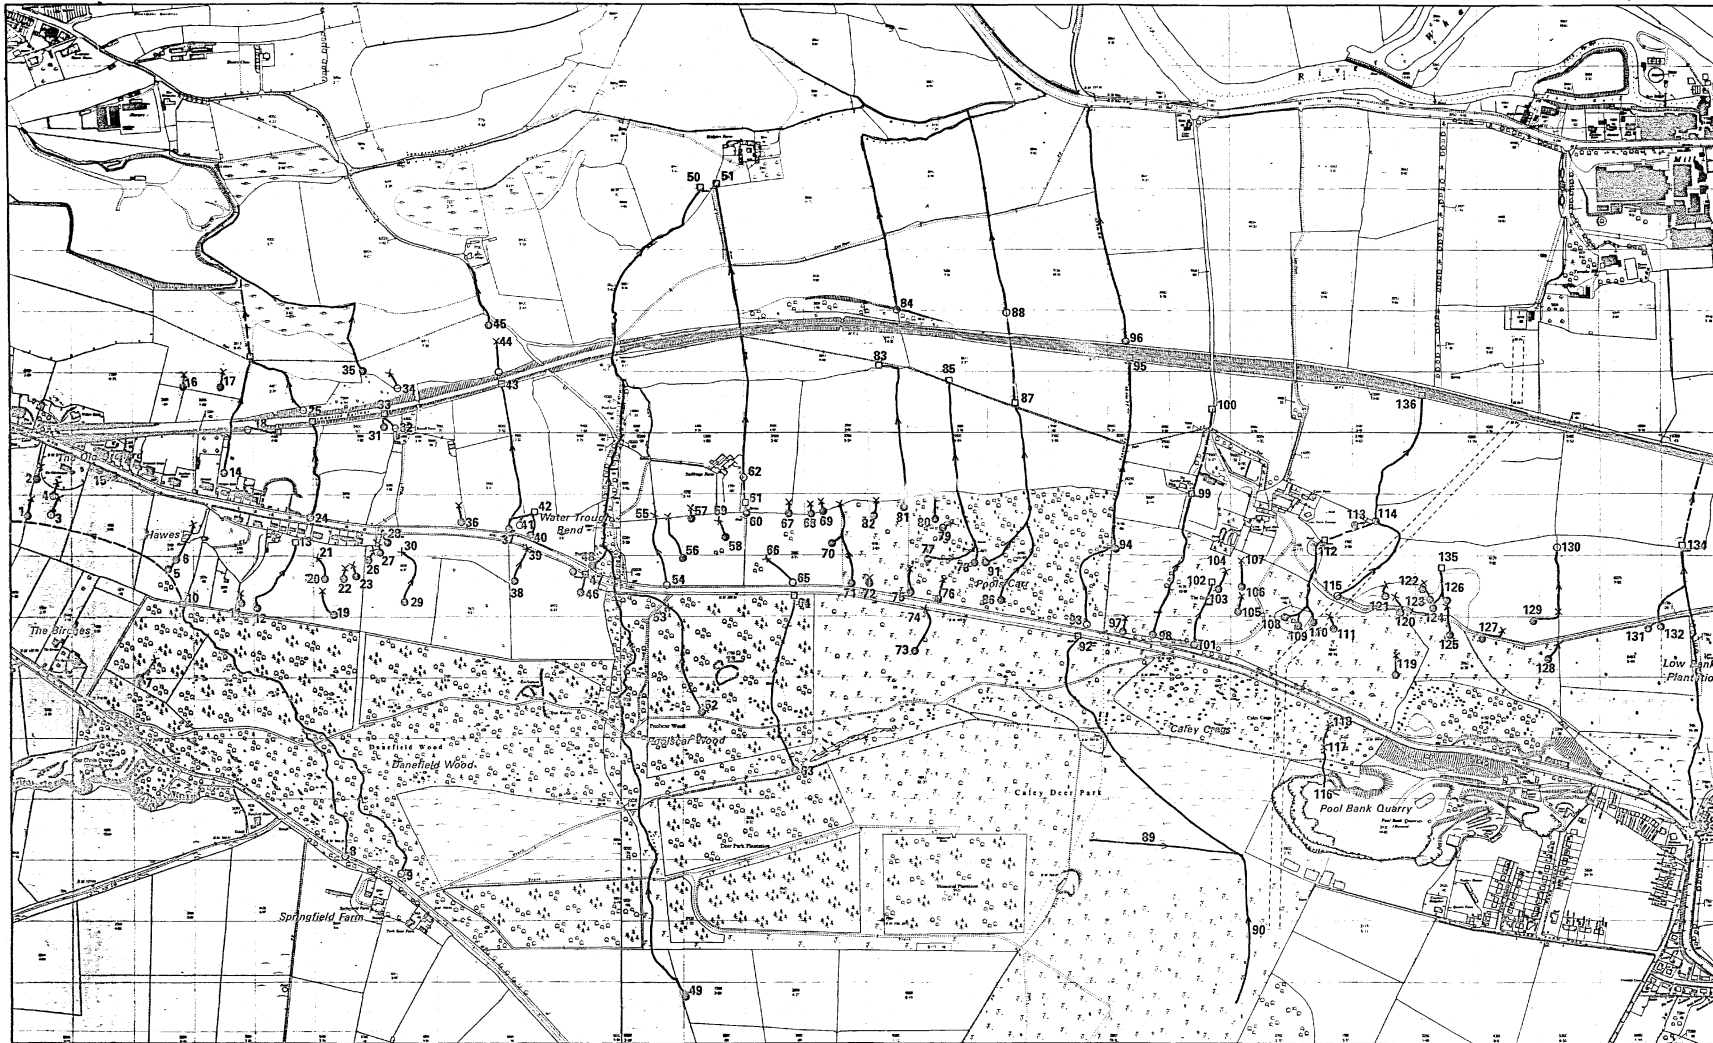
FIGURE 4: HYDROLOGY OF THE POOL BANK TO OTLEY AREA.

In general, small seepages occur throughout the landslipped area. There is, however, a concentration of springs between about 107m (350 ft) and 130m (425 ft) A.O.D., approximating to the bases of the main rotational landslips. On the lower ground, most of the large mud-flow lobes especially the active ones have springs at their bases. This suggests that the movement planes are well lubricated.

Slight active movement appears to be taking place at sub-area 2-A where a small scar and mud-flow lobe have developed just to the north of the house called "Hawes". This landslip poses a potential threat to both the house and the Leeds-Otley road. Water from Springs 5 & 6 (Fig. 4) may be partly responsible for this slip. In addition, water which overflows from Drain 10 (Fig. 4) in wet weather runs downhill past "Hawes" and also soaks under the house, to spill onto the landslip and also to run down the track on to the Leeds-Otley road. Drain 10 (Fig 4) feeds Silver Mill reservoirs and was installed as a conduit for the Otley Water Works at some time prior to 1847, as shown on the 1:10,560 scale Ordnance Survey map of that date. Recent improvements in the drainage of Danefield Wood and the installation of new tributary culverts leading to Drain 10 appear to have increased the run-off rate to such an extent

that the drain can no longer cope with the flow. Consequently, it overflows at times and water cascades downhill soaking in to the landslips and mud-flows and probably rising again at Spring 14 (Fig. 4) north of the main road. The drainage problems in this area can not contribute to the stability of this tract.

are damaged in several places, and water issues from three springs (36, 37, 40; Fig. 4) just north of the road. The most severe damage to the road has occurred where Spring 38, south of the road, flows to a water-trough in a field then sinks under the road at 39 (Fig. 4), and issues again at Spring 40. The flow of water is considerable and the walls on both sides of the road have subsided. The other springs (36 and 37) are of less clear origin than Spring 40, but it is possible that they are linked to Spring 38 by the failure plane of the landslide and mud-flow. Immediately west of, and slightly lower than, Spring 38 there is a boggy hollow coincidental with the back scar of the slip. It may be that water is soaking in here to lubricate the landslide and mud-flow, finally emerging at Springs 36 and 37. This tract was the subject of Site Investigation Report No. WY/ES/F/660/2/AC.

Sub-area 3-A₂ shows slight movement of the retaining wall to the northern side of the road on the eastern side of the mud-flow lobe. The morphological features of the area are very marked, and Springs 26, 27 and 28 (Fig. 4) issue from the central part of the landslide; water also sinks into the landslide at 30.

It is recommended that within the landslip area particular attention should be paid to the movement of surface and underground drainage. Where water emerges at the surface it should be prevented from soaking back into the landslips and causing instability problems lower down the slopes. The following areas of active landslip 2-A, 3-A₁, 3-A₂, 5-A, 7-A₁, 7-A₂, which affect the main A660 road have been identified, and these in particular should be examined in more detail. The geological situation of Pool Bank Quarry suggests that this area should be investigated to ensure its long term stability.
