# East Cliff Landslide, Bournemouth

Last updated 15:00, 07/06/2016

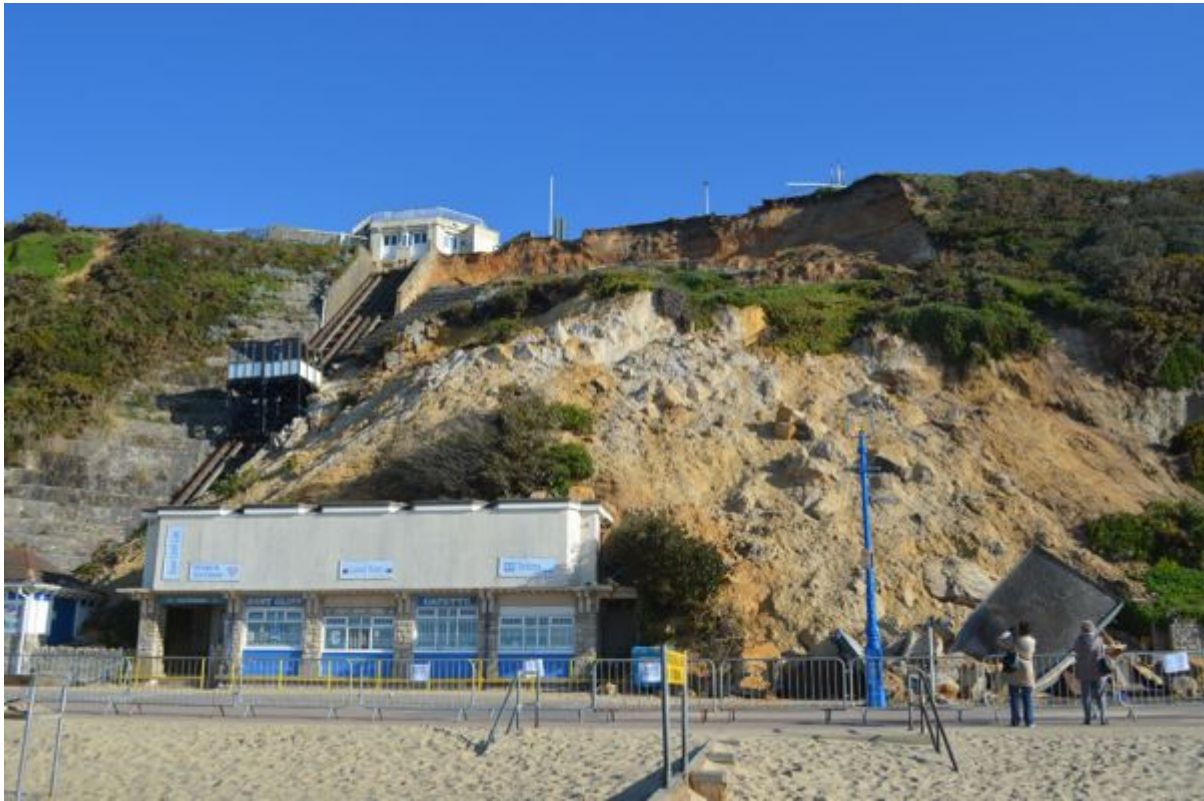
It was reported that the landslide had damaged an Edwardian funicular railway as well as a toilet block and an array of fences and benches from the top of the cliff.

Landslide at East Cliff, Bournemouth, 24 April 2016. East Cliff lift (funicular) on far left, café on left and destroyed toilet on right. Undercliff Drive in foreground.

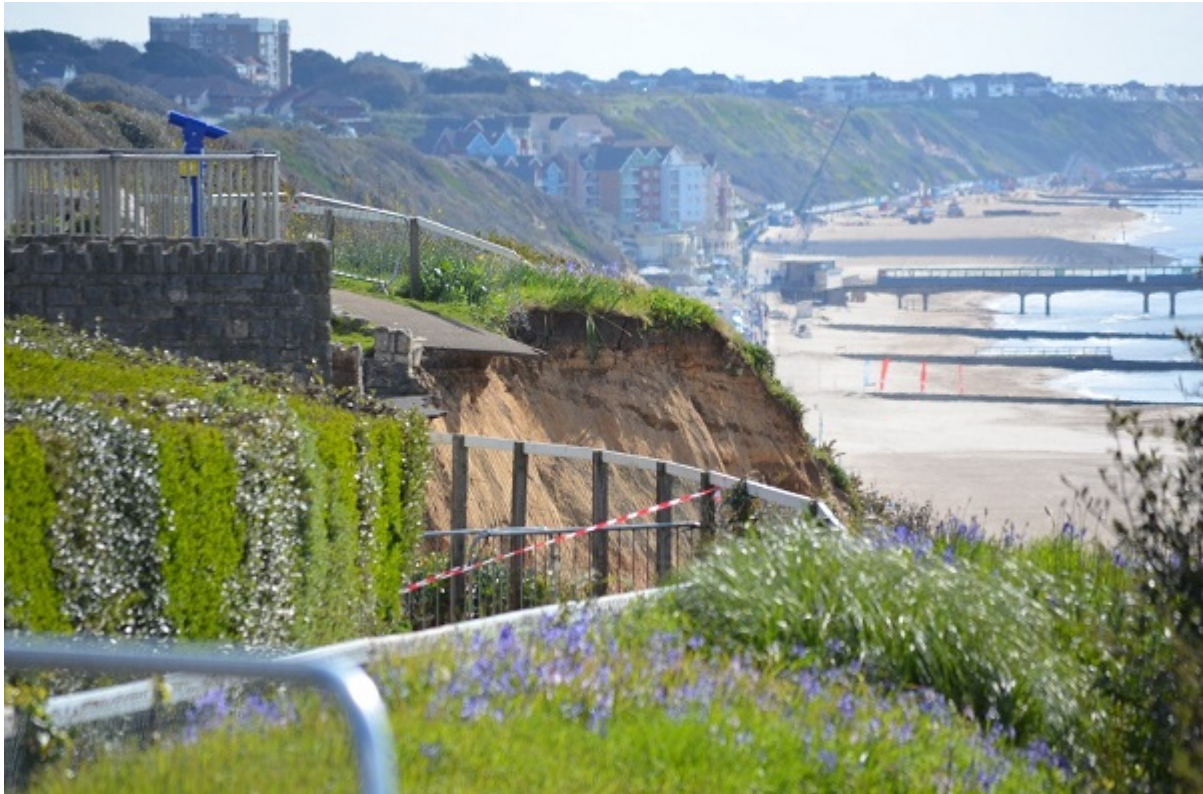
Backscarp of the East Cliff landslide, Bournemouth, 24 April 2016.

The landslide occurred on Sunday 24 April 2016 at approximately 05:00 on a section of East Cliff where it is approximately 35 m high with an overall angle (unslipped) of about 36 degrees.

The landslide is one of [partial rotation, and possibly translation, with debris flows](#) in the central and lower parts. A steep backscarp remains and a small secondary slip mass was seen at the upper eastern side of the main slip mass.

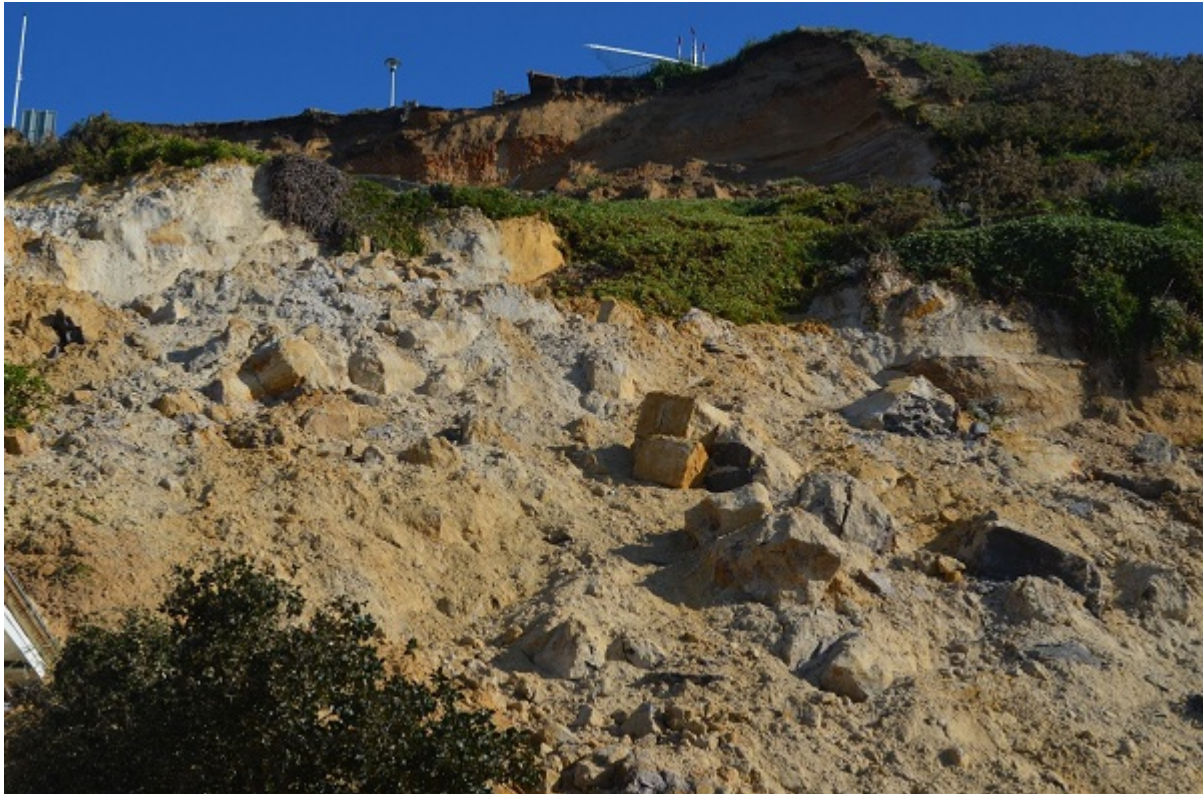
The slip mass of the East Cliff landslide, Bournemouth, 24 April 2016.

The landslide split either side of the café block (which remained intact) forming two masses of material. The slip masses contain several large boulders up to approximately  $2 \times 1 \times 1$  m. The larger, eastern mass progressed farther downslope than the western due to the destruction of the toilet block. **The slip mass as a whole appeared potentially unstable and further movements were considered likely.**

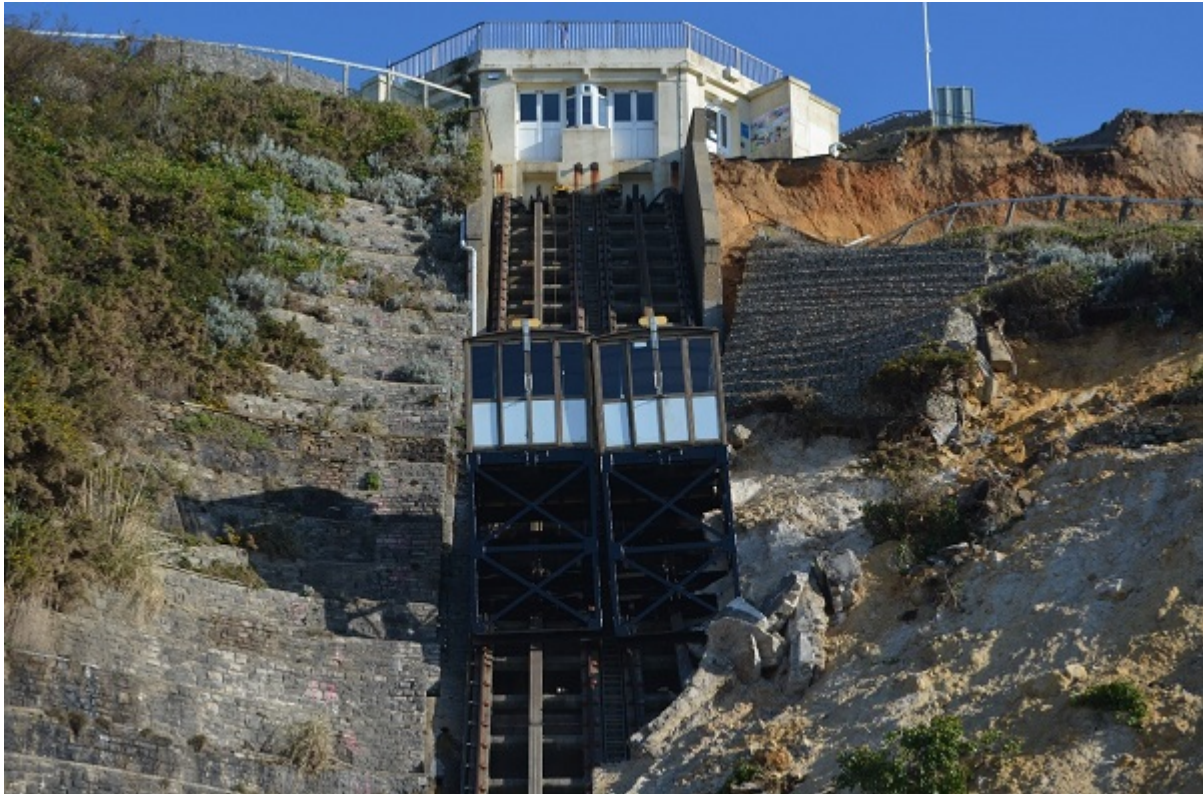
East Cliff lift funicular railway, constructed 1908, after the landslide, Bournemouth, 24 April 2016.

Little revetment masonry from the flanks of the East Cliff lift (constructed 1908) was evident in the landslide, though the eastern flank had dropped several metres leaving the concrete wall exposed. It is therefore possible that the landslide had overridden the bulk of the masonry on the central and lower parts of the slope.

The lower part of the lift track had been overridden by the landslide and the eastern of the two cable vehicles was affected, though they both remain in place. The western end of the upper part of the landslide had been curtailed by the concrete wall running along the trackside, thus effectively forming a western sidescarp.

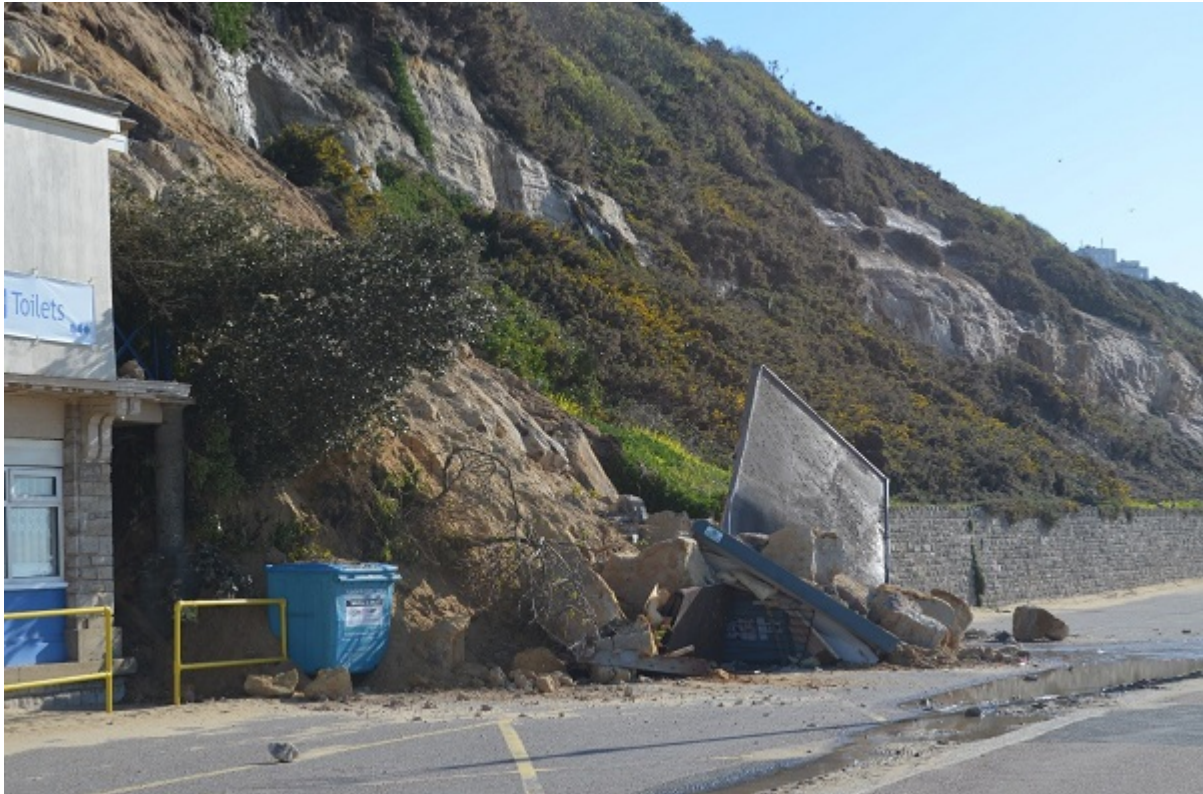
Toe of the landslide at East Cliff, Bournemouth, showing the toilet block, 24 April 2016.

What appeared to be clean water was seen emerging from the destroyed toilet block onto the road. This is assumed to be from a fractured water supply pipe within the toilet block. No water was observed emerging from the landslide itself, although access onto the landslide was not possible and hence the presence (or absence) of water within the landslide could not be confirmed.

A small landslide occurred at the location of the toilet block in 2008, destroying the previous block. The block now destroyed was its replacement.

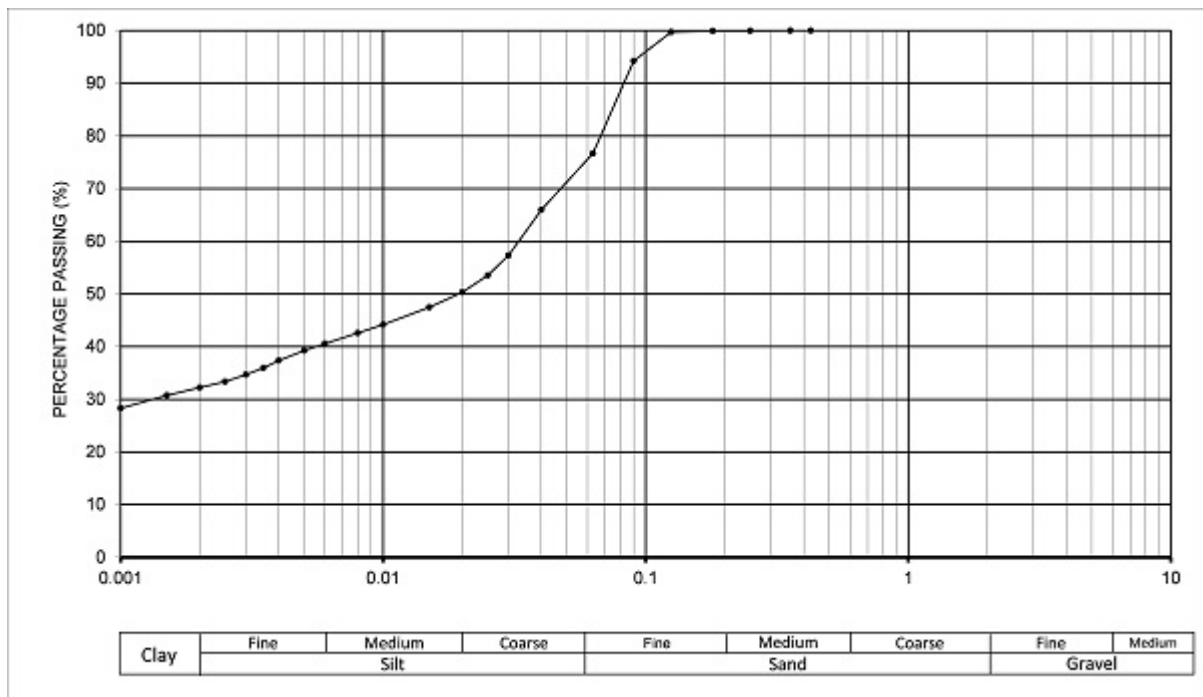
Particle size chart for Branksome Sand Formation sample. Note dominance of coarse silt/very fine sand.

The particle size chart shows the dominance of very fine silt and coarse sand with a significant clay content (sand: 23.3 per cent; silt: 44.5 per cent; clay: 32.2 per cent).

The intimate juxtaposition of sand and clay, characteristic of the Branksome Sand Formation, allows rapid movement of water through the rock mass and exposure of the clay component to water and hence [swell/shrink deformation](#) and cracking. These conditions are likely to have contributed to the development of a landslide shear plane within the Branksome Sand Formation, which has migrated upward to the cliff top forming a continuous surface.
