SLOPE INSTABILITY ON THE JORDANIAN HIGHWAYS

Thesis submitted to the University of London
for the degree of Doctor of Philosophy in
Engineering Geology.

October, 1974.

Engineering Geology Division,
Imperial College of Science and
Technology,
London S.W.7.

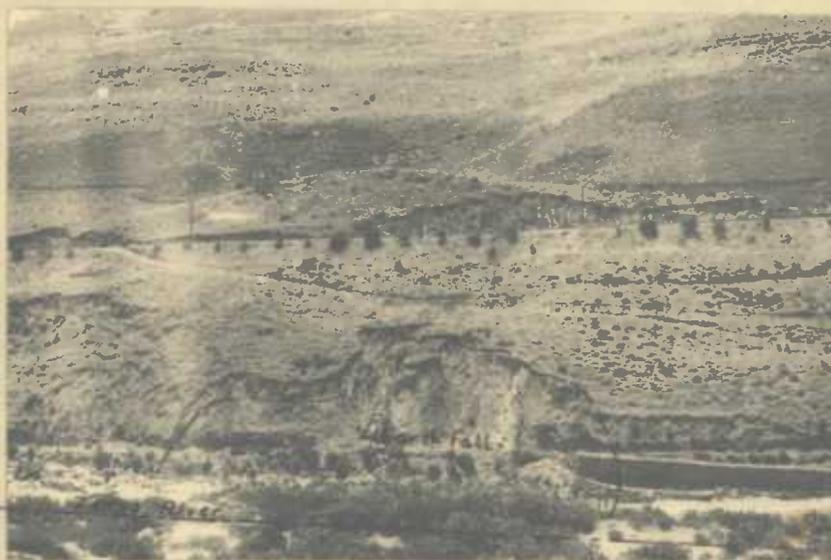
Plate 1.4 Earthfall due to erosion by the river.

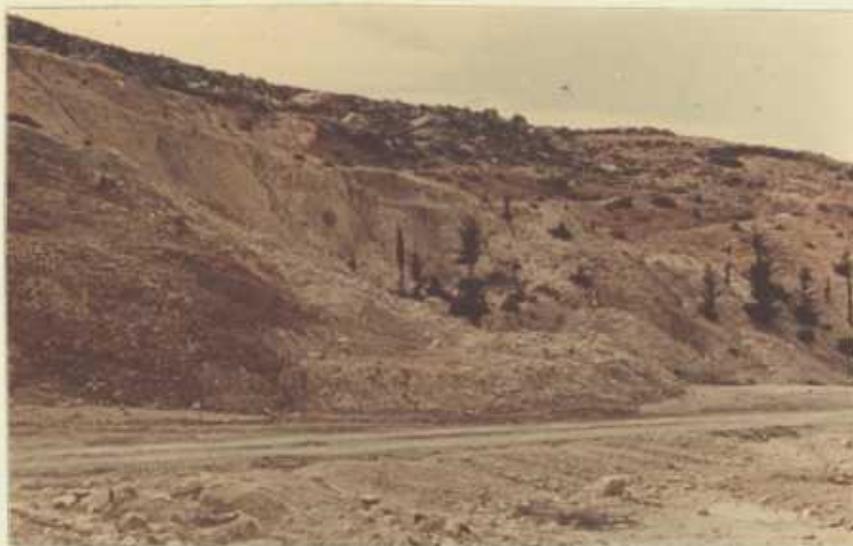
Plate 4.5 A mudflow consisting of yellowish marl and green clay; trees have recently been planted (observation point 8).

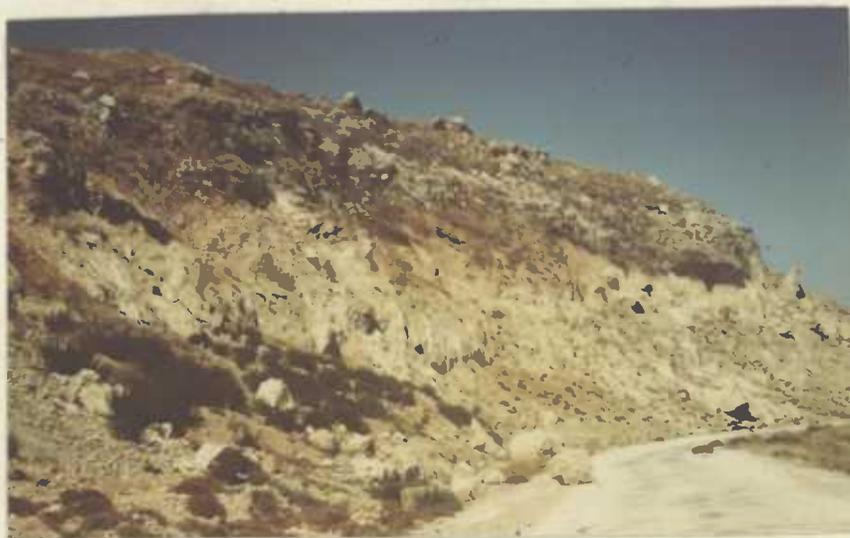
Plate 4.6 Marly limestone underlain by marl and clay. Notice loose blocks of limestone adjacent to the pavement (observation point 11).

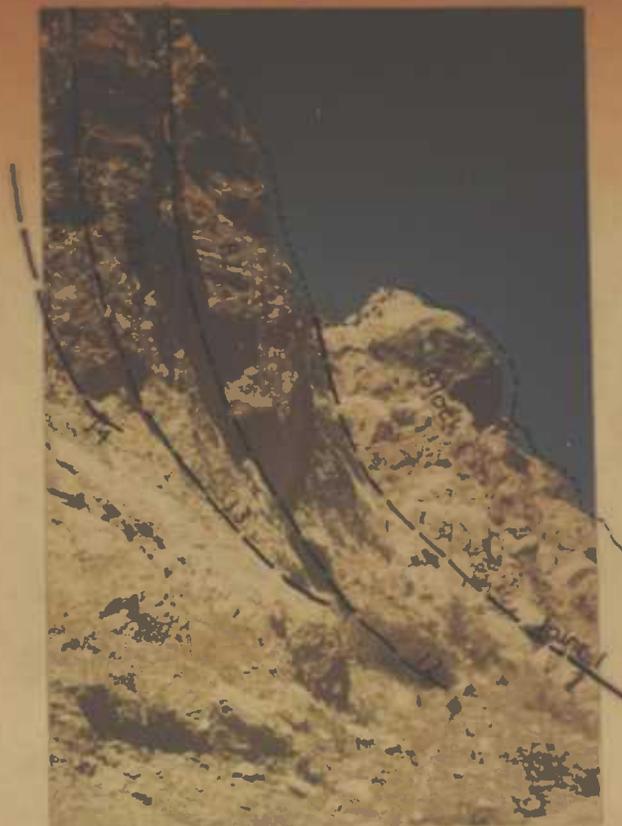
Plate 4.8 Shows sets of continuous downward movement of rock masses along pre-existing joint surfaces. Block 1 failed. The final collapse of the blocks 2, B3 and B4 will take place in the same manner along pre-existing joint surfaces J2, J3 and J4.

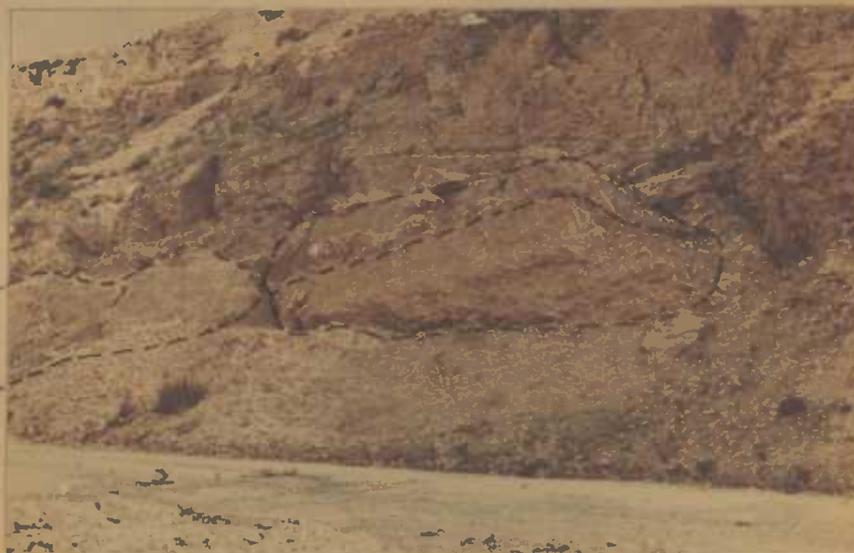
Plate 4.7 Shows two blocks separated from the parent rock owing to erosion and undercutting of the underlying soft clay and marl.

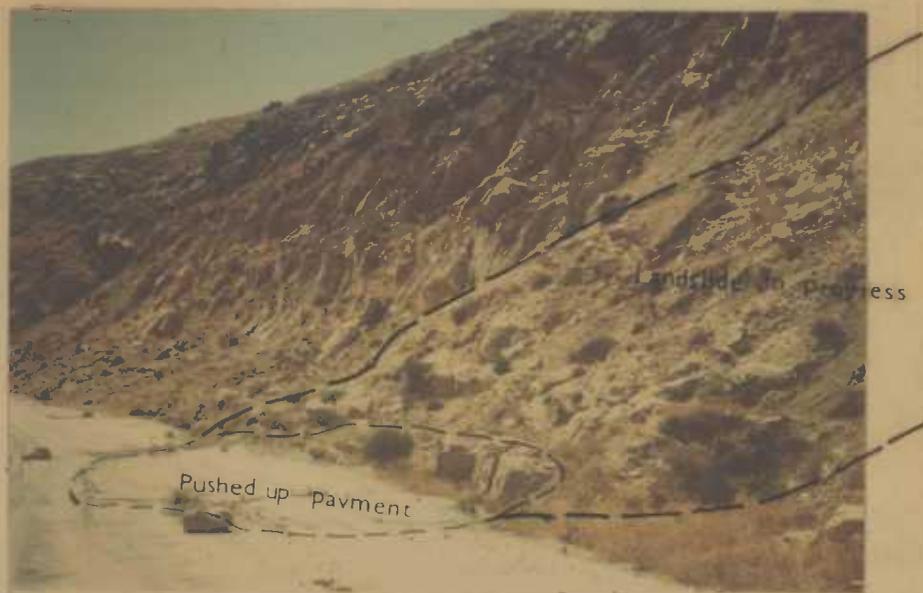
Observation point 12: landsliding in progress was observed. The pavement has been pushed up at the possible toe of the movement (Plates 4.9 and 4.10). The strata consist of 12.5 m of clay and marl overlain by marly limestone of the A3 formation.

Plate 4.9 Active landslide. The pavement is pushed up at the toe of the movement while the upper part shows displacement. Notice loose blocks adjacent to the pavement (Observation Point 12).

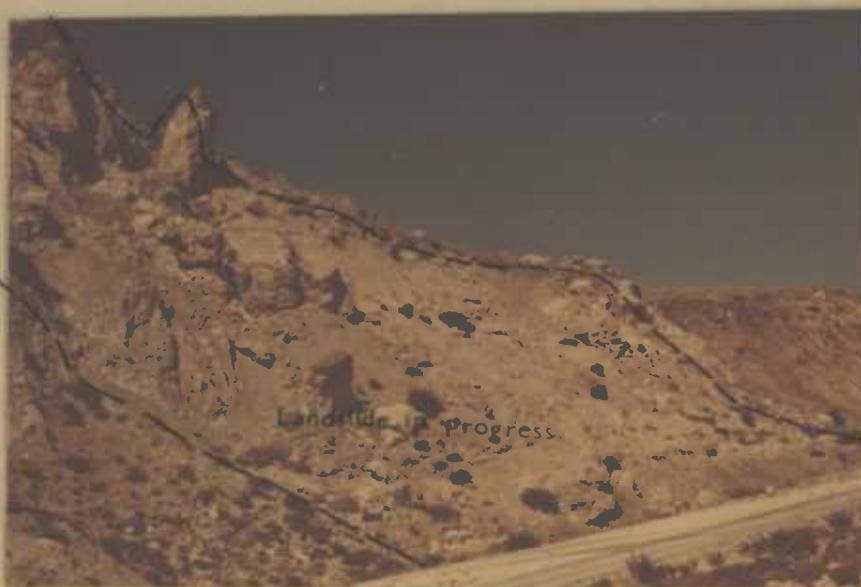
Plate 4.10 Active landslide. The upper part shows block creeping and probable toppling failure mode (Observation Point 12).

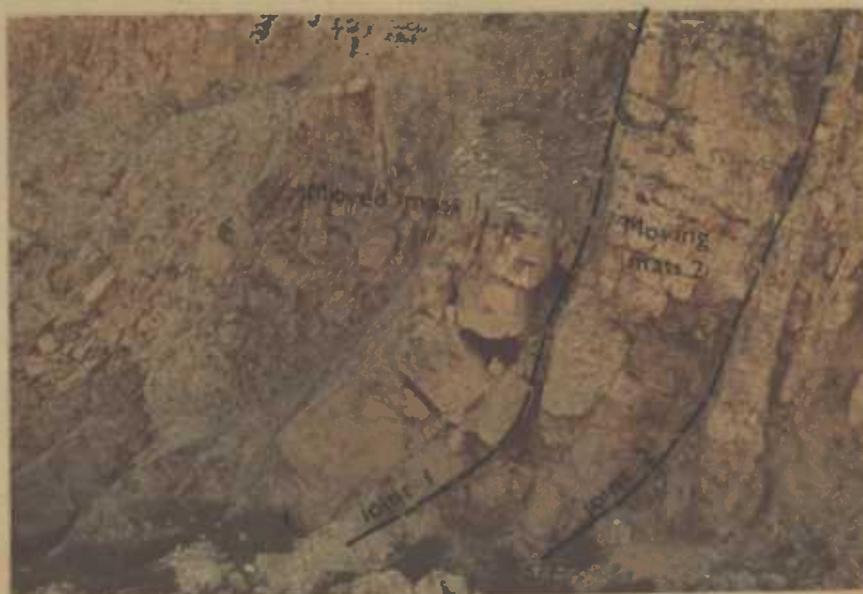
Plate 4.12 Sets of continuous mass movements along pre-existing failure surface (joints). Mass 1 moved along Joint 1. The final collapse of the moving mass 2 will occur after the lateral support is removed completely. Mass 1 shows intense jointing and disturbance while mass 2 is less disturbed (Observation Point 14).

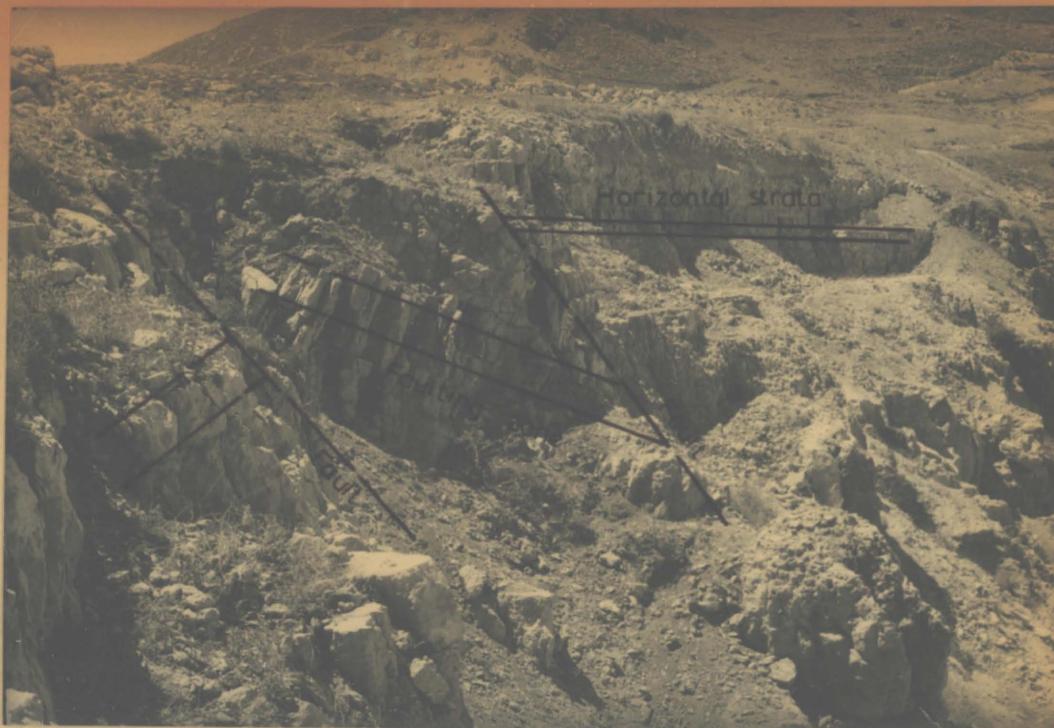
Plate 4.14 Jointing and faulting of the strata at the crown of landslide V. The bedrock is marly limestone underlain by marl and clay.

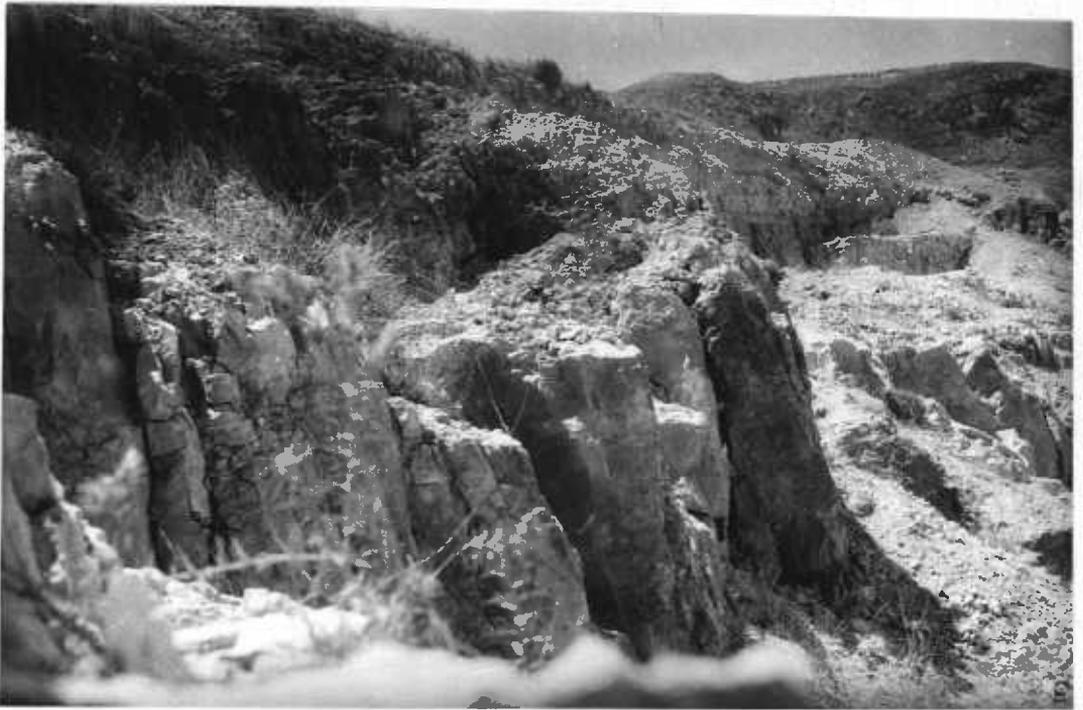
Plate 4.16 Loose blocky appearance of the strata at the crown of landslide V. Rockfall and potential rockslips are the dominant mechanism at this site.

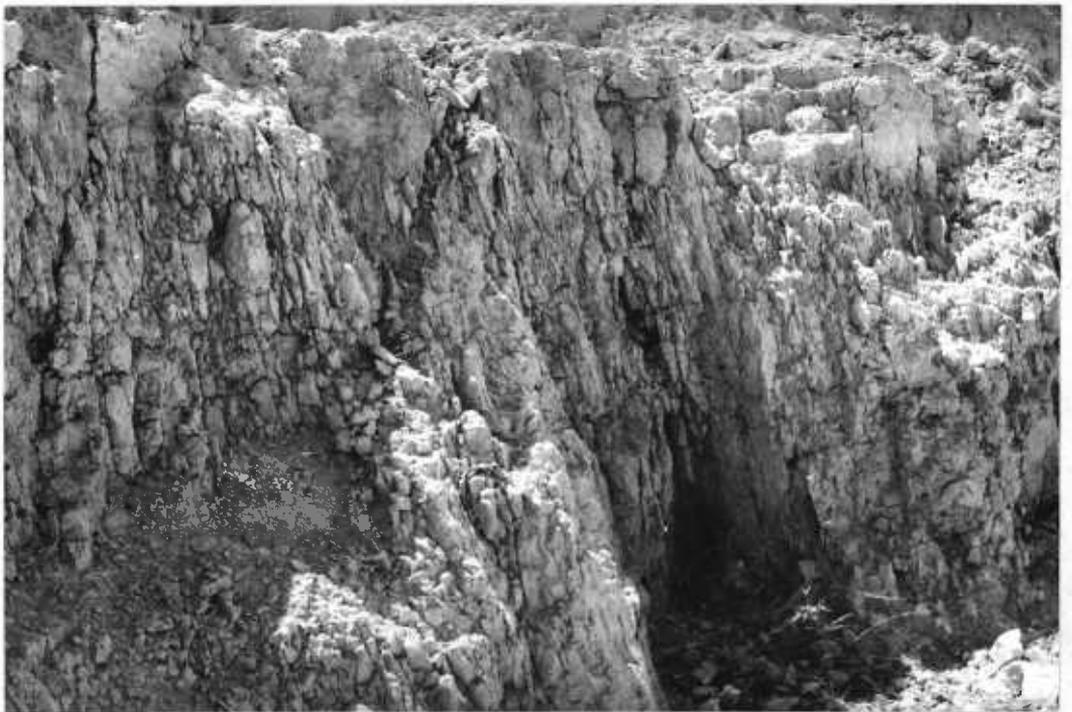
Plate 4.17 Shearing of the strata at the crown of landslide V.

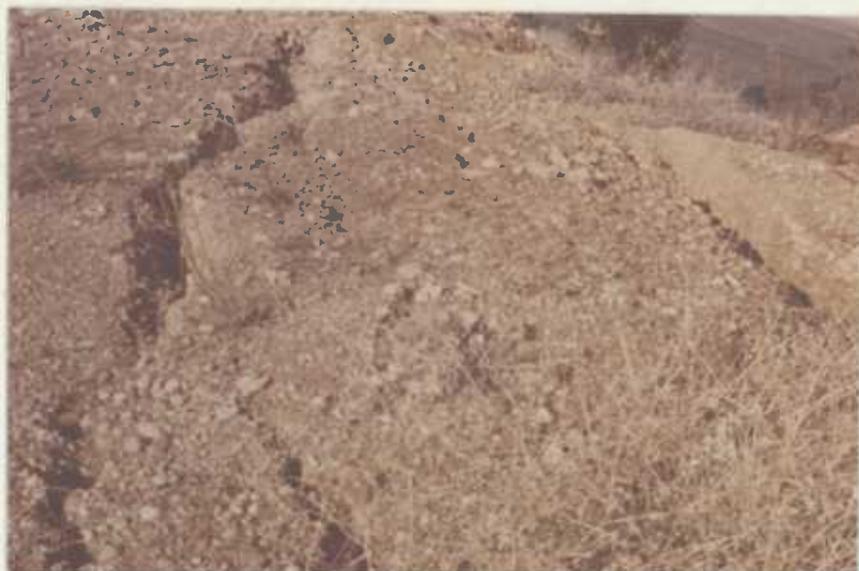
Plate 5.6 Landslide III in 1971.
Establishment of tension
cracks at the crown part
of the landslide.

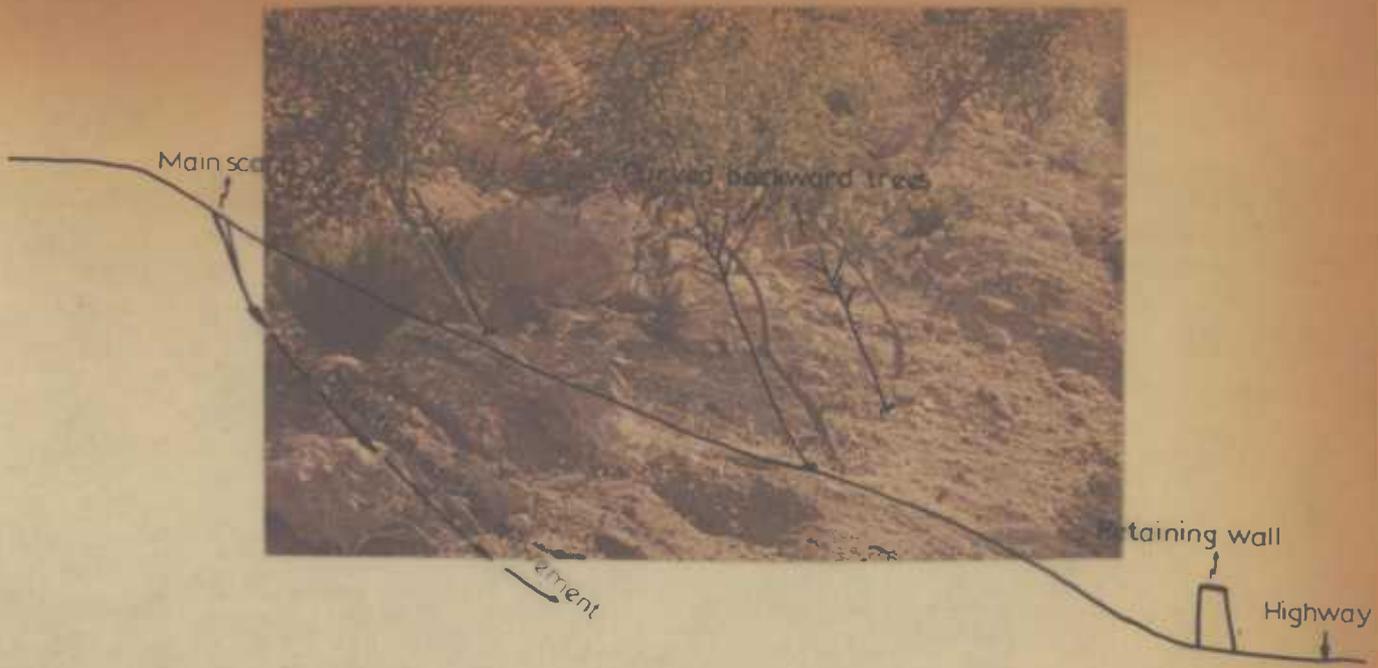
Plate 5.10 Shifted and curved backward trees at the crown of landslide IV indicating the progressive nature of the movement.

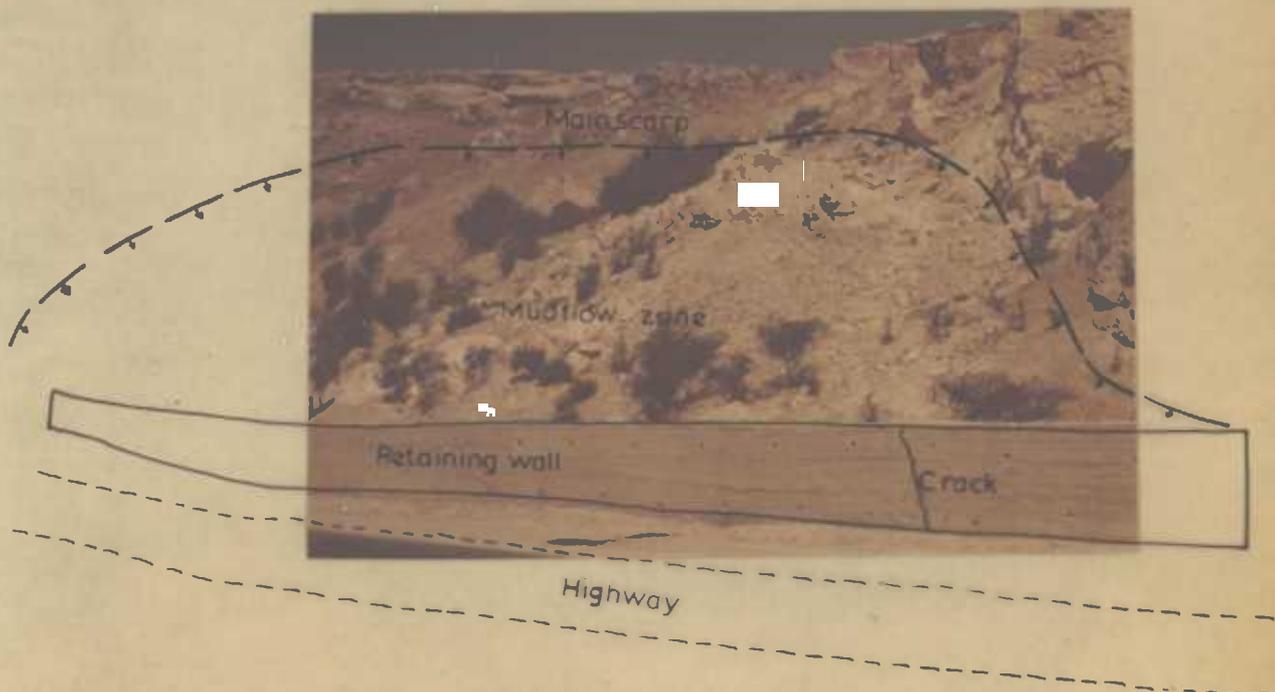
Plate 5.9 Earth and mudflow at the crown part of landslide IV. Notice cracking in the retaining wall.

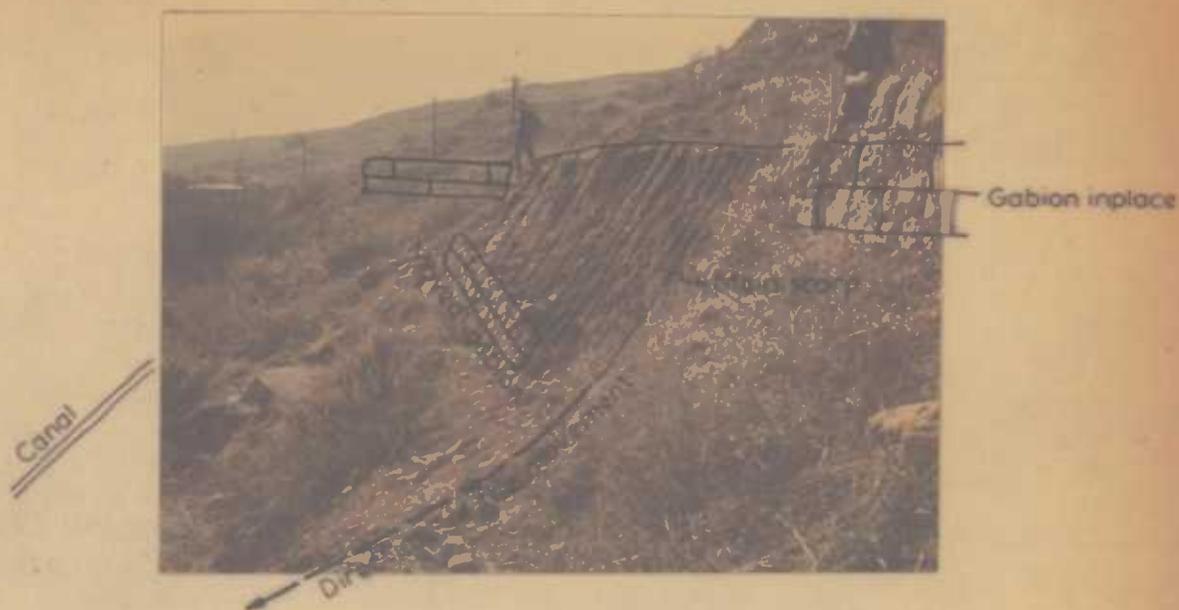
Plate 5.13 The main scarp of 1971 movement, showing the moved gabion at the crown of landslide I.

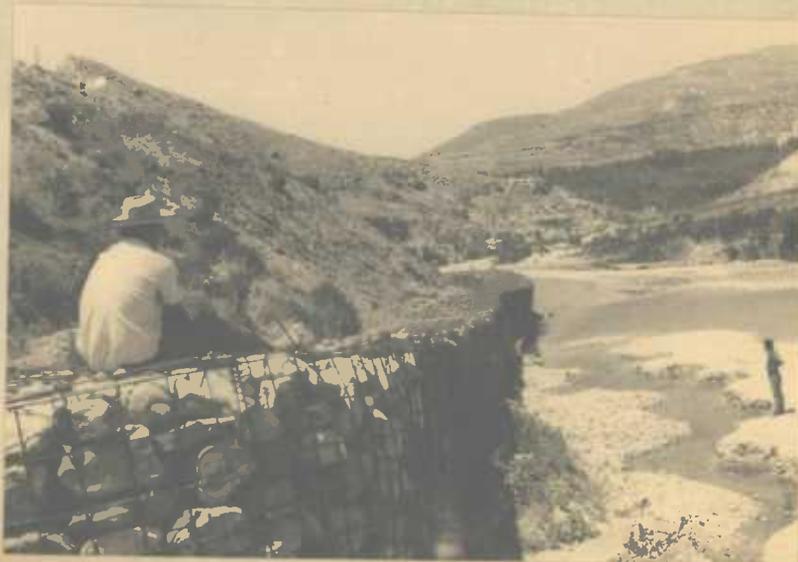
Plate 5.18 Tilting of the lower gabion at the level of Zerqa River - landslide II.

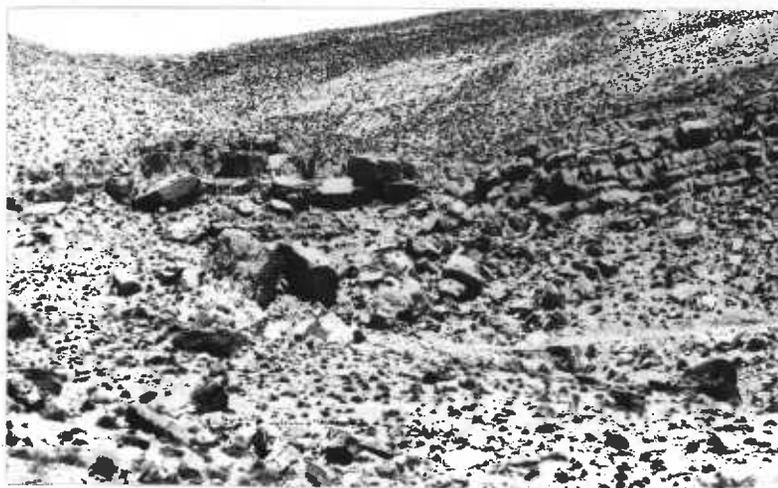
Plate 6.7 Block flow within the Lower Ajlun Formation.
