"Air bubble artefact"

Published in:
Clinical Radiology

Title: "Air bubble Artefact": A new type of artefact on CT heads.

X-ray Department, Ninewells Hospital, Dundee, UK

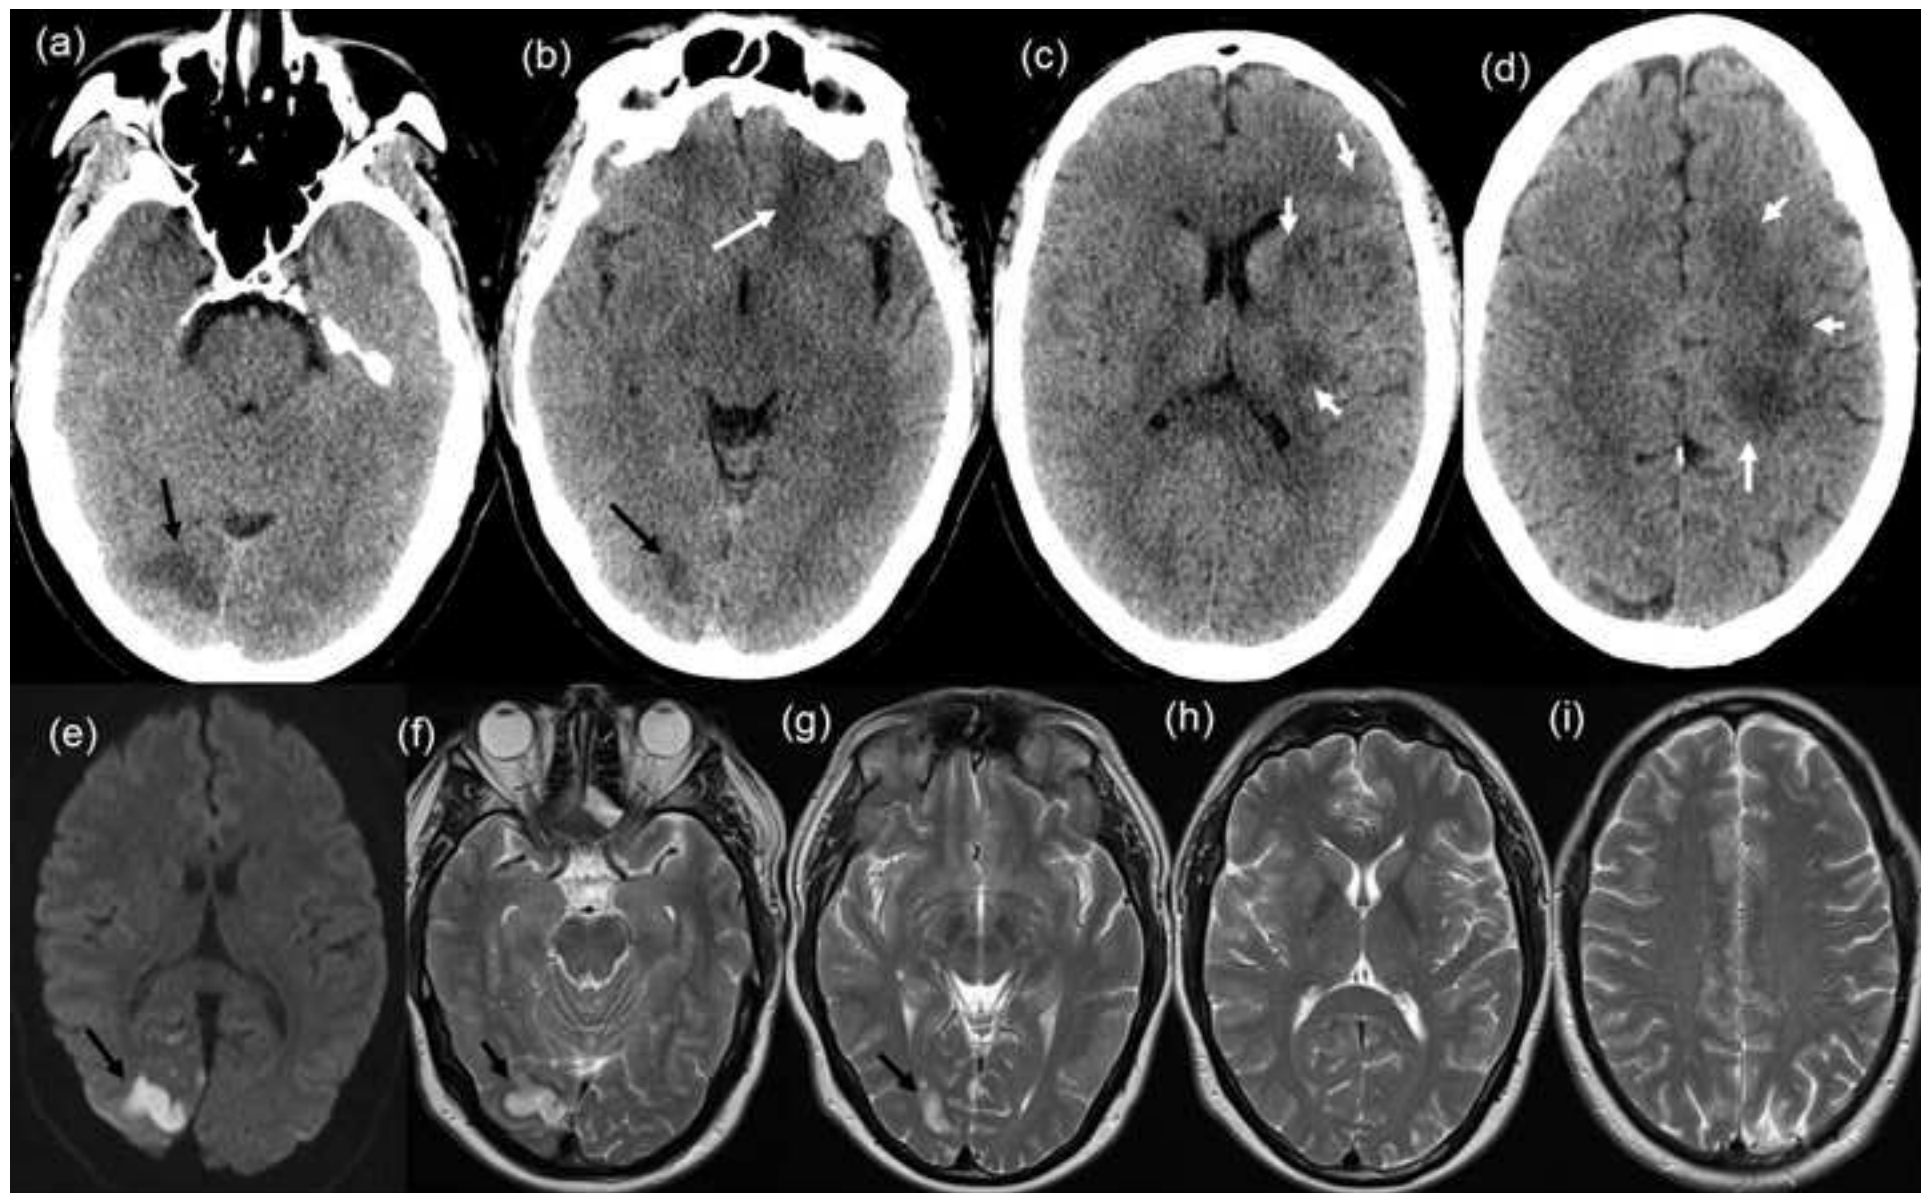
10 Figure 1: Non contrast CT images (a-d) and MR images: DWI (e) and T2 axials (f-i). Several areas of
11 low attenuation on CT (white arrows from b-d) that were not seen on MRI. A further area of low
12 attenuation on CT (black arrow in a,b), persistent on MRI, as diffusion abnormality in e and T2
13 abnormality on f,g consistent with actual infarct.

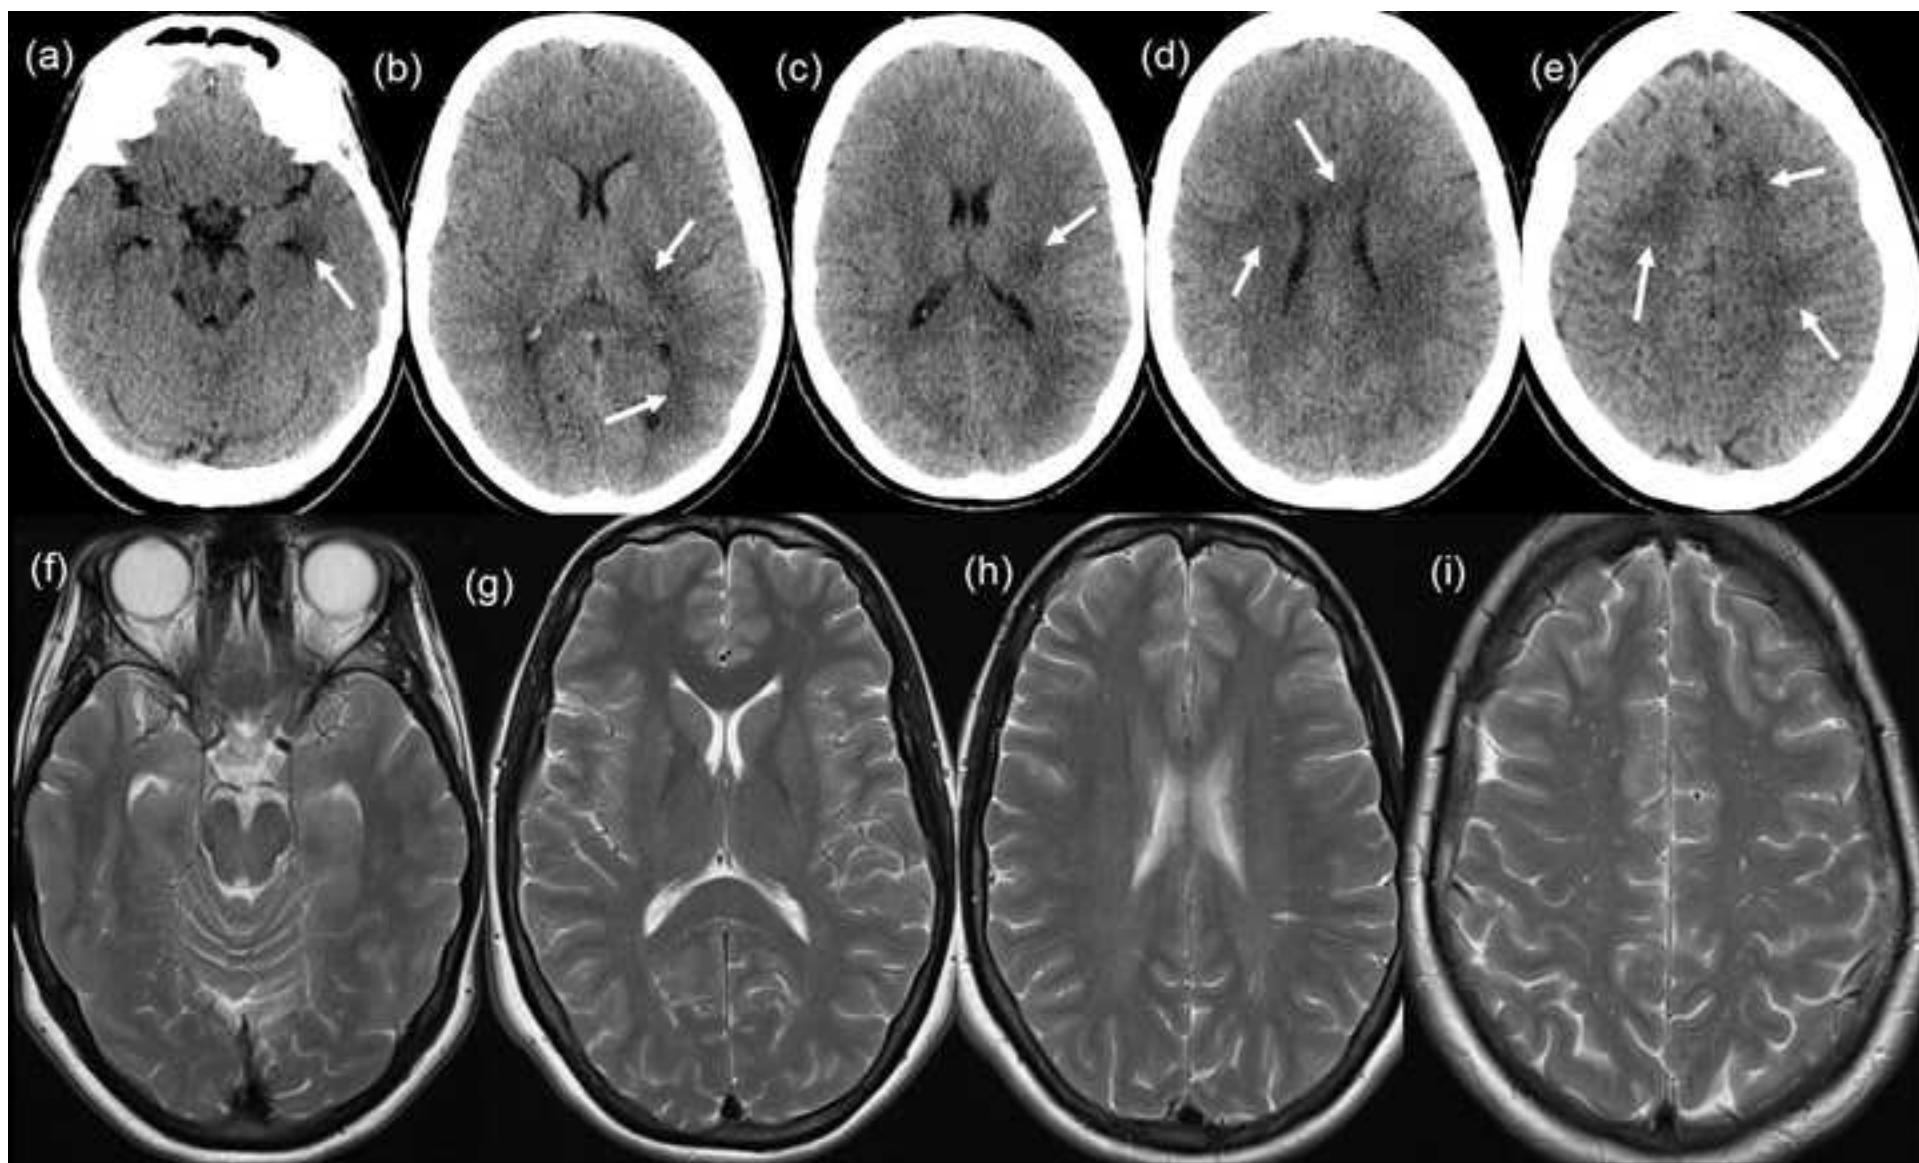
14 Figure 2: Non contrast CT images (a-e) and MR images T2 axials (f-i). Several areas of low attenuation
15 on CT (white arrows from a-e) that were not seen on MRI.

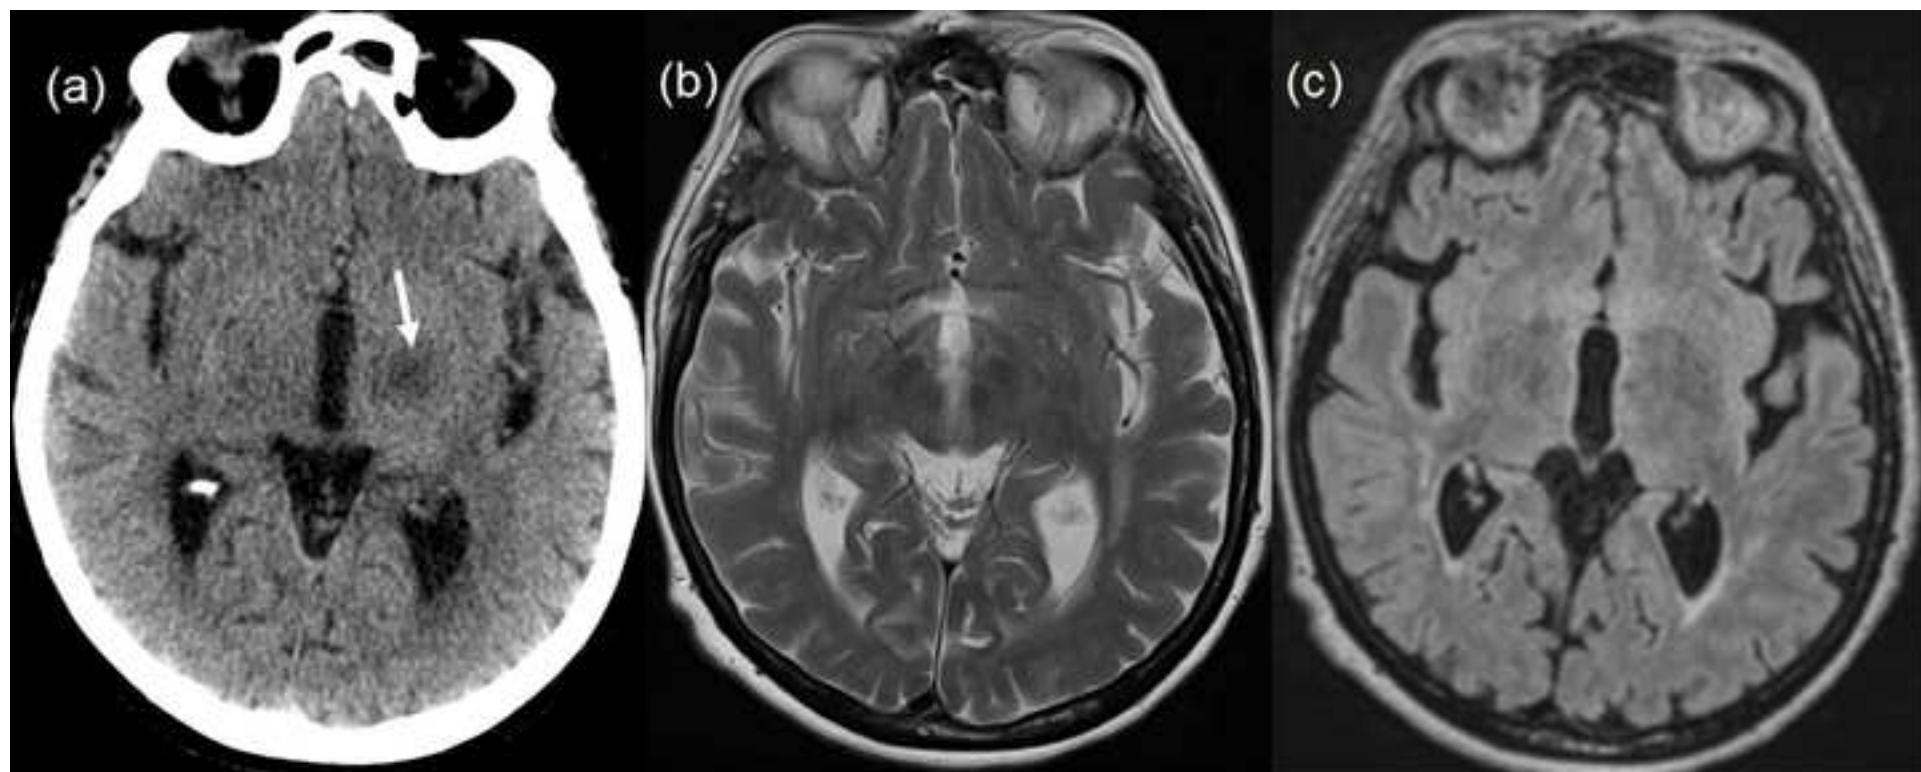
24 **some with multiple somewhat similar ill-defined areas of low attenuation in the cerebral**
25 **hemispheres on both sides, while some others had isolated abnormality (Figure 3) without**

16 Figure 3: Non contrast CT (a) shows focal low attenuation (white arrow) in left thalamus, not seen
17 on MRI T2 (b) and FLAIR (c).

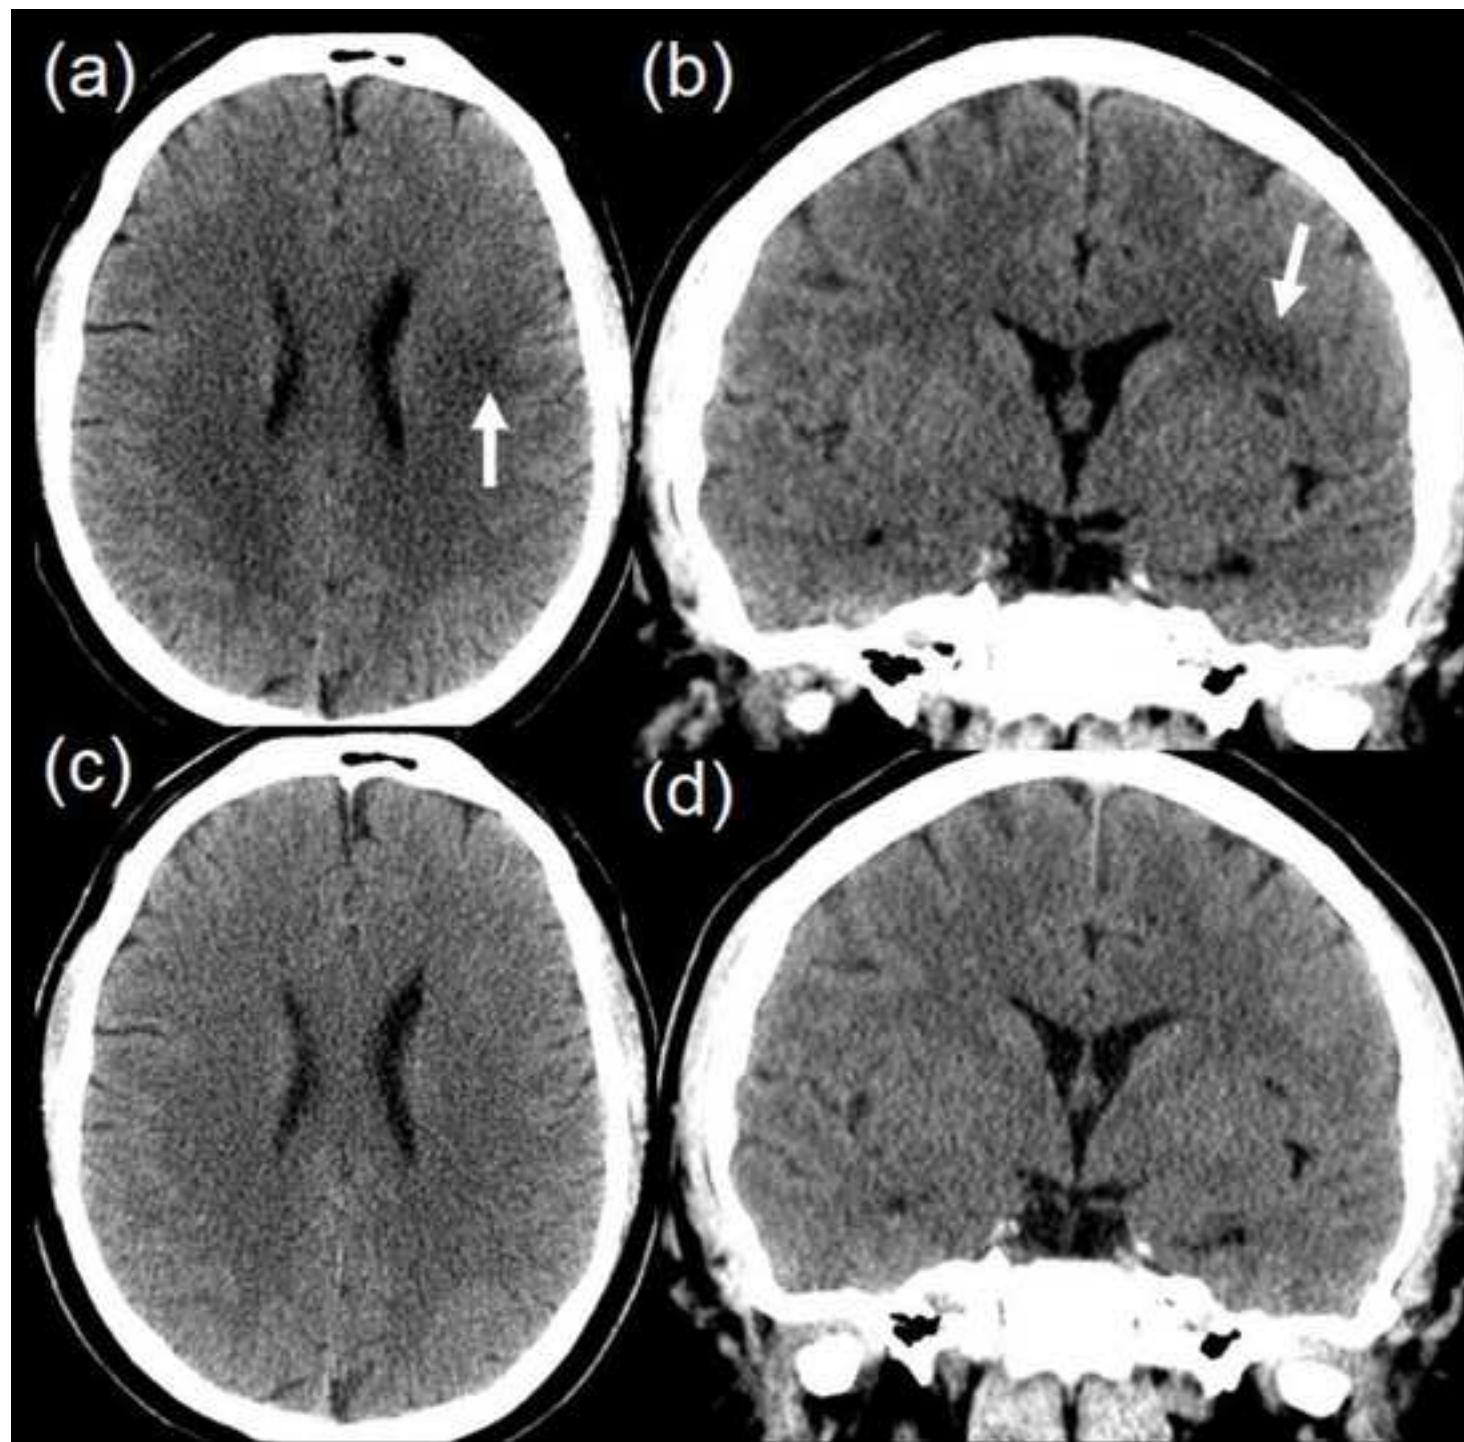
10 minutes. The second CT was normal and it was therefore confirmed that the appearances must be
11 artefactual (Figure 4). As this artefact was only being seen on CT heads, it was immediately decided
12 to stop using the scanner in question for CT Heads pending further investigations.

18 Figure 4: Initial Non contrast CT images in axial and coronal reconstructions (a,b) showing low
19 attenuation area (White arrow). Repeat CT within 15 minutes on a similar type of scanner (c,d) is
20 normal.

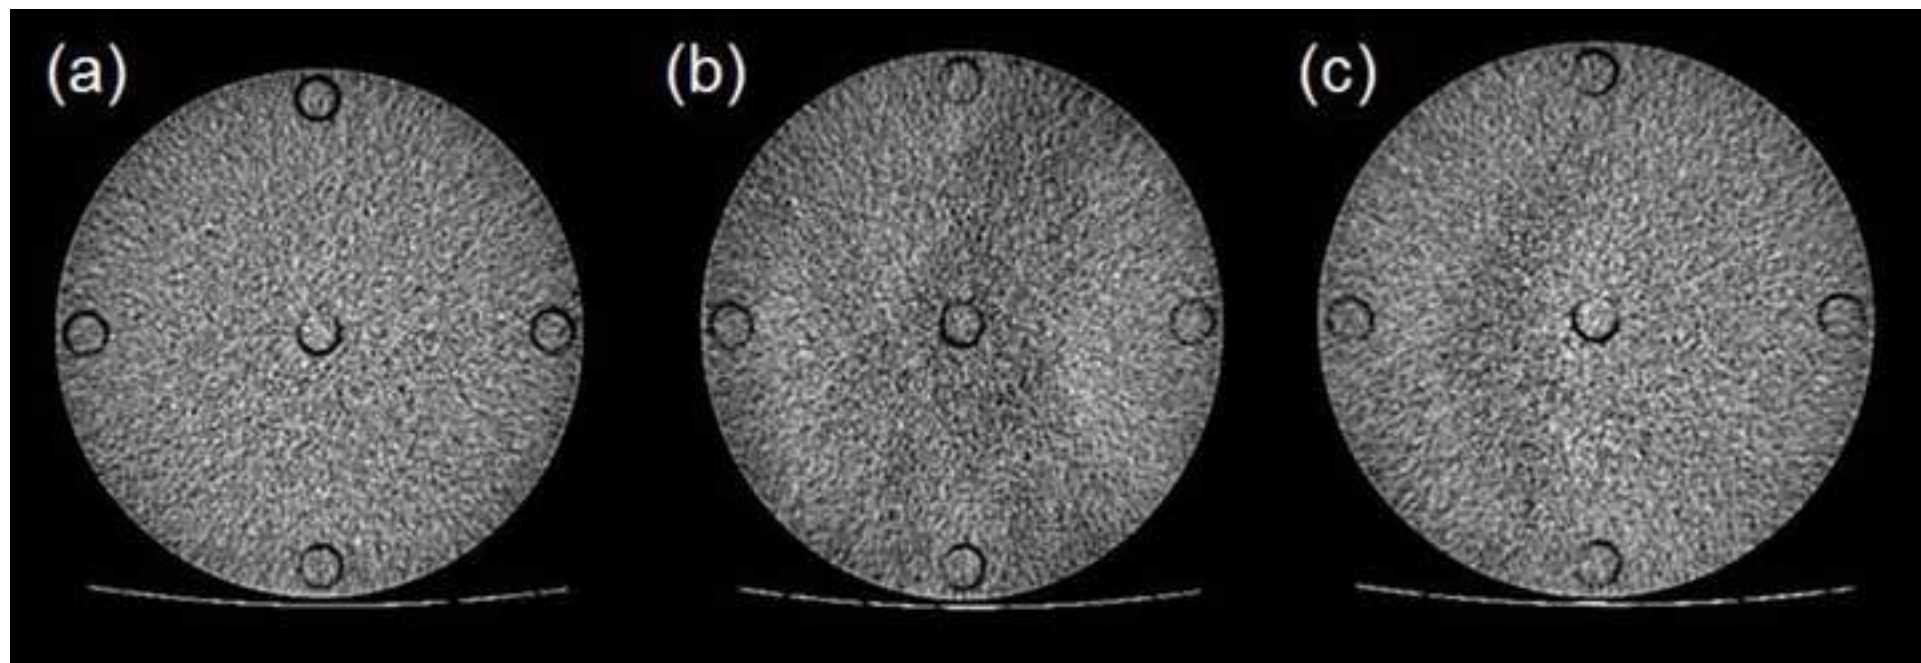
4 The CATPHAN and CTDI Perspex head phantom images were also reviewed. The artefact was not
5 identifiable on the CATPHAN images but could be seen on images of the Perspex head phantom
6 acquired using the clinical CT Head protocol (Figure 5). In this case the motion of the air in the tube
7 oil cooling system could be seen in the phantom as the tube rotated when scrolling through the
8 images. This required a narrow window width of 40 in order to clearly identify the artefact on the CT
9 console.

21 Figure 5a)-c) CT images of the CTDI Perspex Head Phantom acquired using the clinical CT Head
22 protocol, viewed at window level 100 and width 40. Image a) no artefact is visible. Images b) and c)
23 the artefact is visible as the air in tube oil cooling system was present in the primary beam at the x-

1 ray tube output window during the rotation. The position and degree of artefact varies greatly
2 throughout the series due to the motion of the air bubble.

15 The air was removed from the tube oil cooling system by a service engineer.

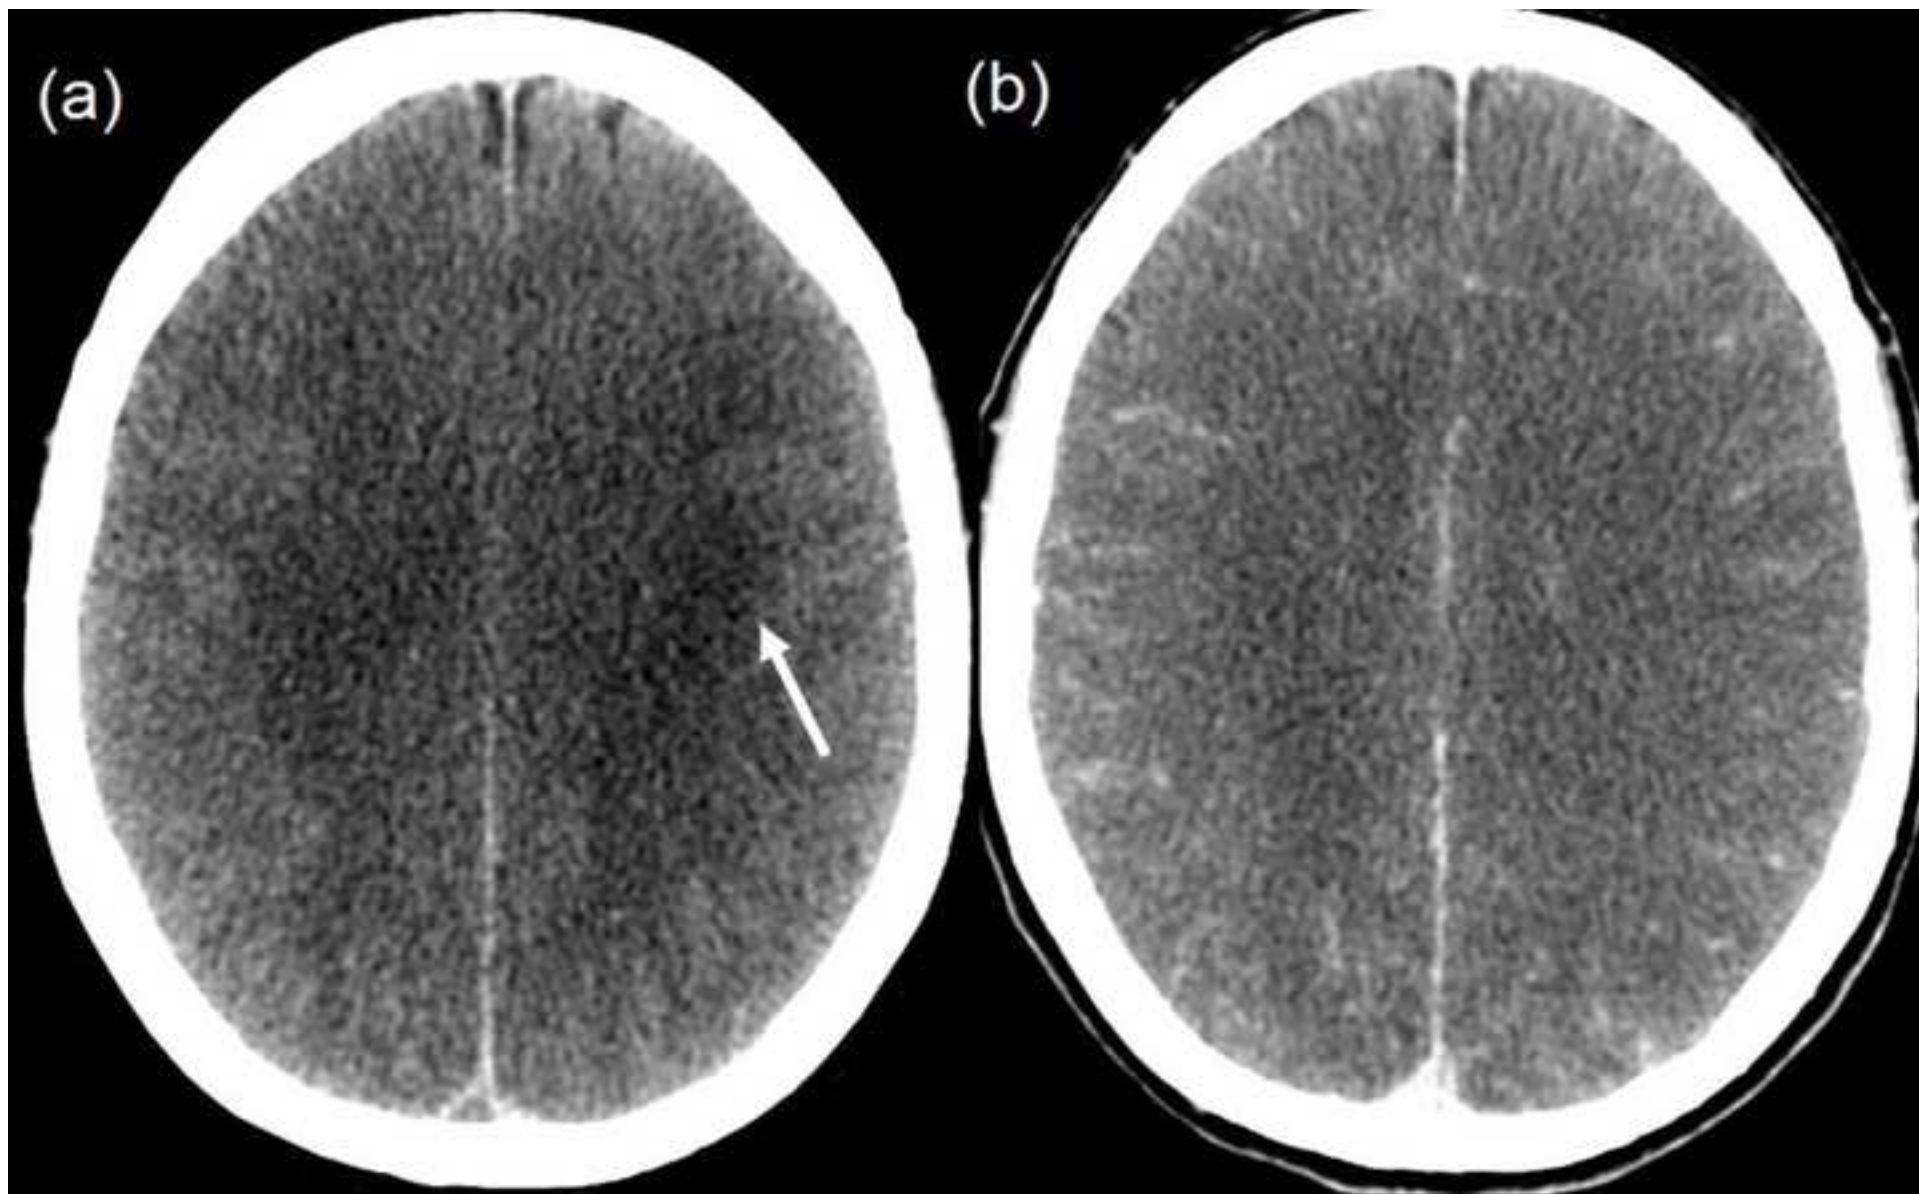
21 During the review of cases, we did come across a "missed opportunity". Some of the CT heads were
22 performed twice as part of CT head/CT venogram and CT heads (pre and post contrast). While most
23 of these were negative for artefacts, in one instance, we identified it to be present on non contrast
24 images but not on the postcontrast images (Figure 6). However, the changes were very subtle and
25 the reporting radiologist did not recognise it.

3 Figure 6: Missed opportunity. Initial non contrast CT (a) showing area of low attenuation on left side
4 (white arrow). It is not seen on the corresponding post contrast image (b)
